- **Call Flow Diagram** - This diagram outlines the major activities that are performed when a service call is made. The **Initial Actions** assist the Service Representative through the customer interface and help to identify the problem. The diagram also directs the Representative to verify, classify, repair the problem and perform the correct Maintenance Procedure.

2. Status Indicator Repair Analysis Procedures

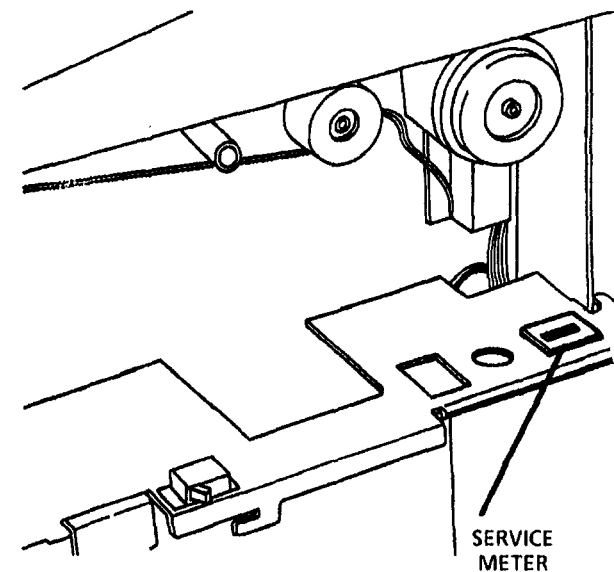
Figure 2. Service Meter Location

A
ENTER CUSTOMIZED
PROGRAM **P15** AND RECORD
THE METER A READING

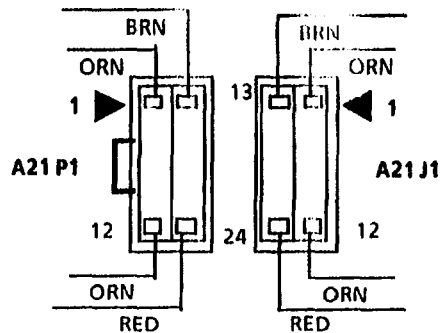
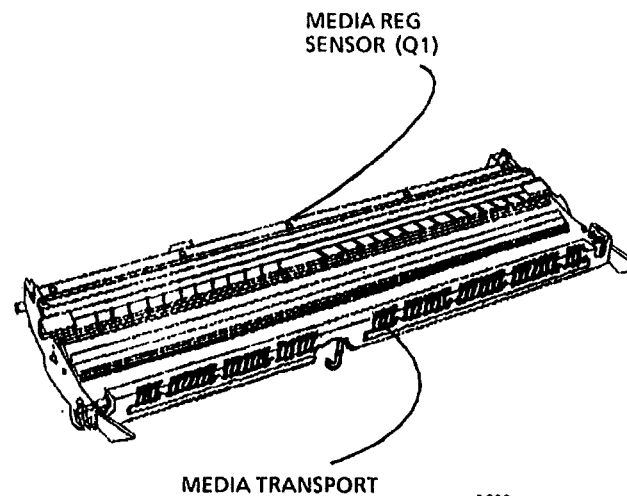
- 1 CONNECTOR A21 P/J1 IS A MULTIPLE MODULE CONNECTOR. REFER TO SECTION 7 FOR REPAIR DATA.

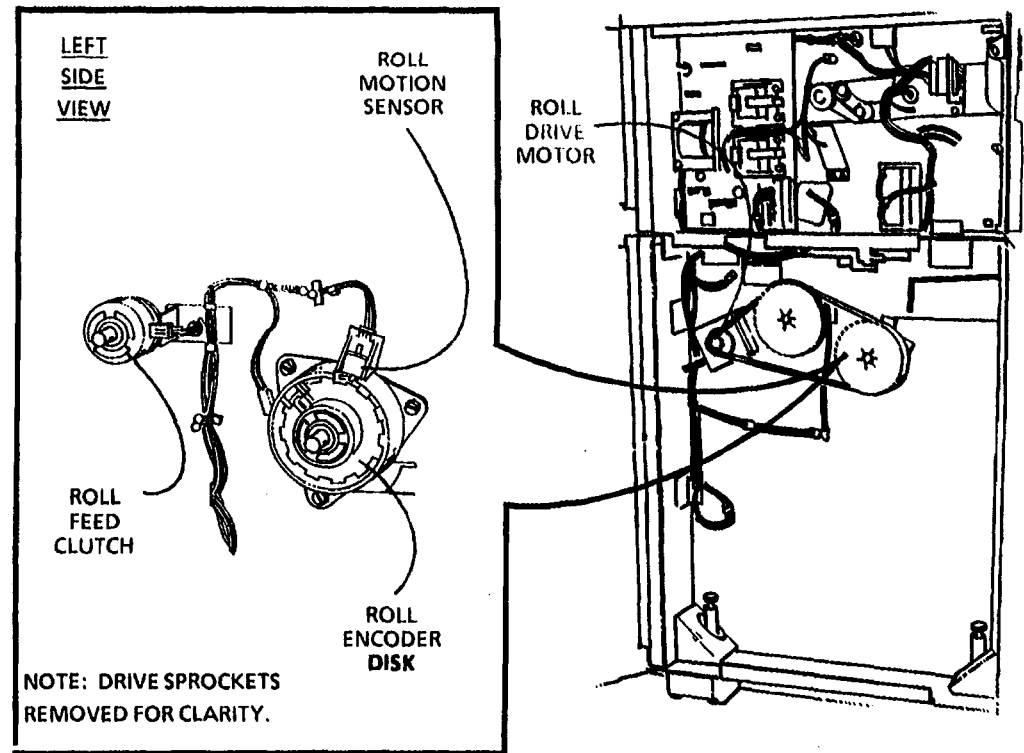
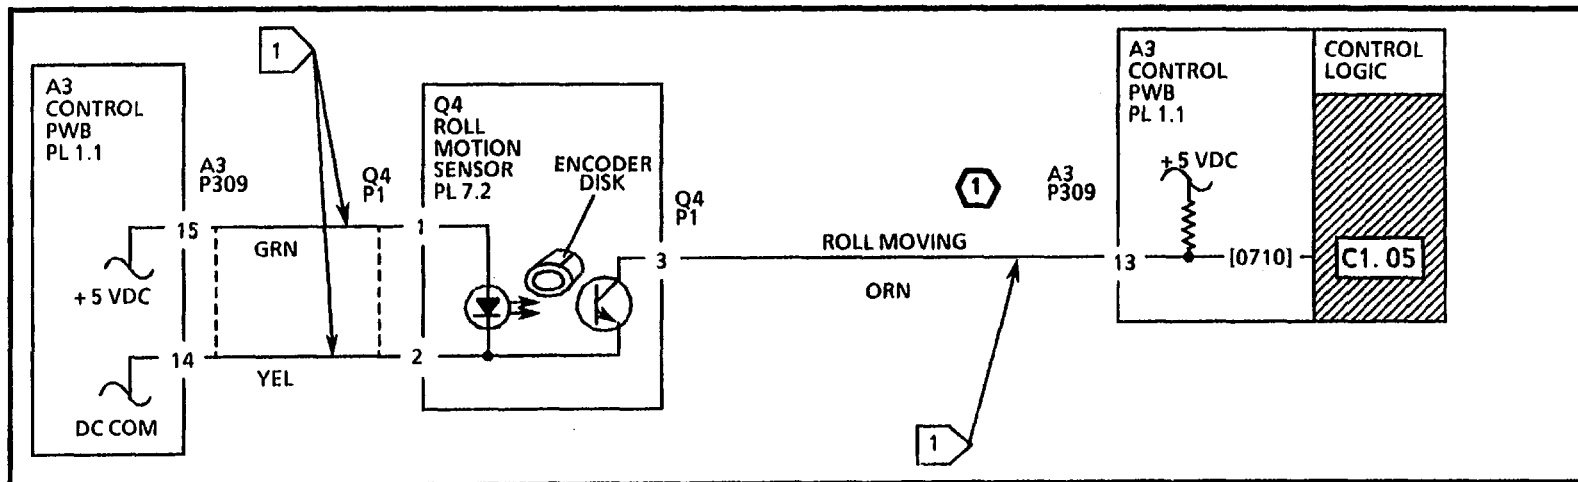
- ① THE ROLL MOVING SIGNAL IS EITHER + 5 VDC OR 0 VDC WHEN THE ROLL IS NOT MOVING. THE SIGNAL IS APPROXIMATELY + 2.4 VDC WITH THE ROLL MOVING.

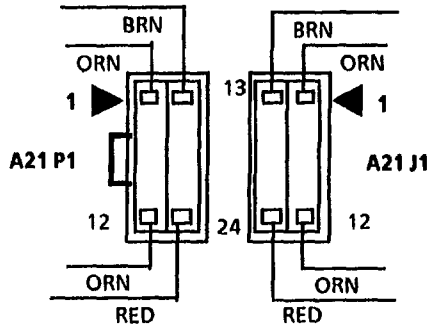
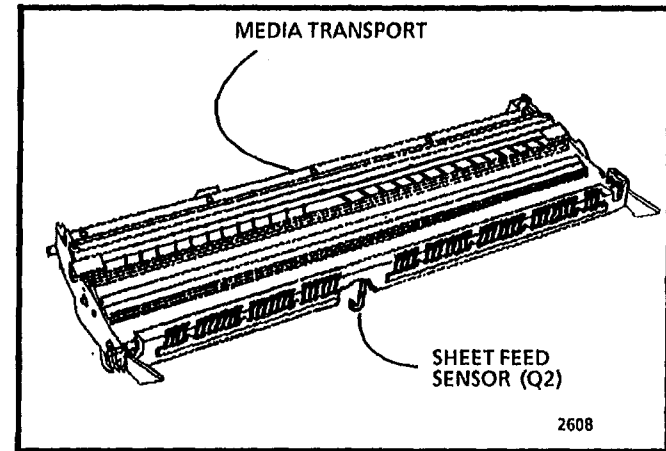
- 1 CONNECTOR A21 P/J1 IS A MULTIPLE MODULE CONNECTOR. REFER TO SECTION 7 FOR REPAIR DATA.

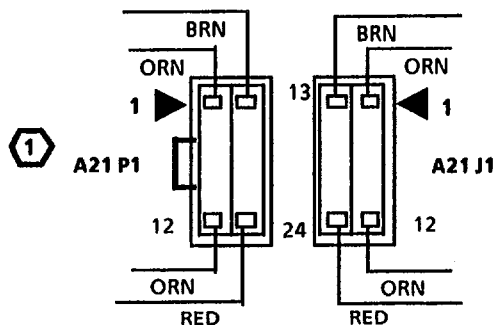
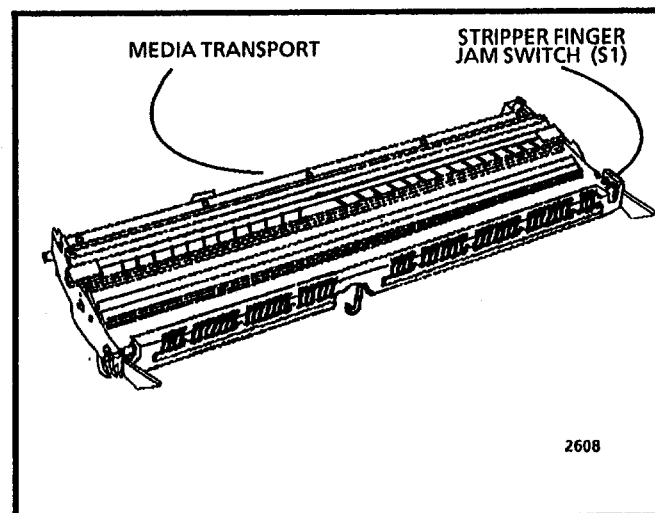
- ① CONNECTOR A21 P/J1 IS A MULTIPLE MODULE CONNECTOR. REFER TO SECTION 7 FOR REPAIR DATA.

- ② SWITCH (S1) IS A NORMALLY CLOSED (NC) SWITCH WHICH IS HELD ACTUATED (OPEN) BY THE STRIPPER FINGER ASSEMBLY. MEDIA MISSTRIP JAMS CAUSE THE STRIPPER FINGER ASSEMBLY TO MOVE OUT OF POSITION CAUSING THE SWITCH (S1) TO DEACTUATE (CLOSE) RESULTING IN THE MEDIA MISSTRIP SIGNAL TO GO LOW (L).

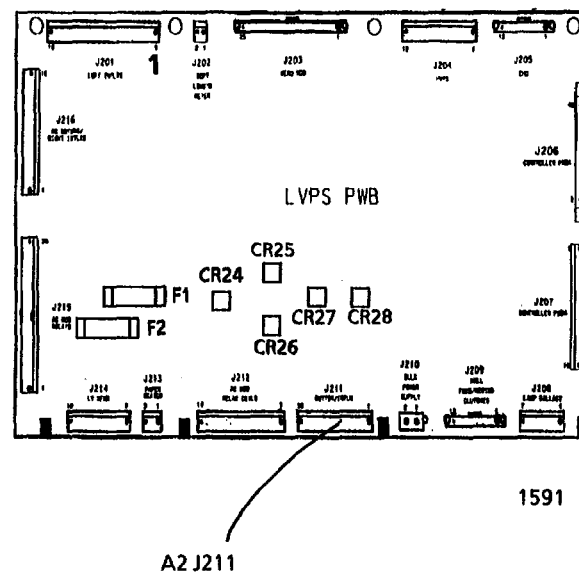
LVPS/ DRIVER PWB (A2)

- Check the connectors A2 P211 on the LVPS/ Driver PWB (A2) and S1 P1 on the Cutter Cover Interlock Switch for damage, and ensure that the connectors are seated correctly.
- Ensure that the Actuator on the Cutter Cover correctly actuates the switch.

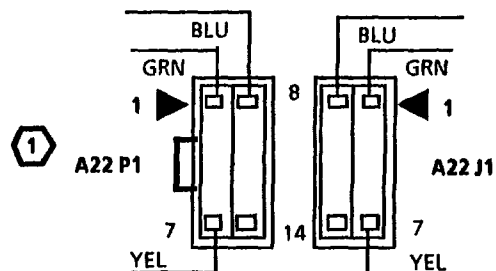
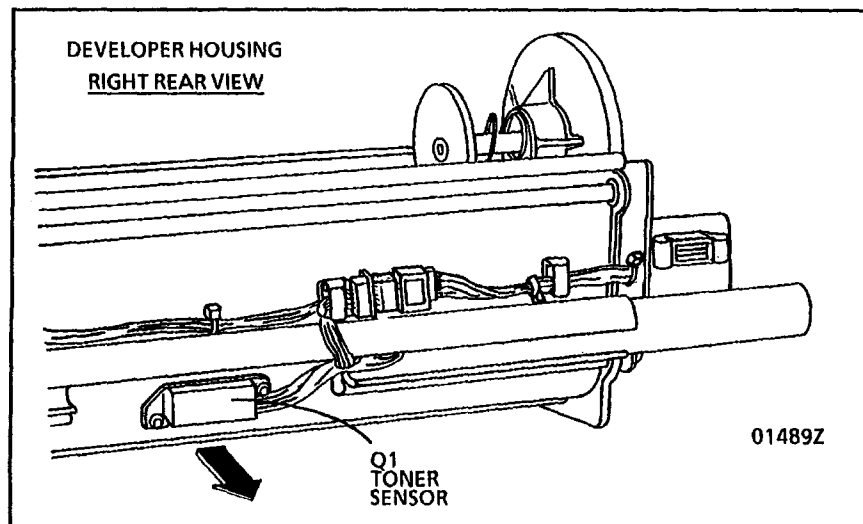
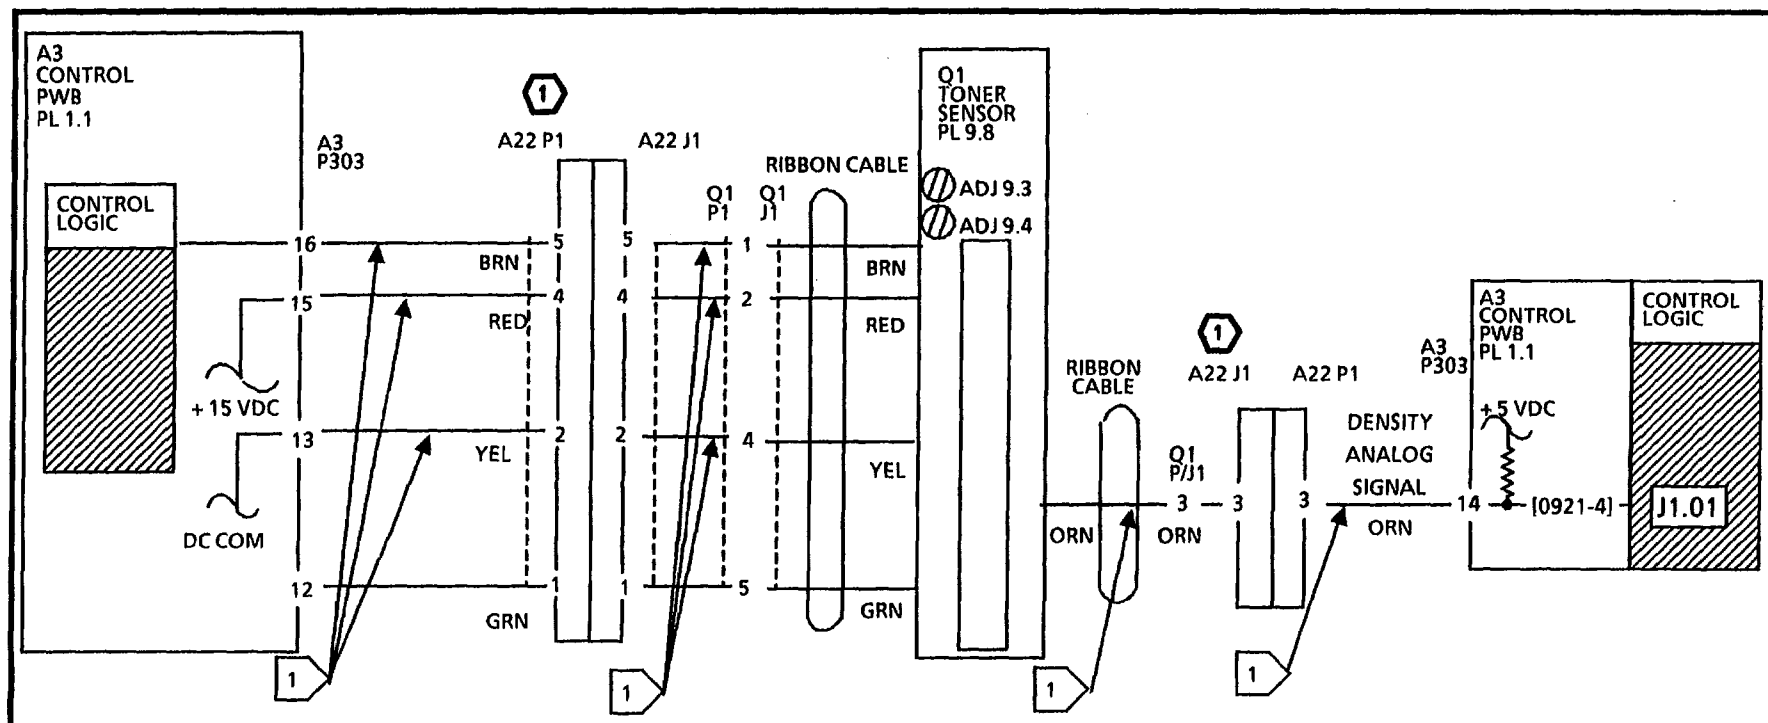
Go to Flag 1 and check the wiring for an open or a short circuit in the wires to ground. If there are no open or short circuits, replace the following components one at a time beginning with "a". After replacing the component, enter the code [0921-06] in order to calibrate the Toner Control System.

- ① CONNECTOR A22 P/J1 IS A MULTIPLE MODULE CONNECTOR. REFER TO SECTION 7 FOR REPAIR DATA.

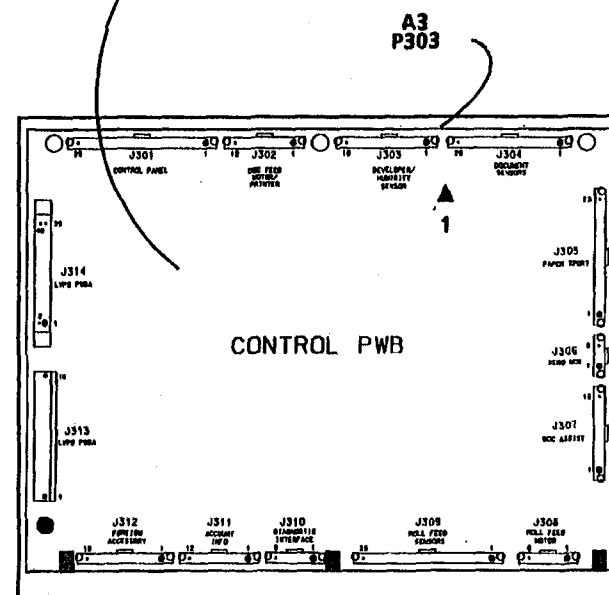
CONTROL PWB (A3)

Replace the Control PWB (A3).

Replace the Control Board (A3).

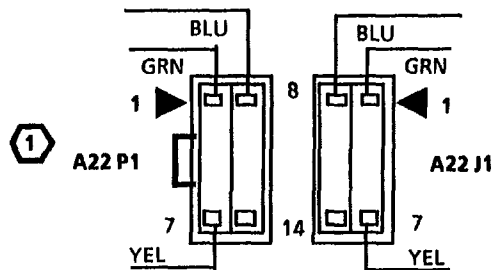
① CONNECTOR A22 P/J1 IS A MULTIPLE MODULE CONNECTOR. REFER TO SECTION 7 FOR REPAIR DATA.

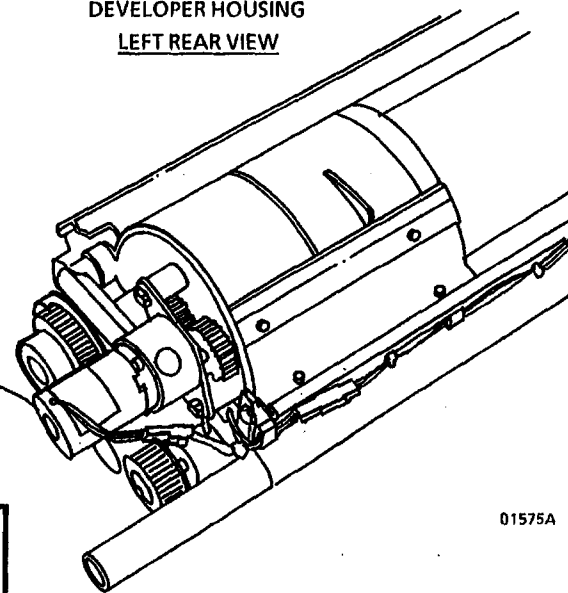
DEVELOPER HOUSING
LEFT REAR VIEW

Unplug A22M1 P/J1 and check the resistance of the motor. If the resistance is not 23 Ohms (± 5 Ohms), replace the Cartridge Drive Motor.

CARTRIDGE DRIVE MOTOR (M4)

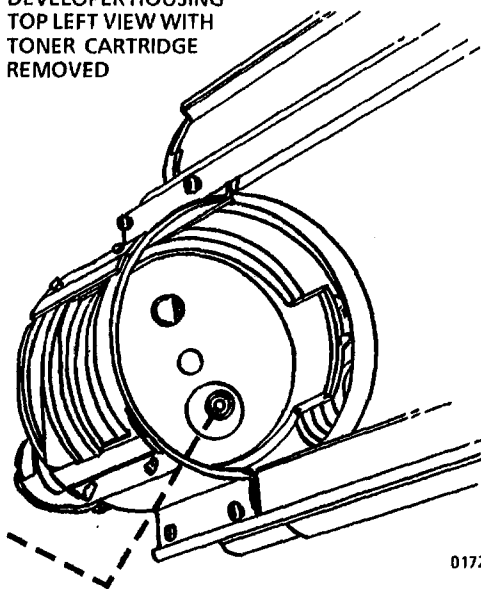
DEVELOPER HOUSING
TOP LEFT VIEW WITH
TONER CARTRIDGE
REMOVED

Go to FLAG 2 and check the wires for an open or short circuit. If there is no open or short circuit, adjust or replace the Cartridge Home Switch.

Note: If the cartridge magnet is missing or not positioned properly, the cartridge drive motor may rotate for more than one revolution when diagnostic code [0925] is entered.

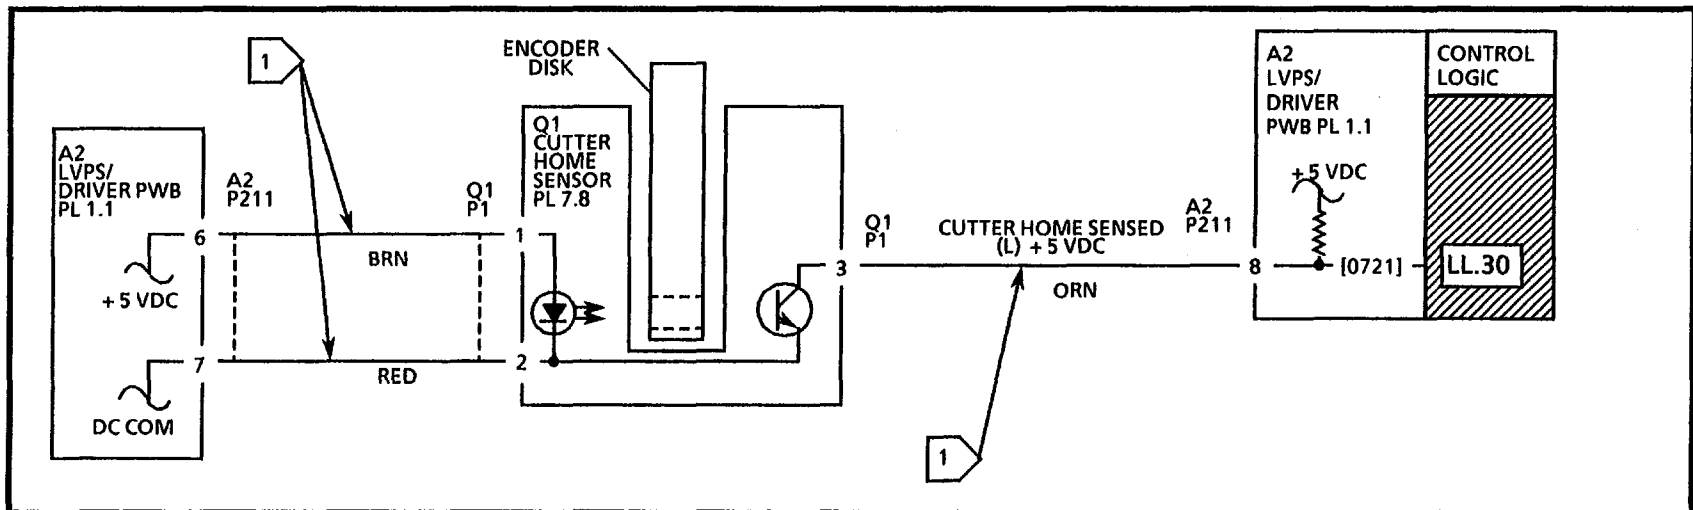
NOTE:

- 1 OUTPUT SIGNAL IS GENERATED BY CUTTER DRIVE (SERVO) MOTOR. SIGNAL VOLTAGE READING IS APPROXIMATELY + 1.7 VDC

The status code LL.30 is displayed when the logic detects that there is a media cutter problem. As the cutter bar rotates to cut the media, the Cutter Home Sensor is blocked and not blocked by the rotating encoder disk. The logic detects a change in the state of the Cutter Home Sensor signal.

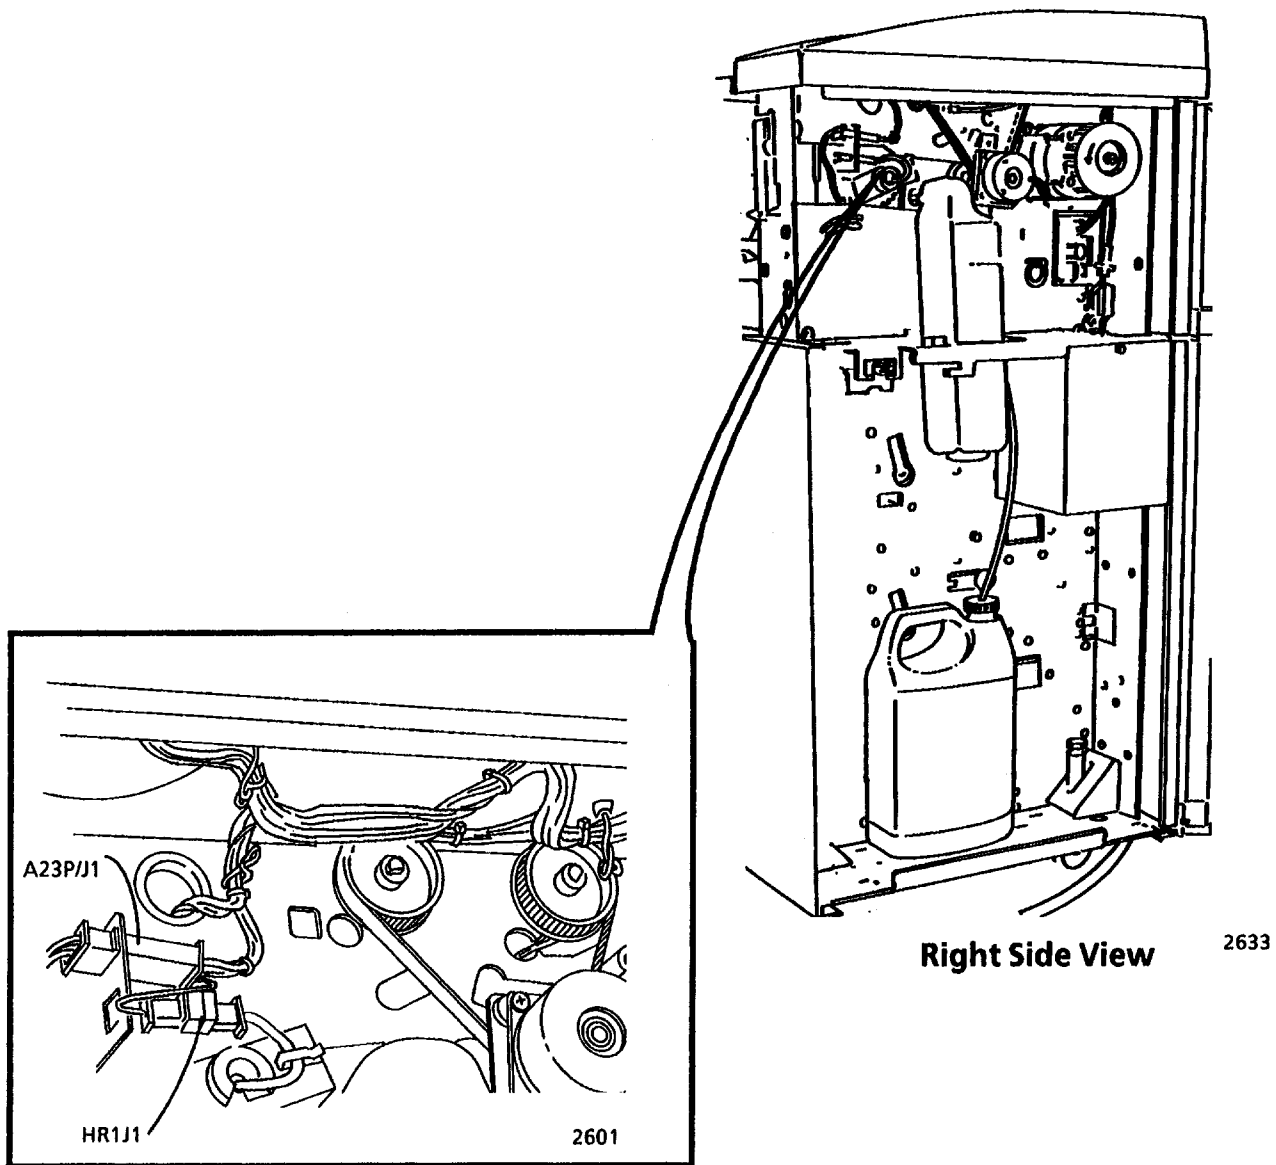
NOTES:

- ① THERMISTOR PAD CONTAINS THE FUSER THERMISTOR (RT1), AND THE TEMPERATURE LIMIT THERMISTOR (RT2). THE THERMAL CONTROLLER PWB CONTAINS THE THERMISTOR PAD AND THE THERMAL FUSE (A23A1F1).

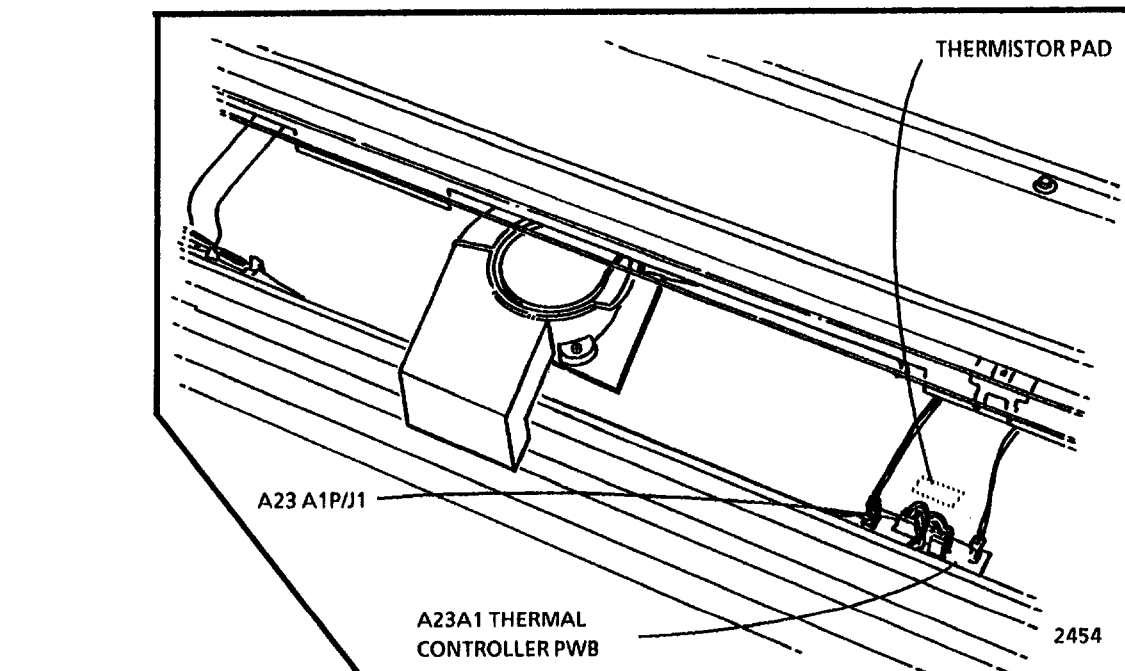
NOTES:

- ① THERMISTOR PAD CONTAINS THE FUSER THERMISTOR (RT1), AND THE TEMPERATURE LIMIT THERMISTOR (RT2). THE THERMAL CONTROLLER PWB CONTAINS THE THERMISTOR PAD AND THE THERMAL FUSE.(A23A1F1).

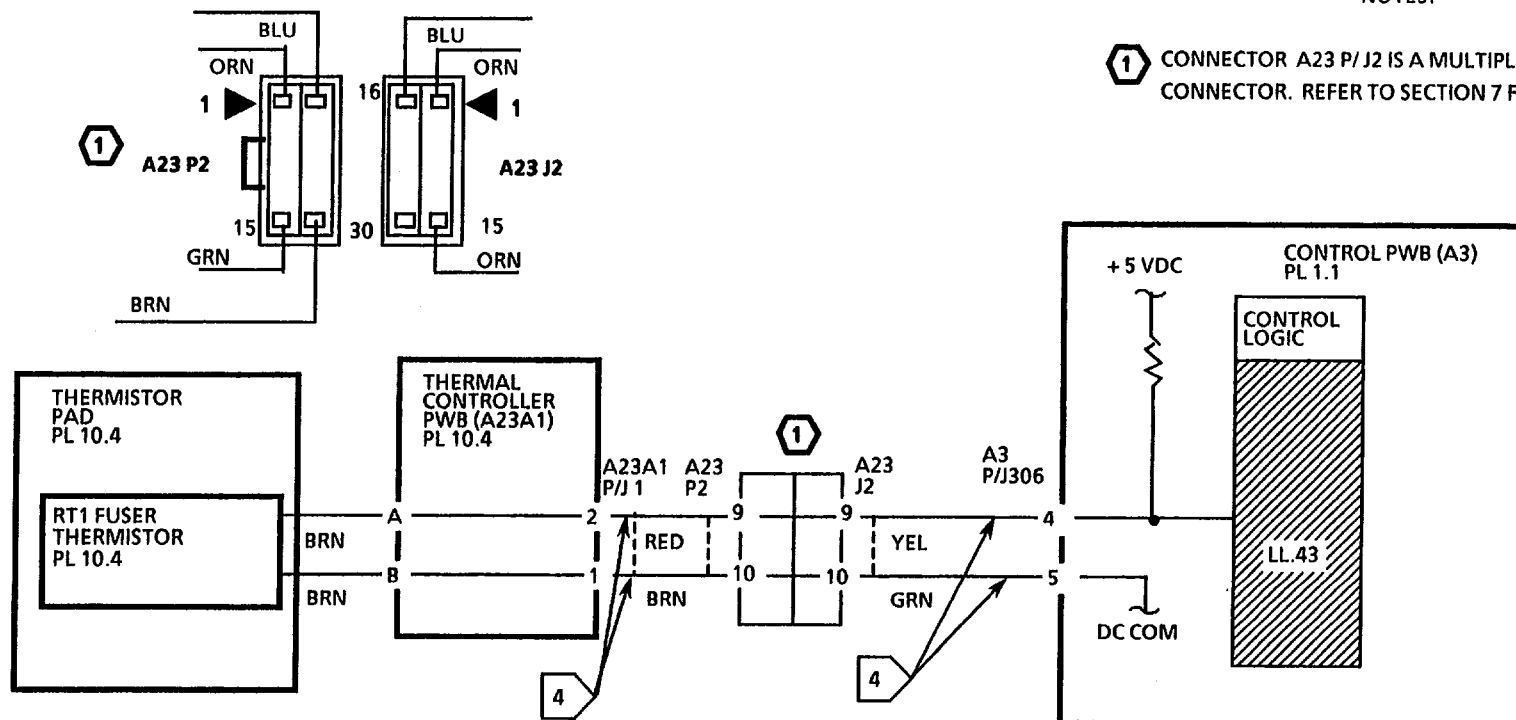
NOTES:

① CONNECTOR A23 P/J2 IS A MULTIPLE MODULE CONNECTOR. REFER TO SECTION 7 FOR REPAIR DATA.

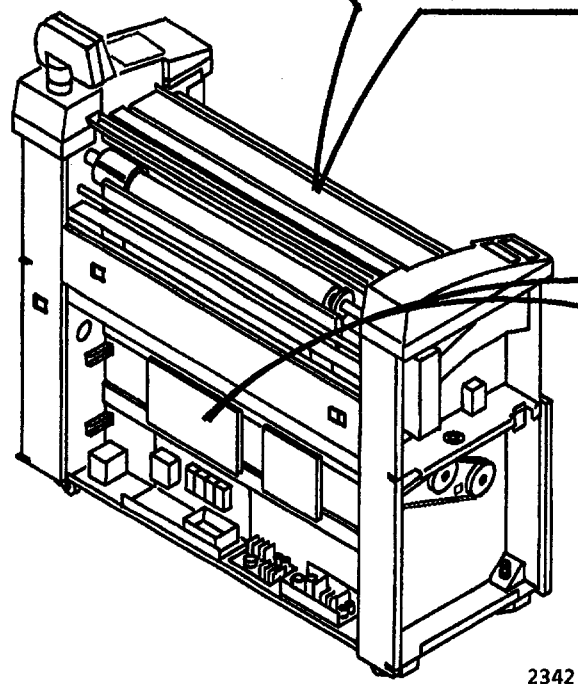
- ① THERMISTOR ASSEMBLY CONTAINS FUSER THERMISTOR (RT1) AND TEMPERATURE LIMIT THERMISTOR (RT2).

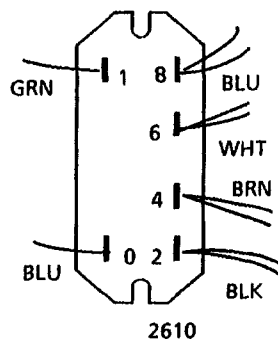
K1 MAIN
POWER
RELAY

- 1 IF THIS FUSE IS OPEN, DO NOT REPLACE. THIS IS AN INDICATION OF A SERIOUS POWER SUPPLY FAULT. REPLACE THE 26 VDC BULK POWER SUPPLY

- Ensure that connectors A4P1 and A4P2 on the +26 VDC Bulk Power Supply are correctly installed and fully seated.
- Ensure that Fuse FU2 on the +26 VDC Bulk Power Supply has continuity. If not, the power supply has an internal fault. Replace the power supply.
- Before troubleshooting, ensure that all AC Interlocks are closed. An open Interlock will cause the Main Power relay to open.

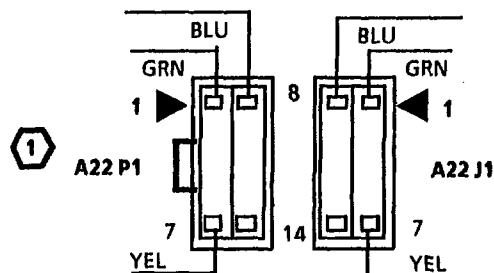
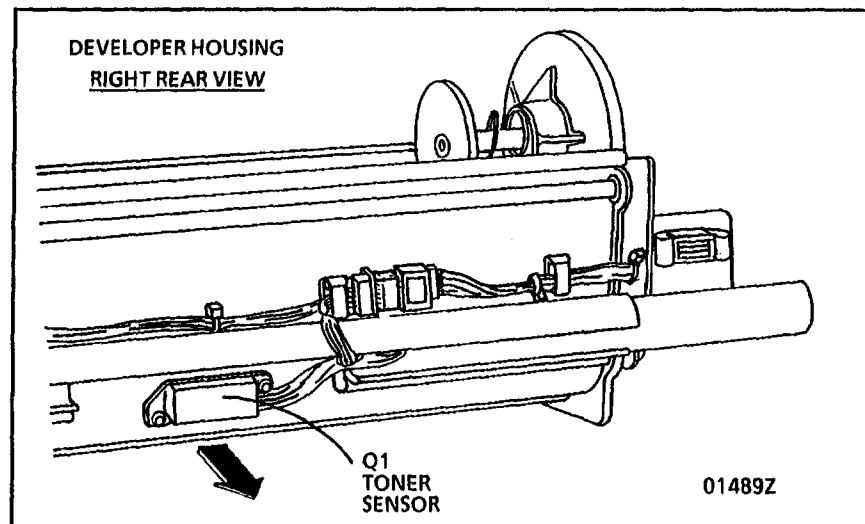
- ① CONNECTOR A22 P/J1 IS A MULTIPLE MODULE CONNECTOR. REFER TO SECTION 7 FOR REPAIR DATA.

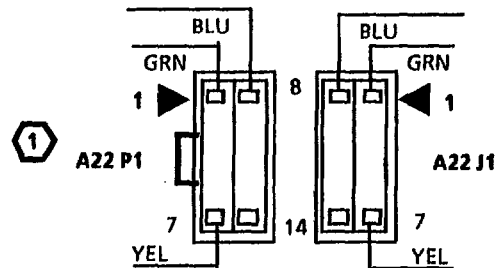
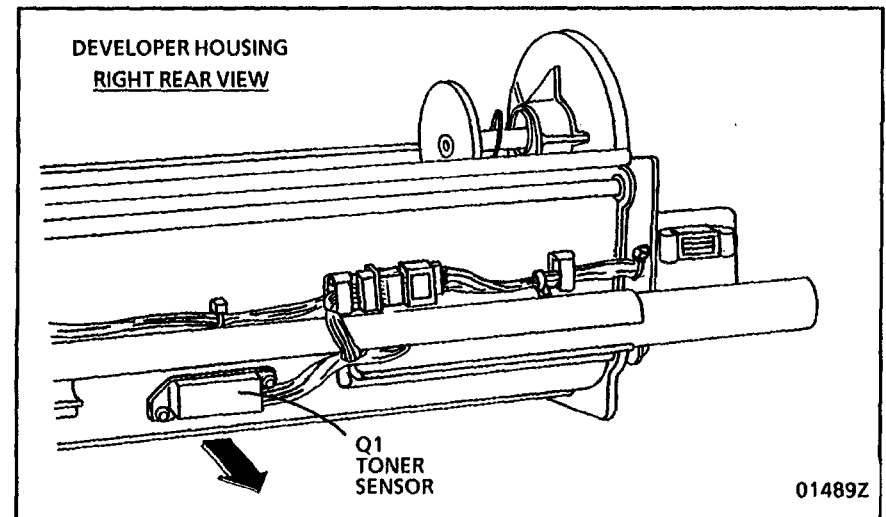
- 1 CONNECTOR A22 P/J1 IS A MULTIPLE MODULE CONNECTOR. REFER TO SECTION 7 FOR REPAIR DATA.

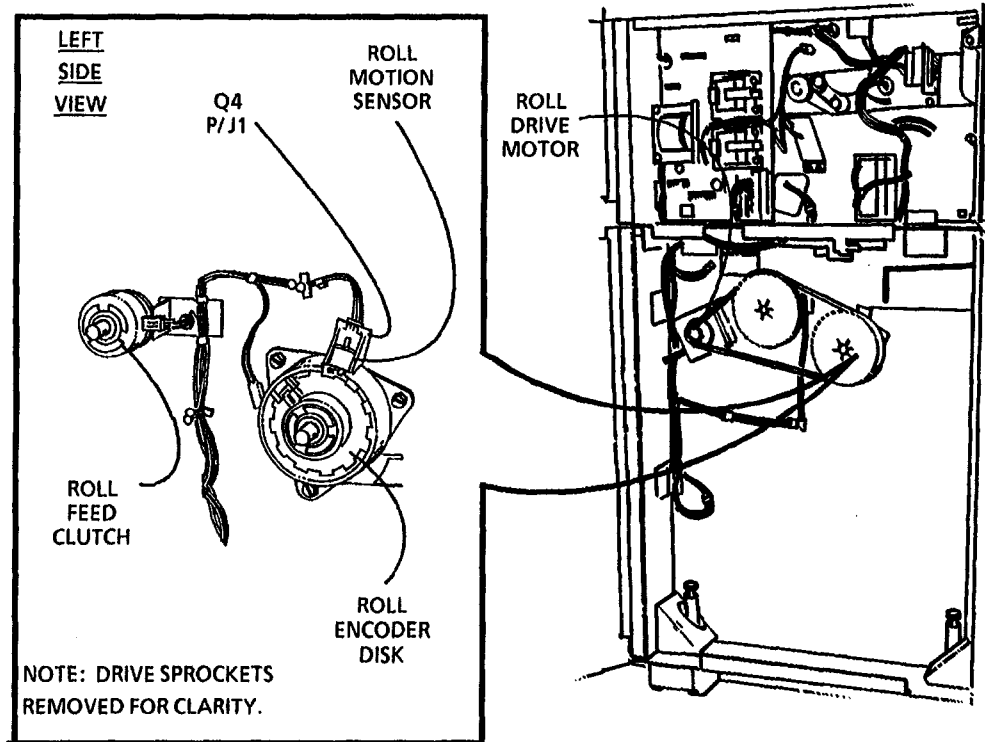
- ① THE ROLL MOVING SIGNAL IS EITHER + 5 VDC OR 0 VDC WHEN THE ROLL IS NOT MOVING. THE SIGNAL IS APPROXIMATELY + 2.4 VDC WITH THE ROLL MOVING.

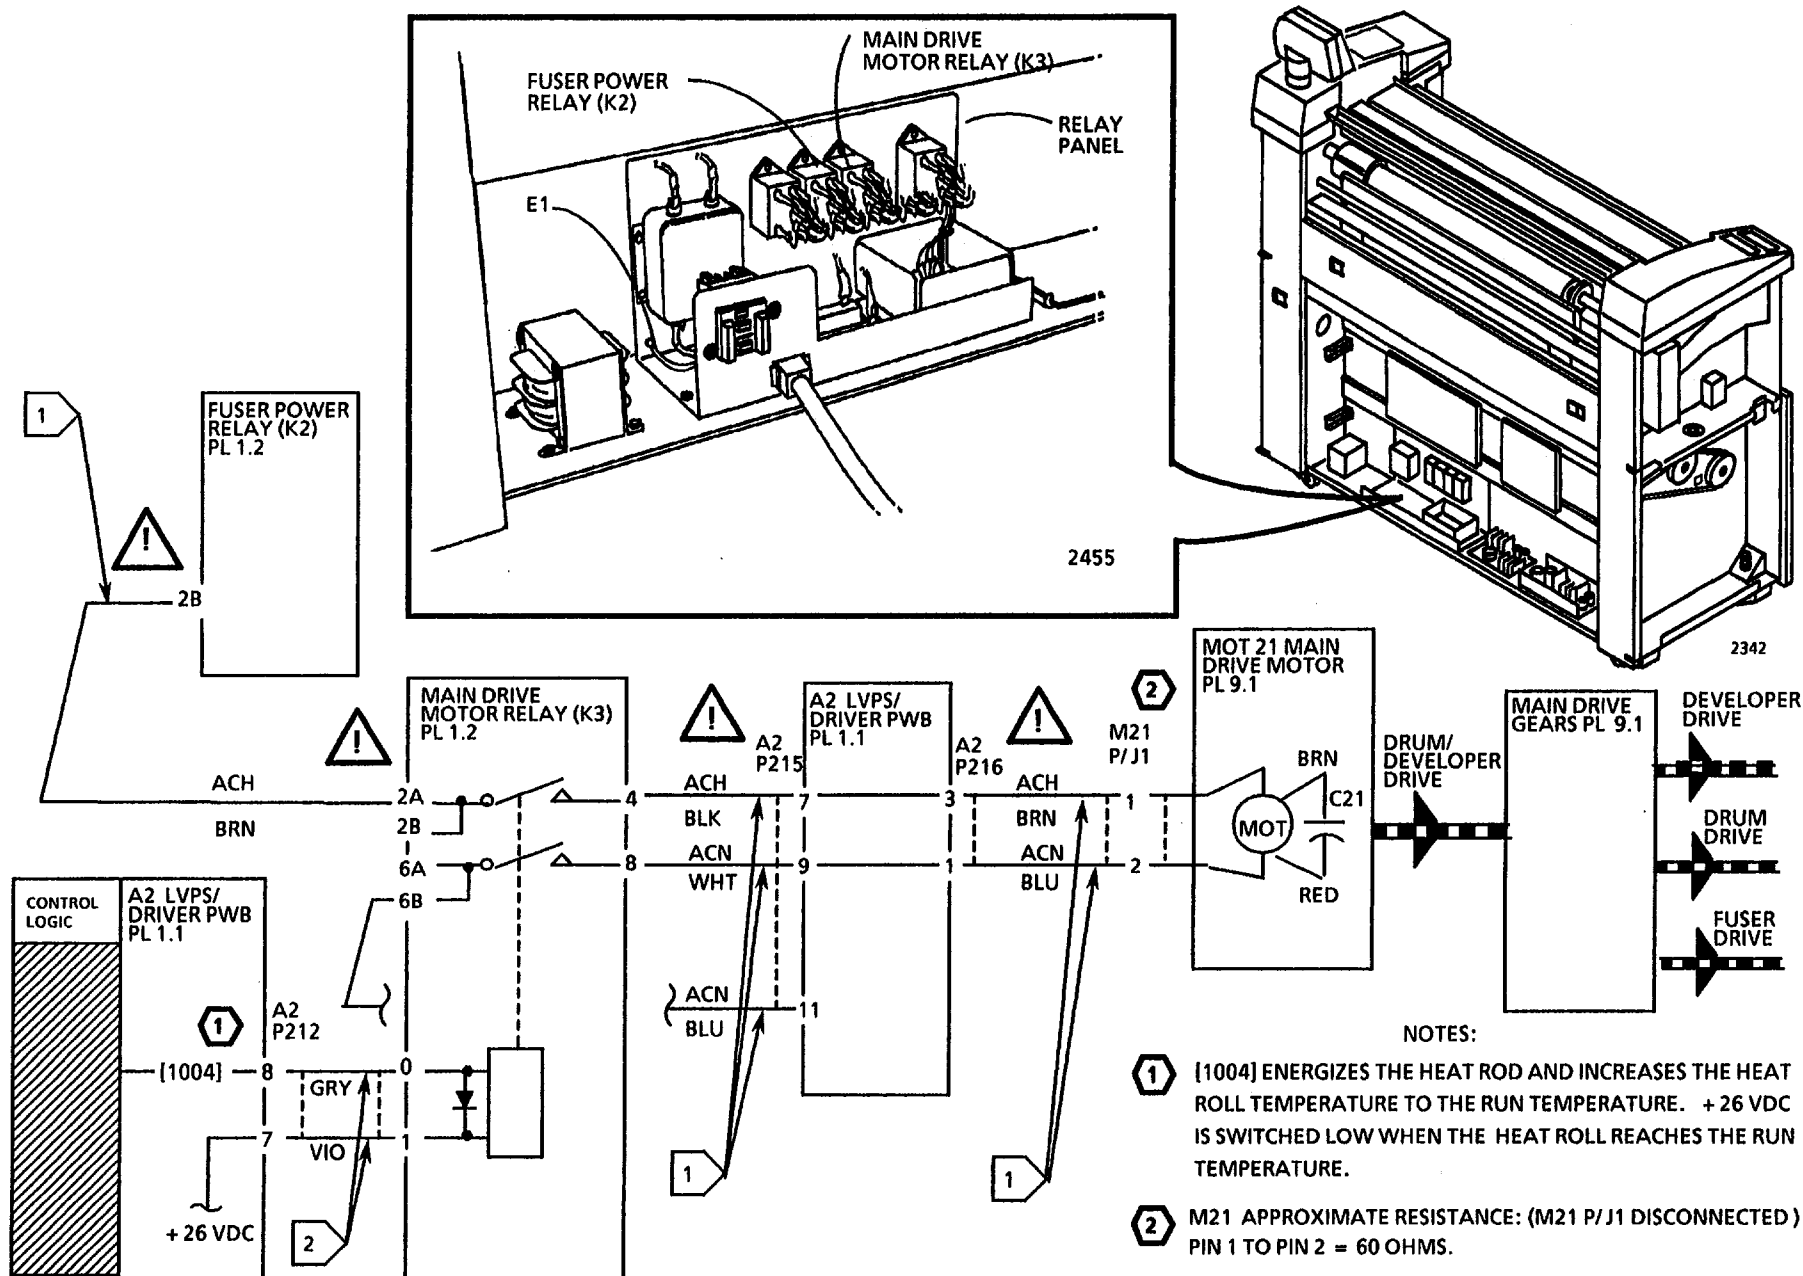
REAR VIEW WITH THE
COVERS REMOVED

Check the drive system for binding by manually rotating the motor shaft. Rotate the shaft by turning the motor cooling fan which is attached to the motor shaft. If the system is binding, check the Main Drive Gears and the Cleaner Blade Drive Gear for damage.

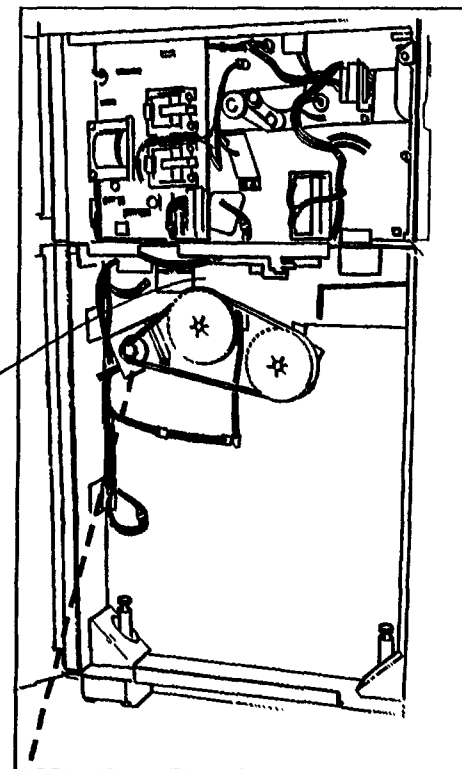
LEFT
SIDE
VIEW

ROLL FEED
DRIVE
SPROCKET

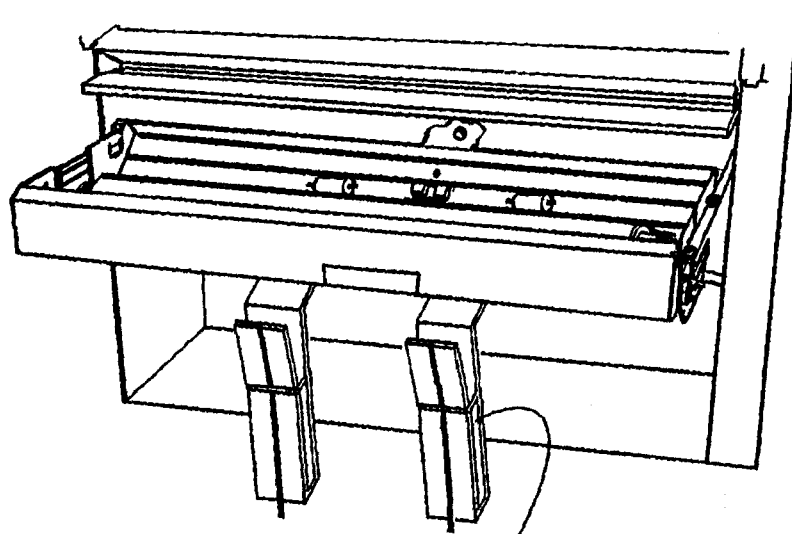
FEED
PINCH
ROLLS

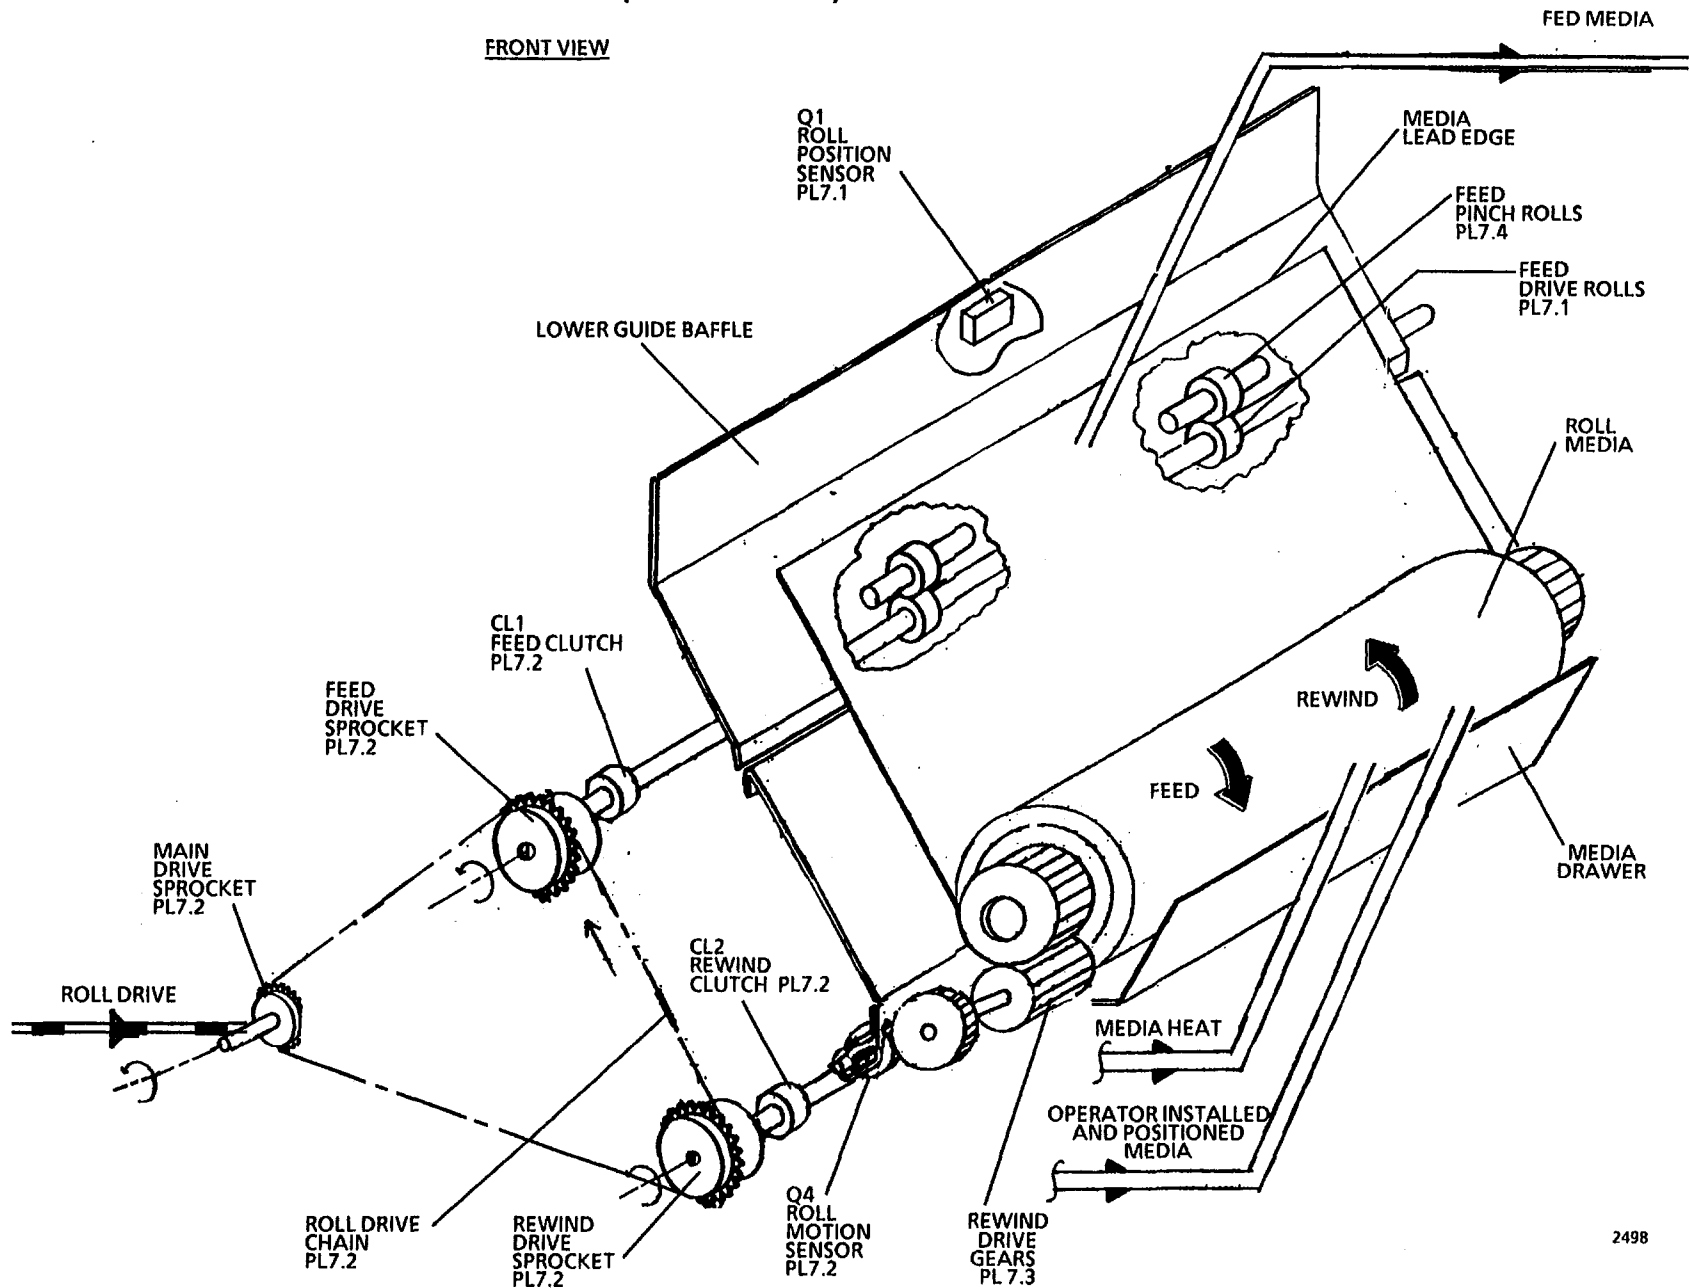
ROLL FEED (MEDIA DRAWER)

- ④ [0716-1] ENERGIZES THE ROLL DRIVE MOTOR AND THE ROLL FEED CLUTCH (CL1).
[0730] ENERGIZES THE ROLL FEED CLUTCH (CL1).

[0703] ENERGIZES THE ROLL DRIVE
MOTOR AND THE MOTOR ROTATES IN
THE COUNTERCLOCKWISE DIRECTION.
[0704] ENERGIZES THE ROLL DRIVE
MOTOR AND THE MOTOR ROTATES IN
THE CLOCKWISE DIRECTION.

A7 P2 APPROXIMATE RESISTANCE:
(A7 P2 DISCONNECTED FROM A7
DRIVE MOTOR PWB)
PIN 1 TO PIN 2 = 3.5 OHMS
PIN 3 TO PIN 4 = 3.5 OHMS

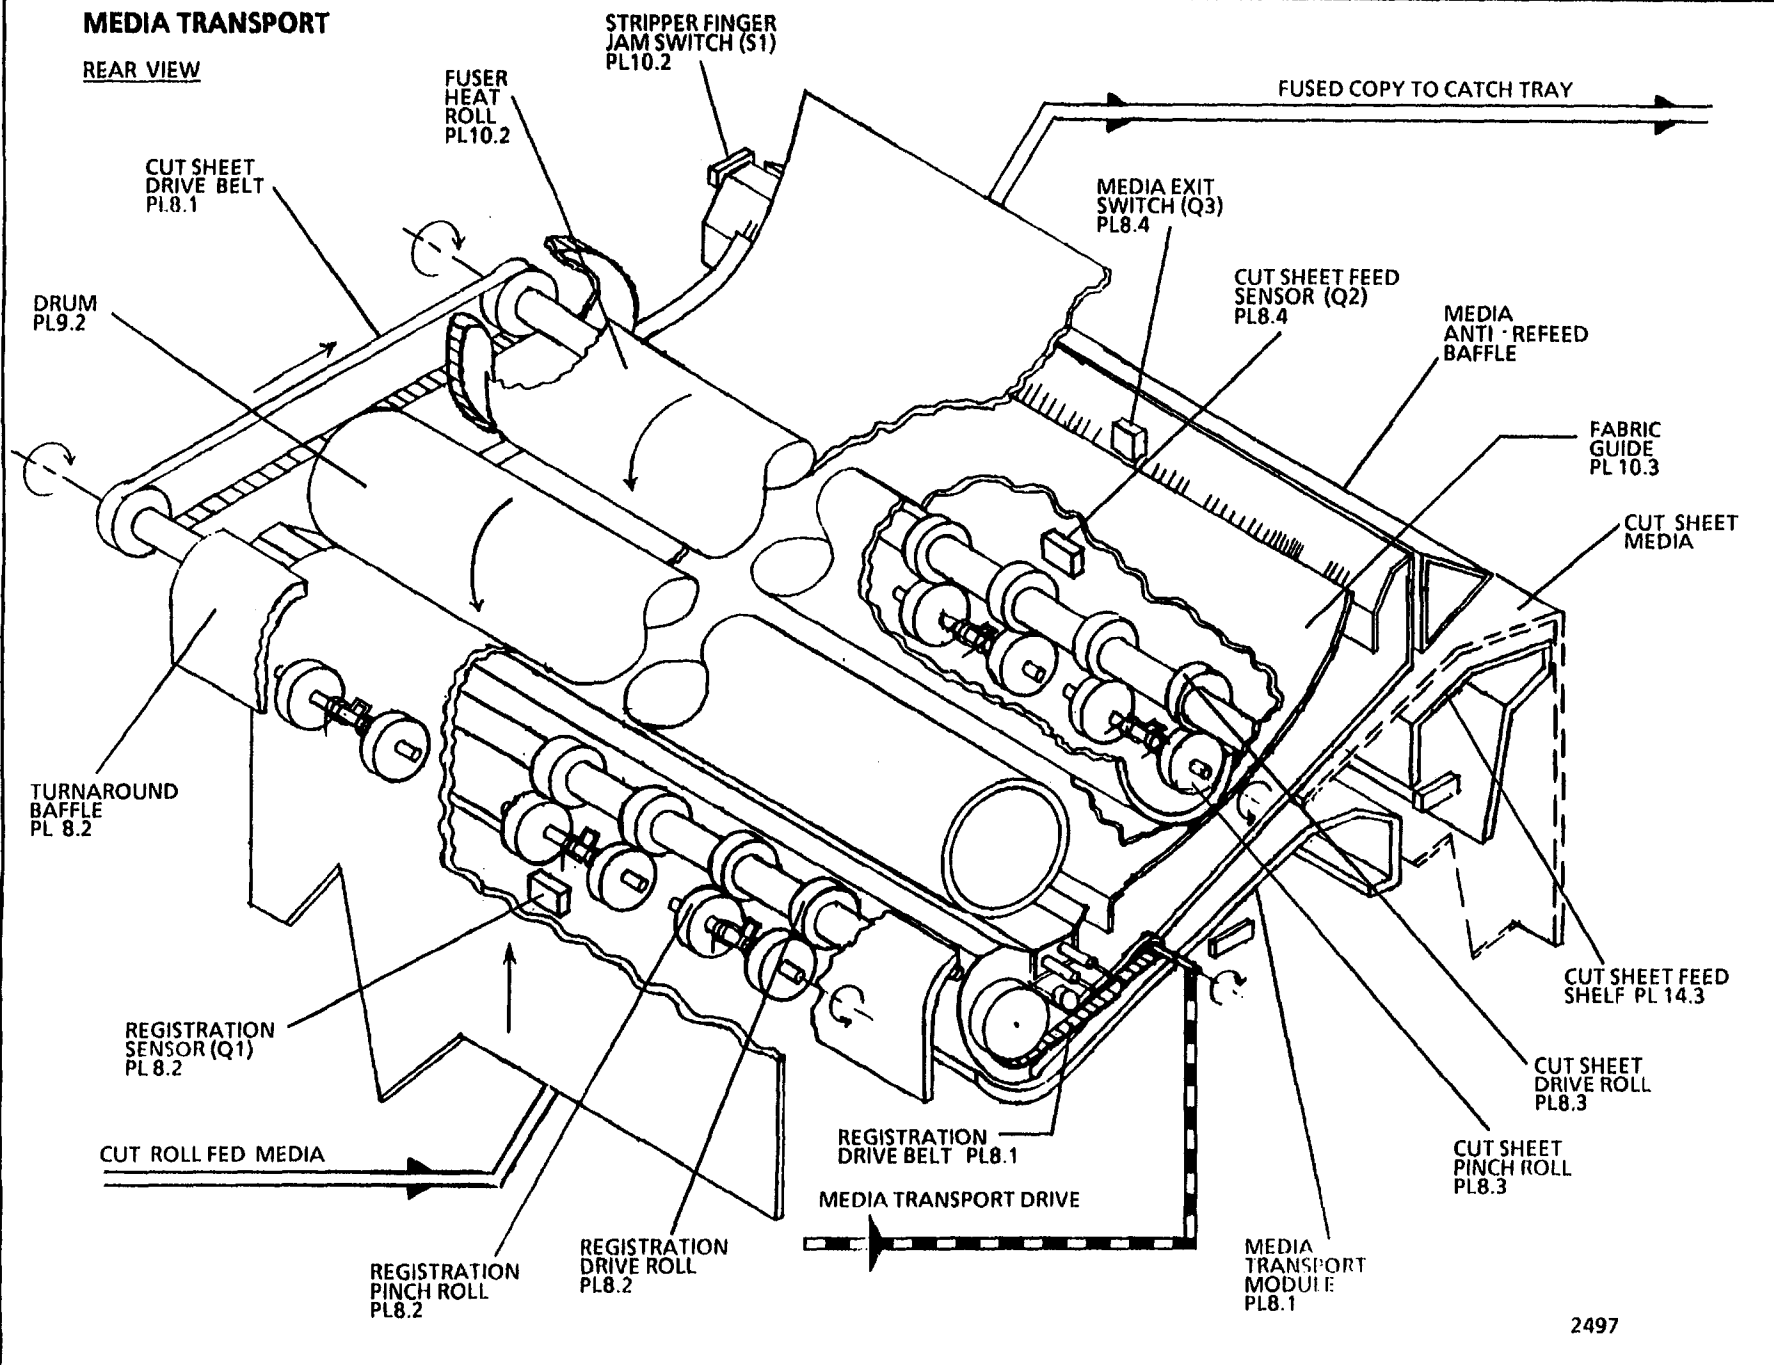
2497

MEDIA TRANSPORT

REAR VIEW

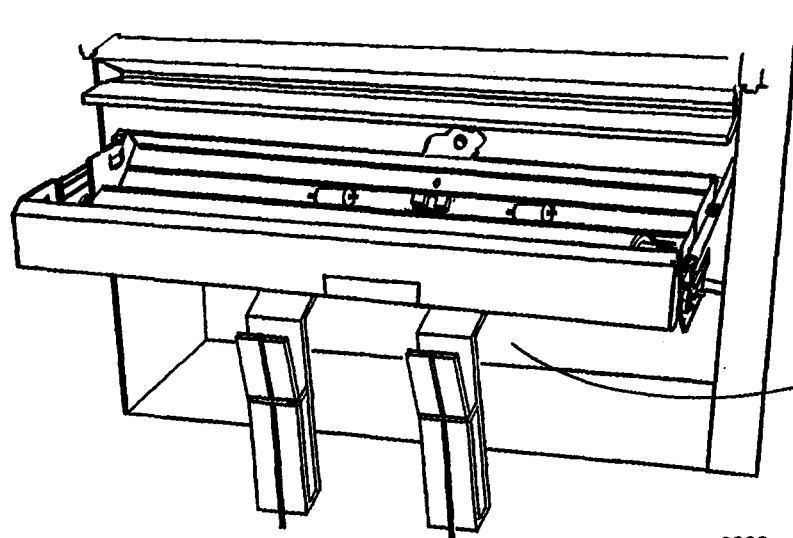
2339

THE MEDIA HEATER IS LOCATED
UNDER THE THE MEDIA SUPPLY
DRAWER

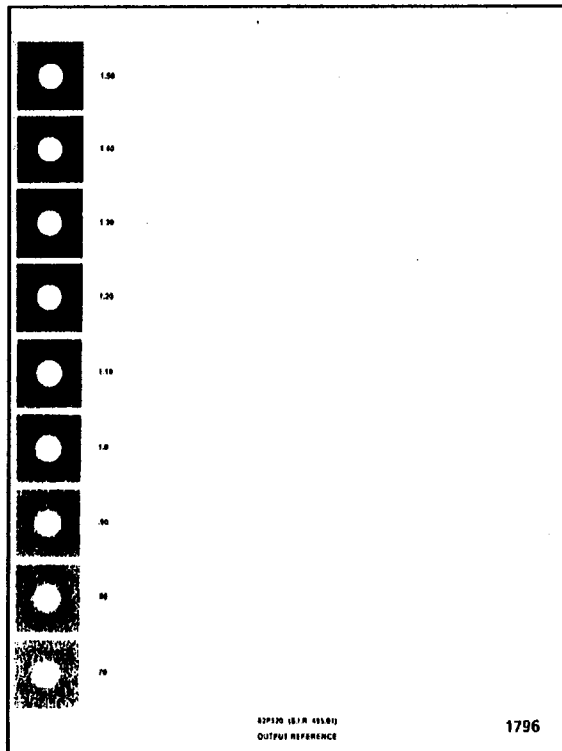
Figure 2. Image Reference Scale 82P520 (SIR 495.01)

Image Reference Scale 82P520 (SIR 495.01) (Figure 2) is used to evaluate the solid area density of the black one inch square on Test Pattern 82E5980.
