- **Call Flow Diagram** - This diagram outlines the major activities that are performed when a service call is made. The **Initial Actions** assist the Service Representative through the customer interface and help to identify the problem. The diagram also directs the Representative to verify, classify, repair the problem and perform the correct Maintenance Procedure.

2. Status Indicator Repair Analysis Procedures

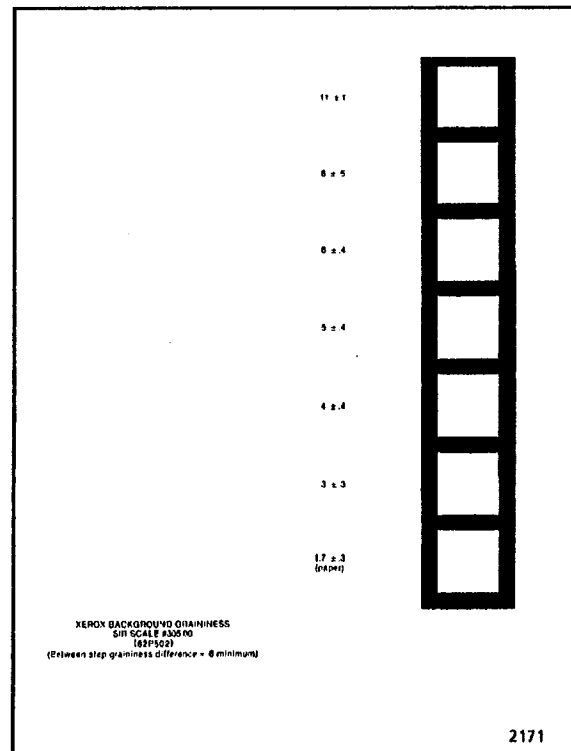
Figure 3. Image Reference Scale 82P502 (SIR 305.00)

Image Reference Scale 82P502 (SIR 305.00) (Figure 3) is used to evaluate the amount of background in the non-image area.

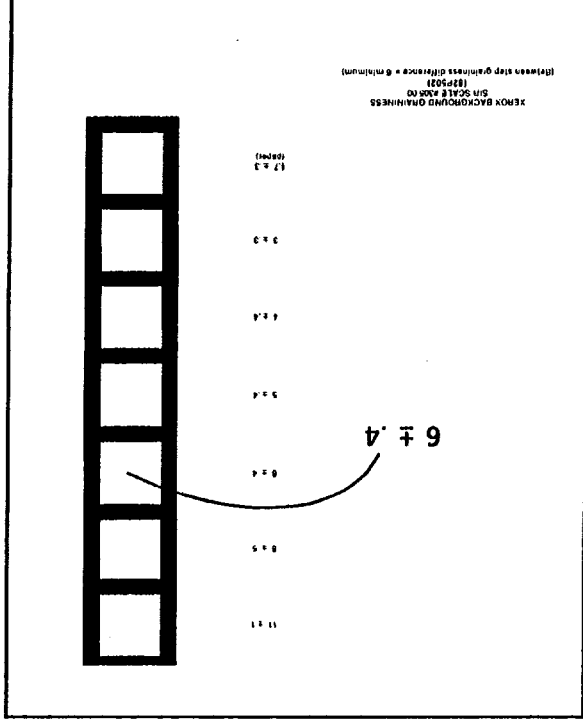
2171

Background

Background must be less than the background of the $6 \pm .4$ patch on the image Reference Scale 82P502.

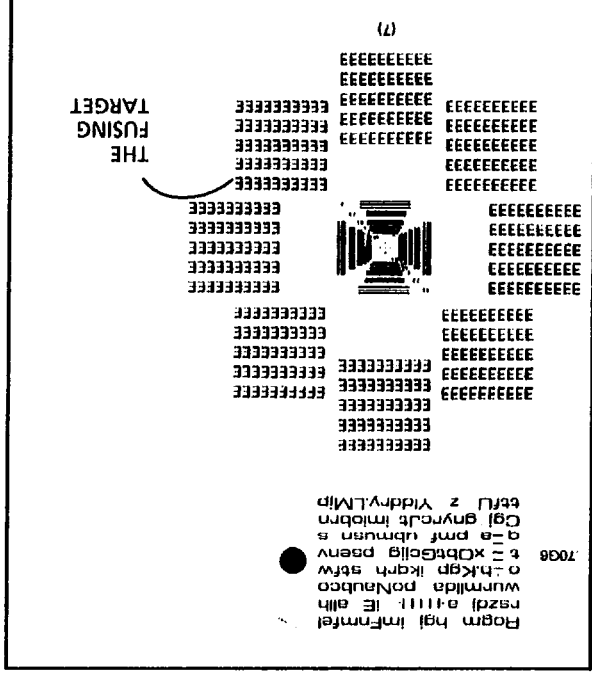
1114

Fusing

Run one copy of the Test Pattern 82E5980 with the 0.7G paragraph on the copy equal to the 1.2G paragraph on the Test Pattern. Check the fusing targets (1), (2), (3), (4), (6), and (7). Gently rub the targets four times with a paper towel (twice top-to-bottom and twice side-to-side). The image must not wipe off of the copy. For corrective action, check the procedure CQ 22.

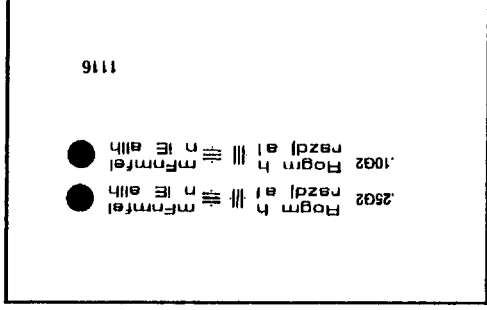
1116

Exposure Level/Low Contrast Lines

The 0.25G2 and 0.25B line pair targets on the copies of the Test Pattern 82E5980 should be greater than or equal to the 7.0 line Darkness Reference Scale 82E7030.

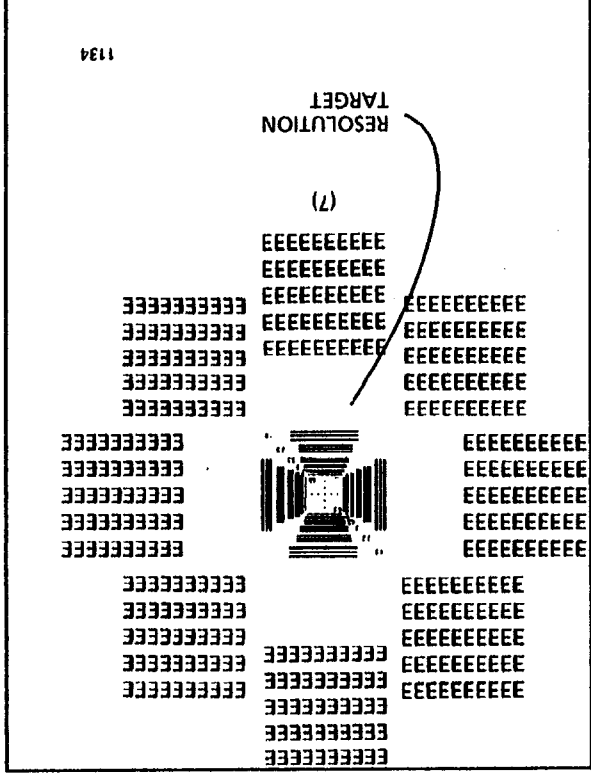
Resolution

The copies of the Test Pattern 82E5980 must exhibit 100% of the 2.5 line pairs in each direction and 50% of the 3.5 line pairs in each direction. Check the resolution targets at the (1), (2), (5), (6), and (7) patterns. For corrective action, check the procedure CQ 16.

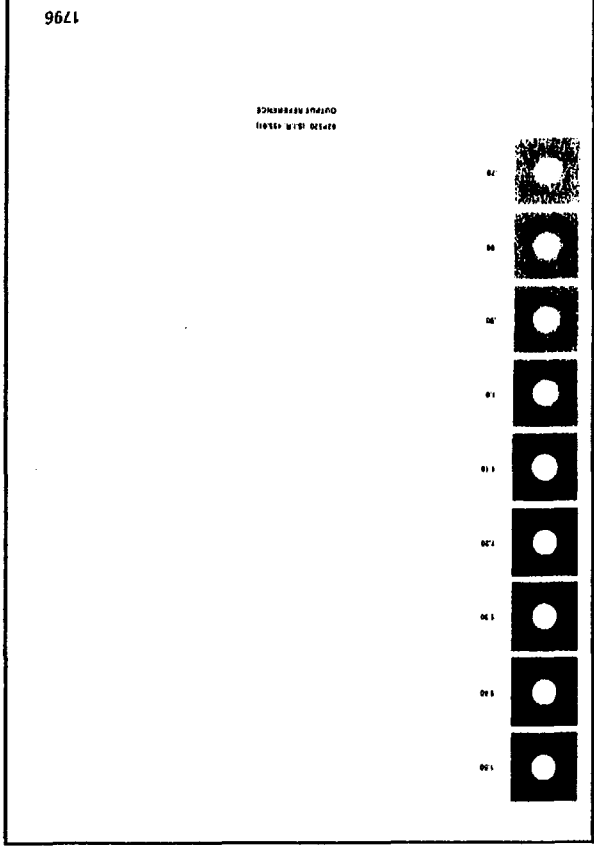
Solid Area Density

The 1.0 density black square on Test Pattern 82E5980 is greater than or equal to the 0.7 Solid Area density square on Test Pattern 82P520.

For corrective action, check ADJ 9.3.

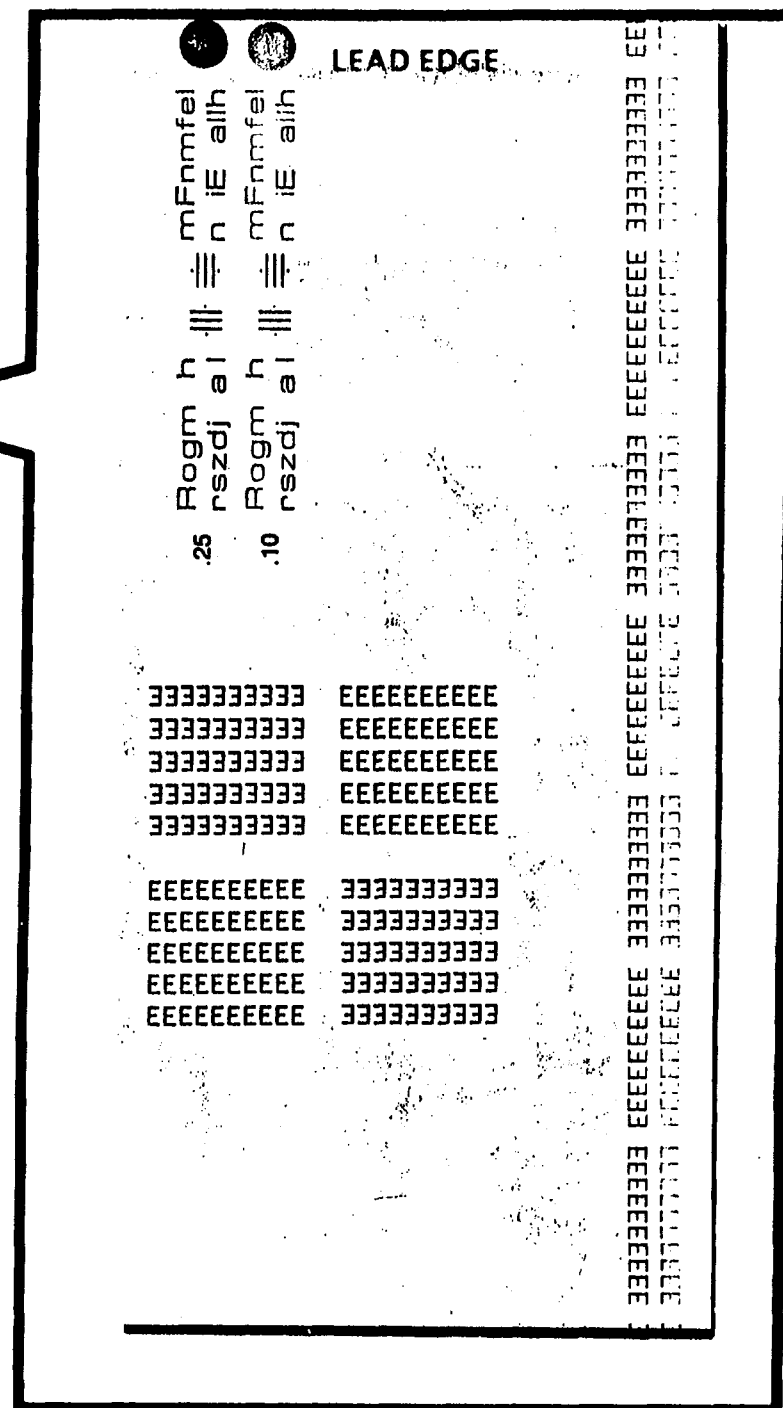
CQ 1 Uniform Background

Background is a degree of dry ink contamination in the non-image areas of the copy. The background defect can be uniform over the entire copy or localized.

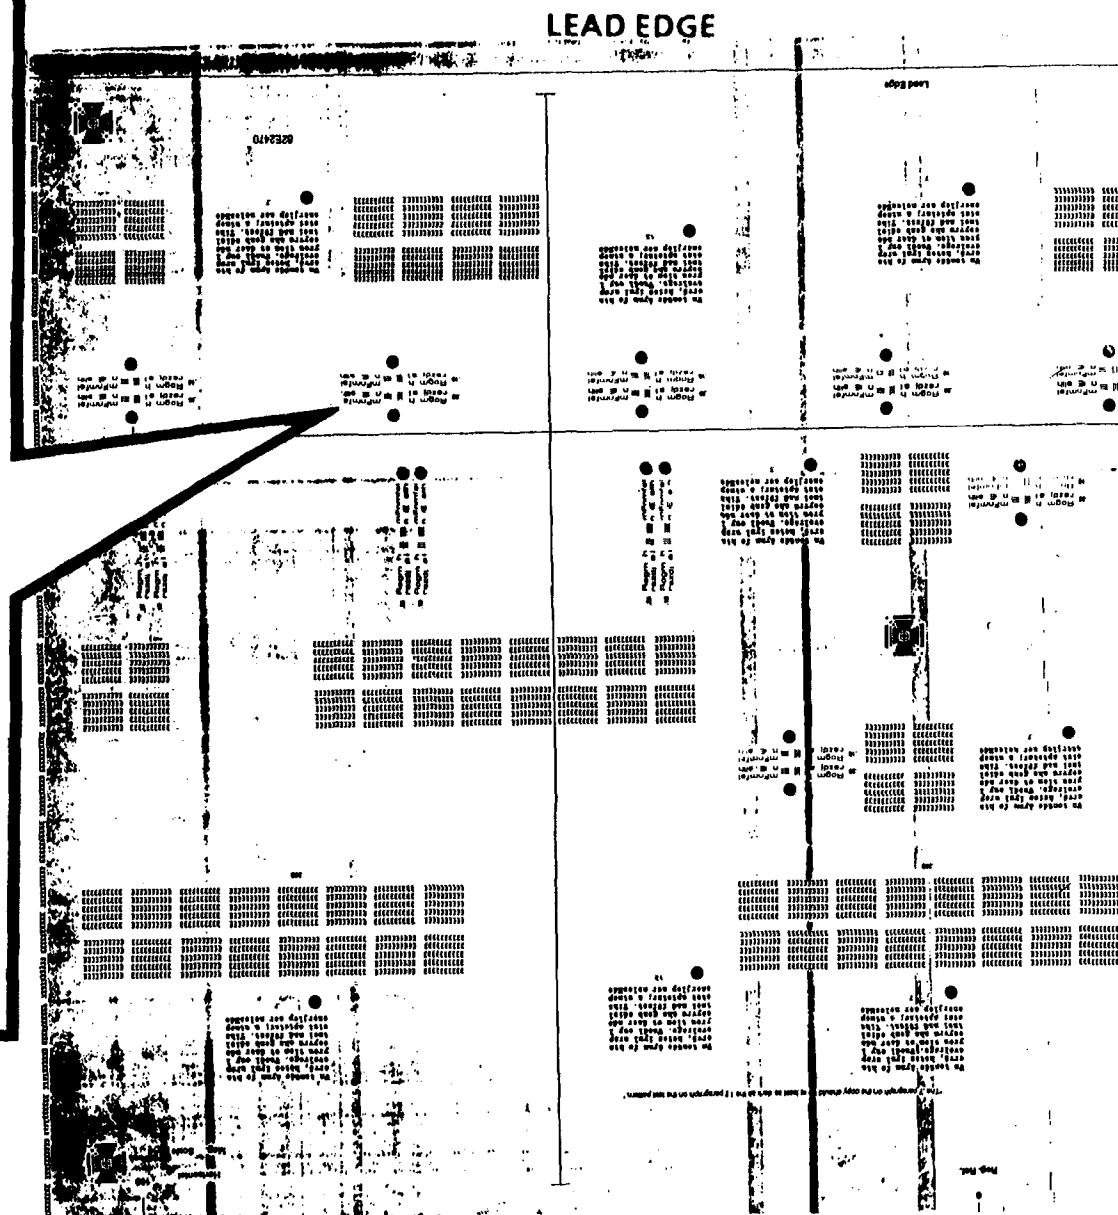
CQ 2 Background Banding/ Streaks

Background banding is a narrow band of background that appears in the direction of media feed.

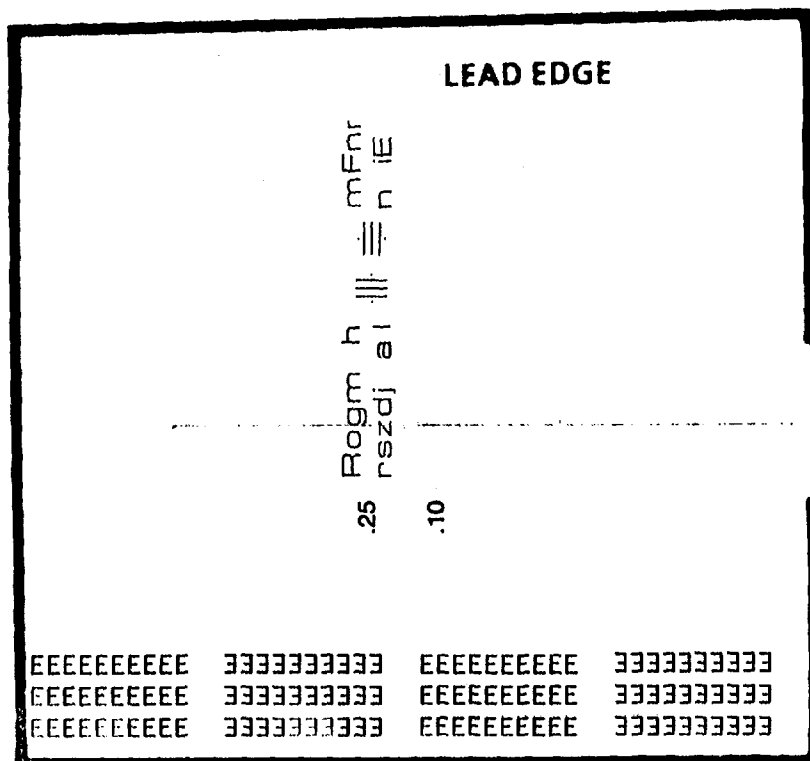
CQ 6 Cold Flow

Cold Flow is a distortion in the selenium alloy coating on the photoreceptor drum. This defect can appear anywhere on the copy and is perpendicular to the paper feed direction. Defect will also appear every 10.4 inches (264 mm).

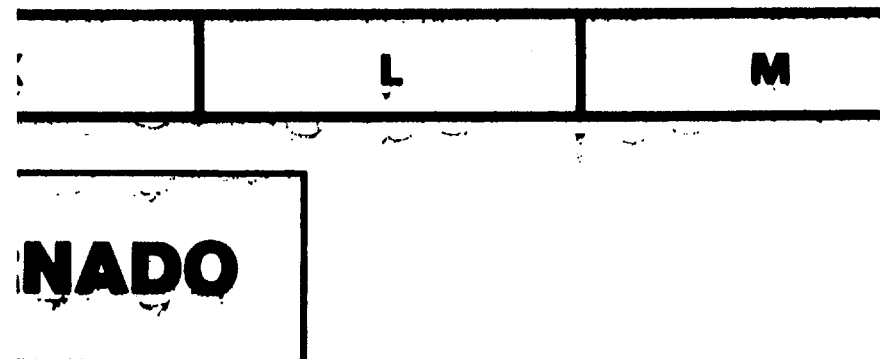
TYPE 2

This is a disturbance of the transferred toner image before the fuser. The defect can appear randomly throughout the image area in the process direction (from lead edge to trail edge) of the copy.

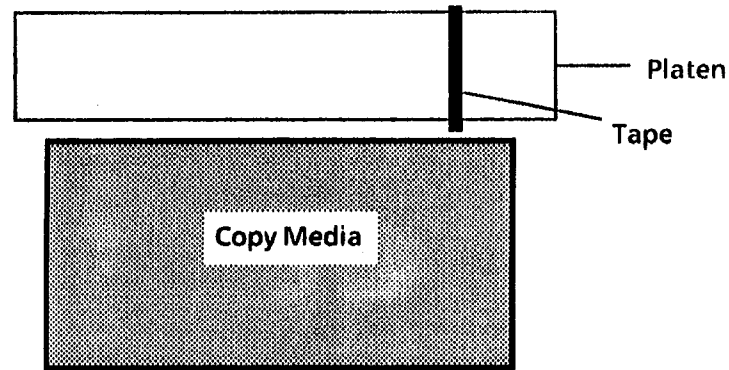
Figure 1. Installing the Tape

1. Figure 1: Place a piece of tape across the width of the platen. Place the tape so that when a copy is made the image of the tape will be a few inches in from the edge of the copy media.
2. Make a copy.
3. If the copy looks like one of the strips in Figure 2, the problem is in the media feed.
4. If the copy looks like Figure 3, the problem is in the document feed.
5. Refer to the appropriate Probable Cause to correct the problem.

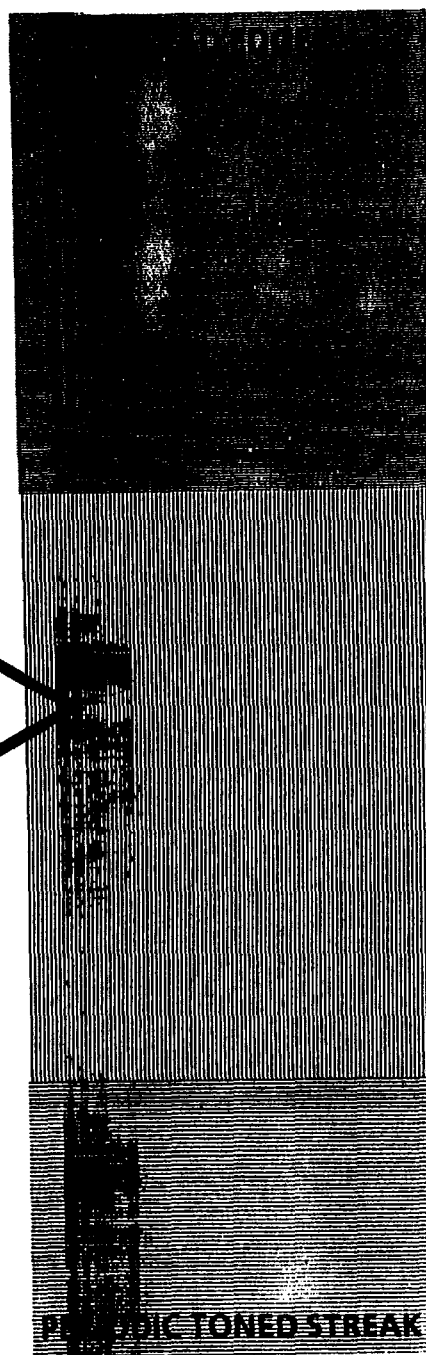
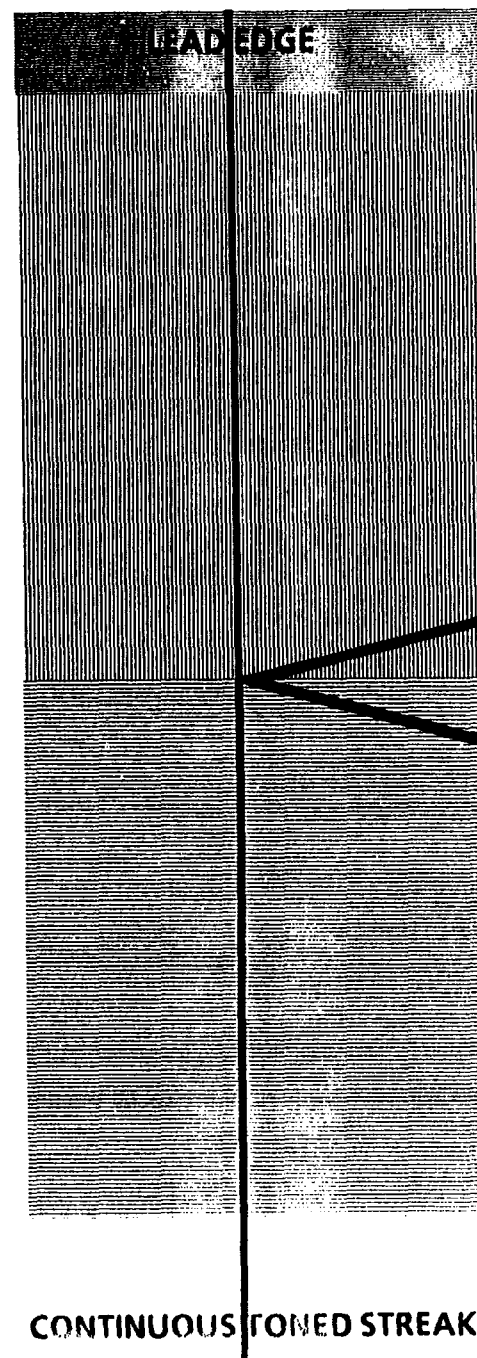
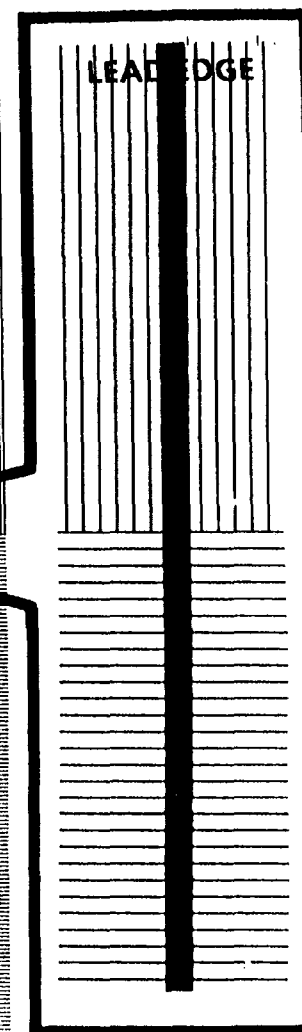
CQ 21 Streaks

Copy defects that appear in the process direction (from lead edge to trail edge). Streaks may be uniform, nonuniform (a smudge with no clearly defined line pattern), or periodic.

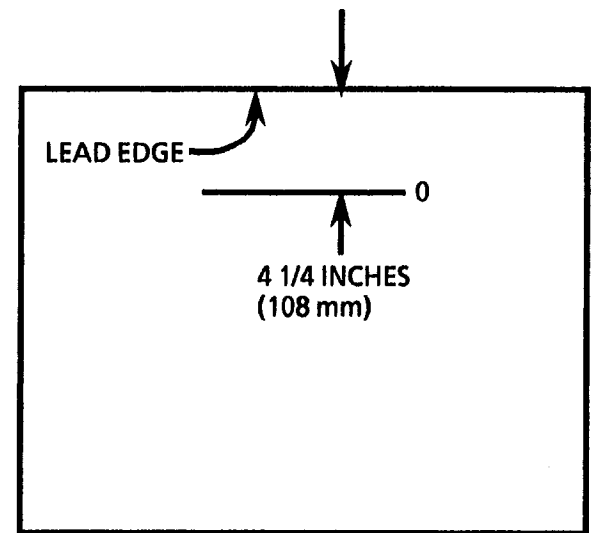
THE PREPARED MEDIA

This RAP is used to differentiate between the Fuser and the Photoreceptor as the source of an offsetting or residual image copy quality problem. It may be necessary to make several copies to see if the problem can be repeated.

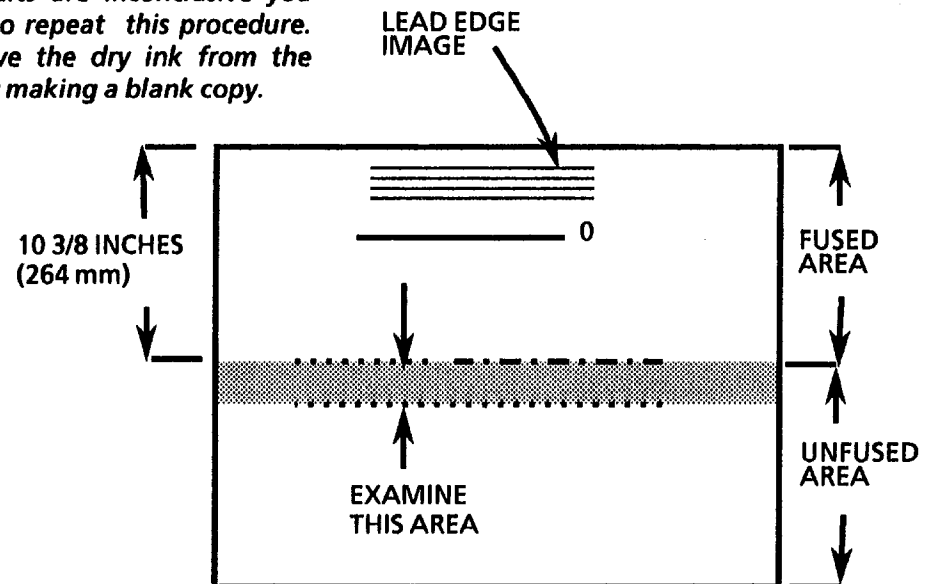
A CHECK FOR RESIDUAL IMAGES

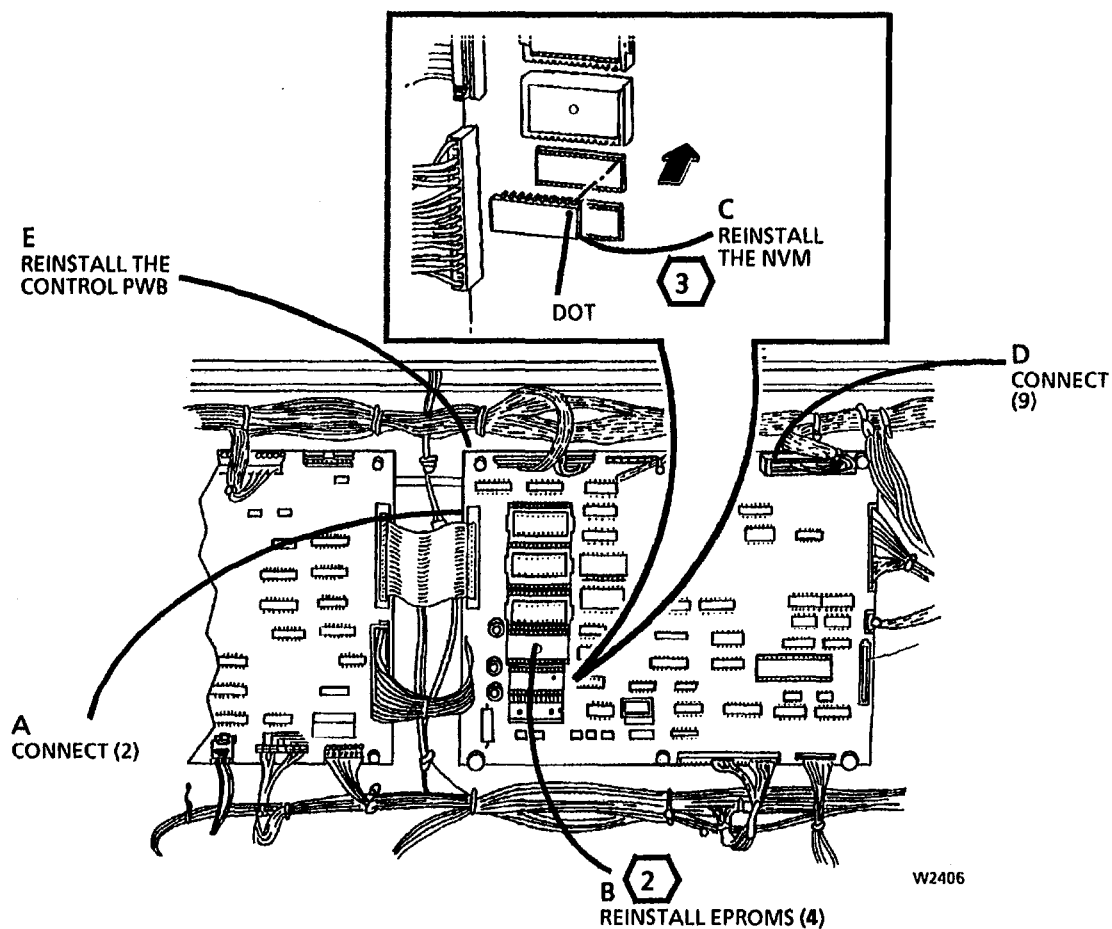
3 STEP 1C: Ensure that the dot on the NVM is located as shown in Figure 2.

1. (Figure 2): Reinstall the Control PWB.

Figure 2. Reinstalling the Control PWB

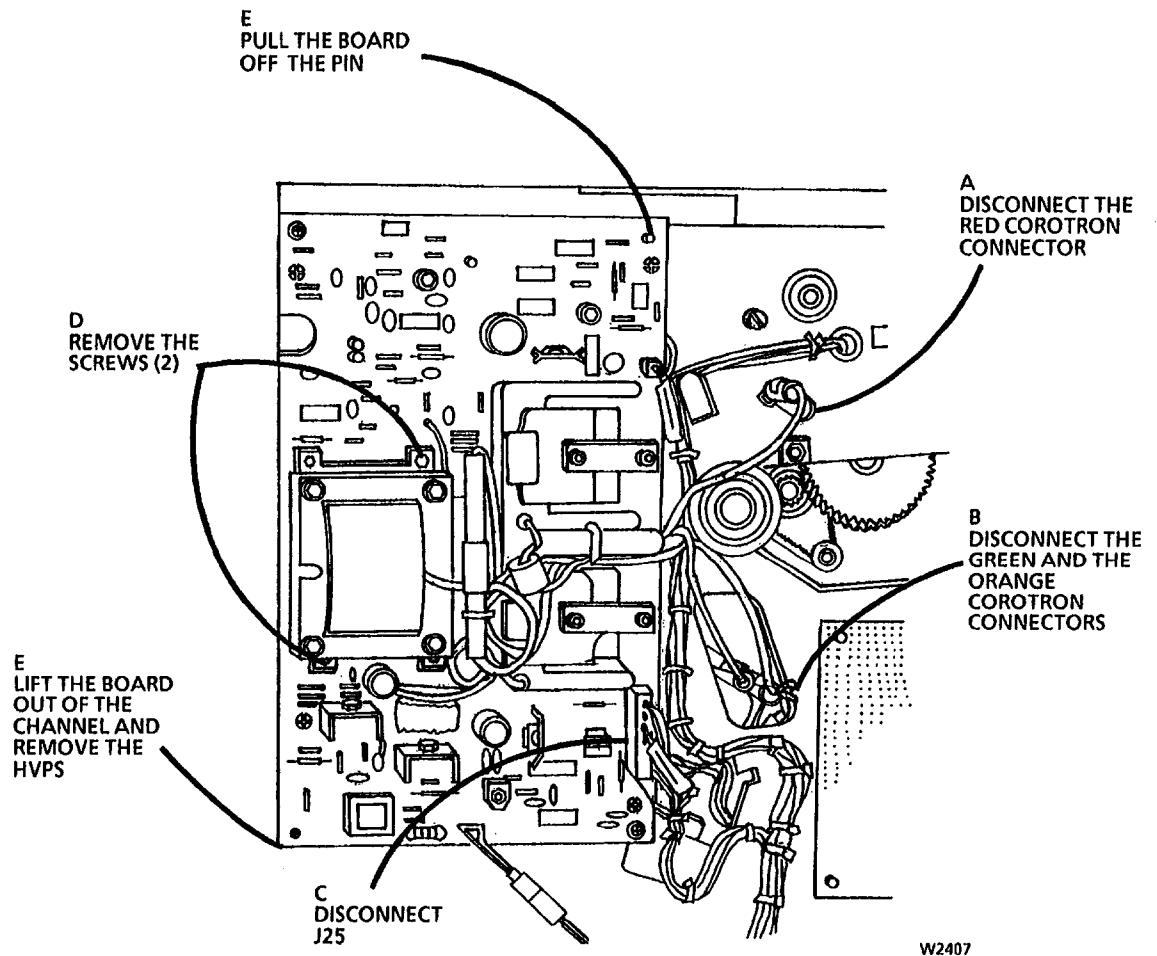
W2407

Figure 1. Removing the High Voltage Power Supply

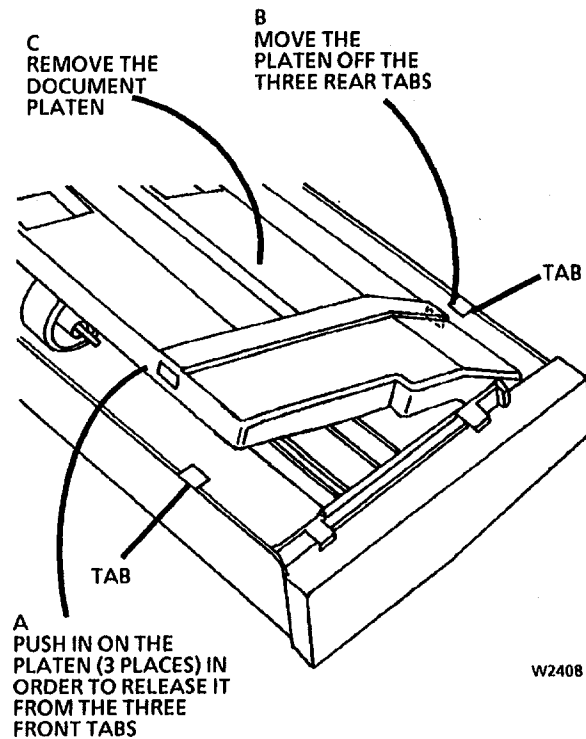
1. Remove the Document Handler and place it upside down on a flat surface.
2. (Figure 1): Remove the Document Platen.

Figure 1. Removing the Document Platen

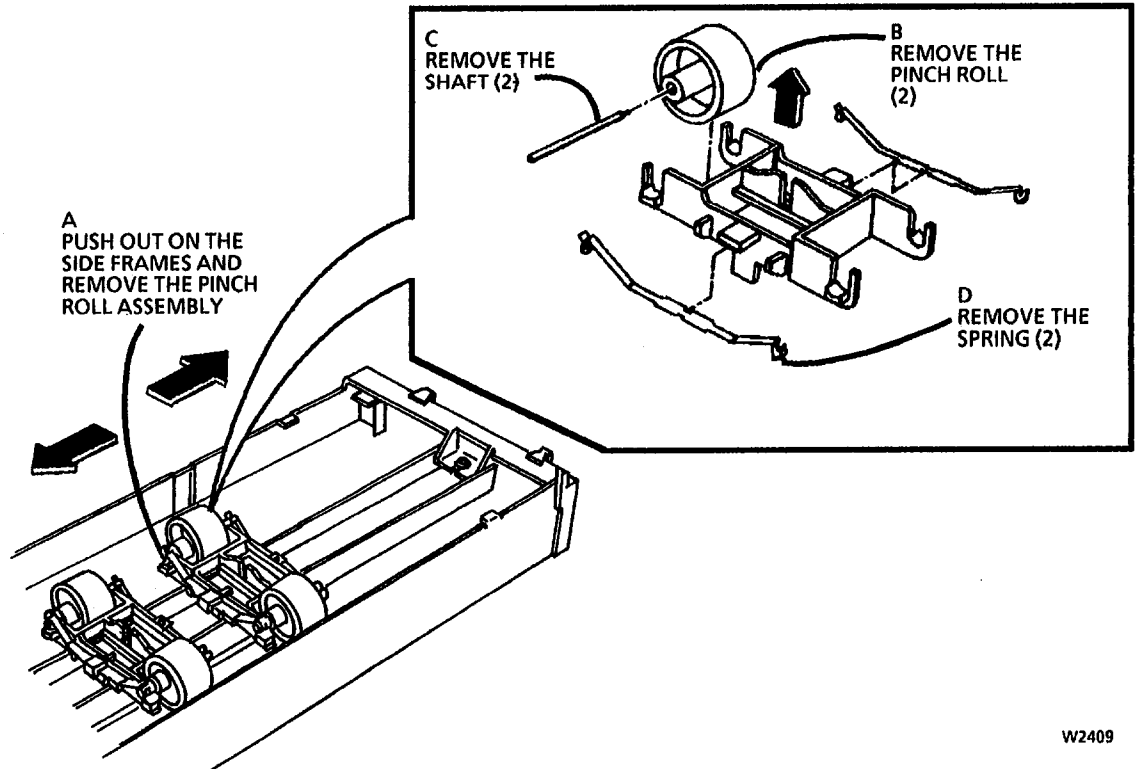
3. (Figure 2): Remove the Document Pinch Rolls.
4. Check/Adjust the Document Stop Position (ADJ 5.2).

Figure 2. Removing the Document Pinch Rolls

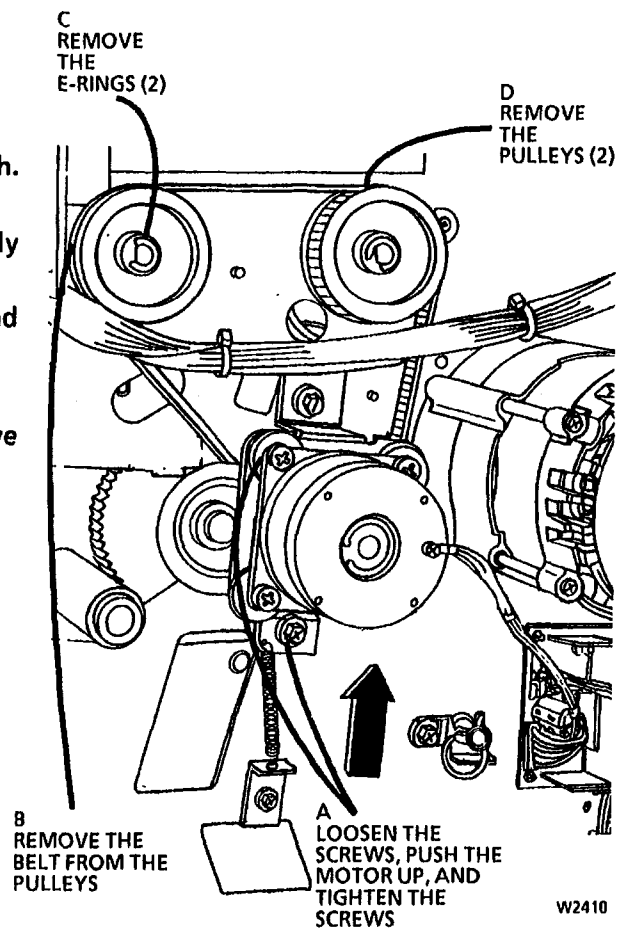
5. (Figure 1): Remove the Drive Pulleys.

Figure 1. Removing the Drive Pulleys

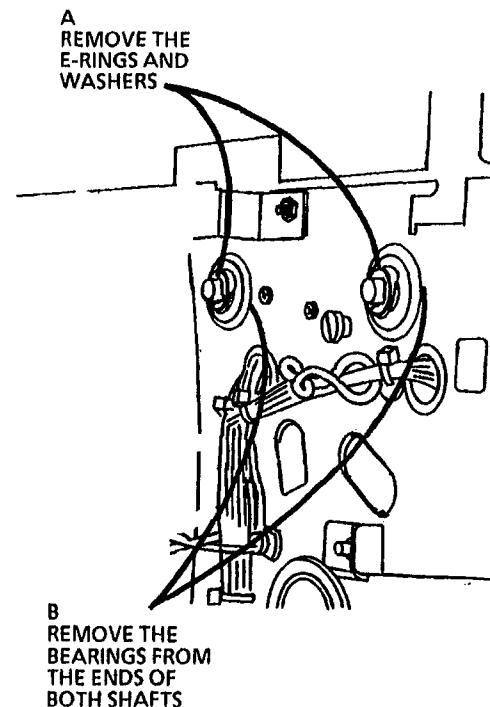
6. (Figure 2): Open the Left Side Door and remove the bearings.

Figure 2. Removing the Bearings

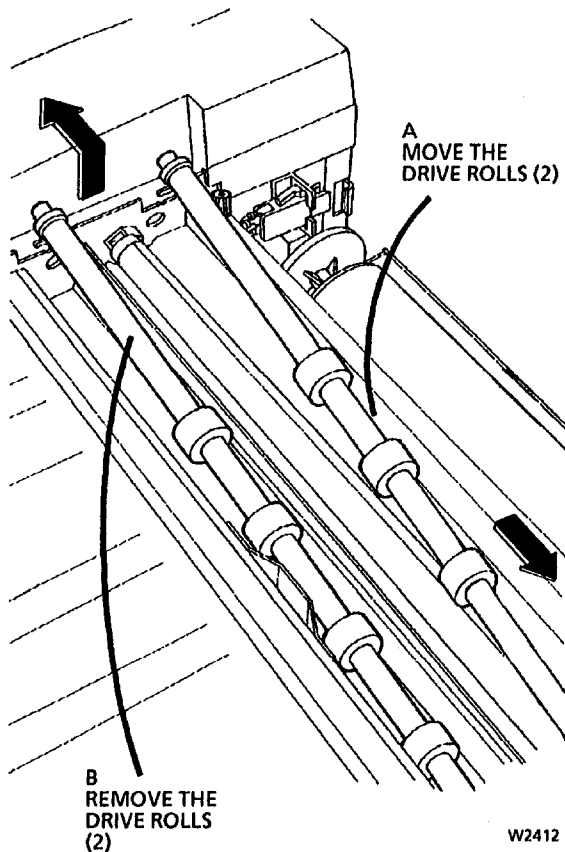
7. (Figure 3): Remove the Document Drive Rolls.

Figure 3. Removing the Document Drive Rolls

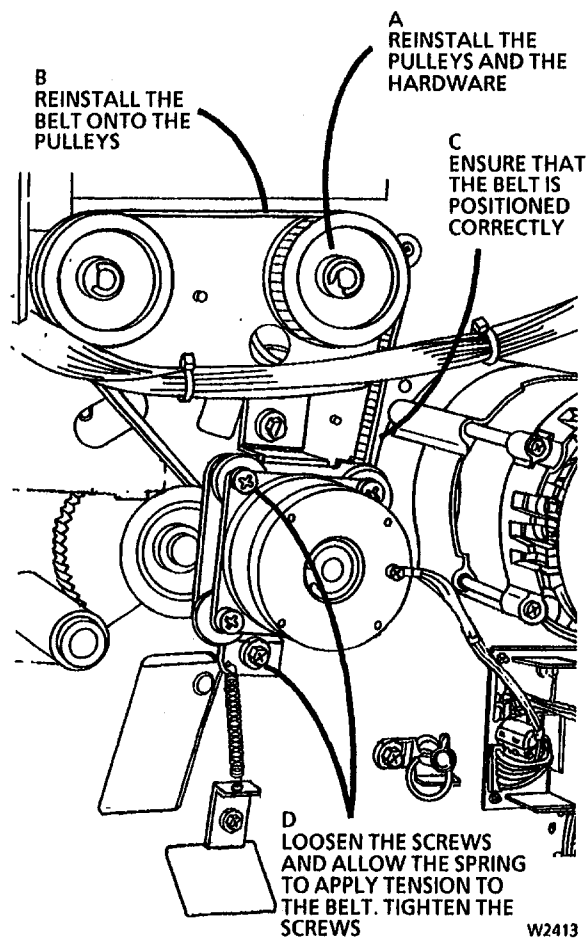
1. Reinstall the Document Drive Rolls and the bearings.
2. (Figure 4): Reinstall the belt.
3. Check/Adjust the Document Stop Position (ADJ 5.2).

Figure 4. Reinstalling the Belt

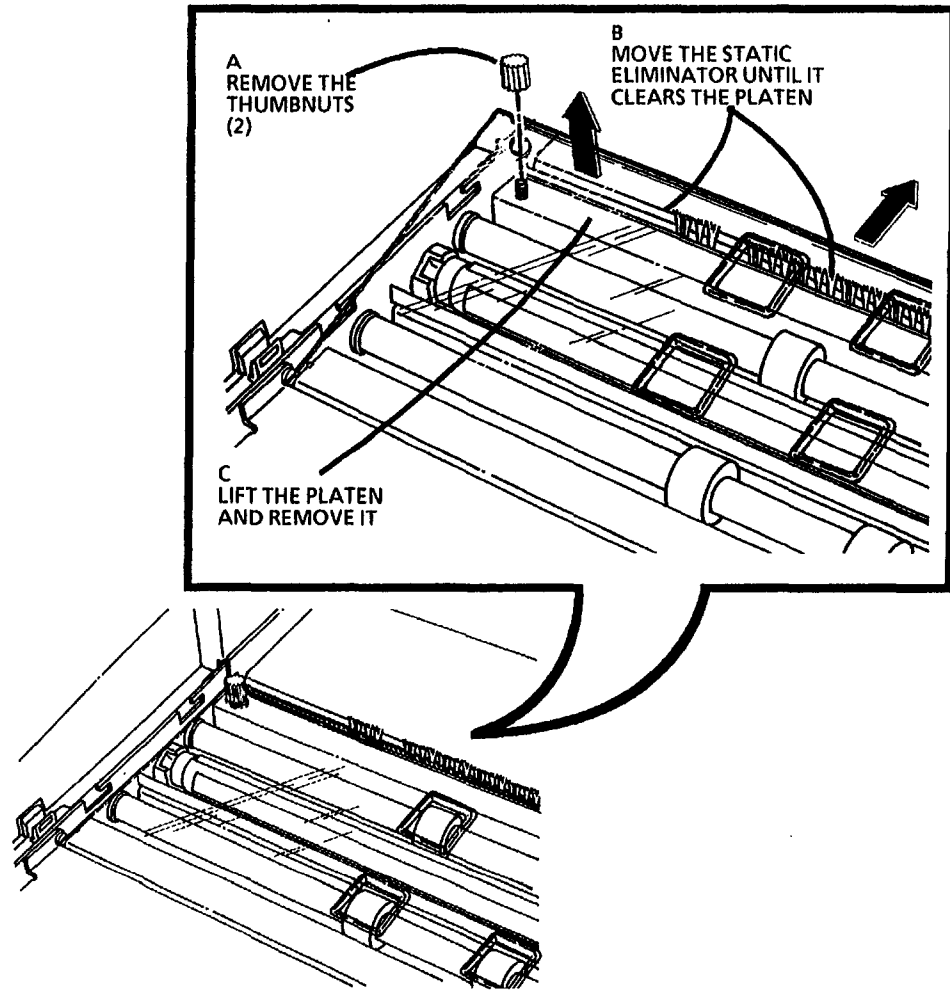
W2414

1. Remove the Document Handler and place it upside down on a flat surface.
2. Remove the platen.

Figure 1. Removing the Platen

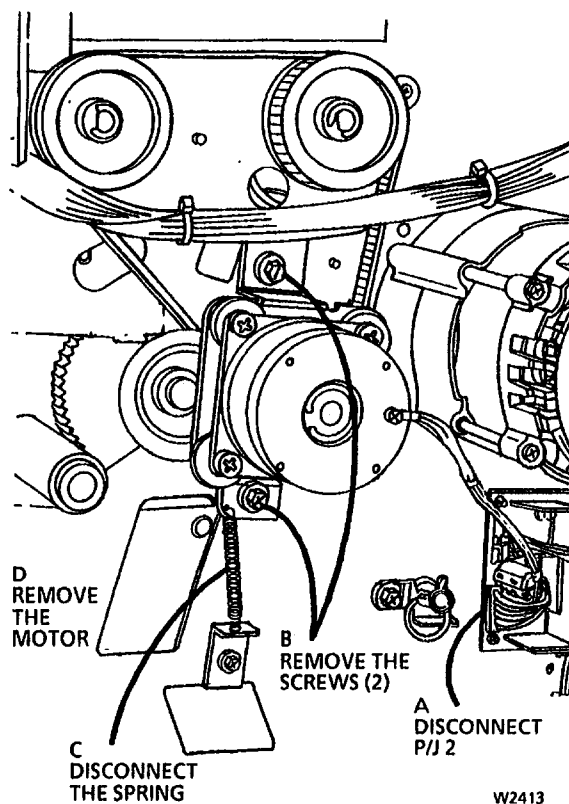
2. (Figure 1): Remove the Document Drive Motor.

Figure 1. Removing the Document Drive Motor

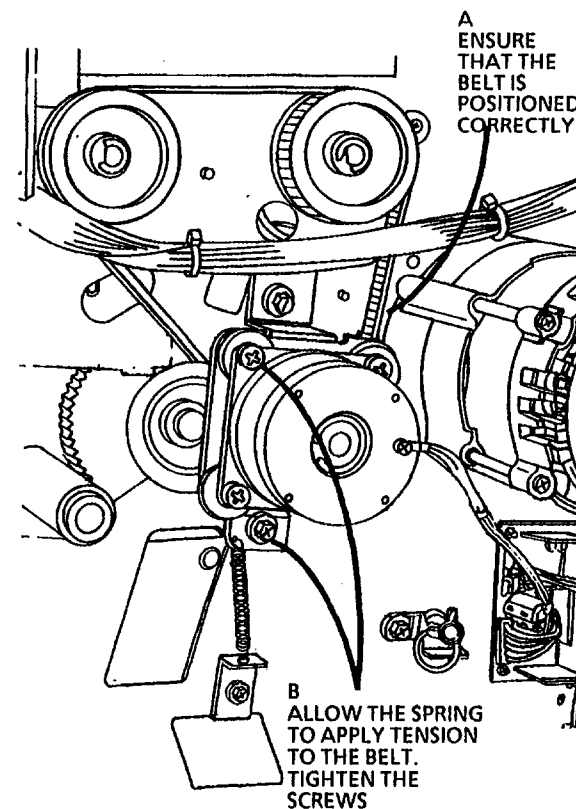
1. Reinstall the Document Drive Motor. Only fingertighten the screws.
2. (Figure 2): Apply tension to the belt.
3. Check/Adjust the Document Stop Position (ADJ 5.2).

Figure 2. Reinstalling the Belt

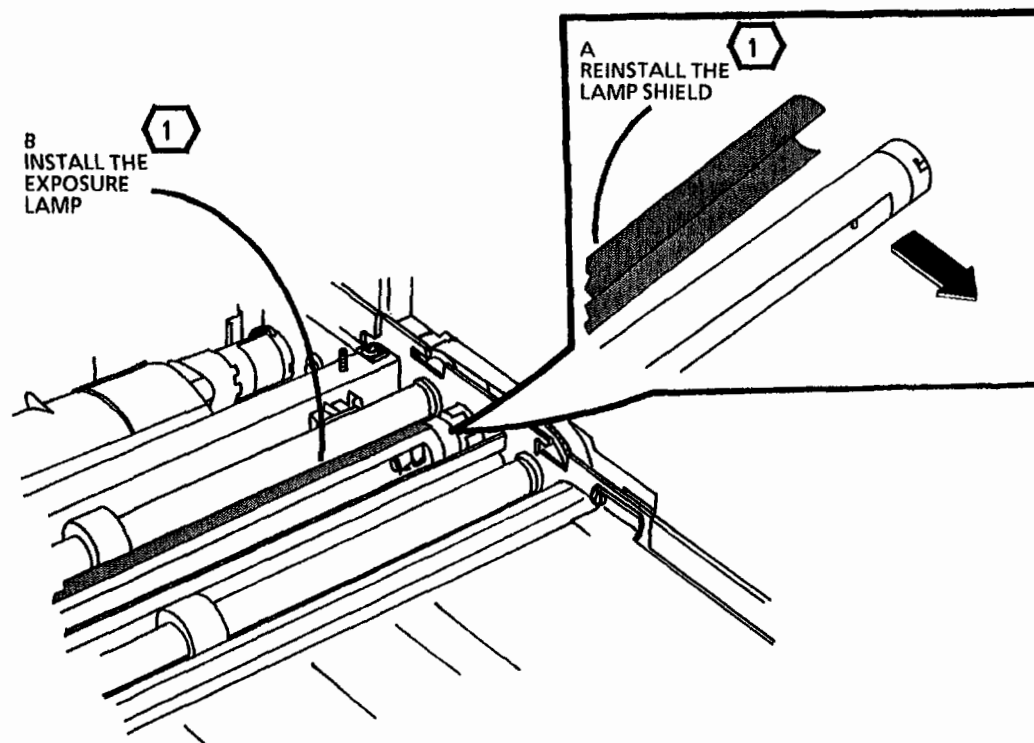
W2415

Figure 1. Reinstalling the Exposure Lamp

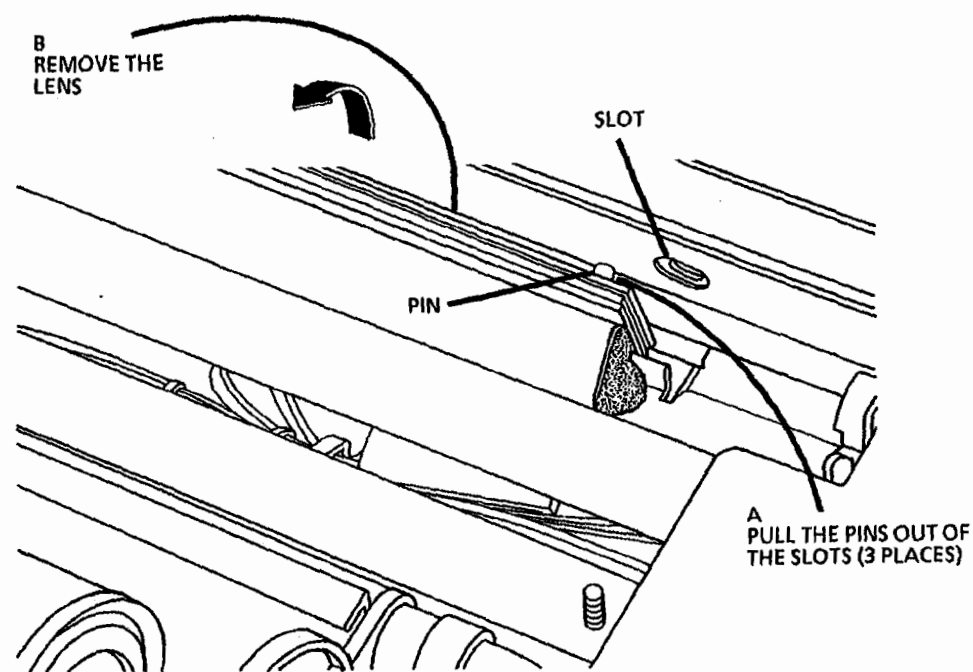
W2416

1. When reinstalling the lens, ensure that the pins are completely reinstalled in the slots.

View from rear of copier

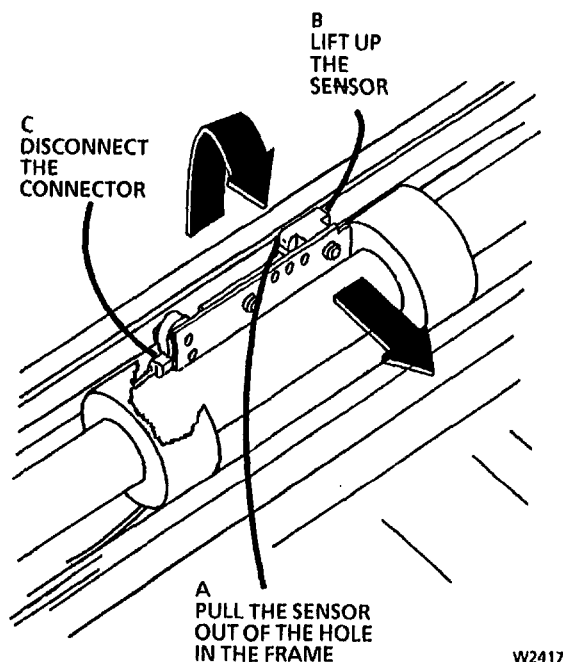
3. (Figure 1): Remove the Illumination Sensor.

Figure 1. Removing the Illumination Sensor

1. When reinstalling the Illumination Sensor, ensure that the sensor is secured in the hole in the frame.
2. Perform the Background (Exposure) Check of the Electrostatic Series (ADJ 9.2).

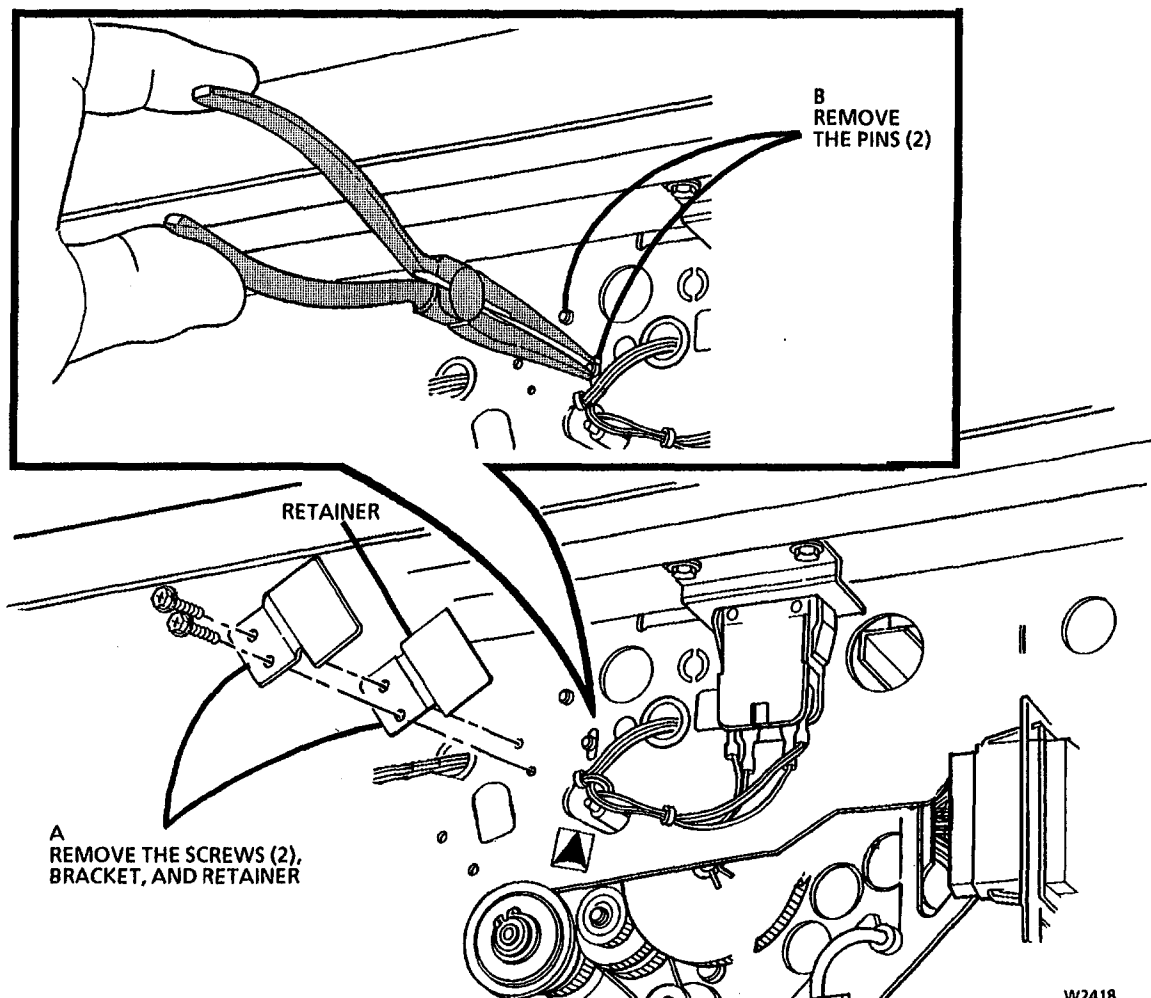
2. (Figure 1): Remove the retainer and the pins.

Figure 1. Removing the Retainer and the Pins

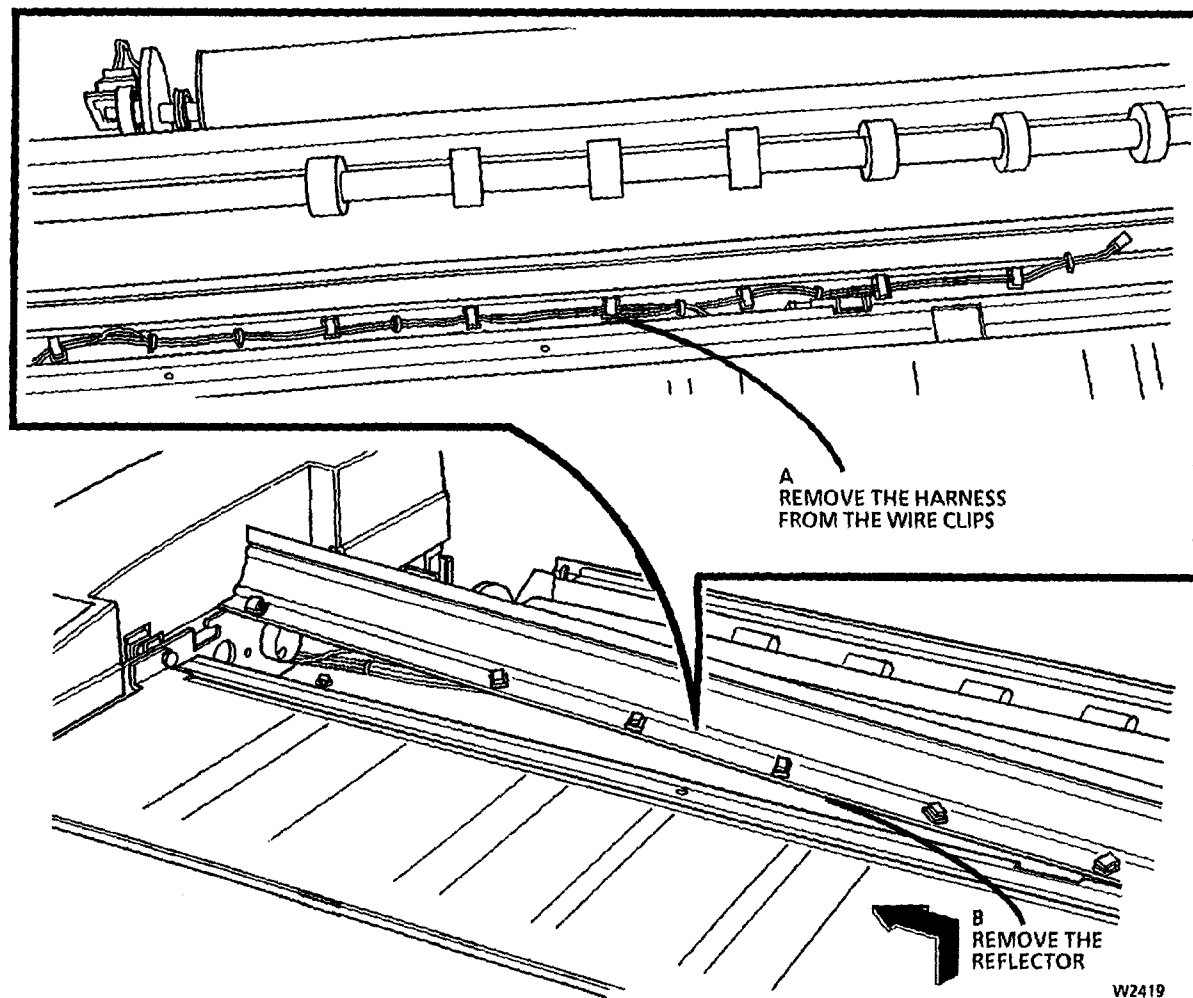
3. (Figure 2): Remove the reflector.

Figure 2. Removing the Reflector

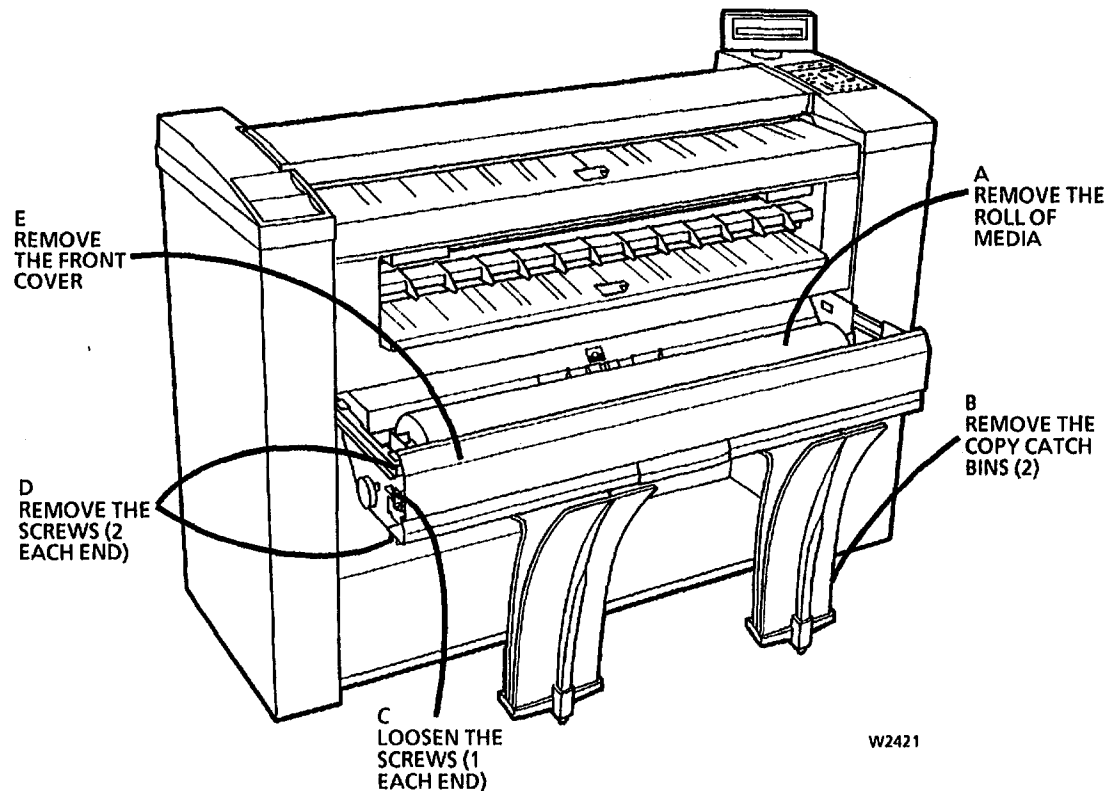
1. (Figure 1): Remove the Front Cover.

Figure 1. Removing the Front Cover

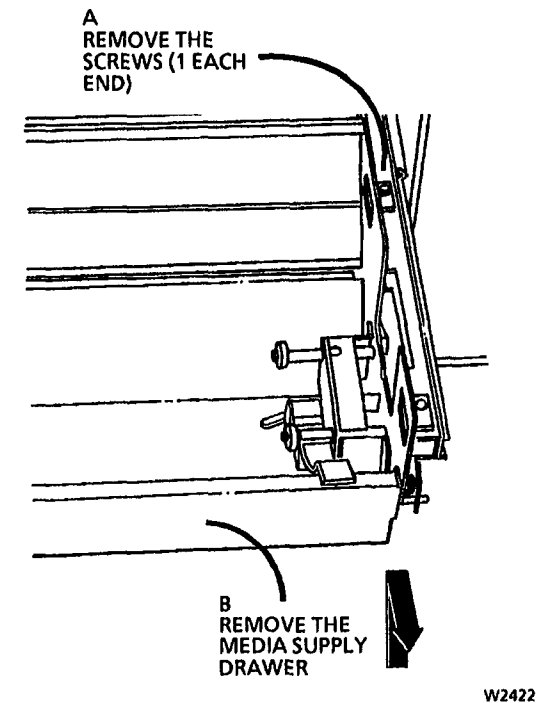
2. (Figure 2): Remove the Media Supply Drawer.

Figure 2. Removing the Media Supply Drawer
