- **Call Flow Diagram** - This diagram outlines the major activities that are performed when a service call is made. The **Initial Actions** assist the Service Representative through the customer interface and help to identify the problem. The diagram also directs the Representative to verify, classify, repair the problem and perform the correct Maintenance Procedure.

2. Status Indicator Repair Analysis Procedures

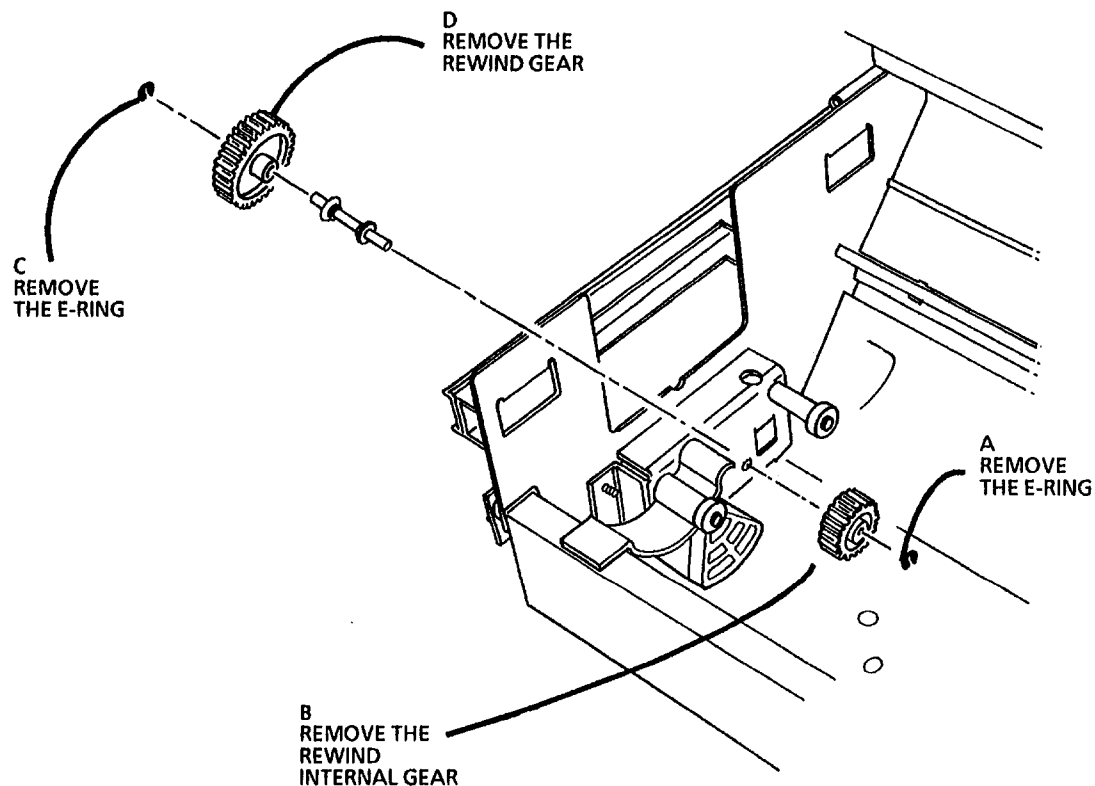
W2420

1. Pull out the Media Supply Drawer.
2. Remove the roll of media.
3. (Figure 1): Remove the Rewind Gear and the Rewind Internal Gear.

Figure 1. Removing the Rewind Gears

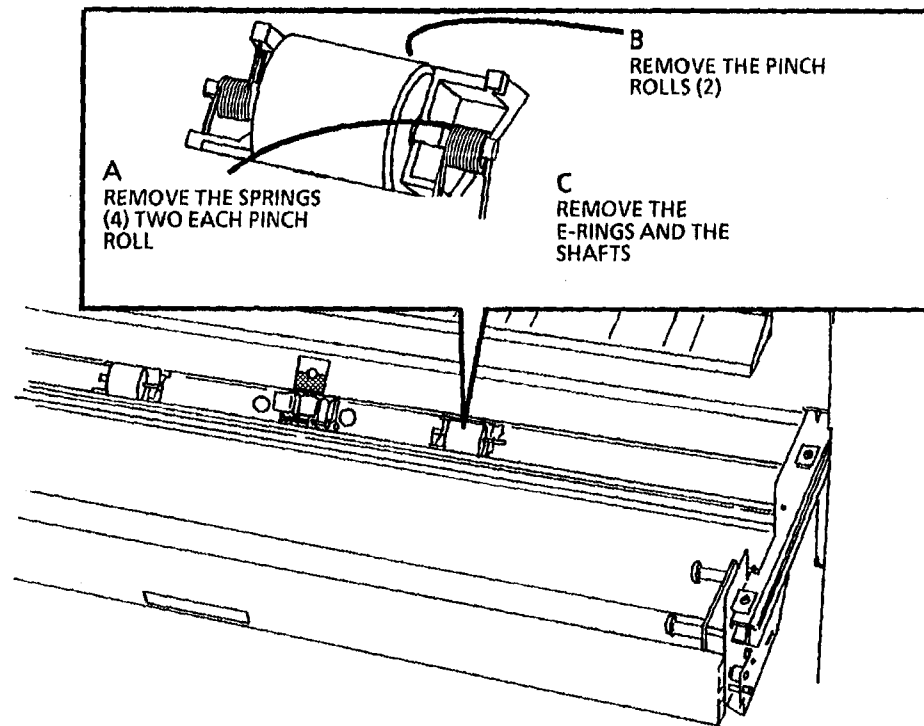
W2423

1. Remove the roll of media.
2. (Figure 1): Remove the Roll Feed Pinch Rolls.

Figure 1. Removing the Roll Feed Pinch Rolls

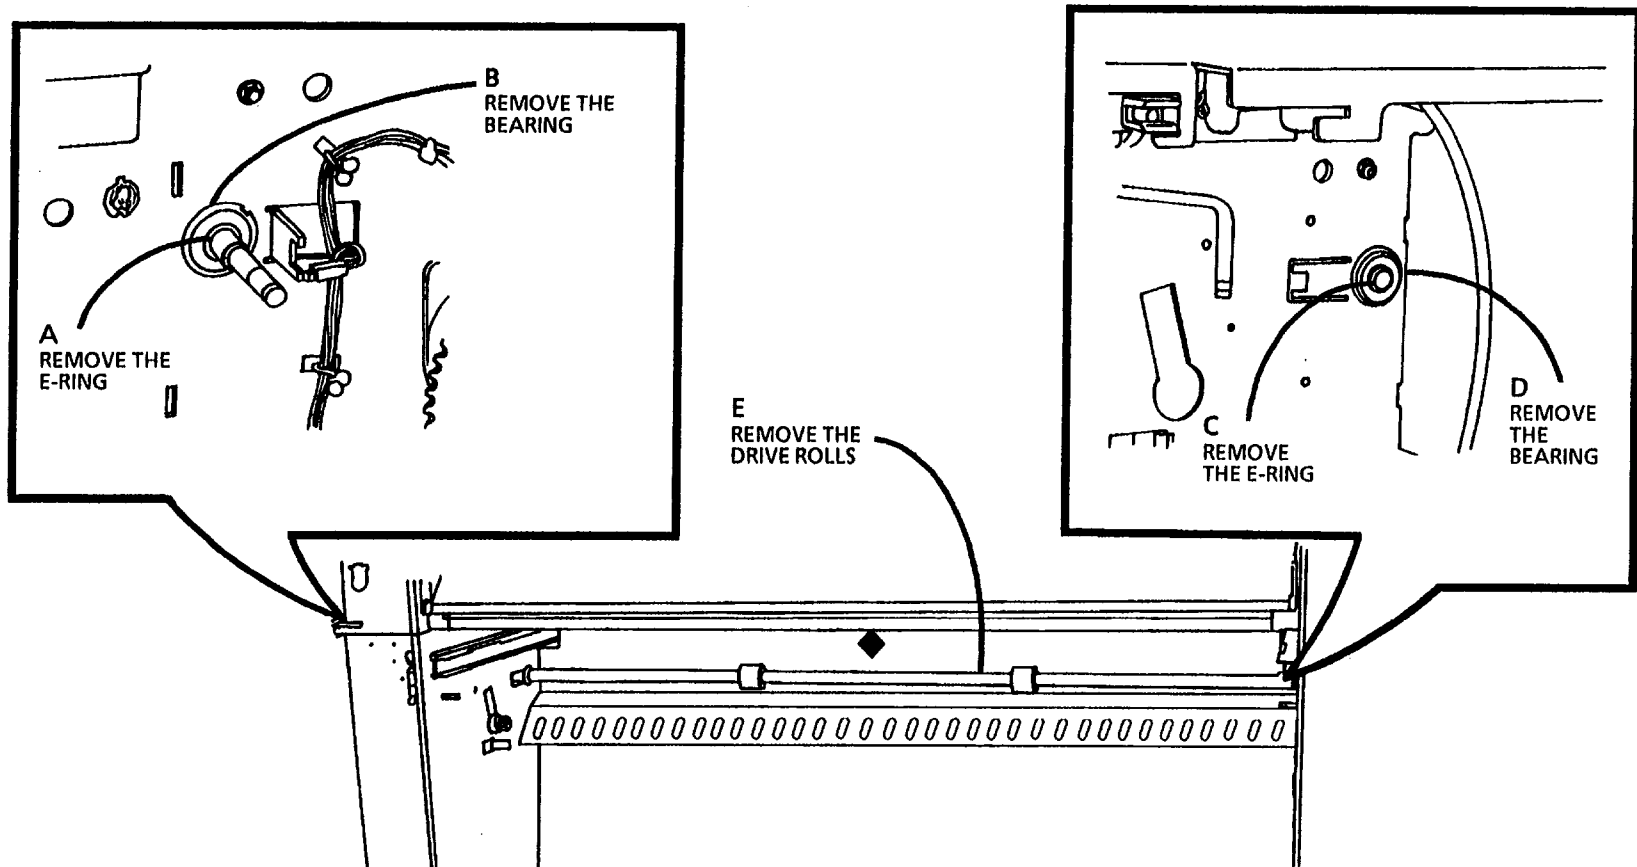
W2424

2. Remove the Feed Clutch (REP 7.5).
3. Remove the Toner Waste Bottle.
4. (Figure 1): Remove the Roll Feed Drive Rolls.

Figure 1. Removing the Roll Feed Drive Rolls

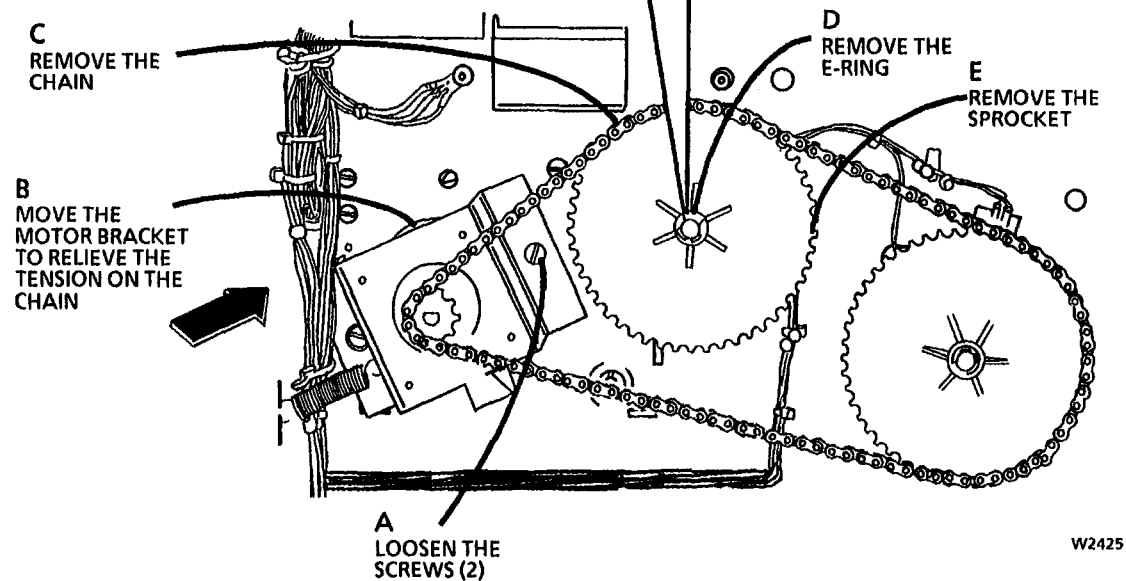
1. Open the Left Side Door.
2. (Figure 1): Remove the Feed Clutch.

Figure 1. Removing the Feed Clutch

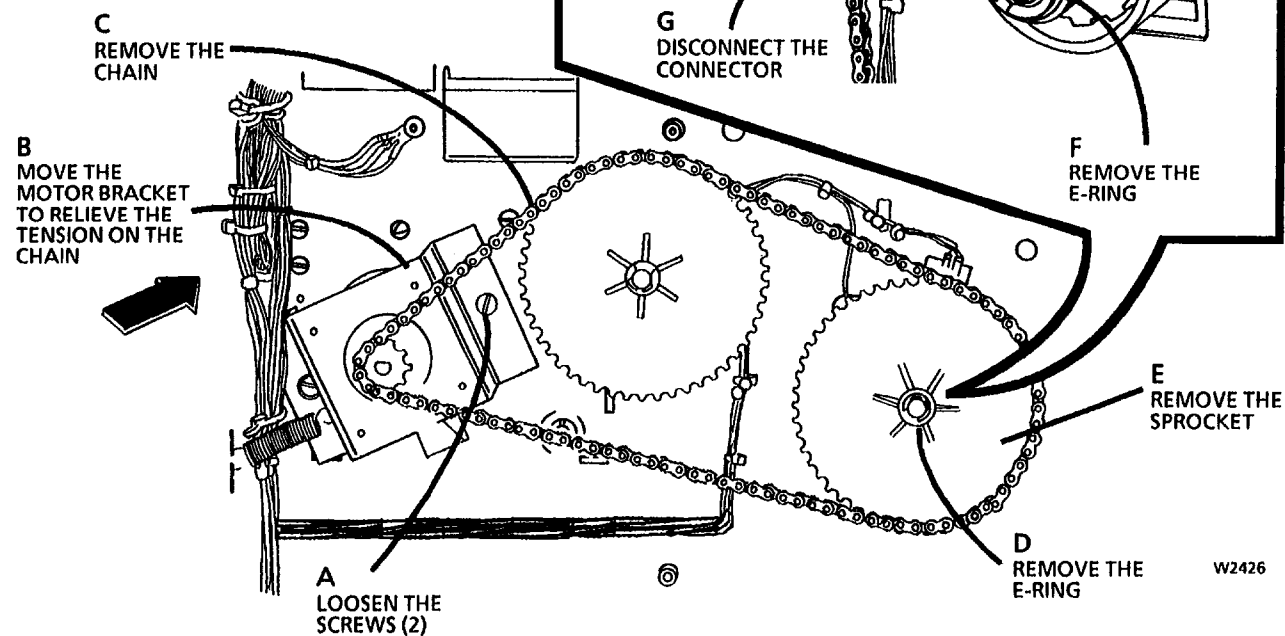
1. Open the Left Side Door.
2. (Figure 1): Remove the Clutch.

Figure 1. Removing the Rewind Clutch

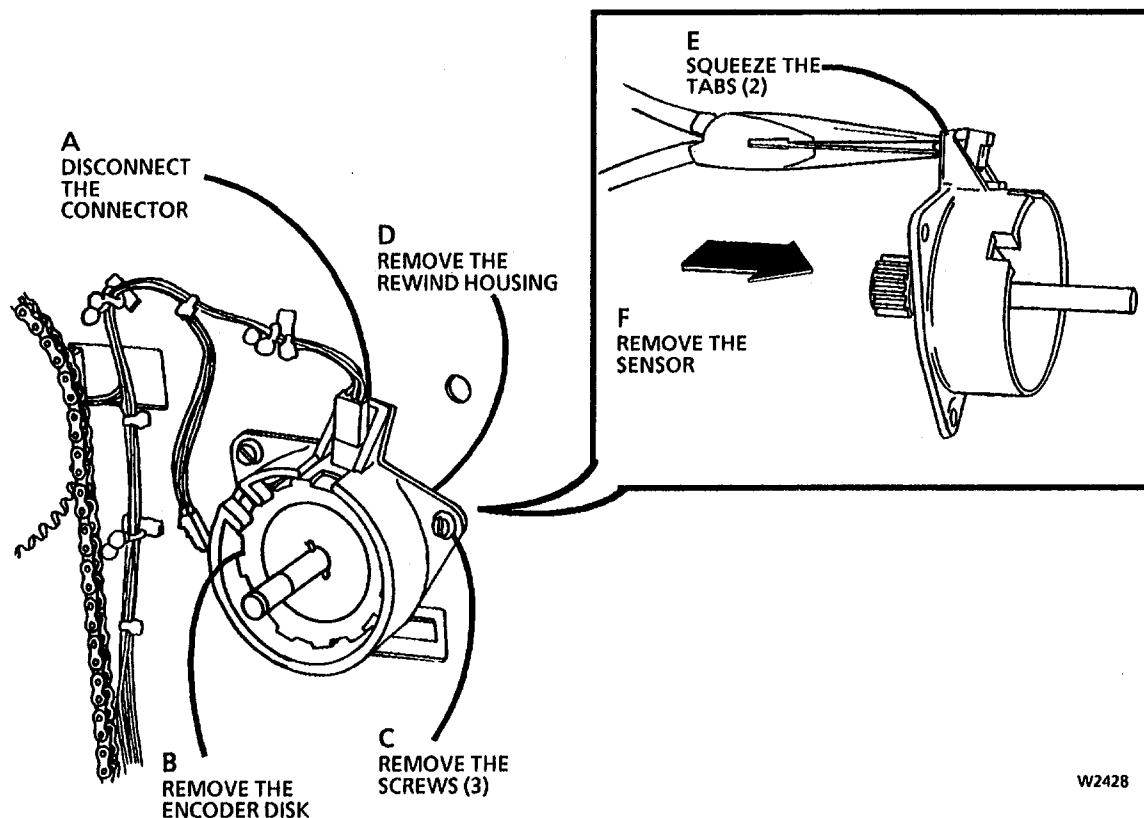
Figure 1. Removing the Encoder Sensor

2. Remove the Rewind Clutch (REP 7.6).
3. (Figure 1): Remove the Motion Sensor.

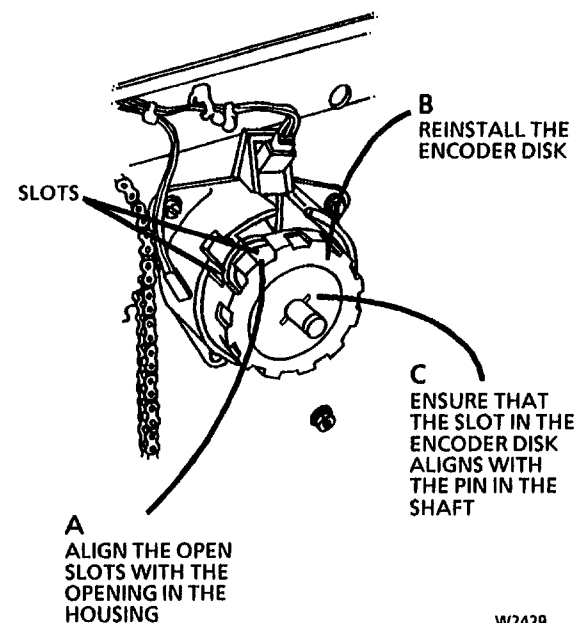
1. Reinstall the Motion Sensor and the Rewind Housing.
2. (Figure 2): Reinstall the Encoder Disk.

Figure 2. Reinstalling the Encoder Disk

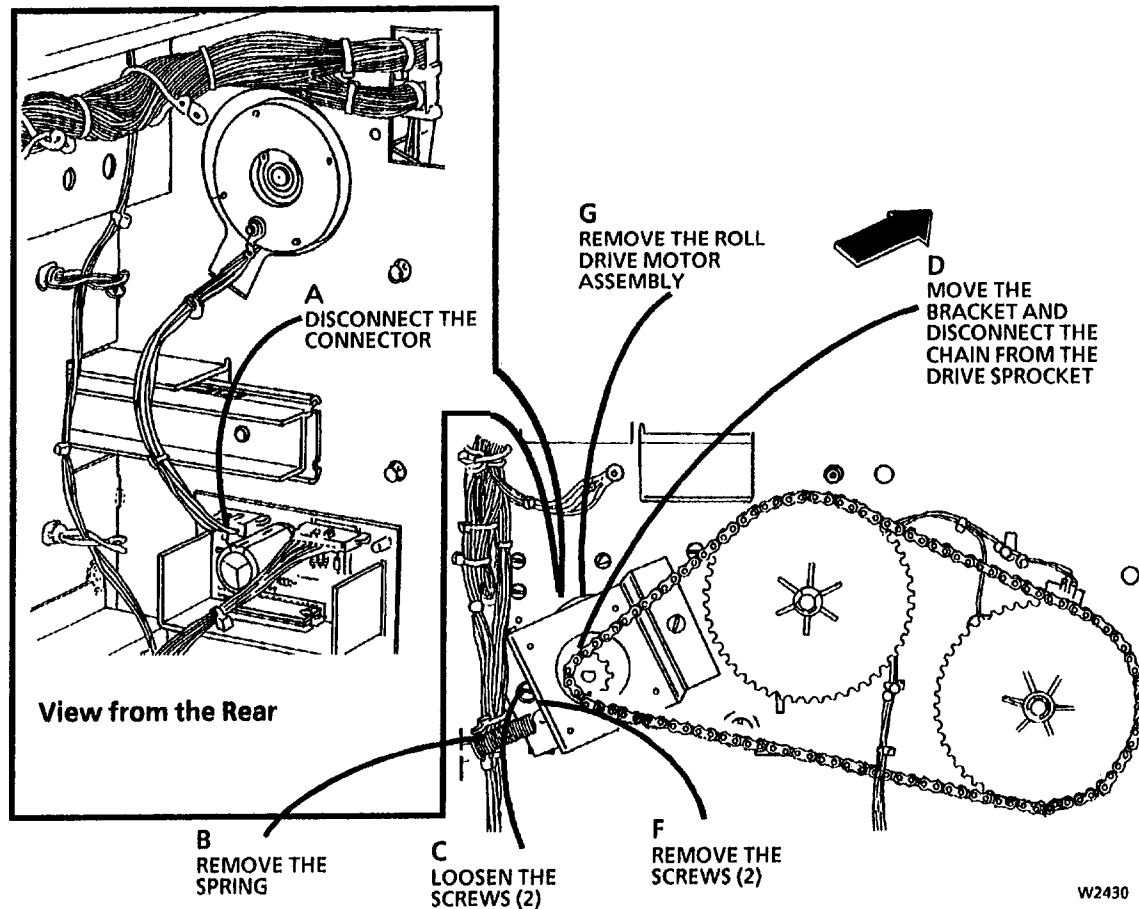
Figure 1. Removing the Roll Drive Motor Assembly

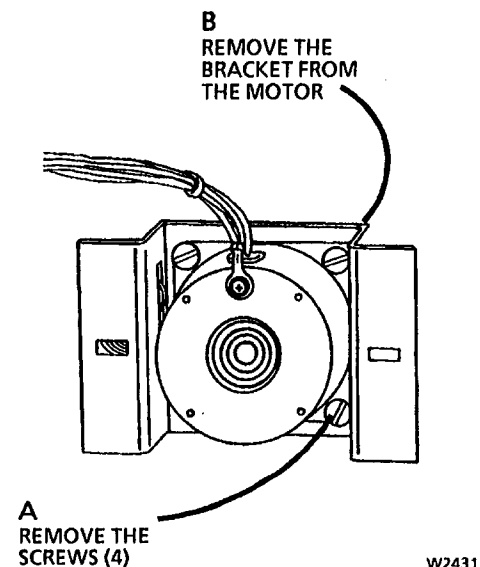
3. (Figure 2): Remove the bracket from the Roll Driver Motor.

Figure 2. Removing the Bracket

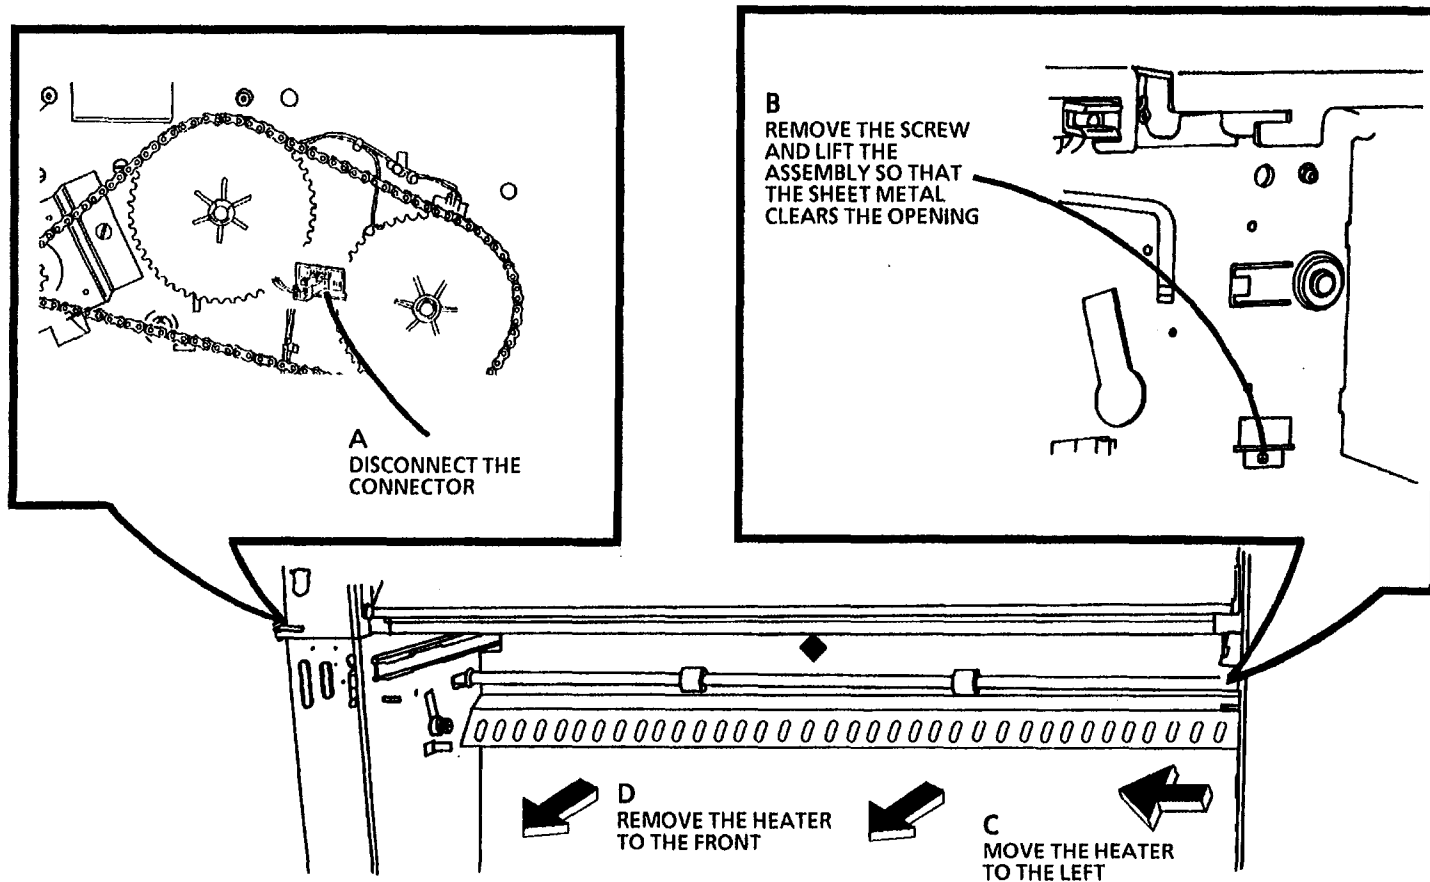
W2432

2. Open the Left Side Door and the Right Side Door.
3. (Figure 1): Remove the Media Roll Heater.

Figure 1. Removing the Media Roll Heater

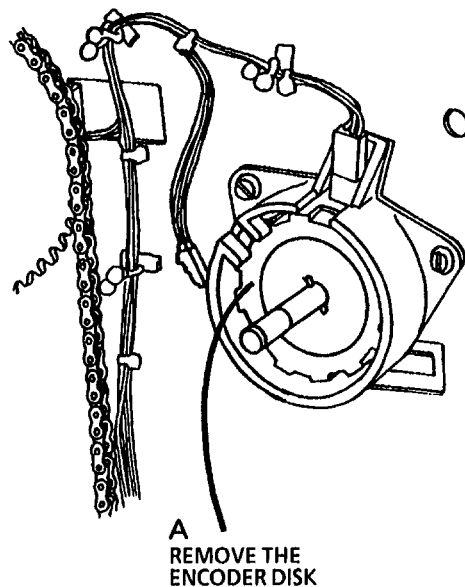
W2433

1. Open the Left Side Door.
2. Remove the Rewind Clutch(Rep 7.6).
3. (Figure 1): Remove the Encoder Disk.

Figure 1. Removing the Encoder

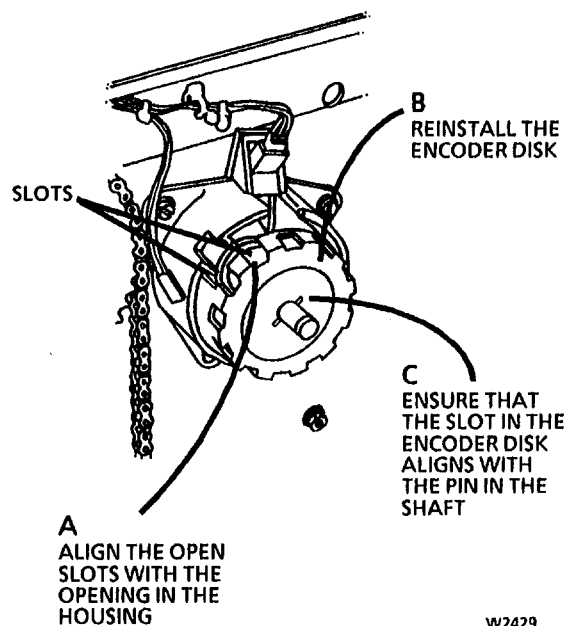
W2429

1. Reinstall the Motion Sensor and the Rewind Housing.
2. (Figure 2): Reinstall the Encoder Disk.

Figure 2. Reinstalling the Encoder Disk

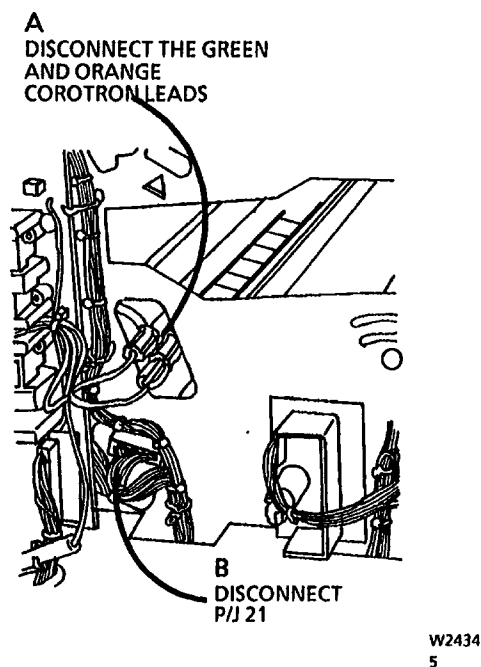
2. (Figure 1): Disconnect the connectors on the left side of the copier.

Figure 1. Disconnecting the Connectors

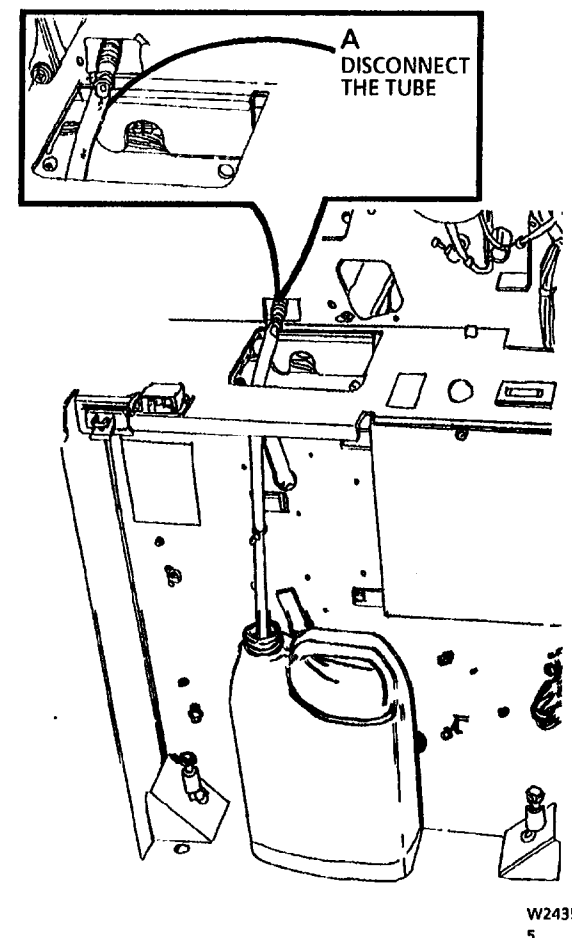
3. (Figure 2): Disconnect the Moisture Collection Tube.

Figure 2. Disconnecting the Tube

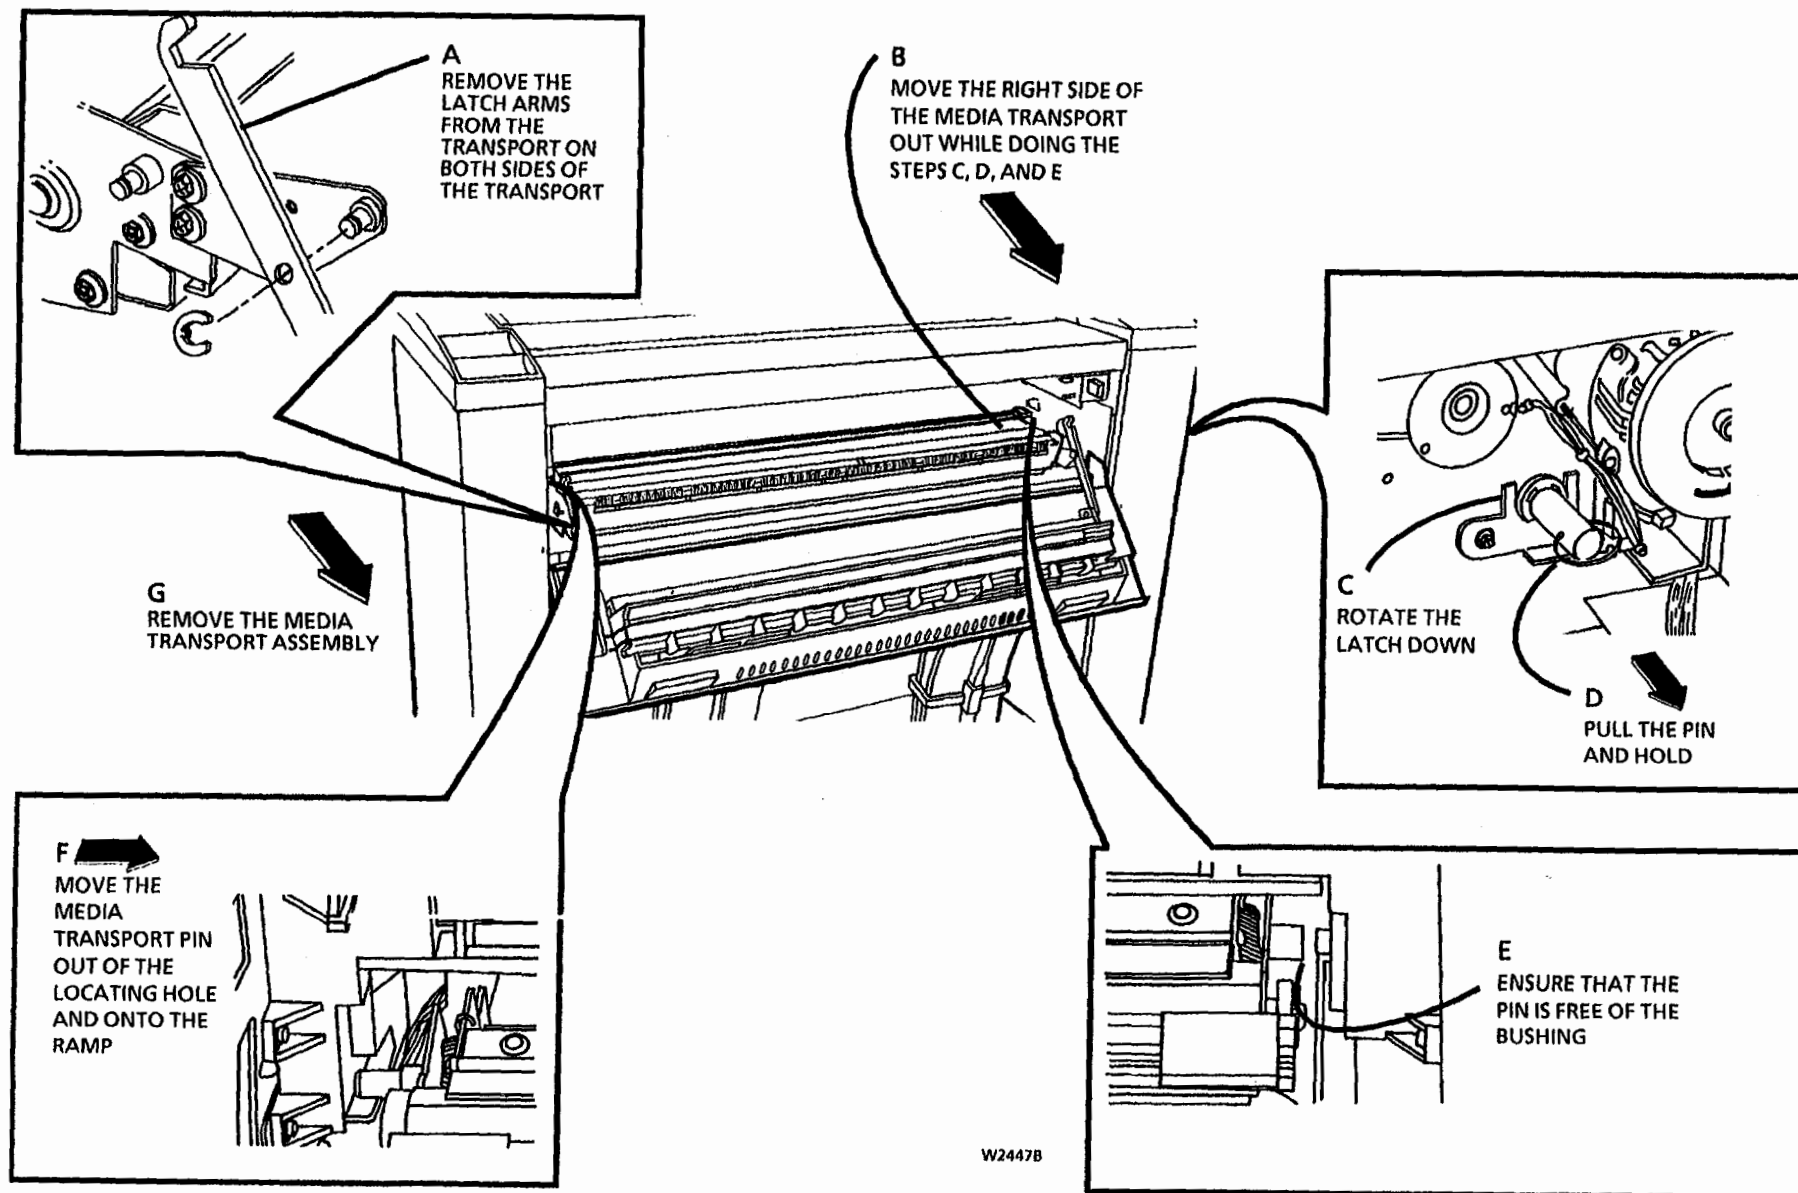
4. (Figure 2): Remove the Media Transport Assembly.

1 Before removing the Media Transport Assembly, ensure that there is a clean area on which to place the assembly.

Figure 2. Removing the Media Transport Assembly

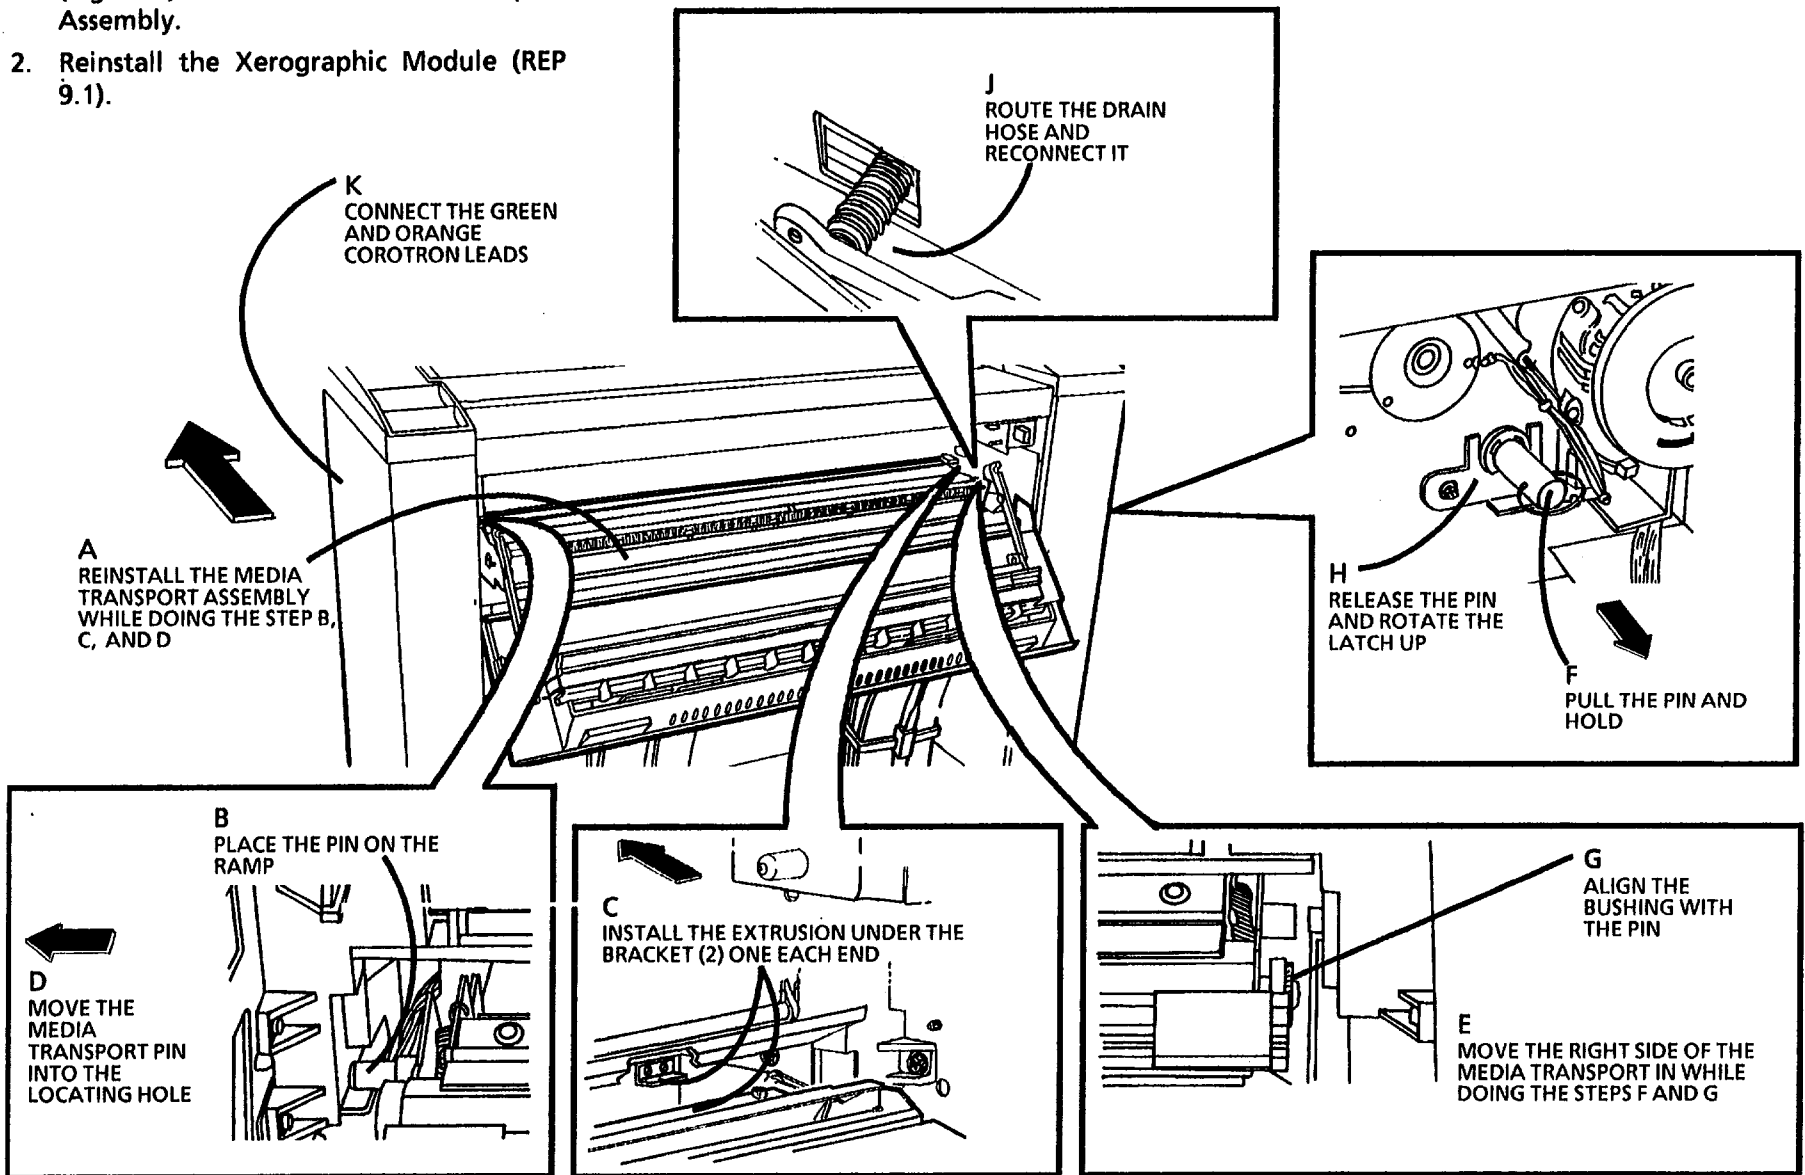
W2446B

1. (Figure 3): Reinstall the Media Transport Assembly.
2. Reinstall the Xerographic Module (REP 9.1).

Figure 3. Install the Media Transport Assembly

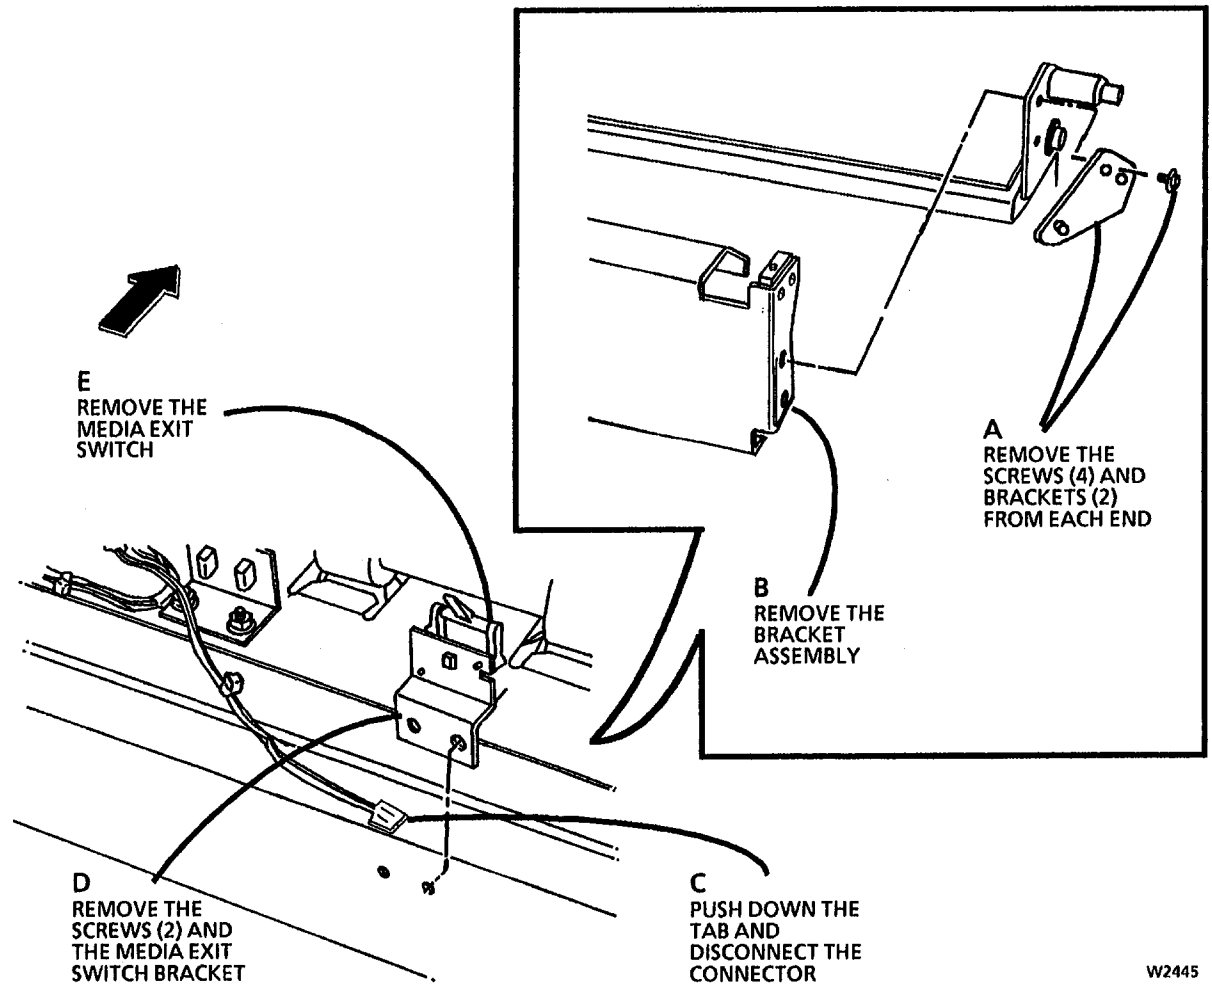
W2445

1. Remove the Document Handler and raise the Document Feed-in Shelf.
2. Remove the Xerographic Module (REP 9.1).
3. Remove the Media Transport Assembly (REP 8.1).
4. (Figure 1): Remove the Media Exit Switch.

Figure 1. Removing the Media Exit Switch

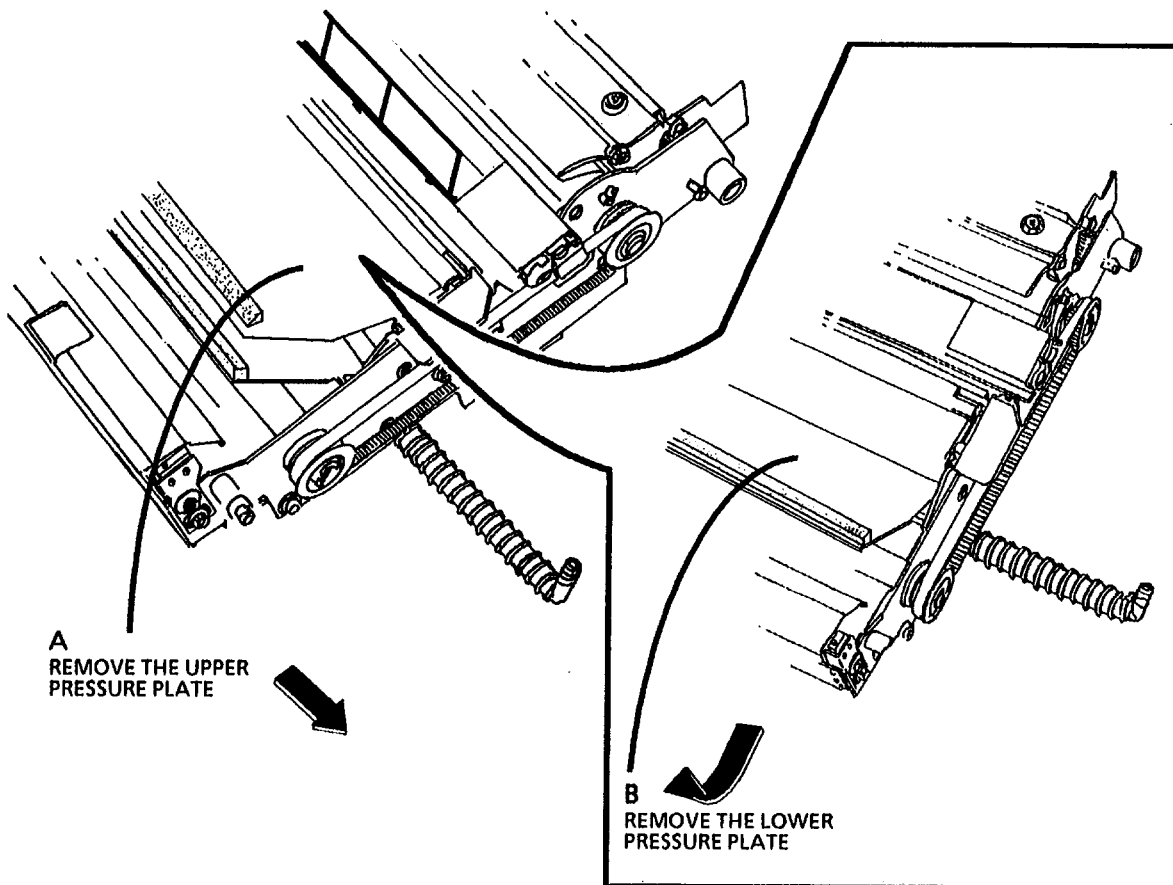
W2440

1. Remove the Xerographic Module (REP 9.1).
2. Remove the Media Transport Assembly (REP 8.1).
3. Remove the Fabric Guide (REP 8.9).
4. (Figure 1): Remove the Upper and Lower Pressure Plates.

Figure 1. Removing the Upper and Lower Pressure Plates

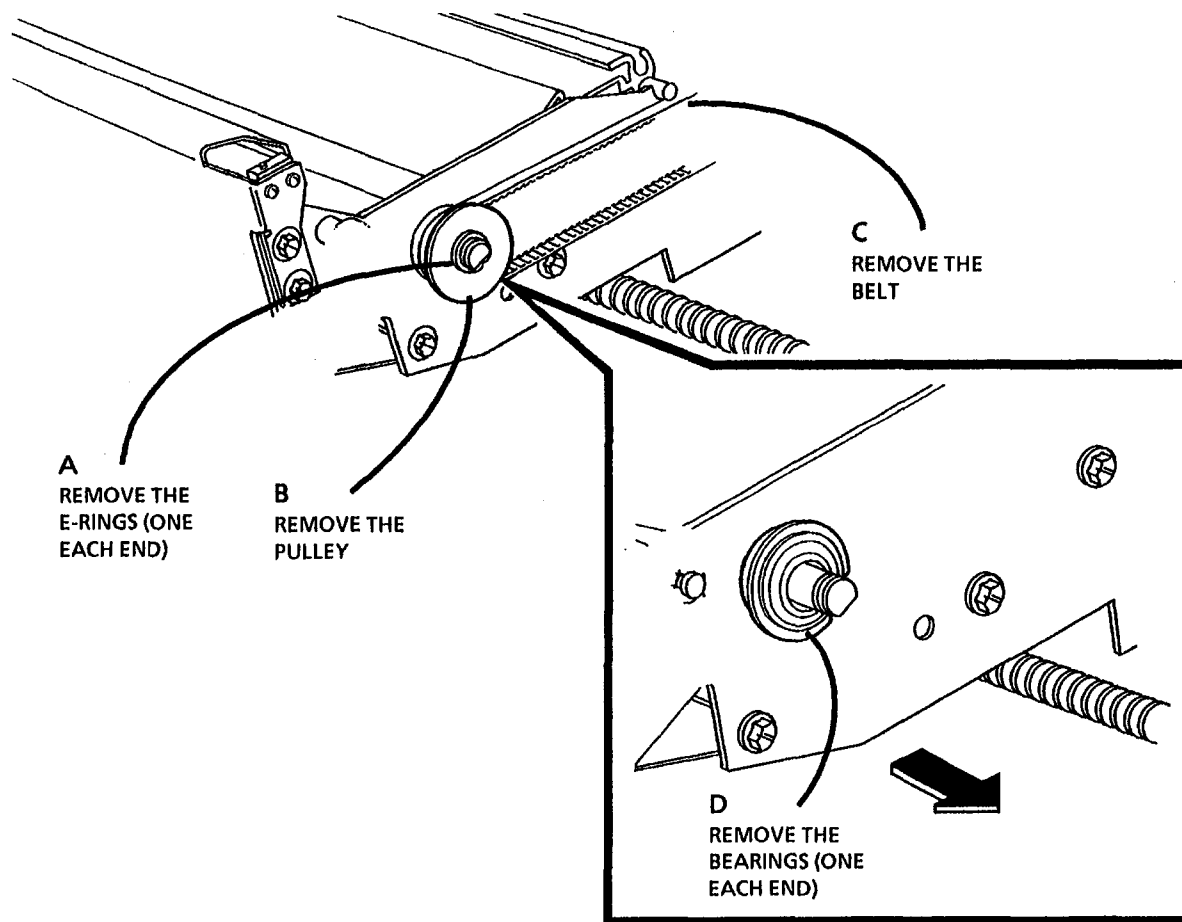
W2441

5. (Figure 2): Remove the belt and the pulley.

Figure 2. Removing the Belt and the Pulley

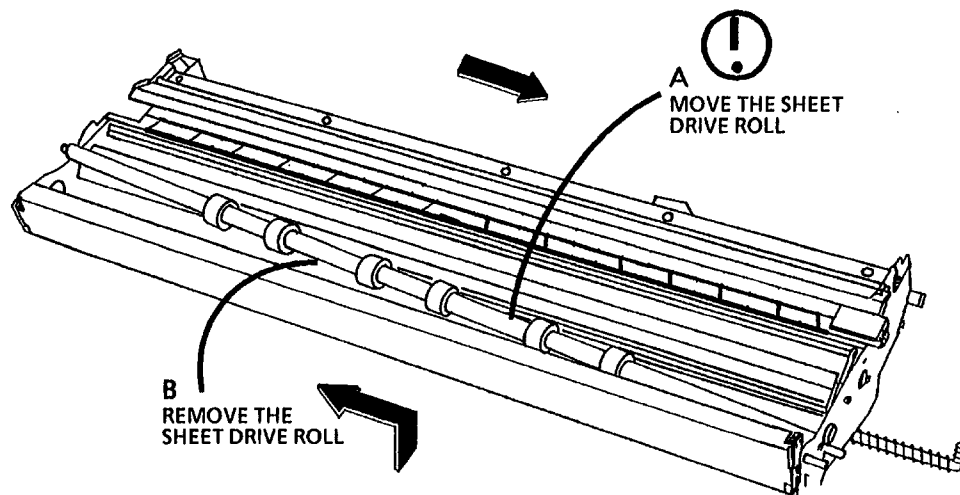
W2442

STEP 6A: *Be careful not to damage the actuator arm on the Sheet Media Feed Switch.*

6. (Figure 3): Remove the Sheet Drive Roll.

Figure 3. Removing the Sheet Drive Roll

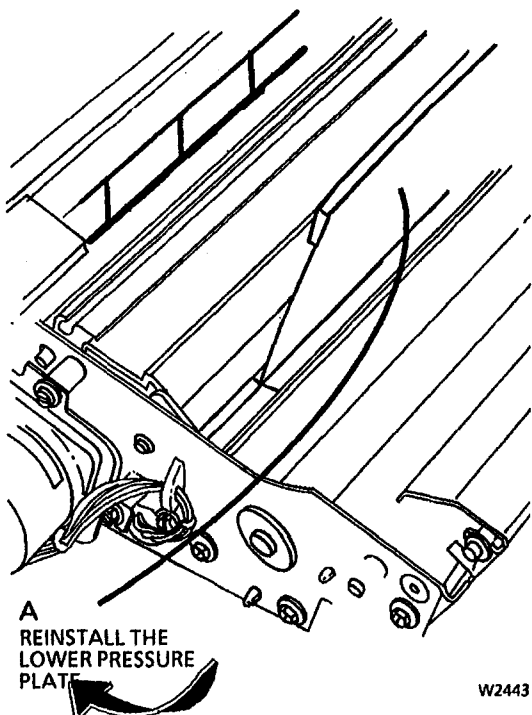
2. (Figure 4): Reinstall the Lower Pressure Plate.

Figure 4. Reinstalling the Lower Pressure Plate

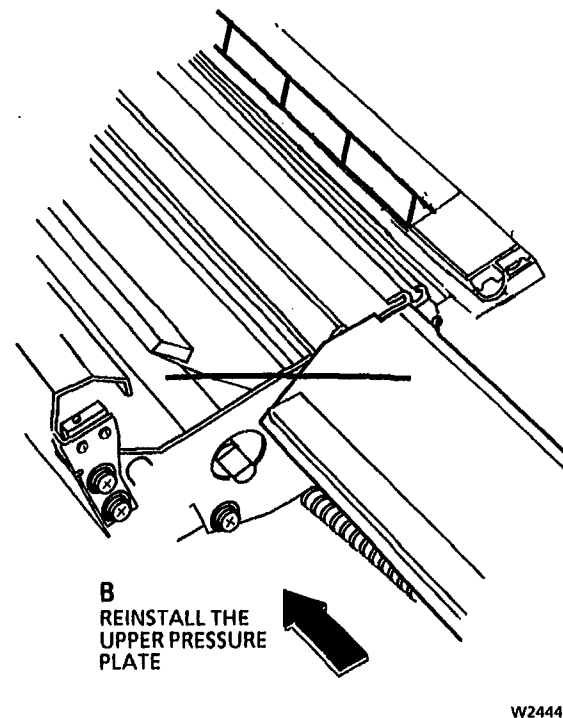
3. (Figure 5): Reinstall the Upper Pressure Plate.

Figure 5. Reinstalling the Upper Pressure Plate

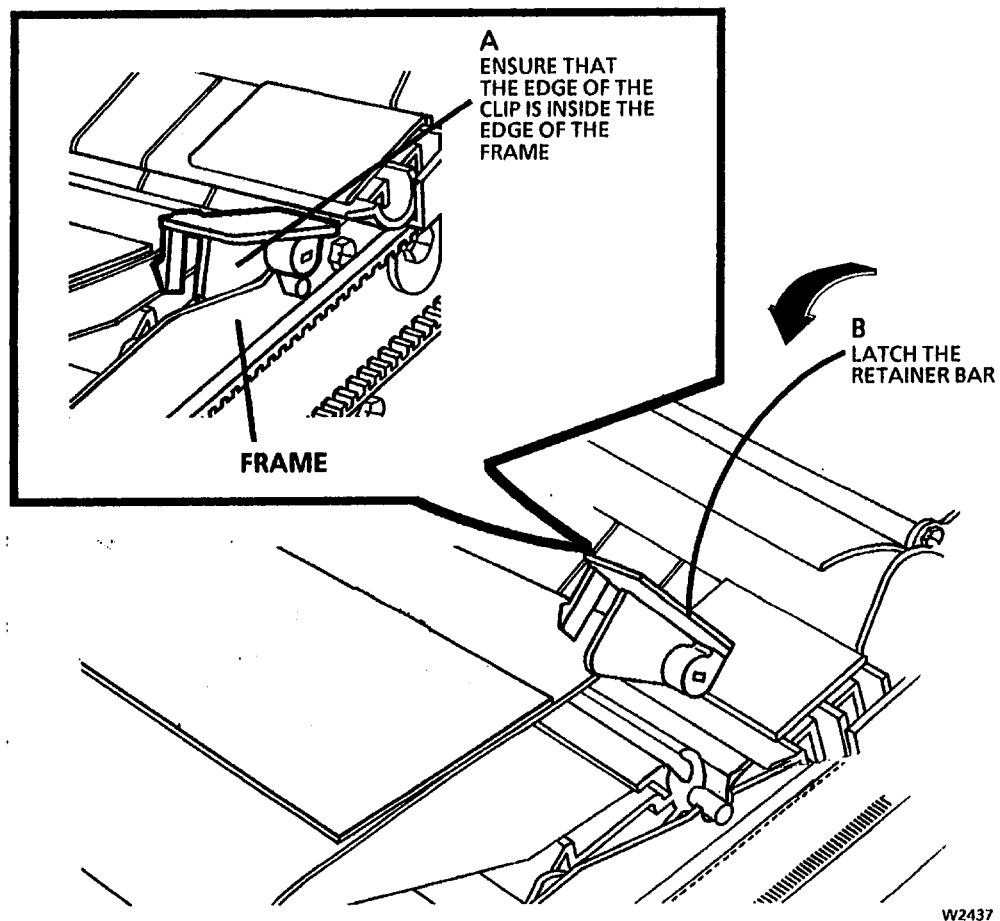
4. (Figure 6): Reinstall the Fabric Guide.

Figure 6. Reinstalling the Fabric Guide

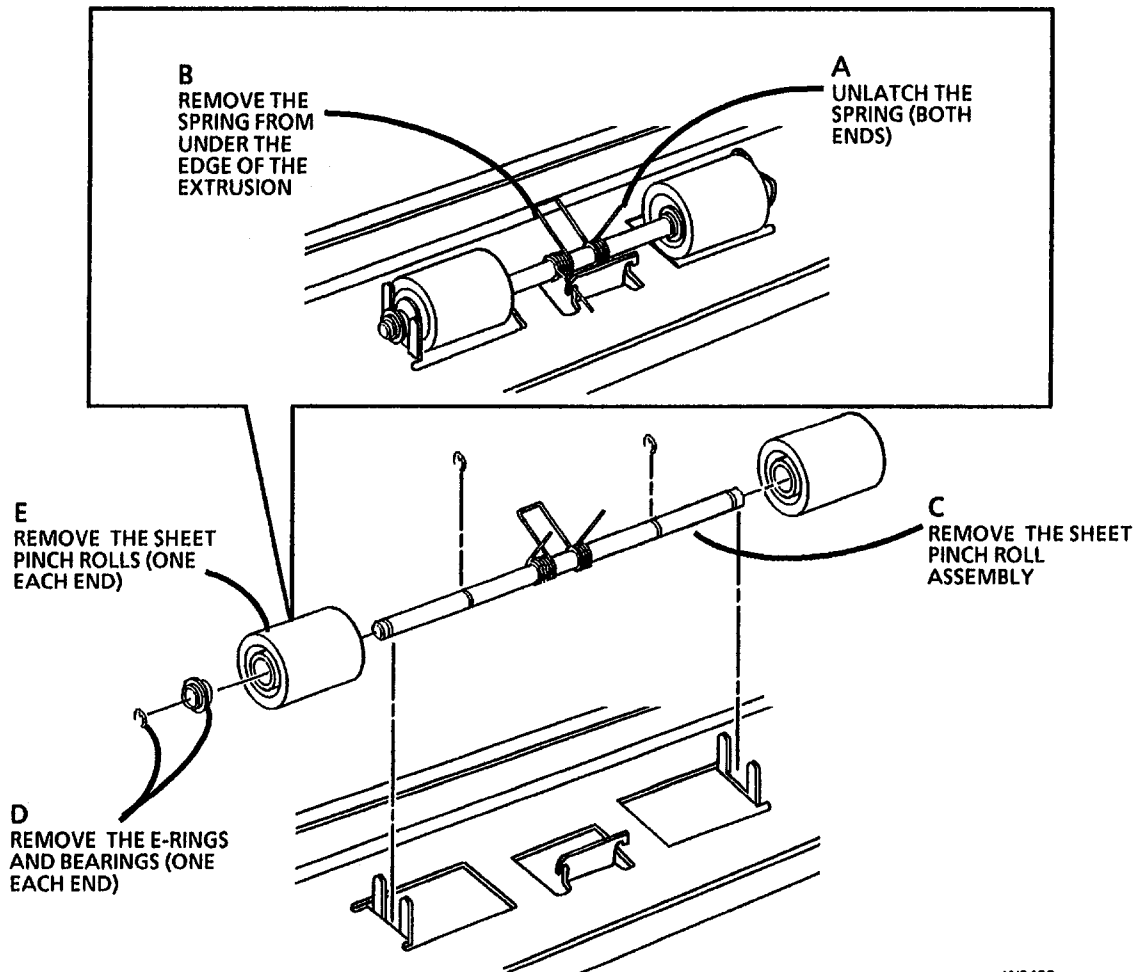
W2439

1. Remove the Xerographic Module (REP 9.1).
2. Remove the Media Transport Assembly (REP 8.1).
3. Turn the Media Transport Assembly over.
4. (Figure 1): Remove the Sheet Pinch Rolls.

Figure 1. Removing the Sheet Pinch Rolls

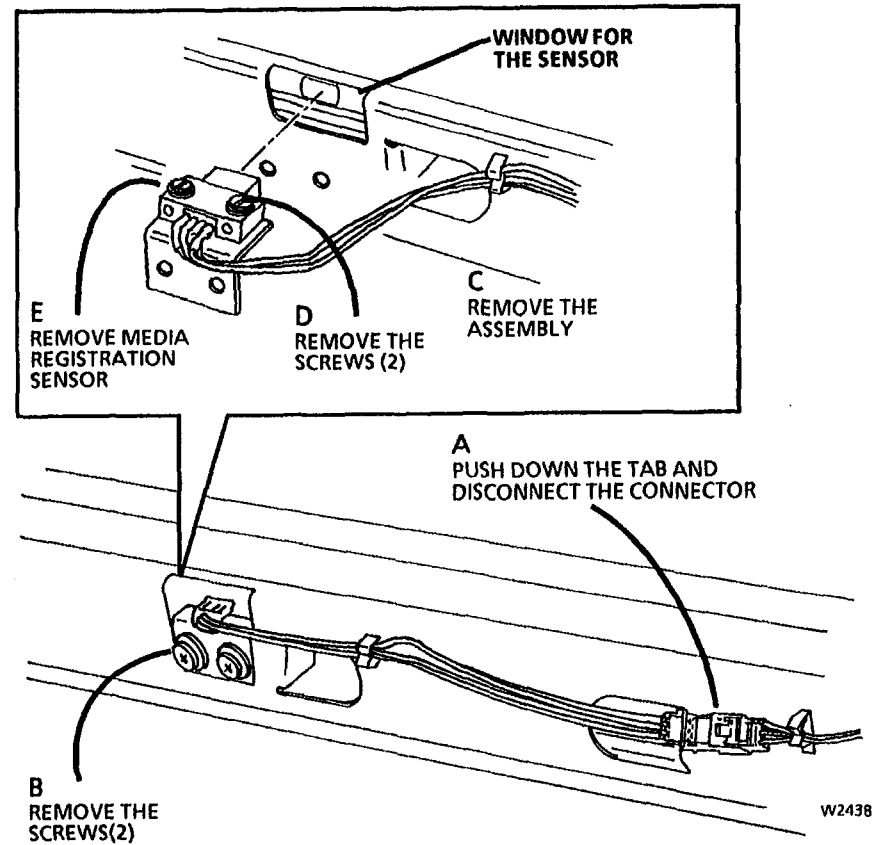
1. Remove the Xerographic Module (REP 9.1).
2. Remove the Media Transport Assembly (REP 8.1).
3. (Figure 1): Remove the Media Registration Sensor.

Figure 1. Removing the Media Registration Sensor

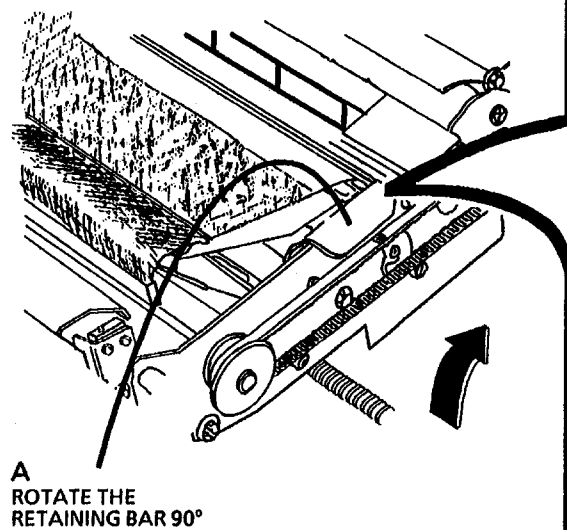
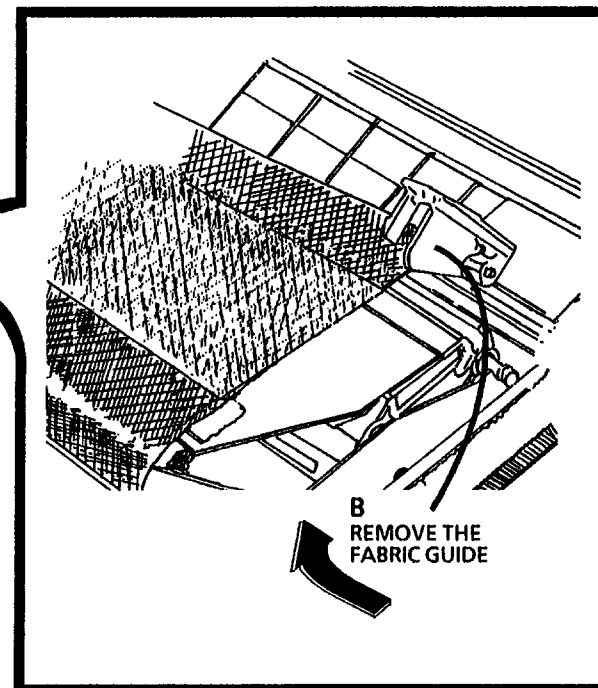
W2436

The Xerographic Module does not have to be removed to remove the Fabric Guide. The Xerographic Module is shown removed for clarity.

2. (Figure 1): Remove the Fabric Guide.

Figure 1. Removing the Fabric Guide
