- **Call Flow Diagram** - This diagram outlines the major activities that are performed when a service call is made. The **Initial Actions** assist the Service Representative through the customer interface and help to identify the problem. The diagram also directs the Representative to verify, classify, repair the problem and perform the correct Maintenance Procedure.

2. Status Indicator Repair Analysis Procedures

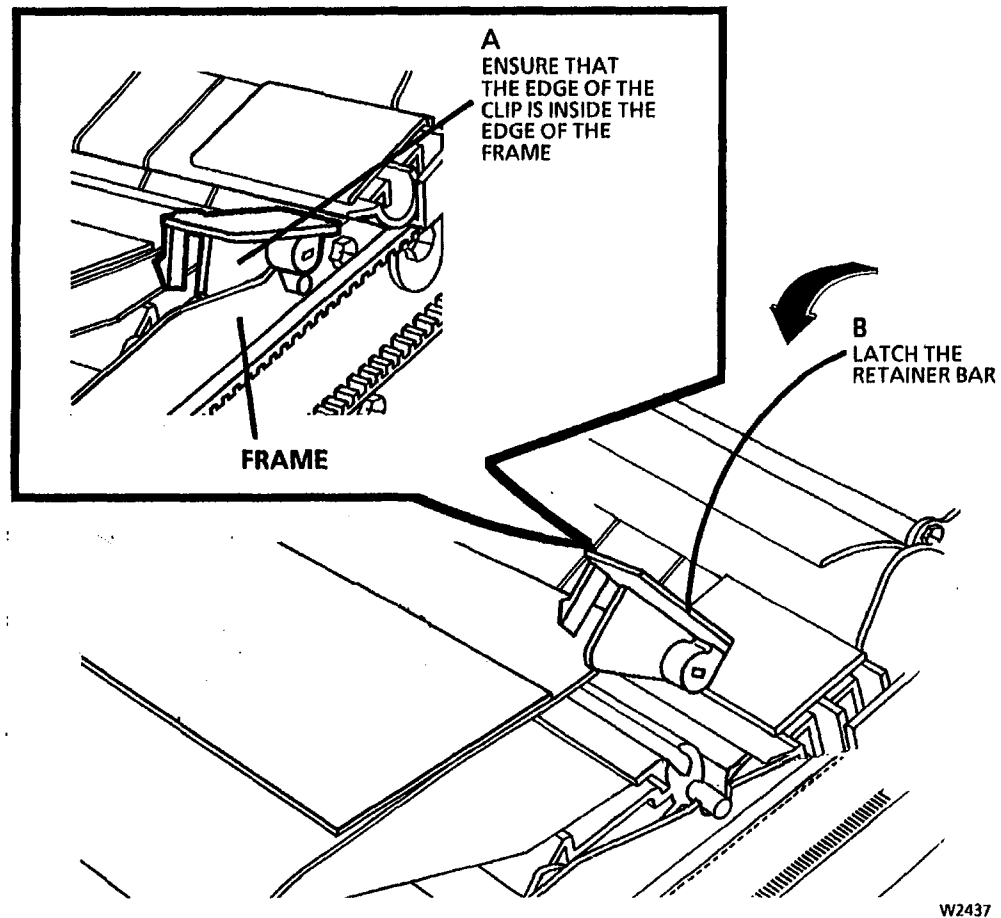
1. (Figure 2): Reinstall the Fabric Guide.

Figure 2. Reinstalling the Fabric Guide

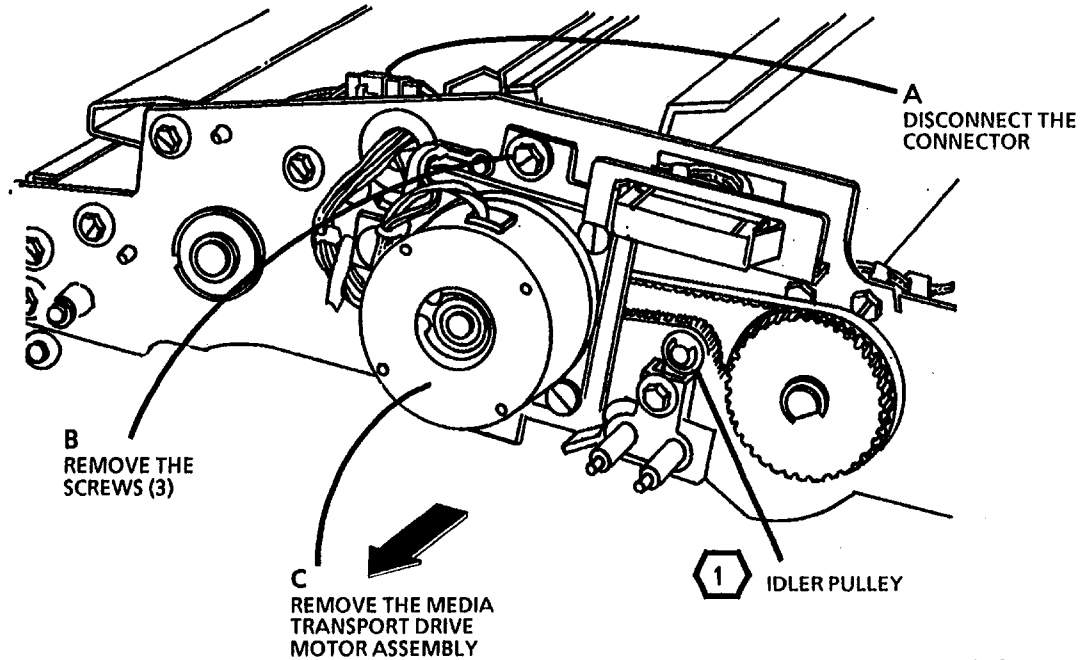
W2448

1. Remove the Xerographic Module (REP 9.1).
2. Remove the Media Transport Assembly (REP 8.1).
3. Turn the Media Transport Assembly over.
4. (Figure 1): Remove the Media Transport Drive Motor Assembly.

Figure 1. Removing the Media Transport Drive Motor

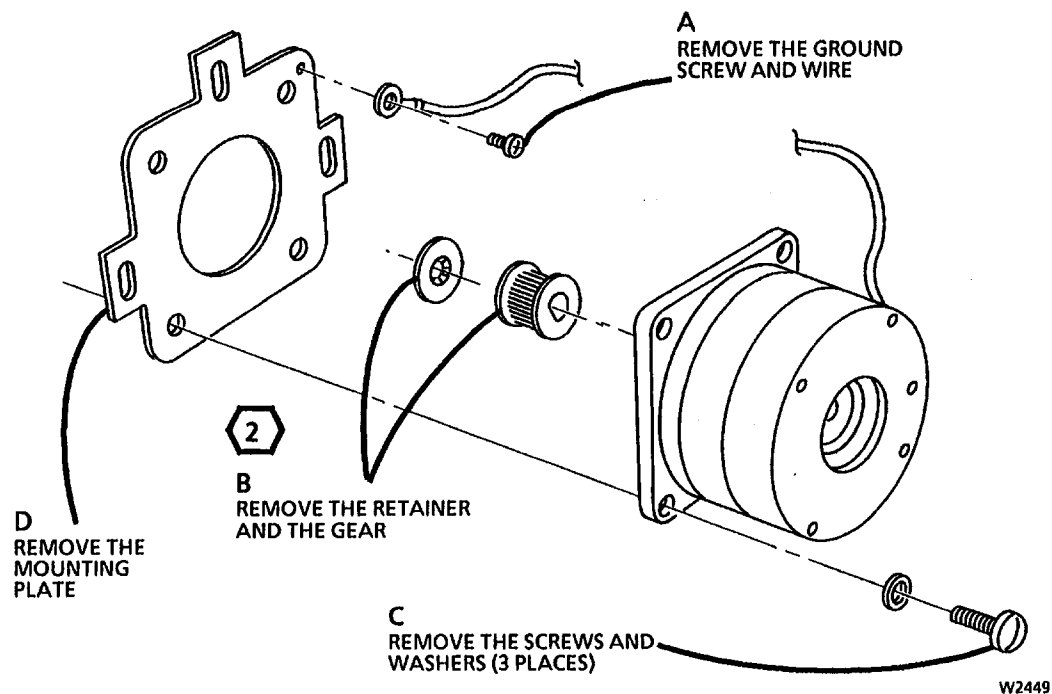
5. (Figure 2): Remove the Media Transport Drive Motor from the mounting plate.

Figure 2. Removing the Media Transport Drive Motor from the Mounting Plate

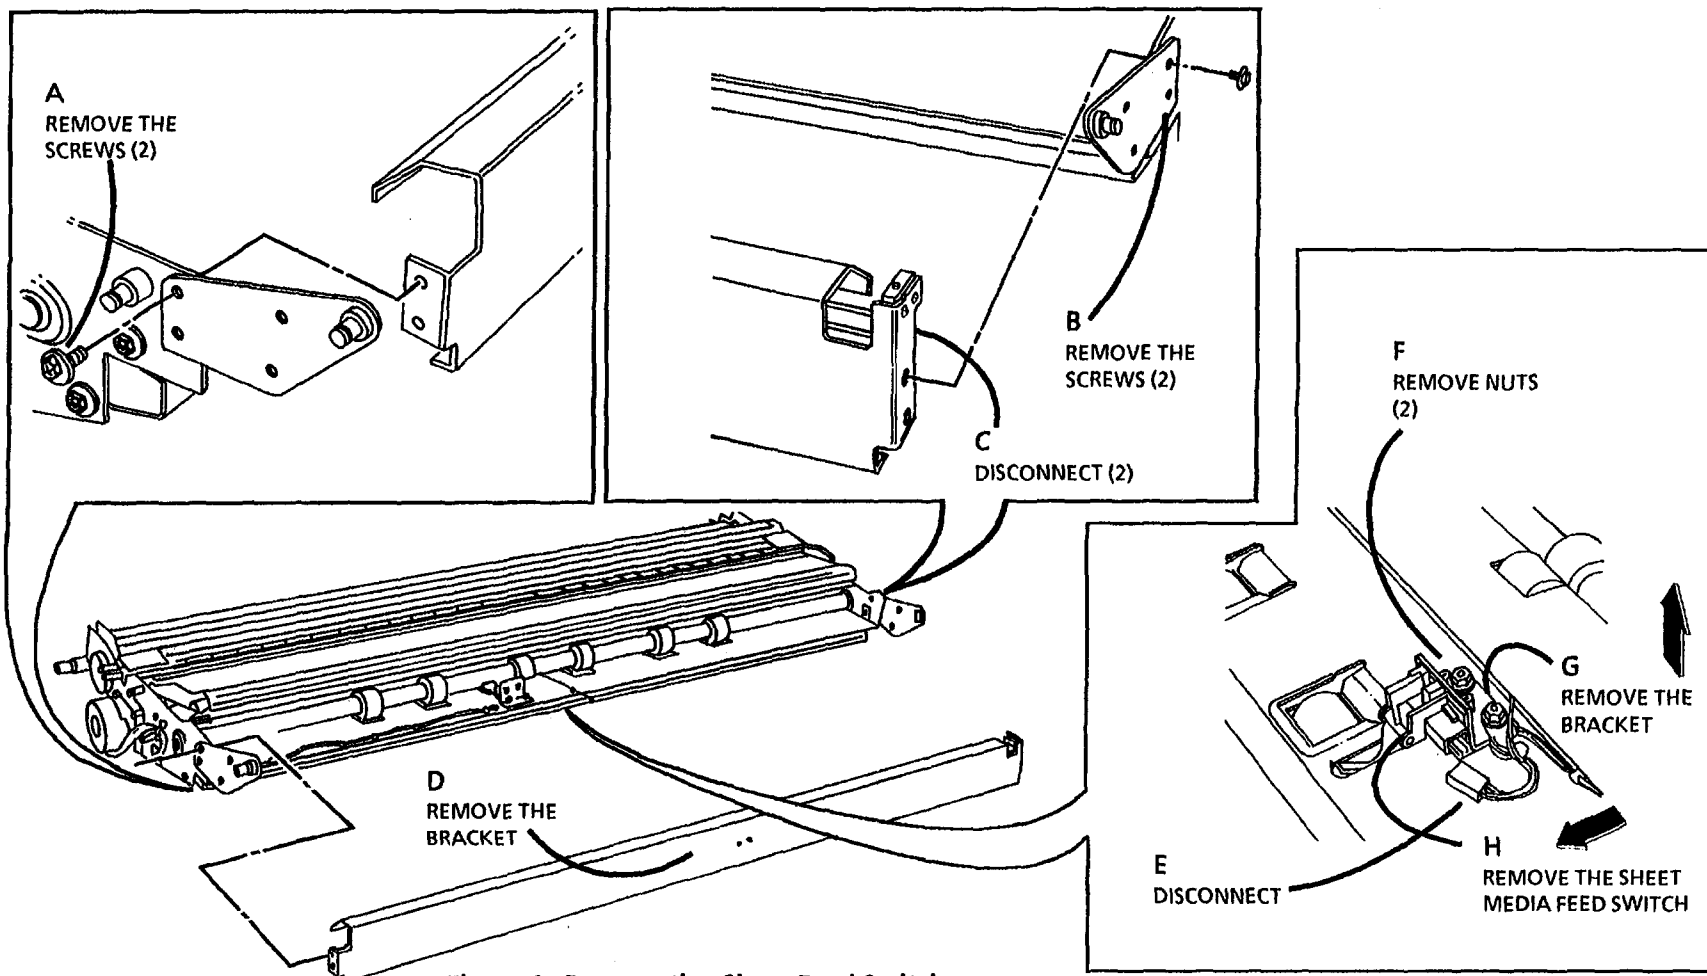
W2450

4. (Figure 1): Remove the Sheet Feed Switch.

Figure 1. Remove the Sheet Feed Switch

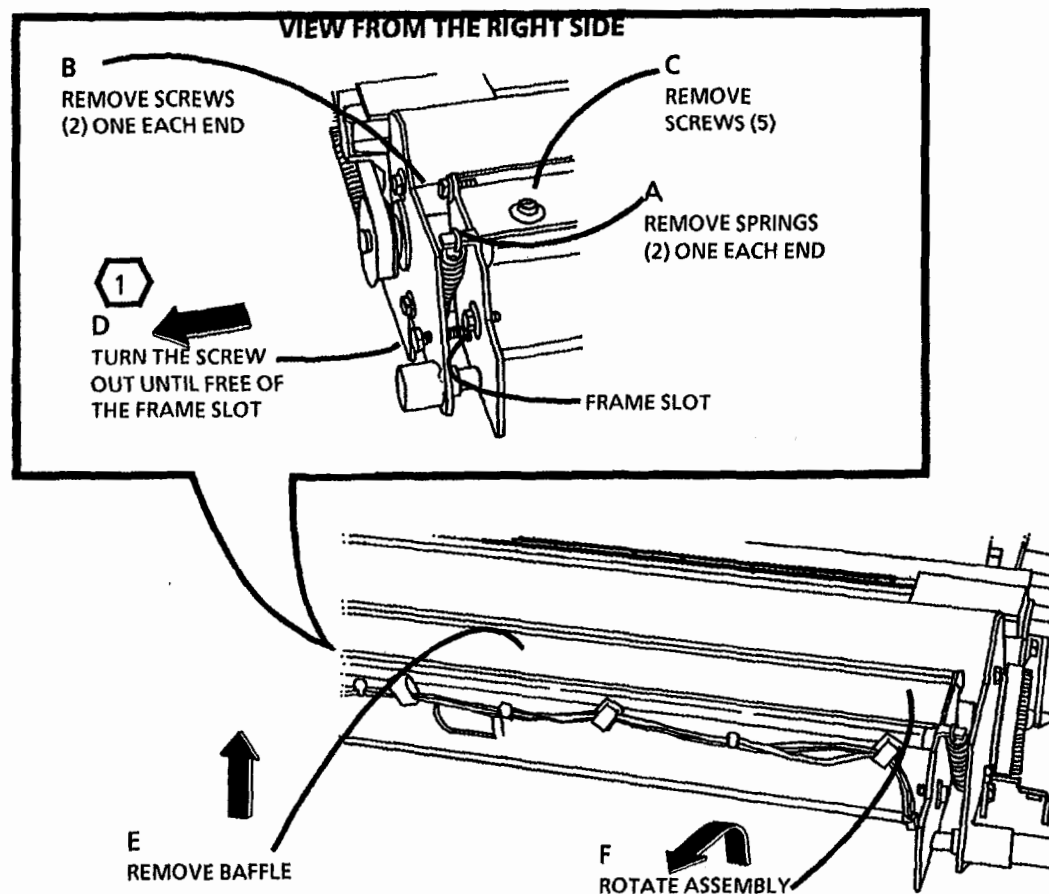
STEP 5 D: Ensure that the screw is free of the frame.

5. (Figure 1): Prepare to remove the Registration Pinch Rolls.

Figure 1. Prepare to Remove the Registration Pinch Rolls

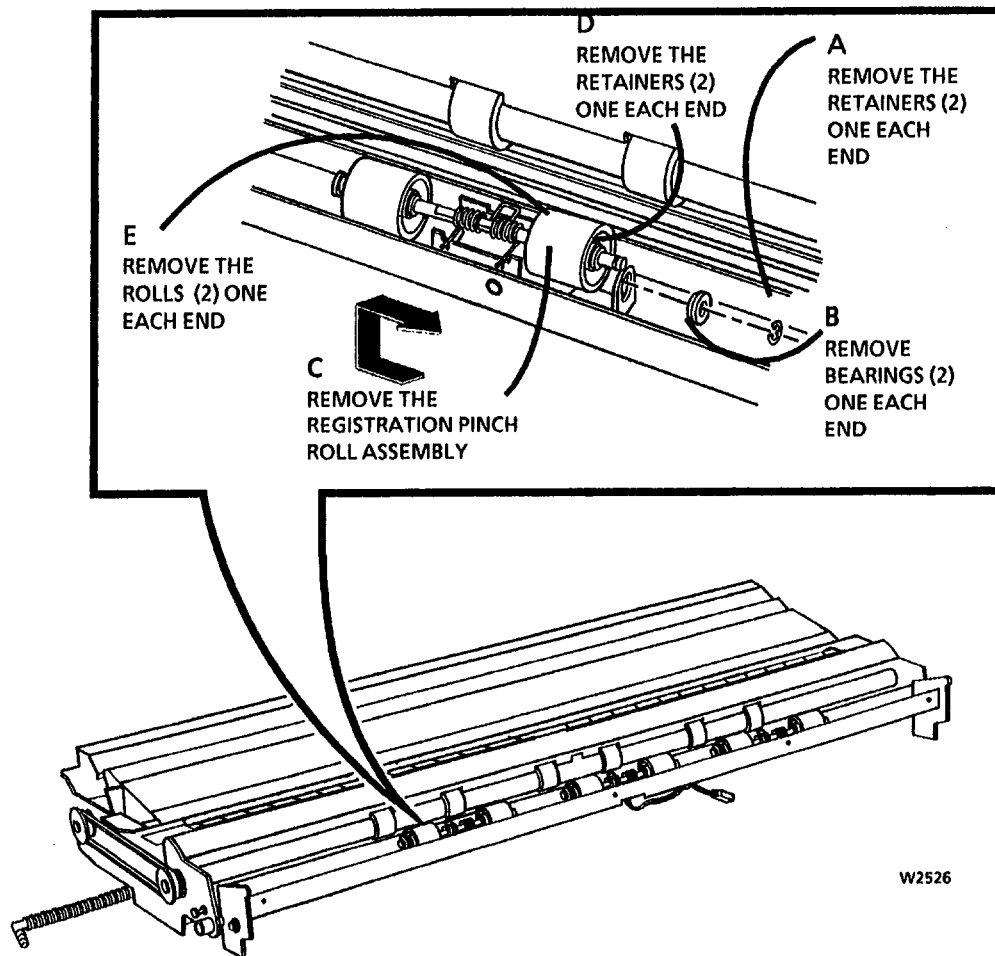
6. (Figure 2): Remove the Registration Pinch Rolls.

Figure 2. Remove the Registration Pinch Rolls

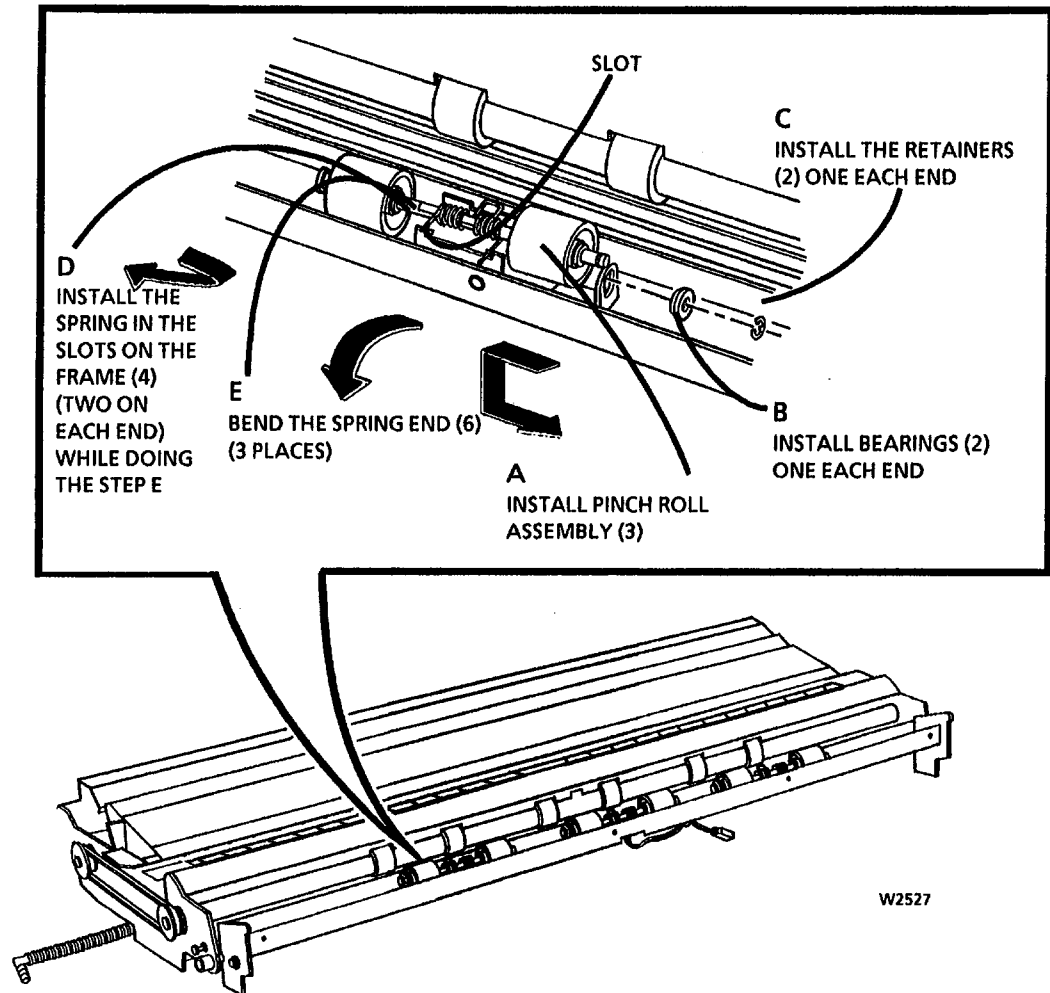
1. Reinstall the rolls and retainers on the shaft.
2. (Figure 3): Install the Registration Pinch Roll Assembly.

Figure 3. Install the Registration Pinch Roll Assembly

2 **STEP 2D:** To restrict the movement of the pinch roll housing, the screw must be through the slot in the frame.

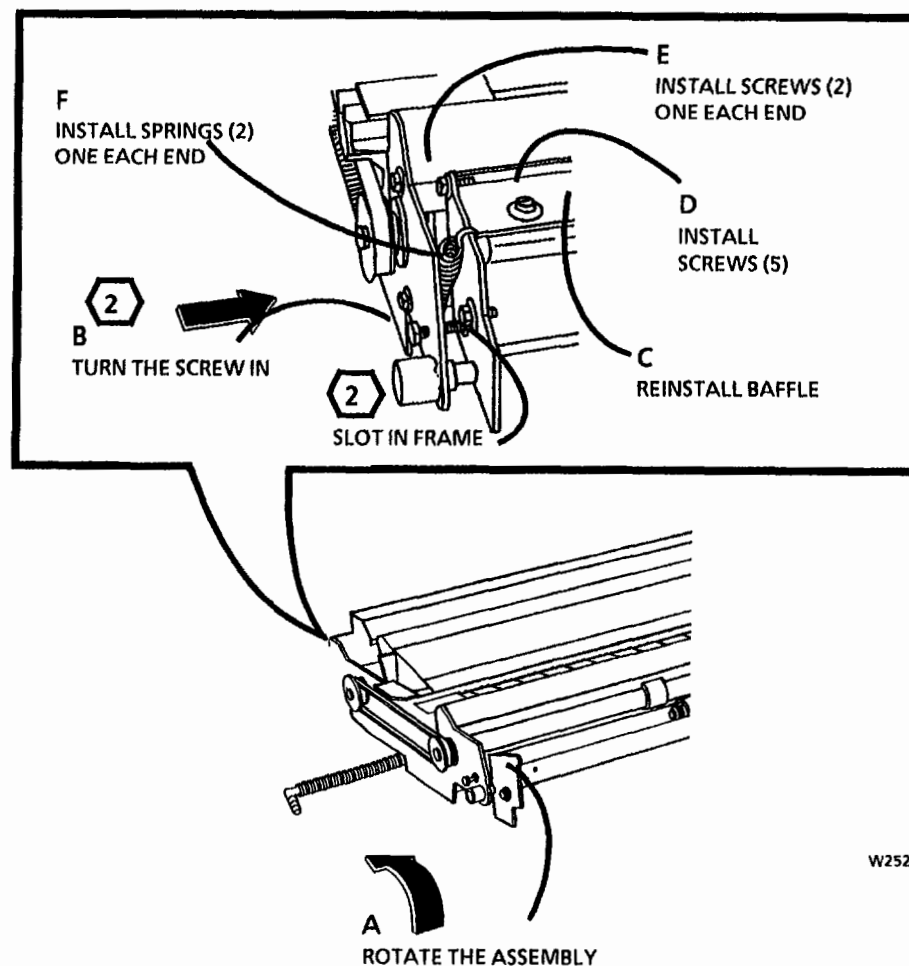
W2528

2. (Figure 4): Install the Springs.
3. The remainder the replacement is a reversal of the removal.
4. Check/Adjust the following:
 - a. Copy Size Adjustment (ADJ 5.1)
 - b. Image Registration (ADJ 8.1)
 - c. Auto Length (ADJ 8.2)

Figure 4. Install the Springs

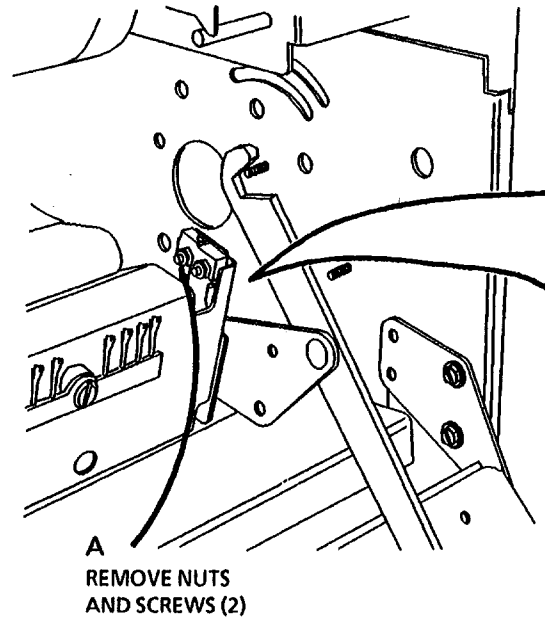
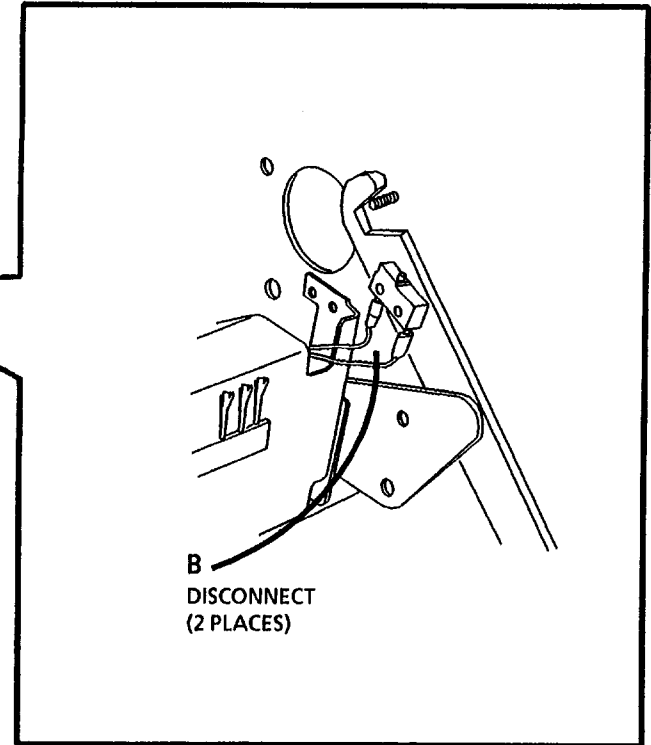
W2563

Ensure that the switch plunger is located in the front.

Figure 2. Remove the Stripper Finger Jam Switch

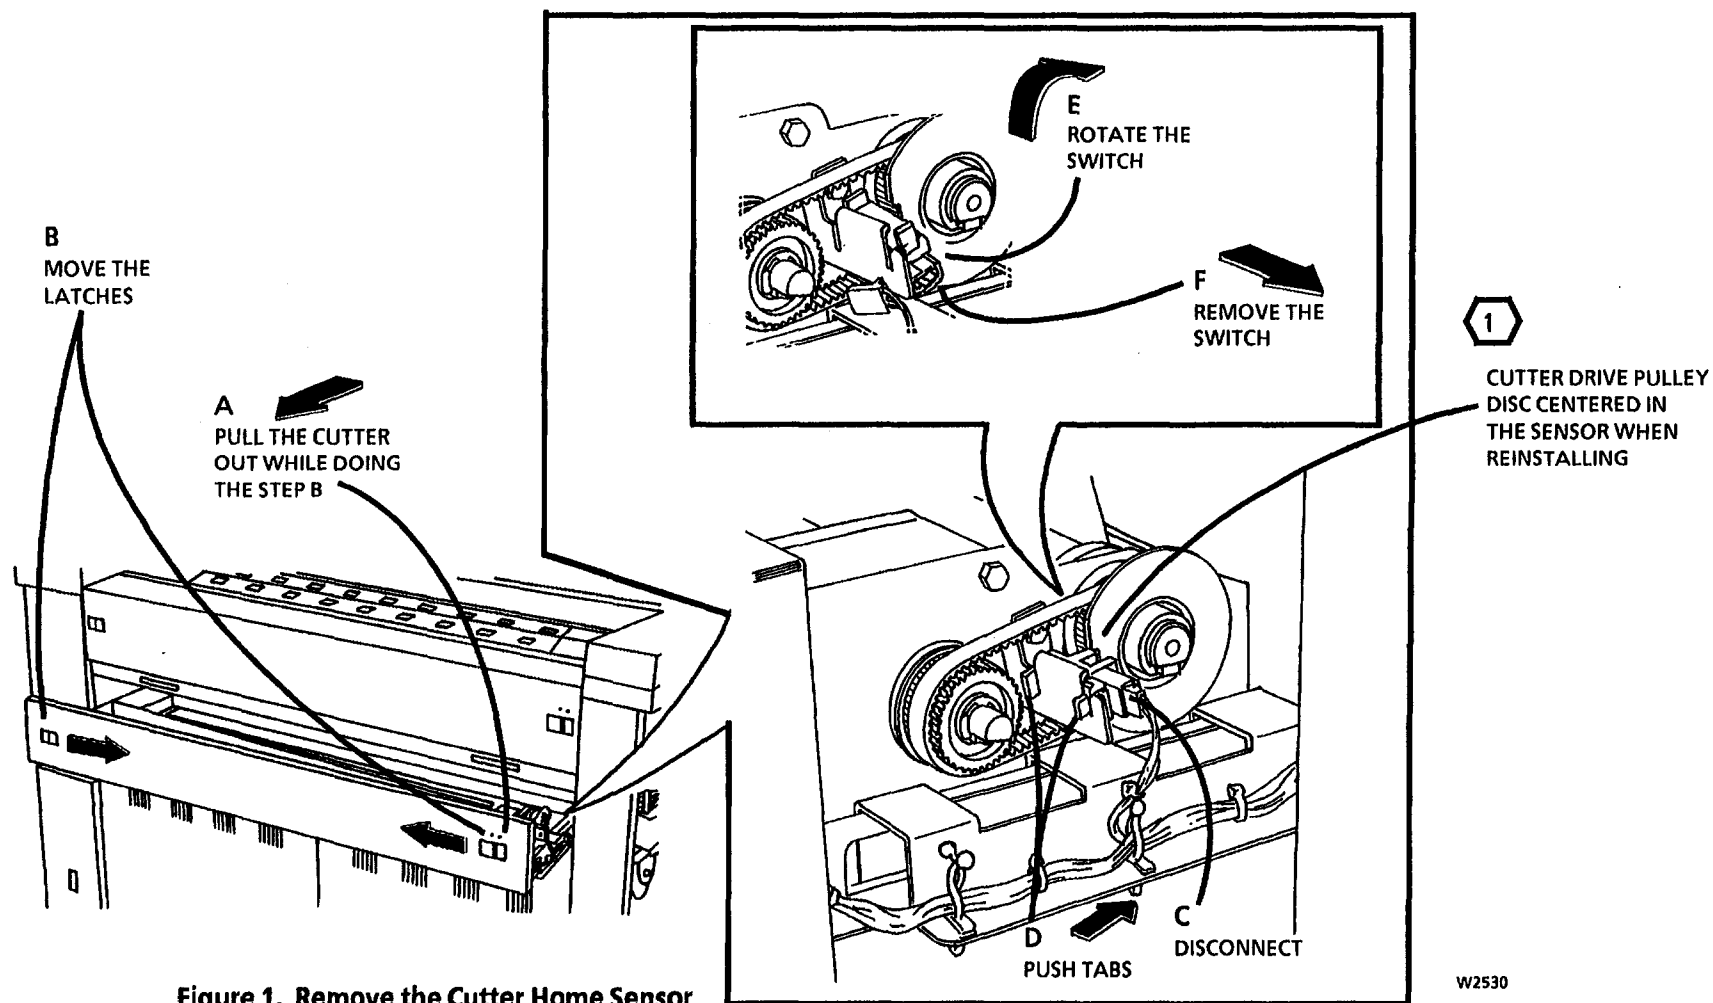
W2530

- 1 Ensure that the Cutter Drive Pulley disc is centered in the sensor.

Figure 1. Remove the Cutter Home Sensor

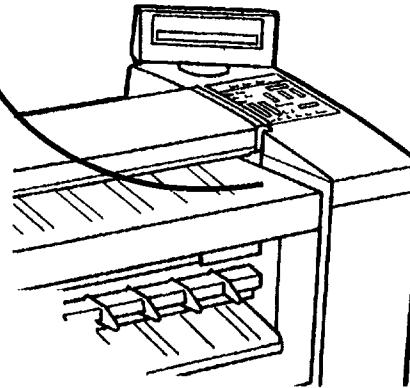
W2562

A
ROTATE 1/4 TURN
SCREWS (2) ONE
EACH END

B
ROTATE THE
DOCUMENT FEED-IN
SHELF FULLY

Figure 1. Lift the Document Feed-in Shelf

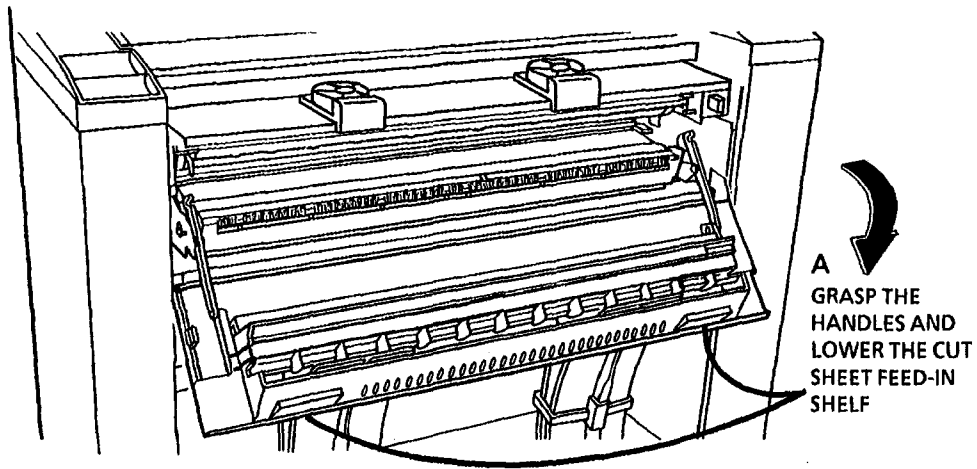
W2507

4. (Figure 2): Lower the Cut Sheet Feed-in Shelf.

Figure 2. Lower the Cut Sheet Feed-in Shelf

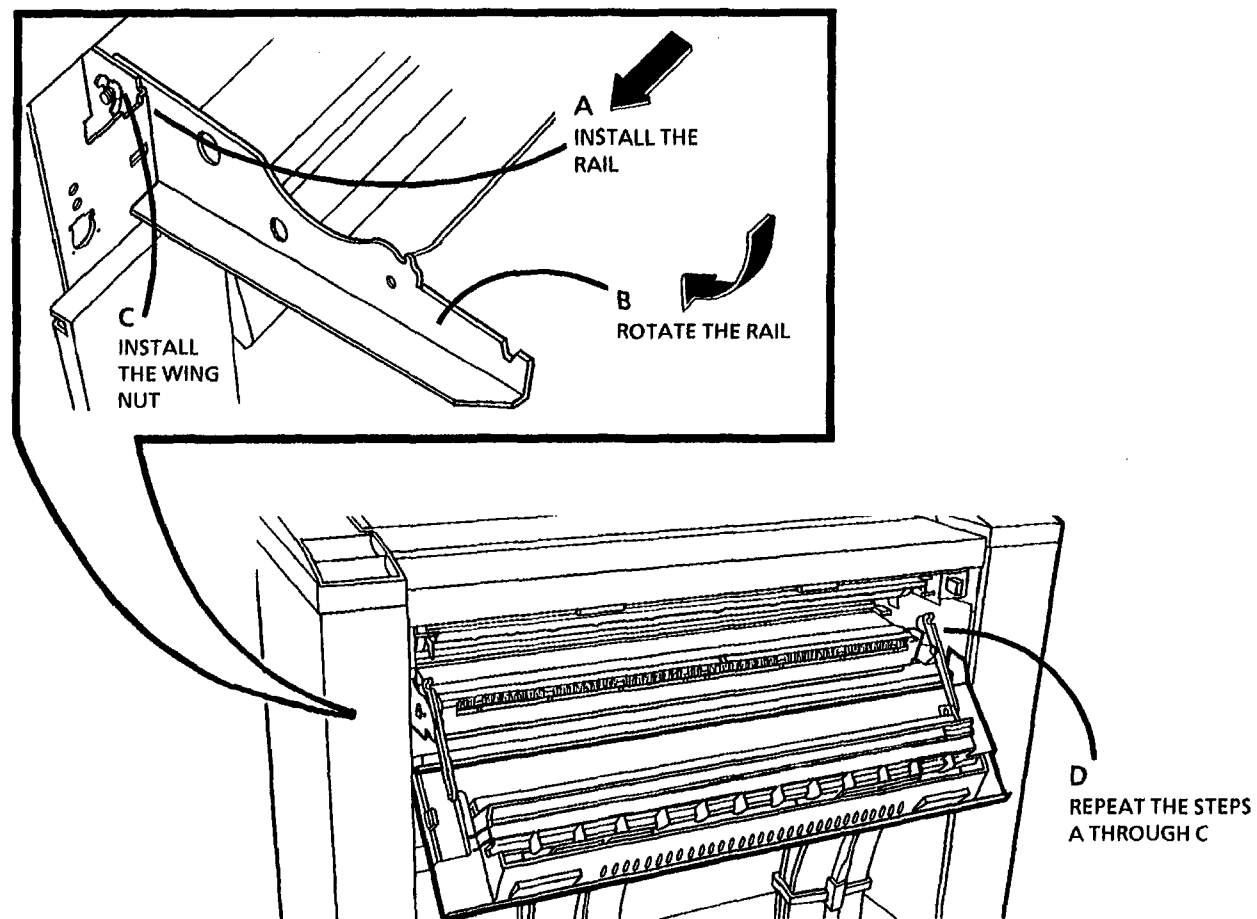
W2509

1 The service rails are stored in the Left Side Door of the Copier.

5. (Figure 3): Install the Xerographic Module Service Rails.

Figure 3. Install the Service Rails

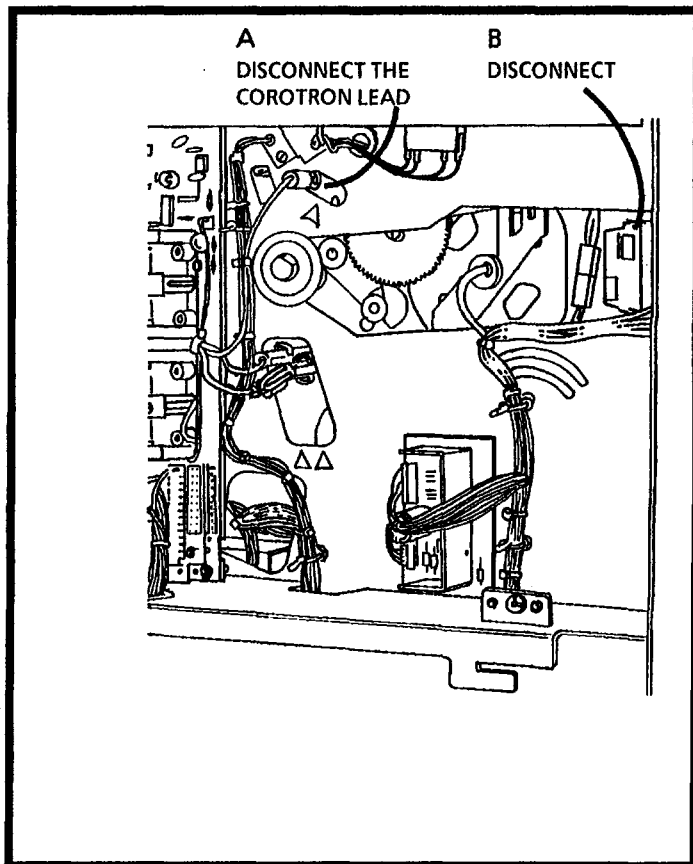
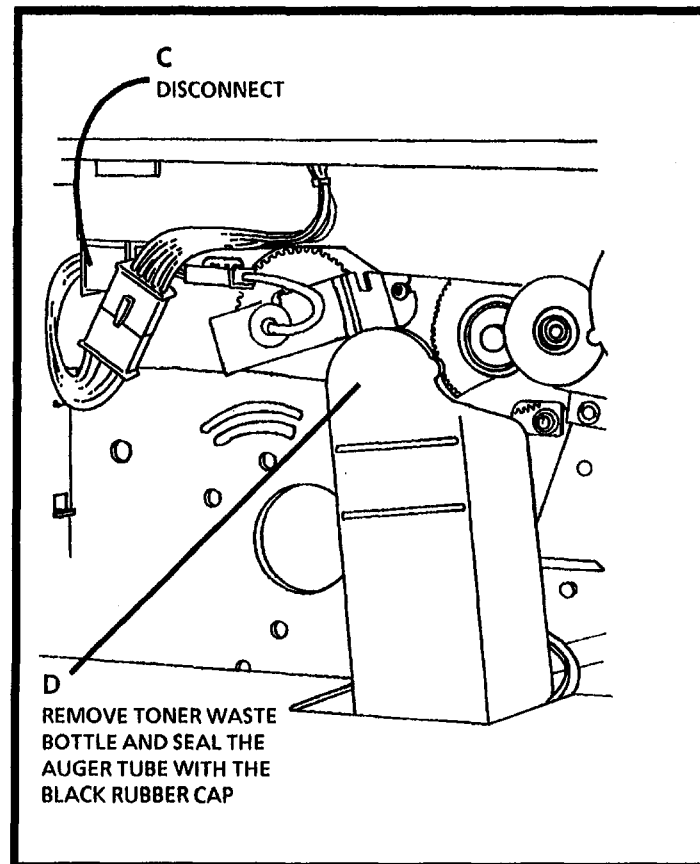
W2561

6. (Figure 4): Prepare to remove the Xerographic Module.

VIEW FROM THE LEFT SIDE

VIEW FROM THE RIGHT SIDE

Figure 4. Preparing to Remove the Xerographic Module

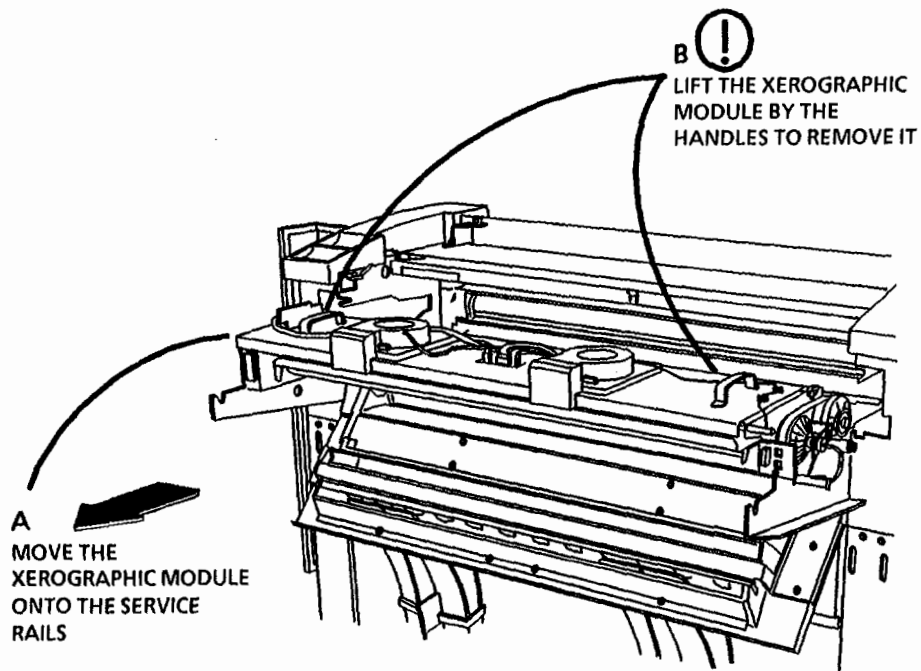
W2510

The xerographic module may remain on the service rails for some of the repair procedures. It may also be removed to a flat, clean surface for service or storage.

7. (Figure 5): Remove the Xerographic Module to clean, flat surface if not being serviced on the service rails. Place a ream of paper or other supports at each end of the module frame to prevent damage to the photoreceptor drum or fuser roll.
8. Continue with Step 9 if the service is being performed on the service rails.

Figure 5. Remove the Xerographic Module to a Clean Flat Surface

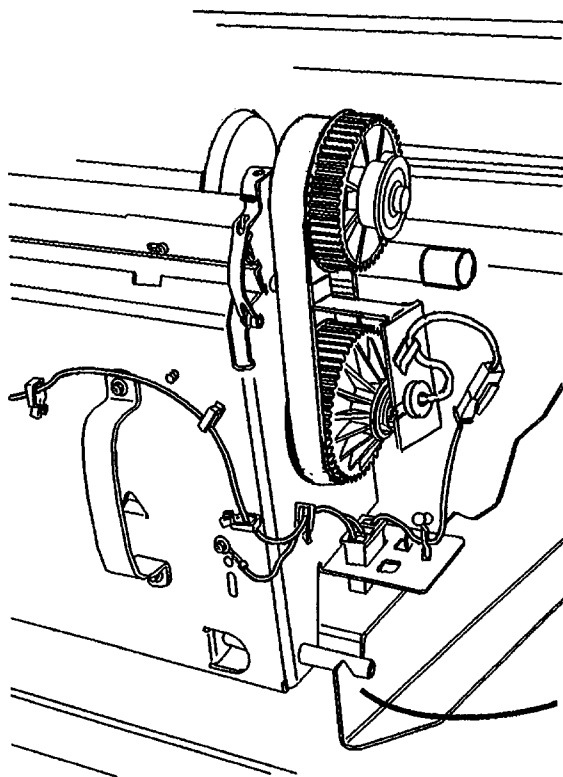
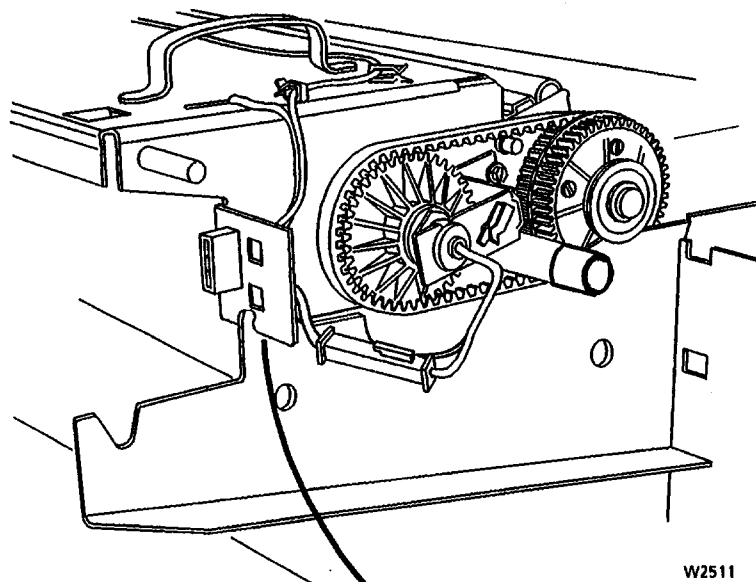
9. (Figure 6): Xerographic Module service position on the Service Rails.
10. If the Xerographic module must be removed from the service rails, position a ream of paper or some support at each end of the module to prevent the fuser roll and photoreceptor drum from being damaged

POSITION A

ENSURE THAT THE PIN ON THE XEROGRAPHIC MODULE IS IN THE SLOT ON THE RAIL

POSITION B

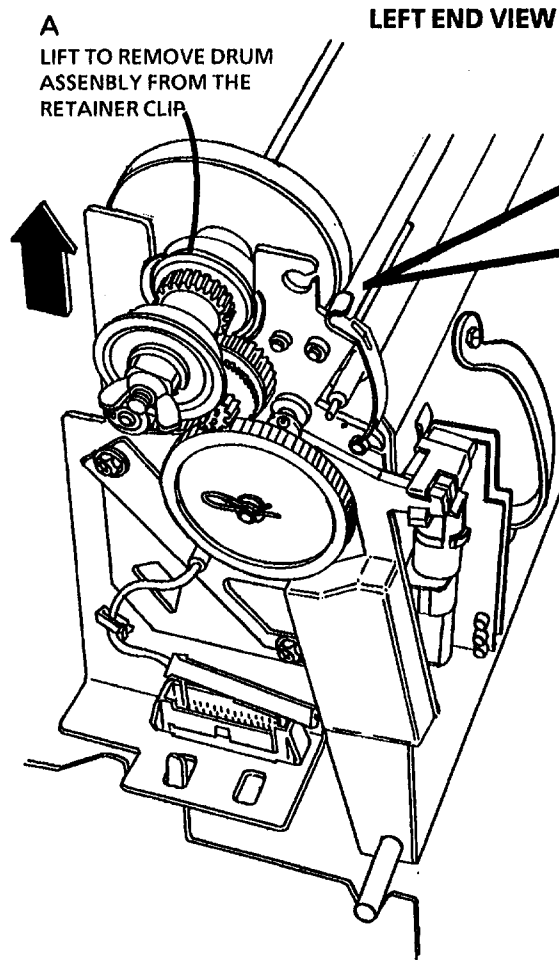
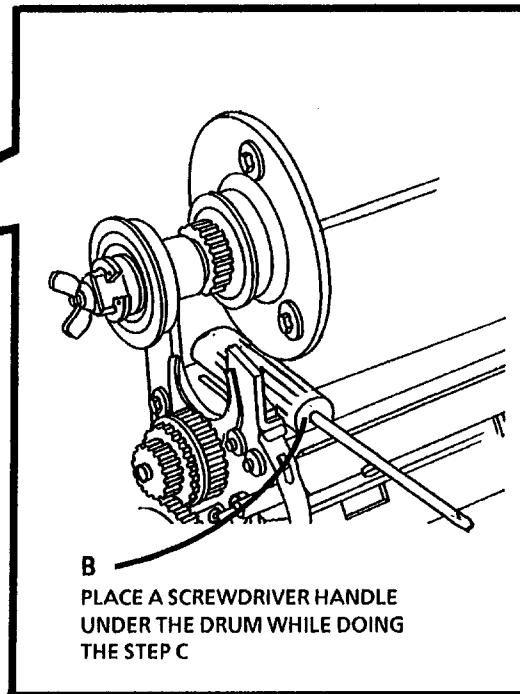
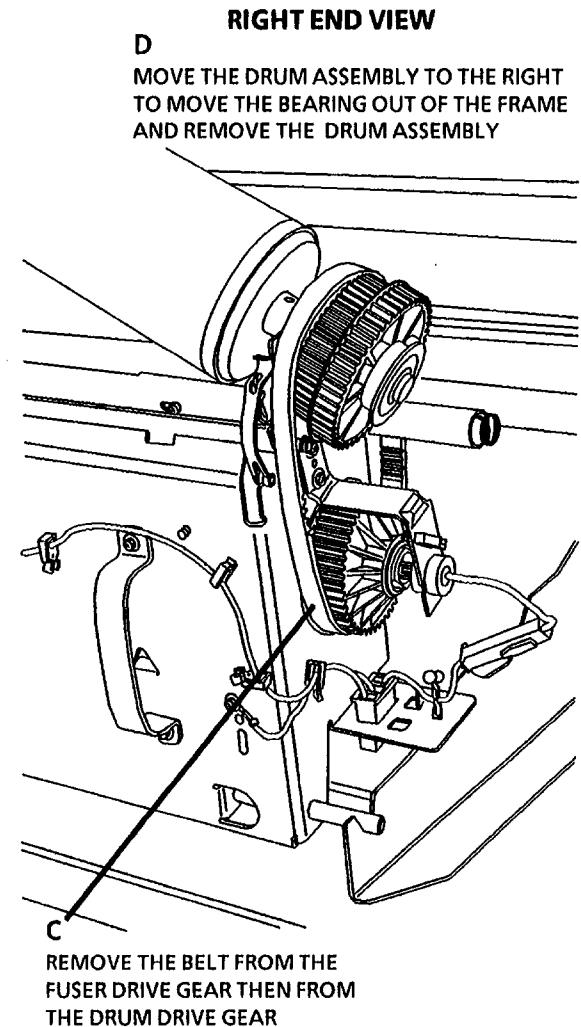
1. Remove the Right and the Left Side Doors (REP 14.1).
2. Remove the Xerographic Module (REP 9.1).
3. (Figure 1): Remove the Photoreceptor Drum Assembly.

Figure 1. Remove the Photoreceptor Drum Assembly

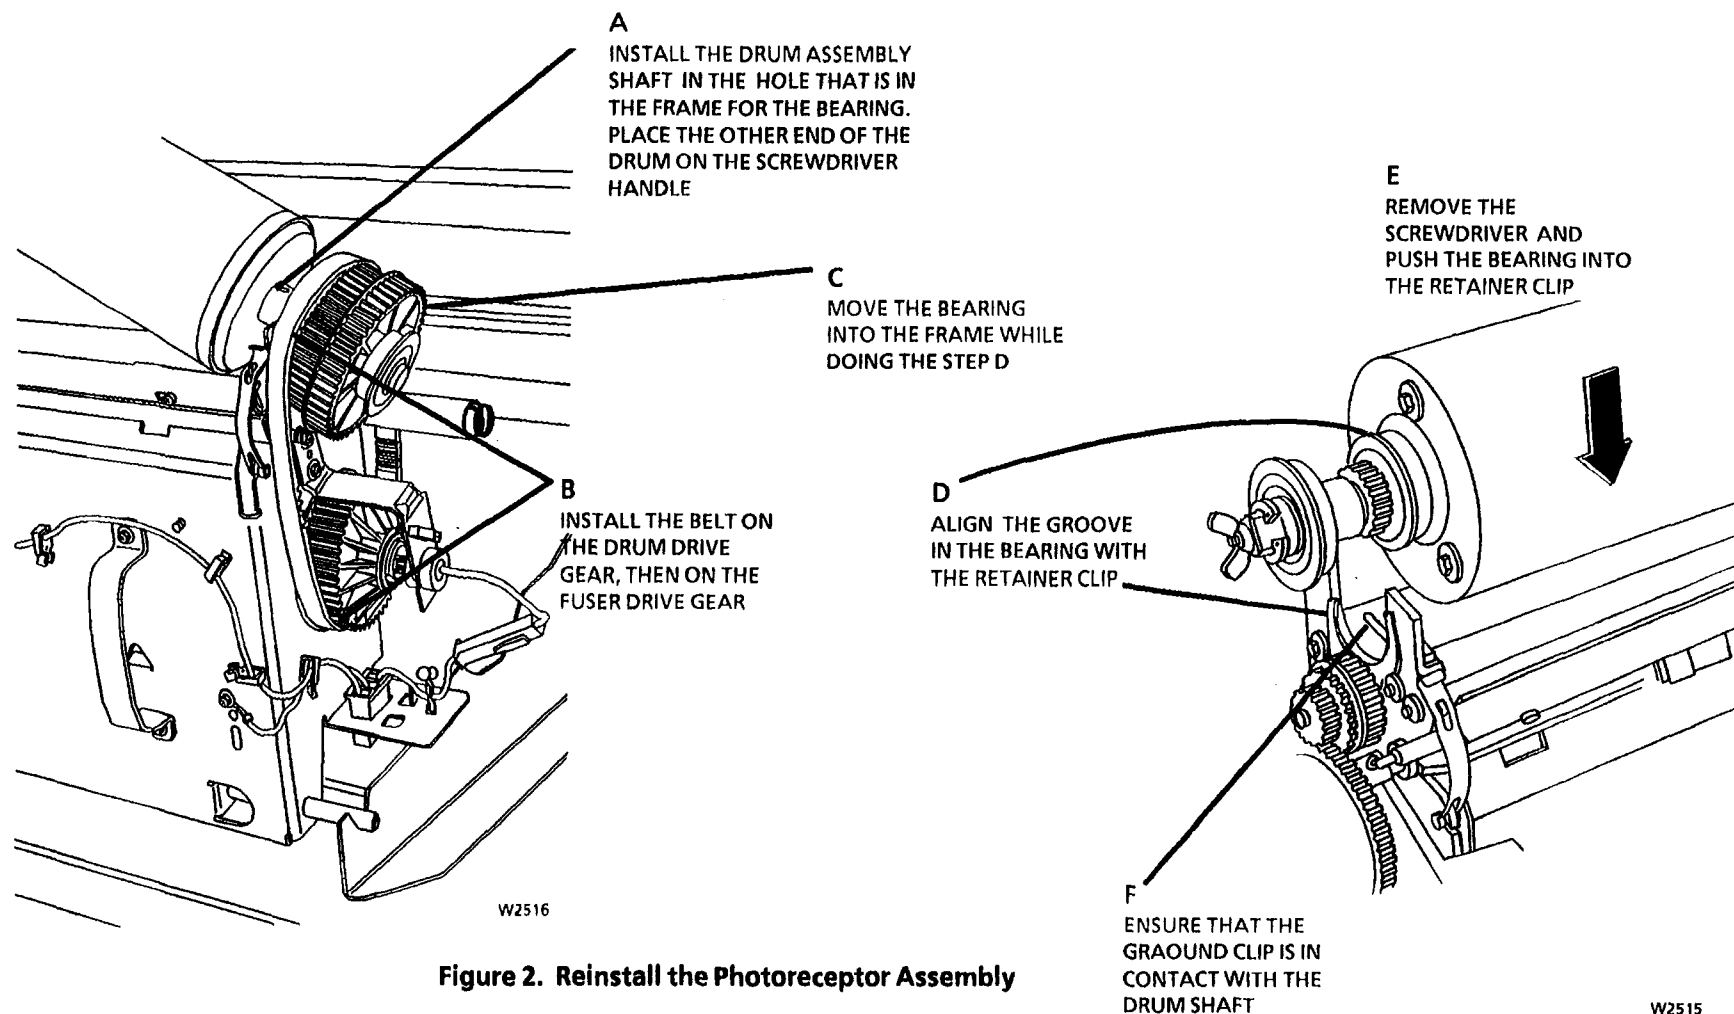
STEP 1: Before installing the photoreceptor drum, reform the photoreceptor seal so that it is pointing to the charge corotron.

1. (Figure 2): Reinstall the Photoreceptor Assembly.

Figure 2. Reinstall the Photoreceptor Assembly

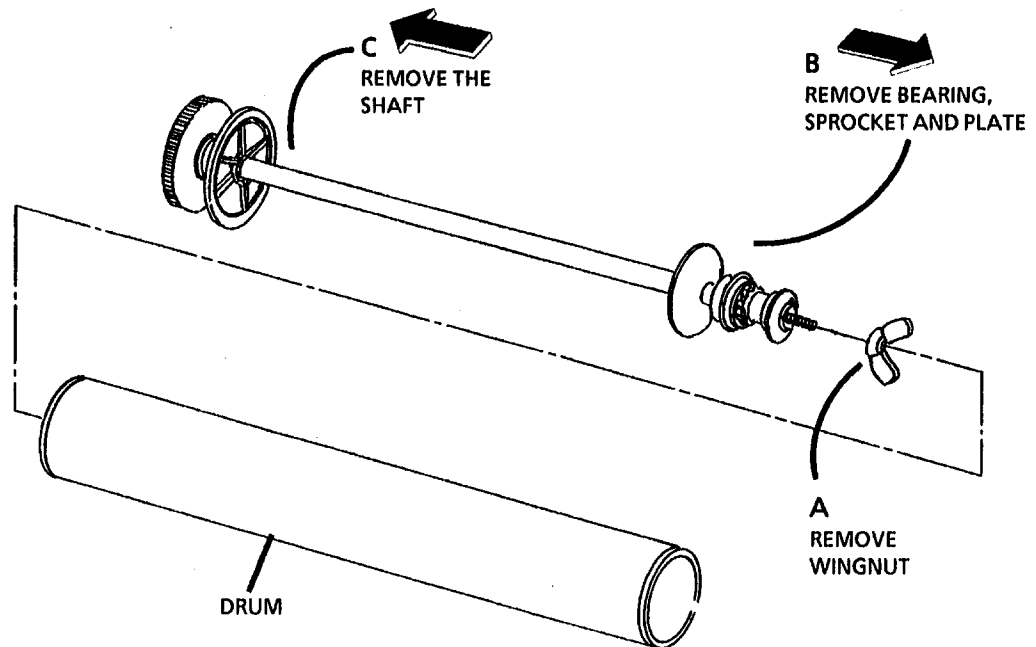
W2565

2. Remove the Right and the Left Side Doors (REP 14.1).
3. Remove the Xerographic Module (REP 9.1).
4. Remove the Photoreceptor Drum Assembly (REP 9.2).
5. (Figure 1): Remove the Photoreceptor Shaft Assembly.

Figure 1. Remove the Photoreceptor Shaft Assembly

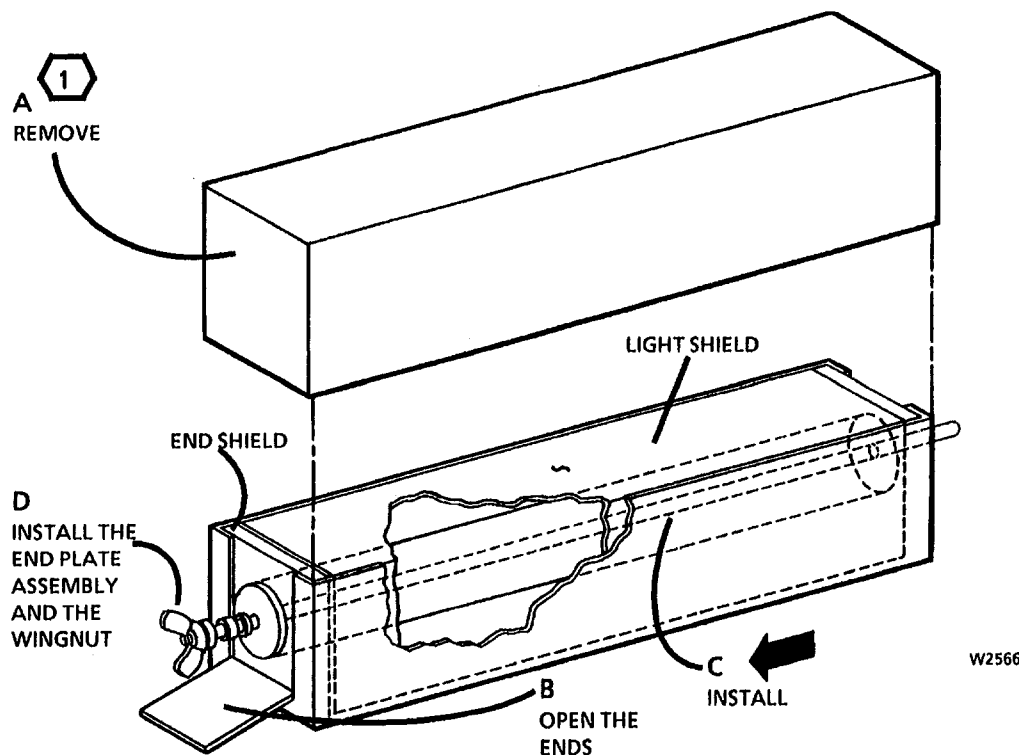
1. (Figure 2): Install the Photoreceptor Assembly Shaft

Figure 2. Install the Assembly Shaft

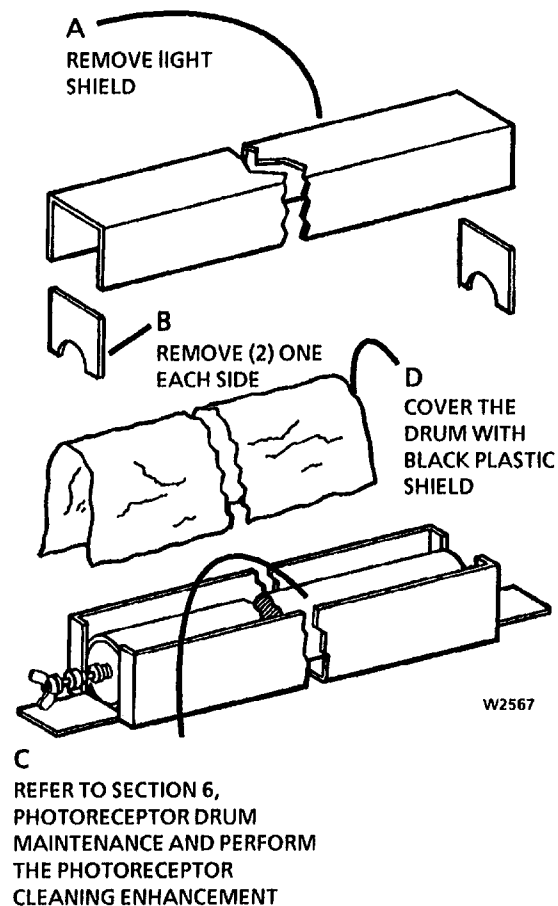
2. (Figure 3): Prepare the Drum for installation.

Figure 3. Prepare the Drum for Installation

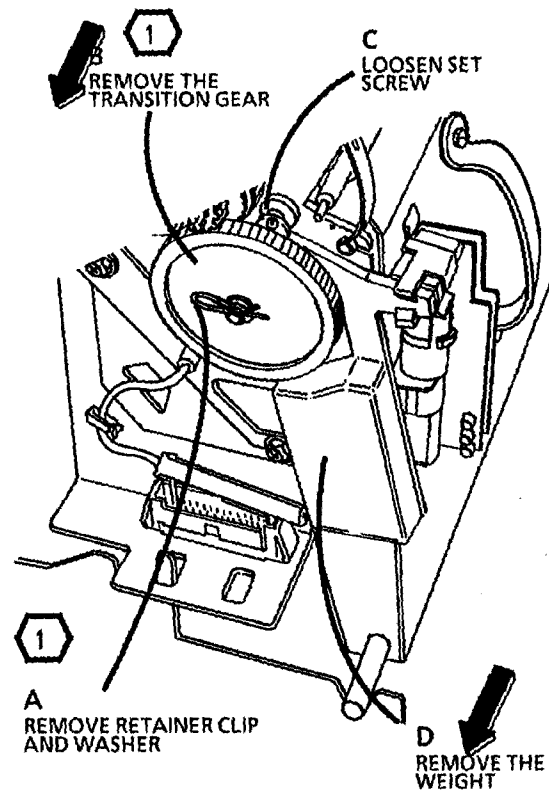
W2568

1. Remove the Xerographic Module (Rep 9.1).
2. Remove Photoreceptor Drum Assembly (REP 9.2).
3. (Figure 1): Remove Transition Gear and Weight.
4. (Figure 2): Remove the Cleaner Blade Assembly.

1 STEPS 3 A AND B: Use care when removing the retainer and the transition gear. The cleaner blade assembly is spring-loaded.

Figure 1. Remove the Transition Gear and Weight

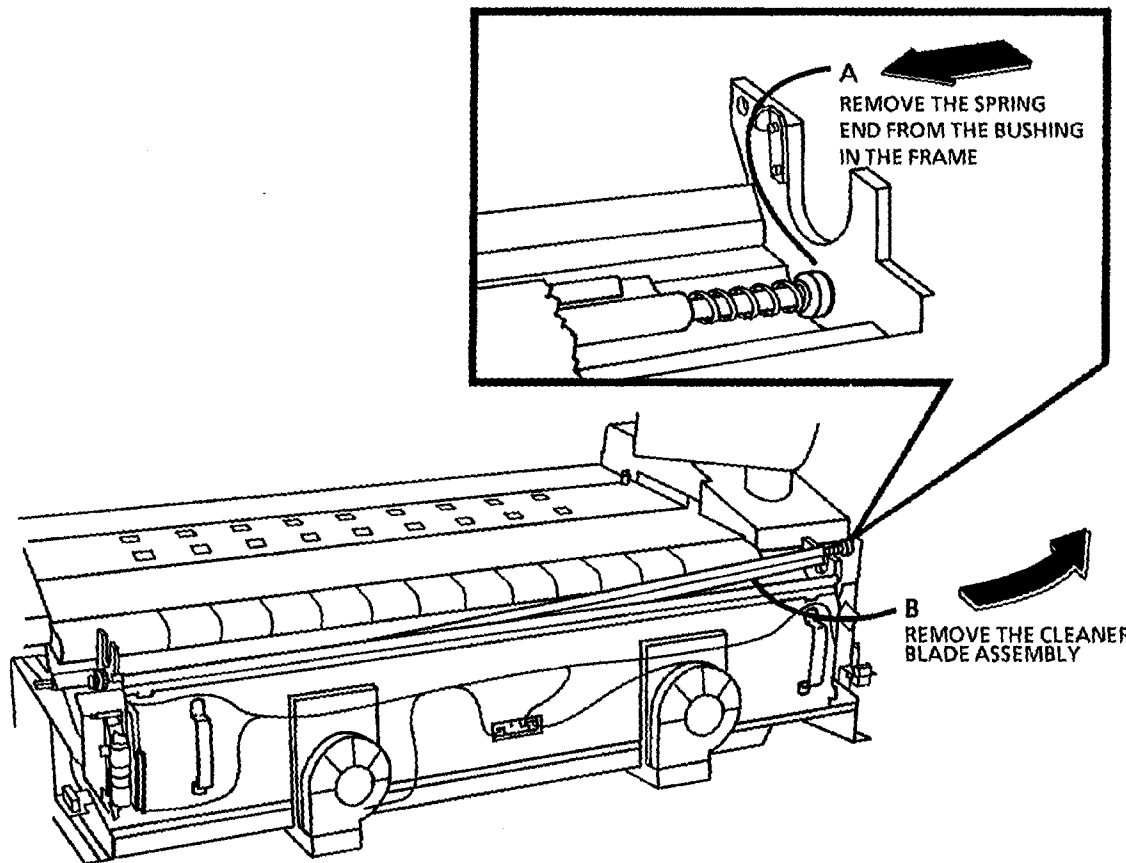
W2517

Figure 2. Remove the Cleaner Blade Assembly

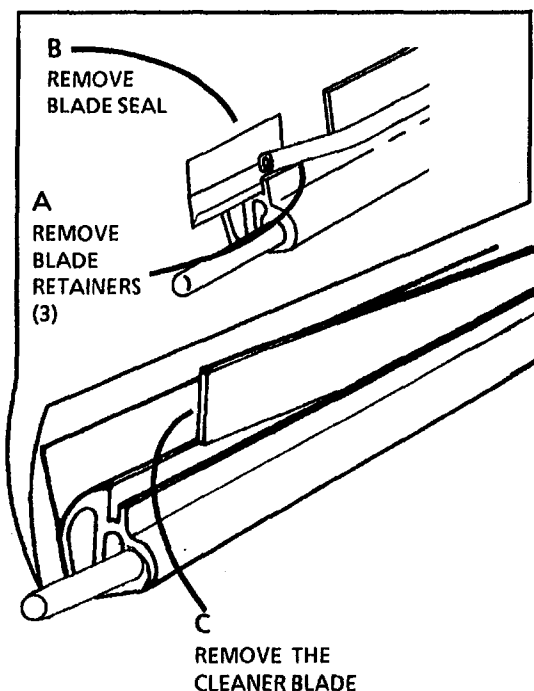
W2569

4. (Figure 3): Remove the Cleaner blade.

Figure 3. Remove the Cleaner Blade
