- **Call Flow Diagram** - This diagram outlines the major activities that are performed when a service call is made. The **Initial Actions** assist the Service Representative through the customer interface and help to identify the problem. The diagram also directs the Representative to verify, classify, repair the problem and perform the correct Maintenance Procedure.

2. Status Indicator Repair Analysis Procedures

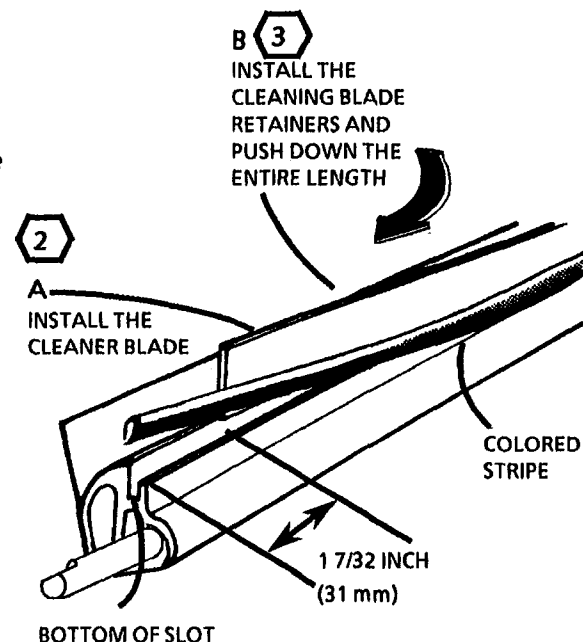
W2570

- 3 STEP 2 B: When installing the cleaner blade retainers, ensure that the colored stripe is installed to the outside and that the holders are completely seated.

2. (Figure 4): Install the Cleaning Blade.

Figure 4. Install the Cleaner Blade

❗ **STEP 3 B:** Do not touch the wiping edge of the cleaner blade with your fingers.

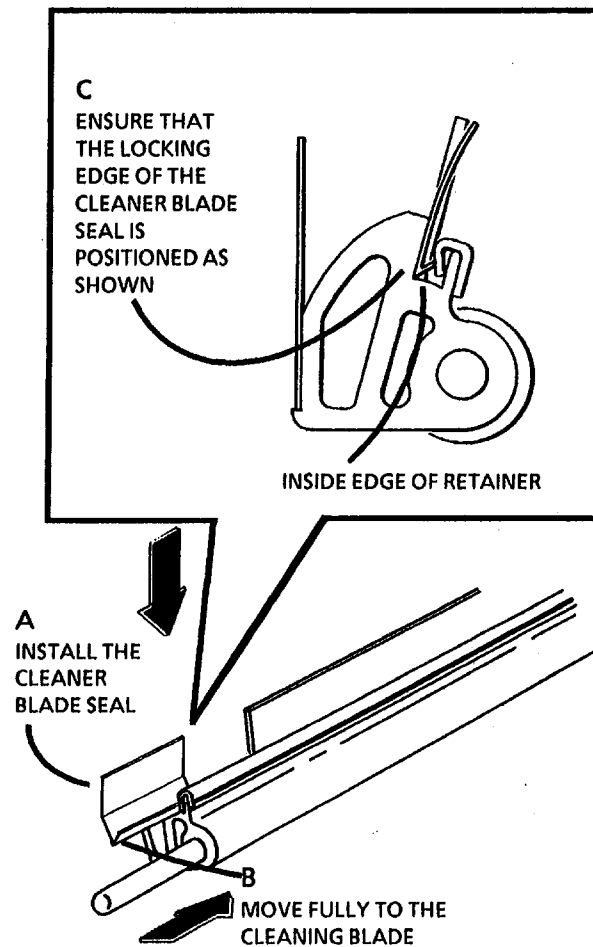
W2571

3. (Figure 6): Install the Cleaner Blade Seal.

Figure 6. Install the Cleaner Blade Seal

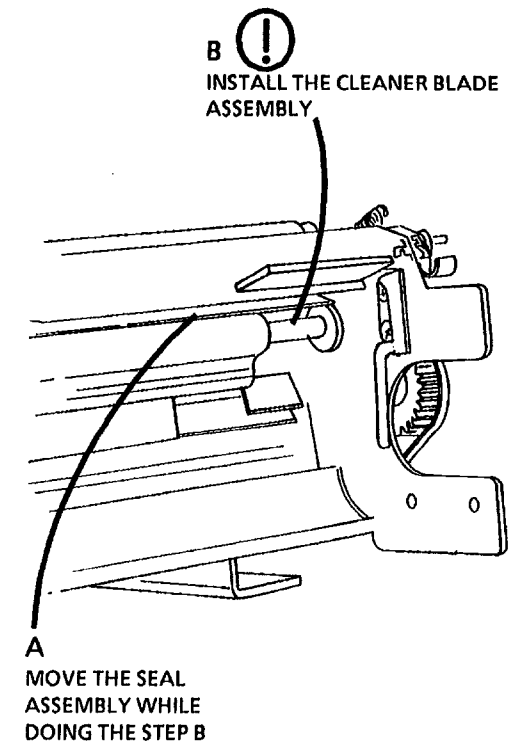
W2572

4. Apply a light coating of Zinc Stearate to the Cleaner Blade.

5. (Figure 6): Install the Cleaner Blade Assembly.
6. The remainder of the replacement is the reverse of the removal procedure.

Figure 6. Install the Cleaner Blade Assembly

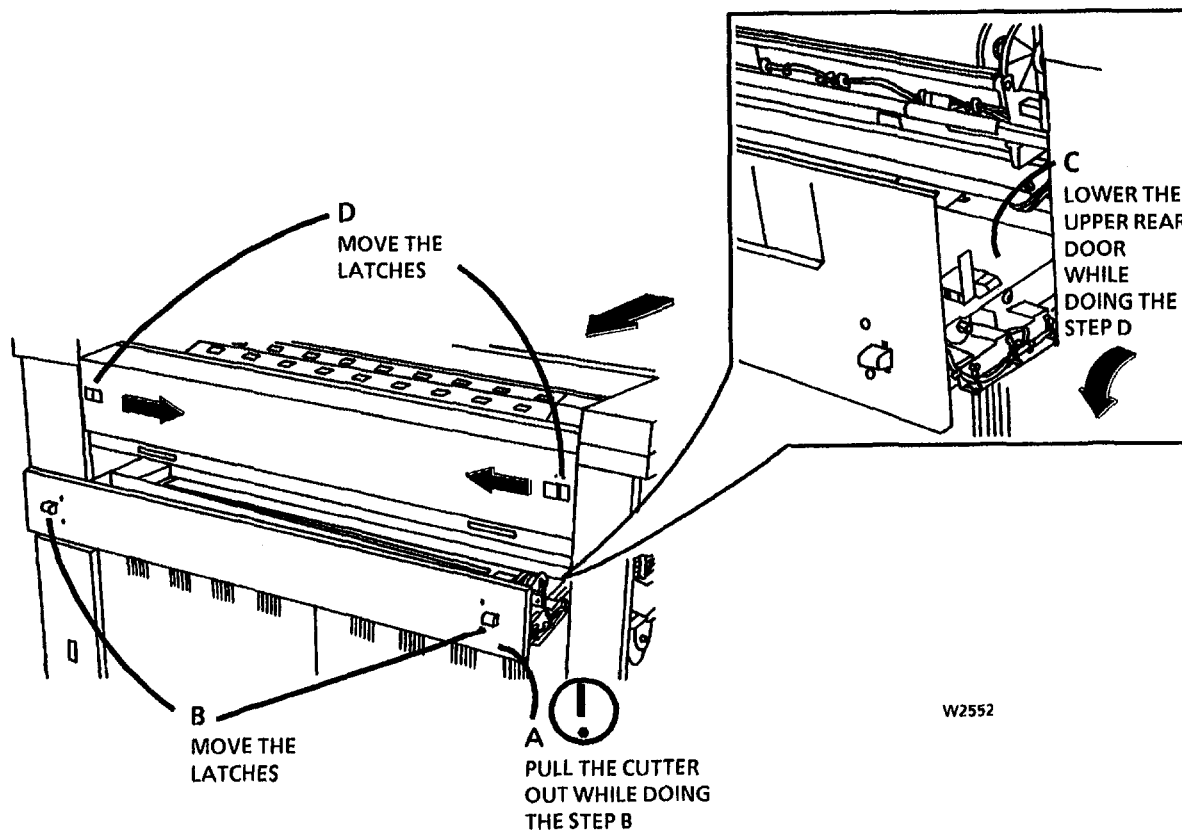
W2552

STEP 2A: To avoid damage to the hinges on the upper rear door, pull the cutter out to support the upper rear door.

1. (Figure 1): Lower the Upper Rear Door.

Figure 1. Lower the Upper Rear Door

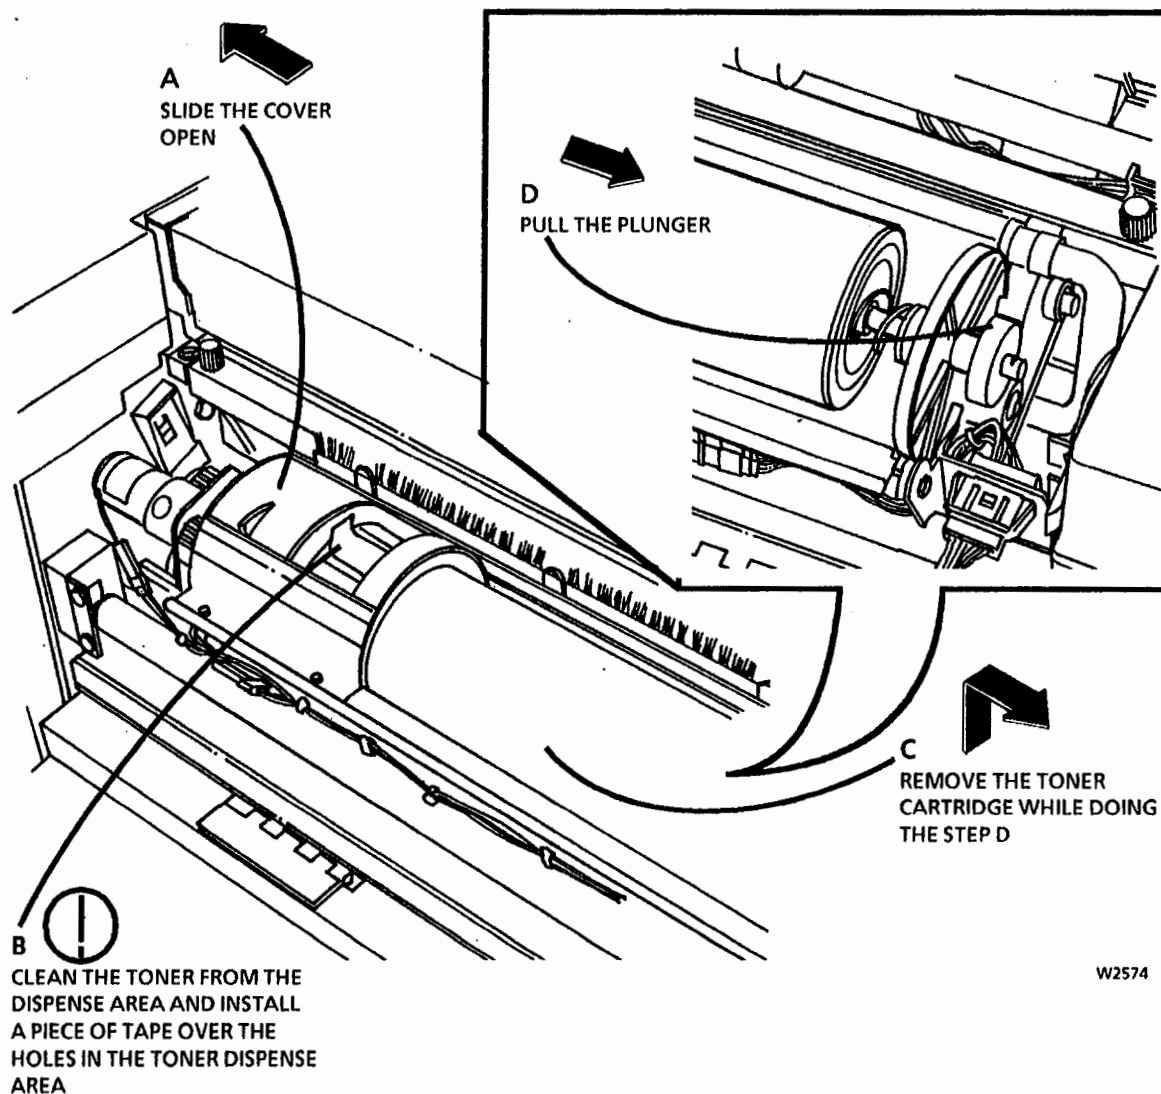
W2574

! *STEP 3 B: Tape the toner cartridge dispense holes in order to prevent toner from pouring out when the toner cartridge is tipped up for removal.*

2. (Figure 2): Remove the Toner Cartridge.

Figure 2. Remove the Toner Cartridge

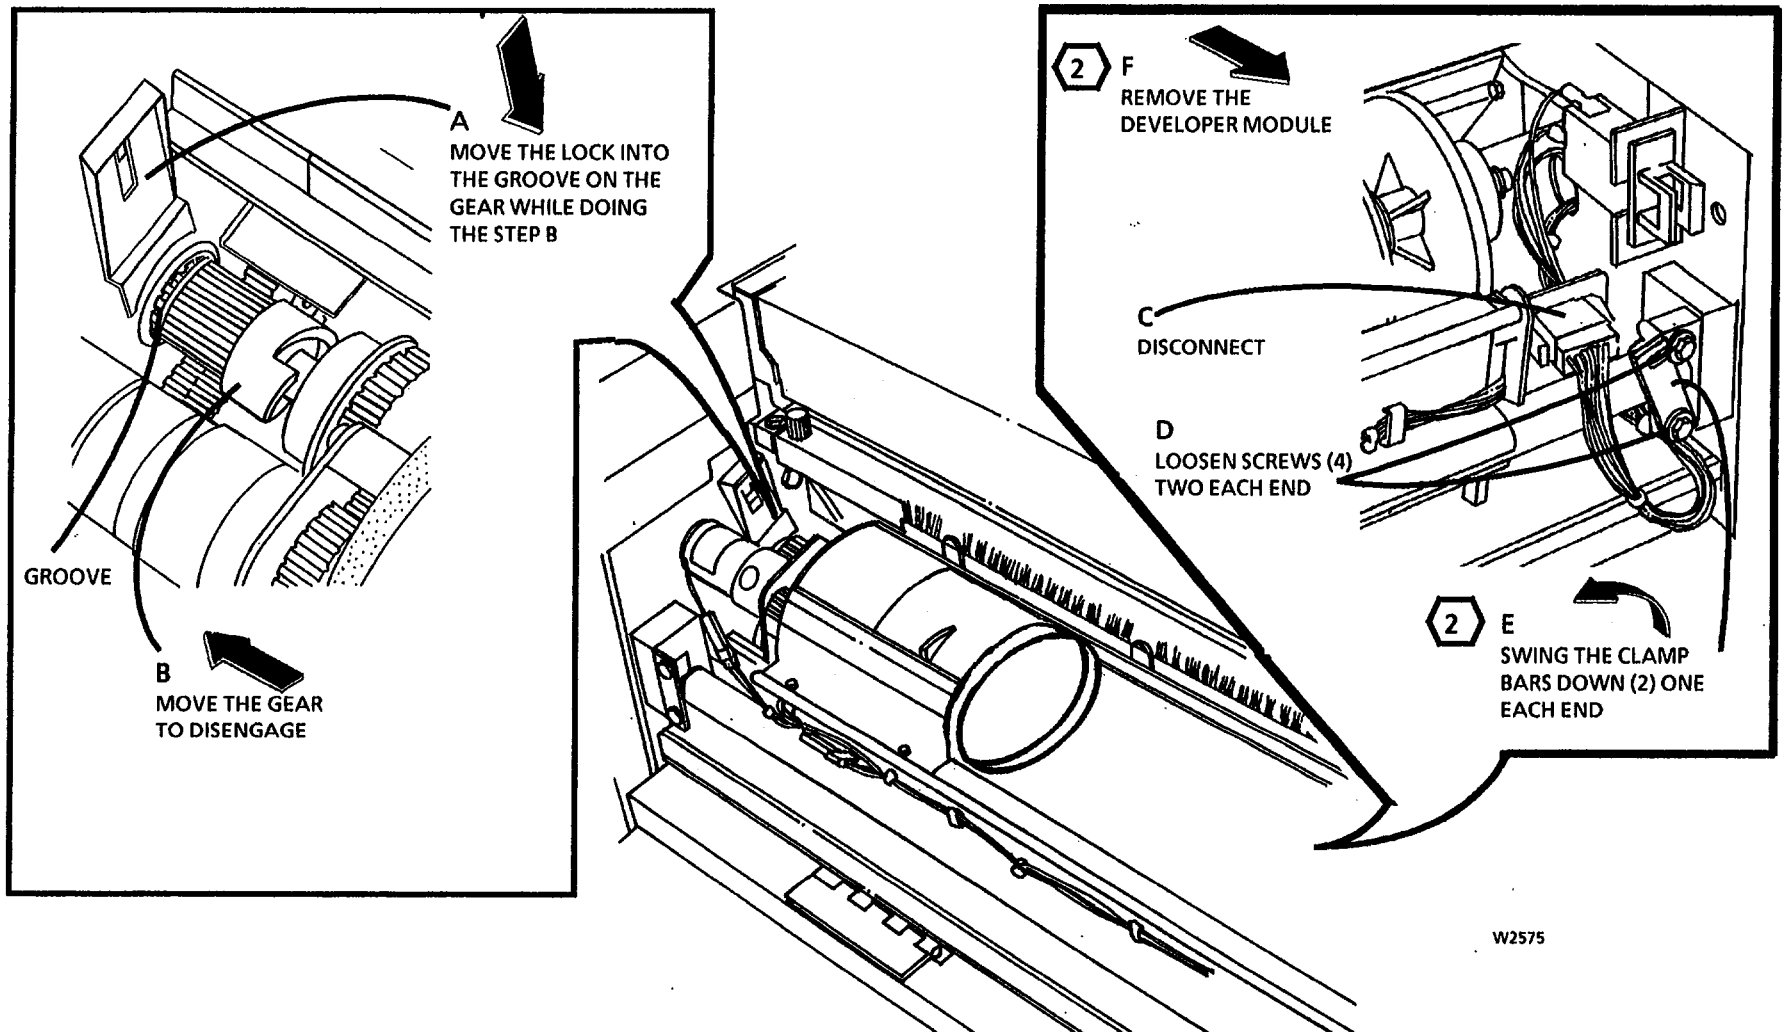
4. (Figure 3): Remove the Developer Module.

2 STEP 4 E and F: Ensure that the clamp will not cause interference when removing the developer module.

Figure 3. Remove the Developer Module

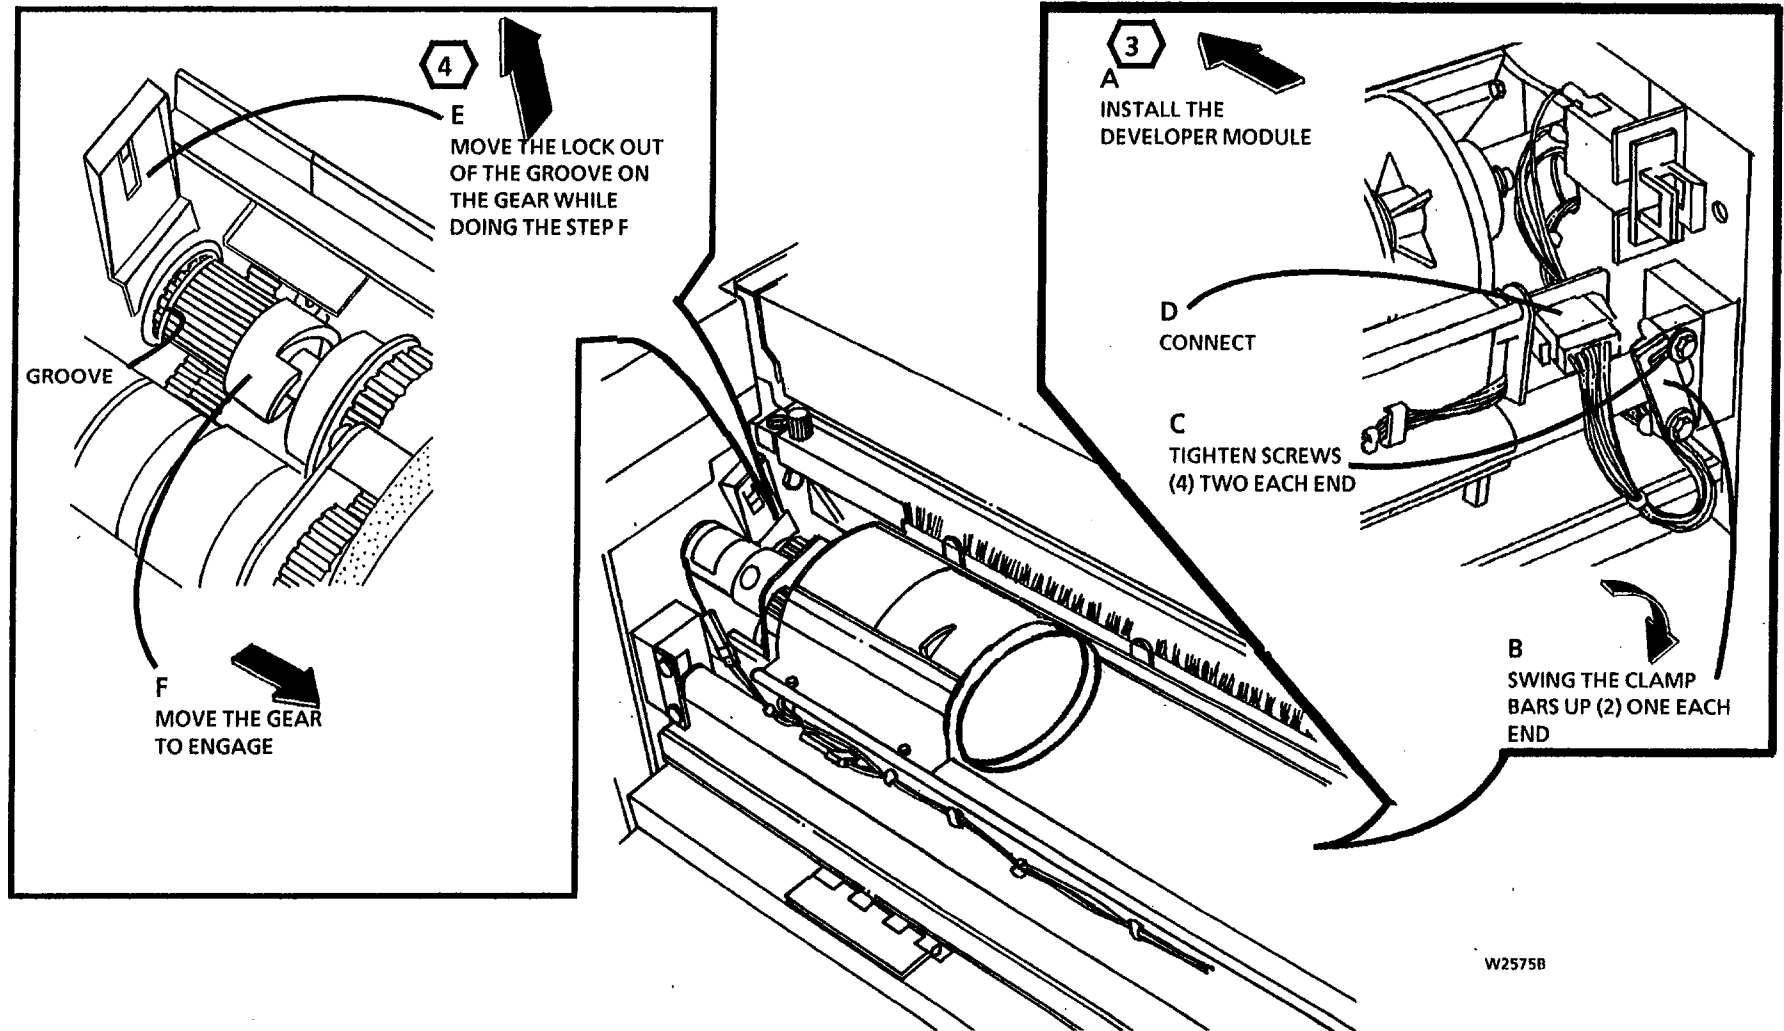
1. (Figure 4): Install the Developer Module.

- 3** STEP 1 A: Ensure that the developer module is fully installed in the brackets.
- 4** STEP 1 E: Ensure that the gear is free to engage with the developer module drive gears.

Figure 4. Install the Developer Module

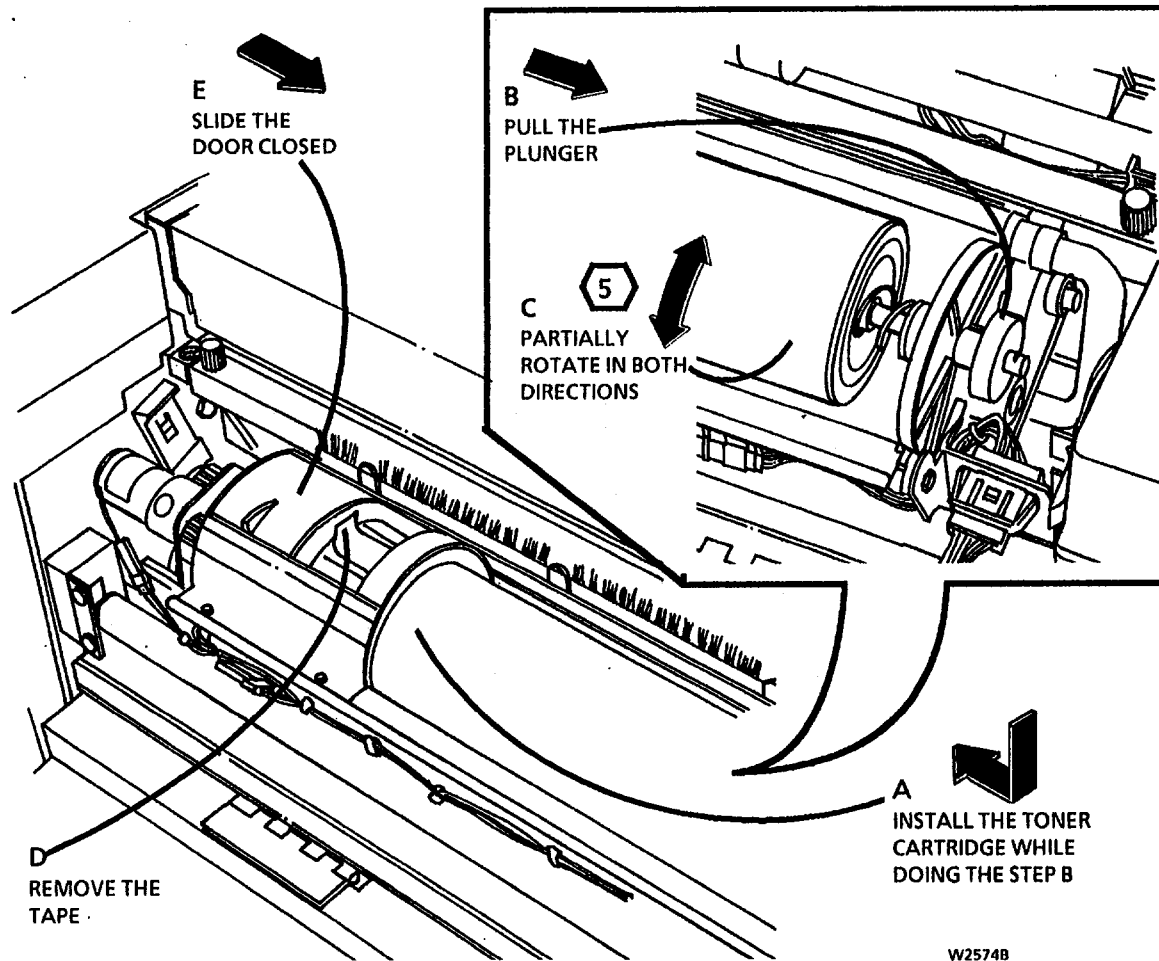
W2574B

2. (Figure 5): Reinstall the Toner Cartridge.

Figure 5. Reinstall the Toner Cartridge

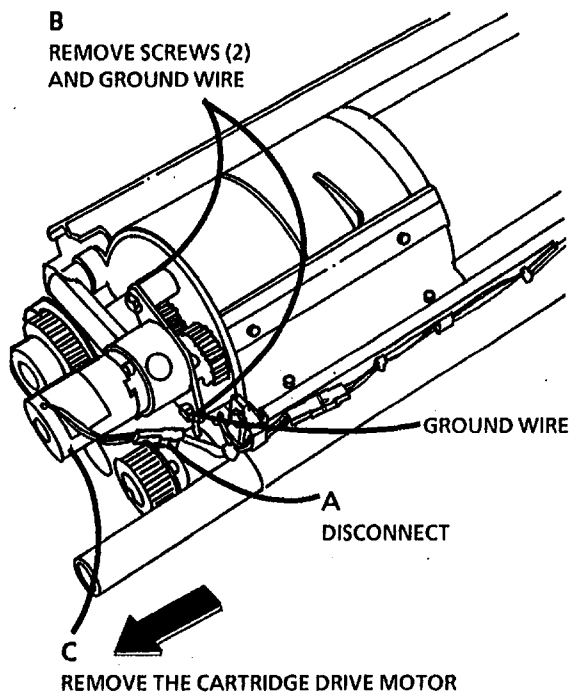
W2576

1. Remove the Developer Module (REP 9.5).
2. (Figure 1): Remove the Cartridge Drive Motor.
3. (Figure 2): Remove the Cartridge Drive Motor from the mounting plate.

Figure 1. Remove the Cartridge Drive Motor

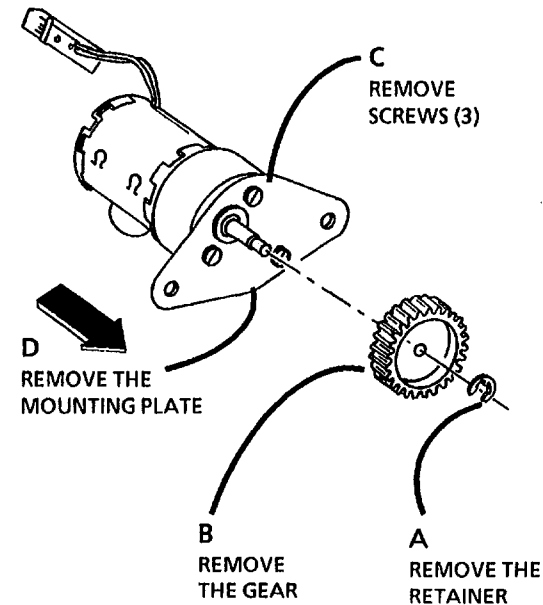
W2577

Figure 2. Remove the Cartridge Drive Motor from the Mounting Plate

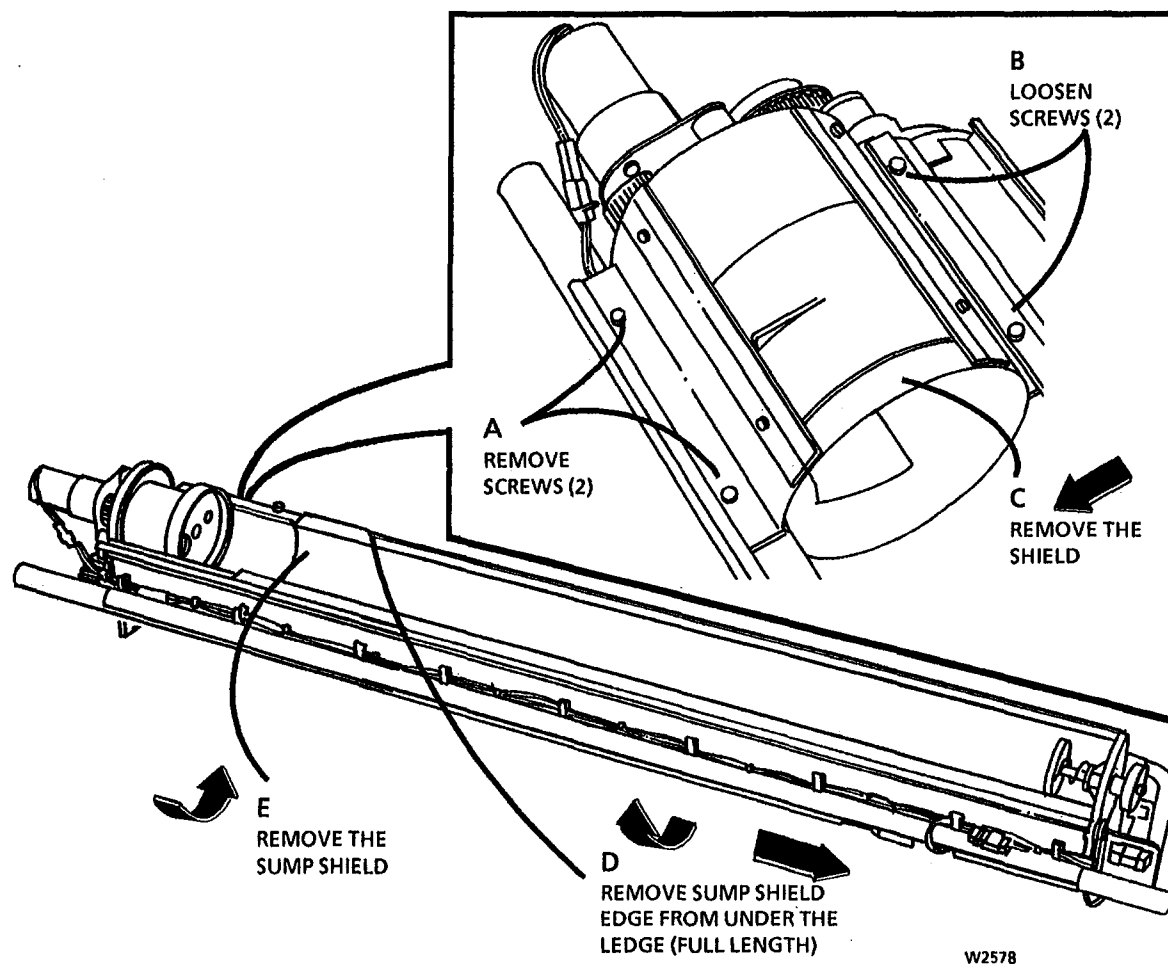
1. Remove the Developer Module (REP 9.5).
 2. Place the Developer Module on a drop cloth on the floor.
 3. (Figure 1): Remove the Sump Shield from the Developer Module.
- Do not rotate the Developer Module in the vertical position. This may cause developer to get into the toner cartridge clutch in the end of the Developer Module.**

Figure 1. Remove the Sump Shield from the Developer Module

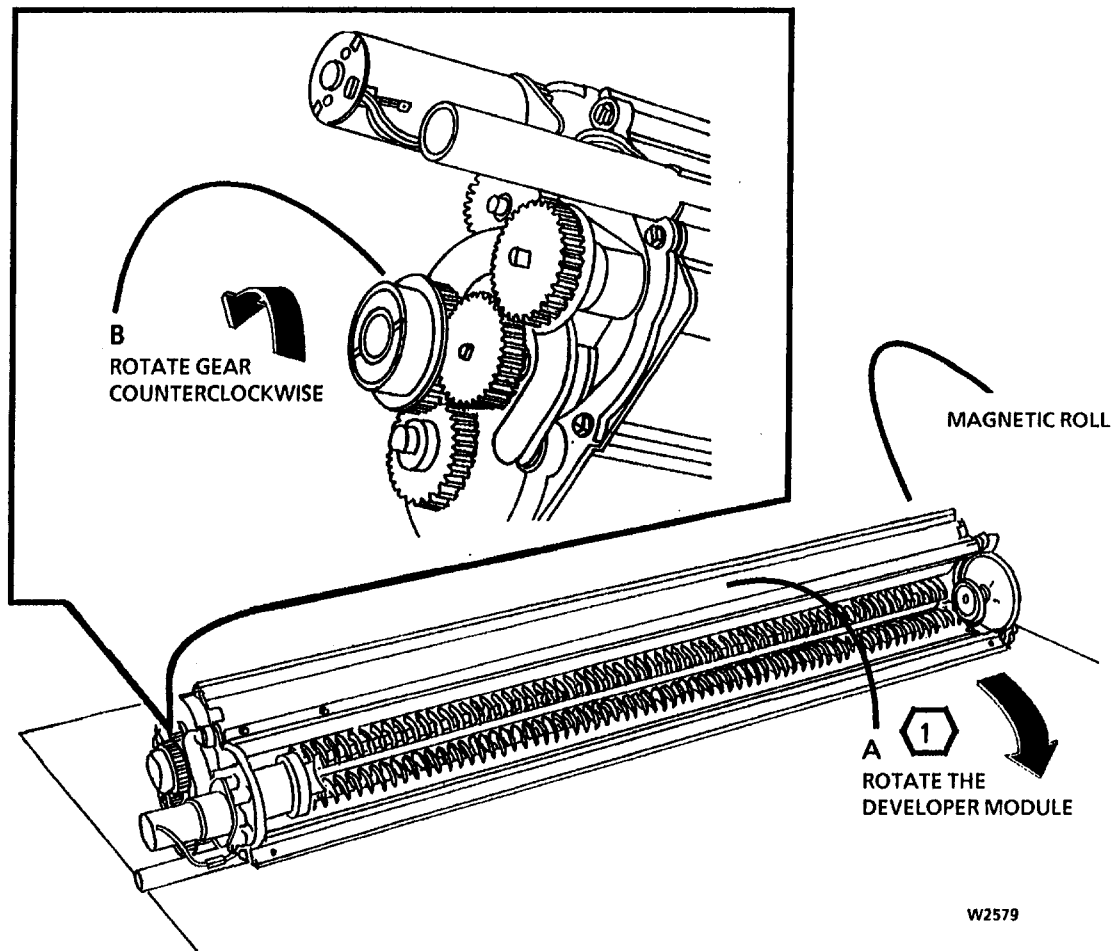
1 STEP 4 A: Rotate the developer module away from the Magnetic Roll.

4. (Figure 2): Dump the Developer Material.

Figure 2. Dump the Developer Material

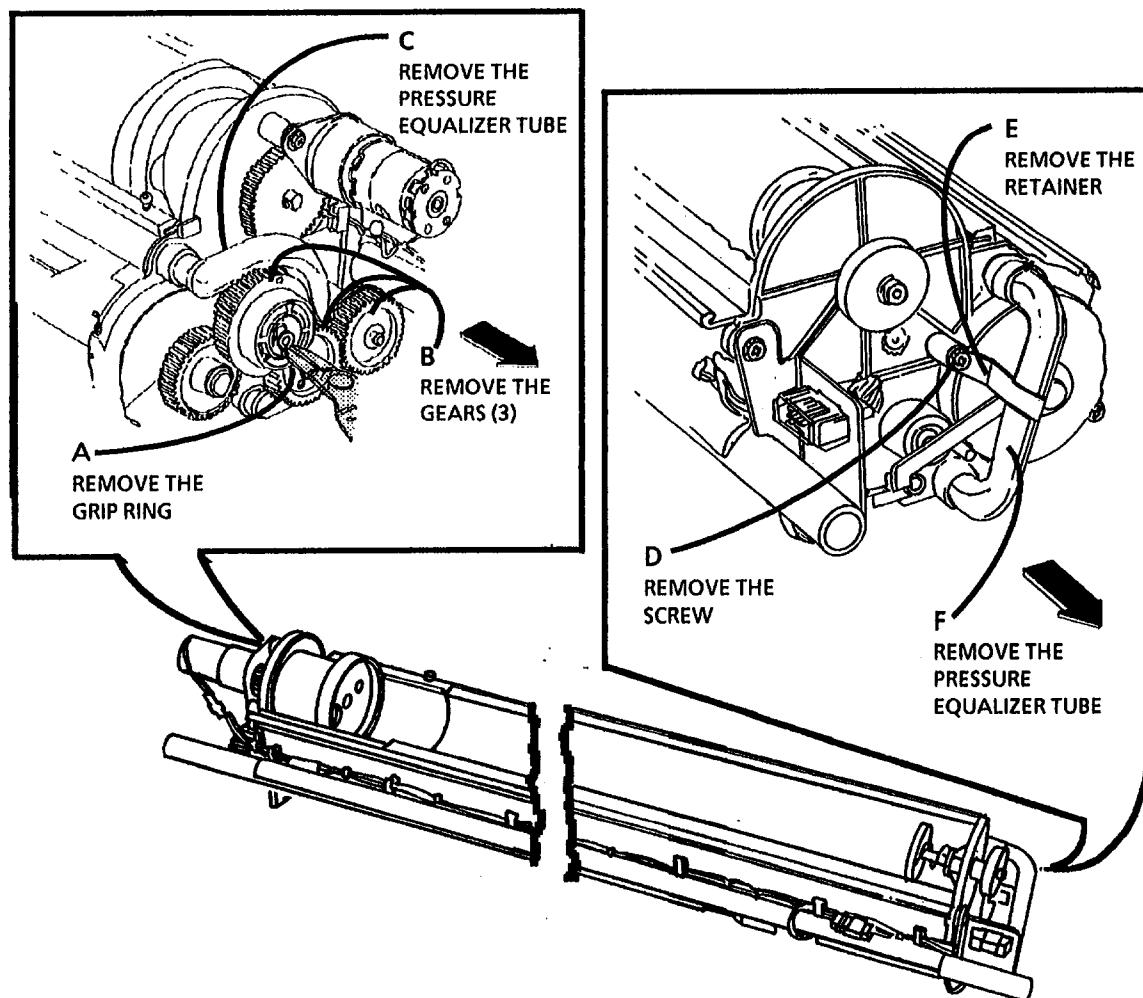
W2580

5. (Figure 3): Remove the Pressure Equalizer Tubes.

Figure 3. Remove the Air Equalization Tubes

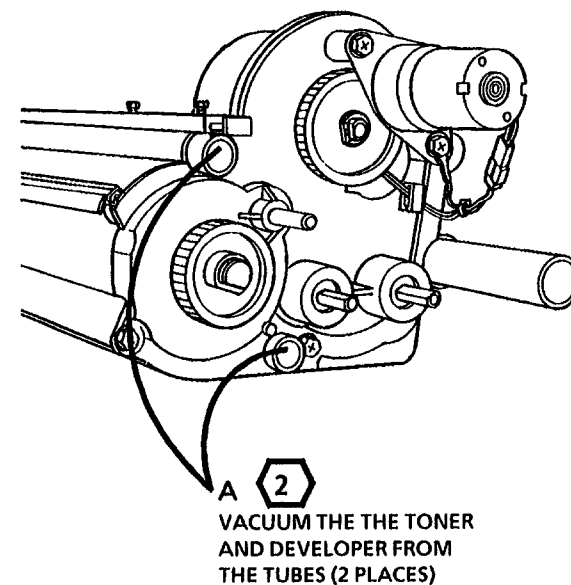
W2581

- 2 STEP 7 A: Ensure that the entire length of the tube on the developer module is clear of any developer.

7. (Figure 4): Using a vacuum cleaner, clean the housing where the pressure equalizer tubes attach.

Figure 4. Vacuum the tubes on the developer module

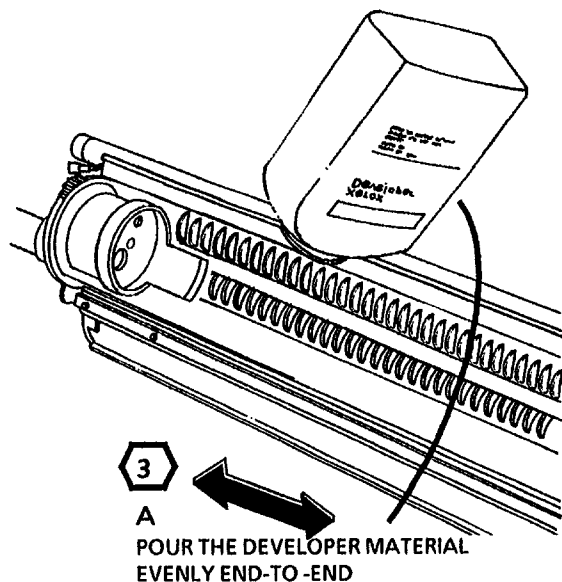
W2582

8. (Figure 5): Install the Developer material and record the batch number on the machine log.

3 STEP 8A: Pour the developer material evenly over the full length of the two augers.

Figure 5. Install the Developer

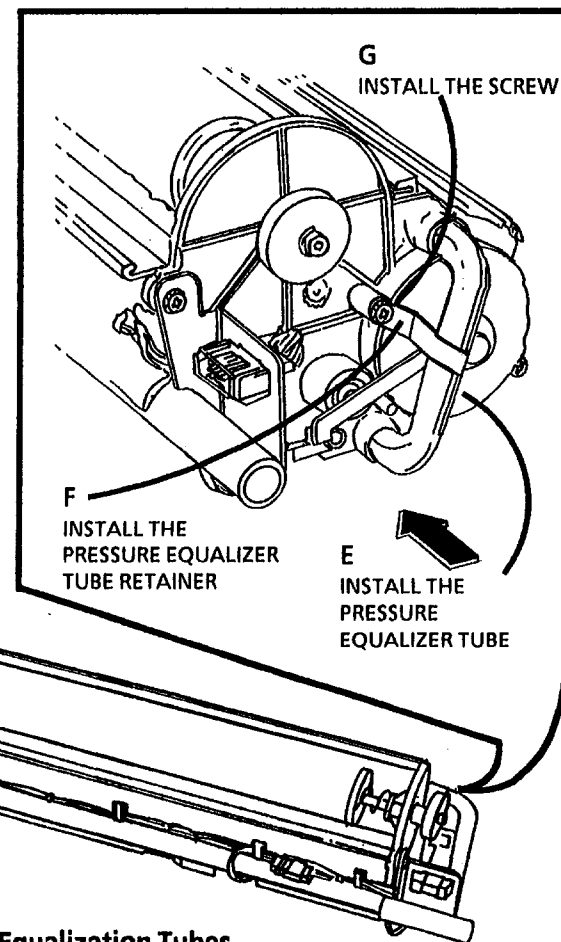
W2583

1. (Figure 6): Reinstall the Pressure Equalizer Tubes.

Figure 6. Reinstall the Air Equalization Tubes

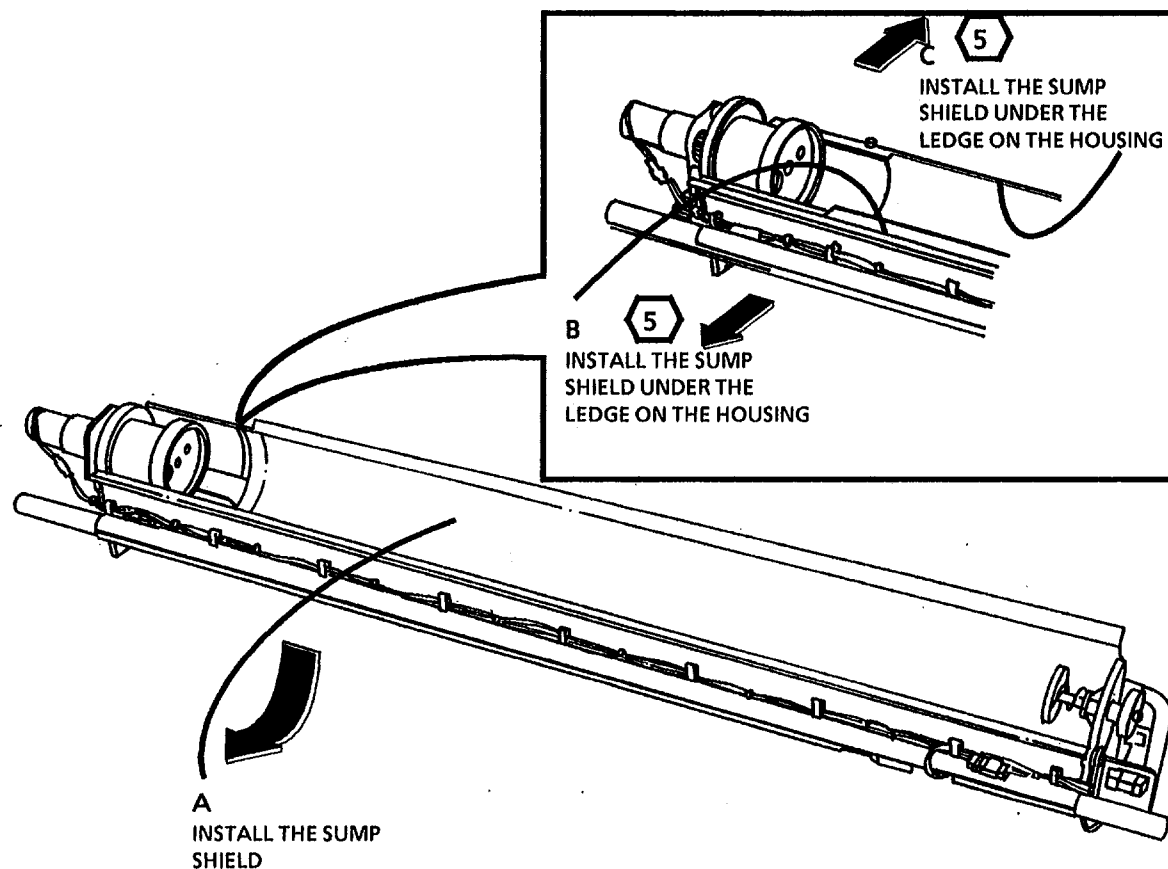
- 5** STEP 4 B AND C: *Ensure that the full length of the edge of the shield is under the edge of the housing.*

2. (Figure 7): Install the Sump Shield in the Developer Module.

Figure 7. Install the Sump Shield in the Developer Module

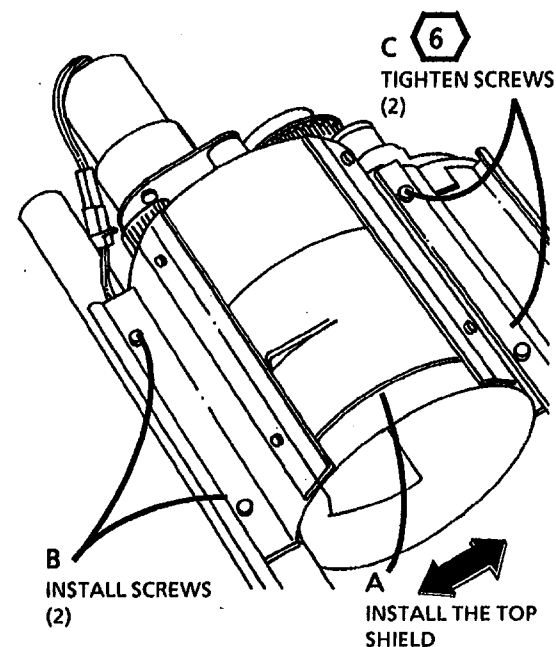
- 6** STEP 3 C: *Do not overtighten the screws.*

3. (Figure 8): Reinstall the Top Shield.

Figure 8. Reinstall the Top Shield

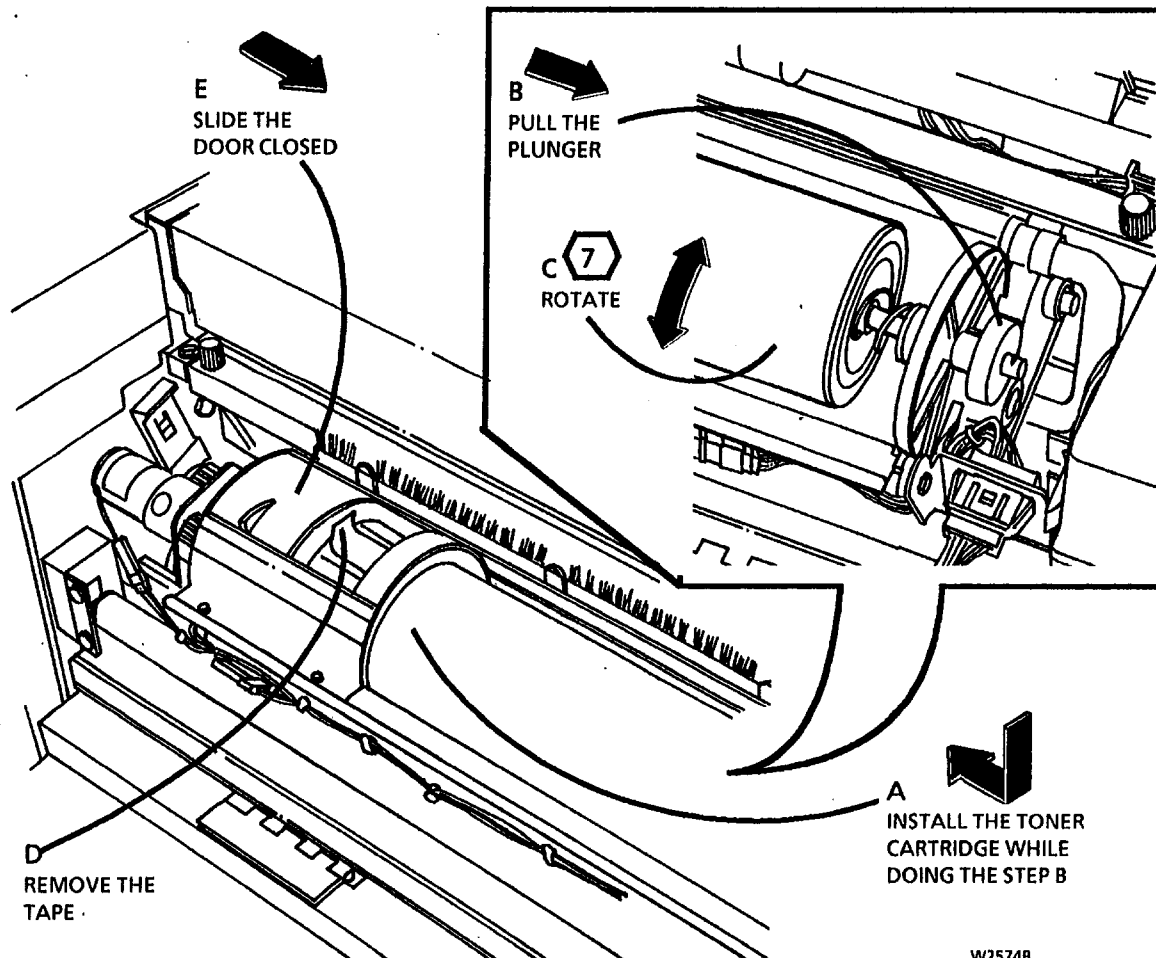
5. (Figure 9): Reinstall the Toner Cartridge.

Figure 9. Reinstall the Toner Cartridge

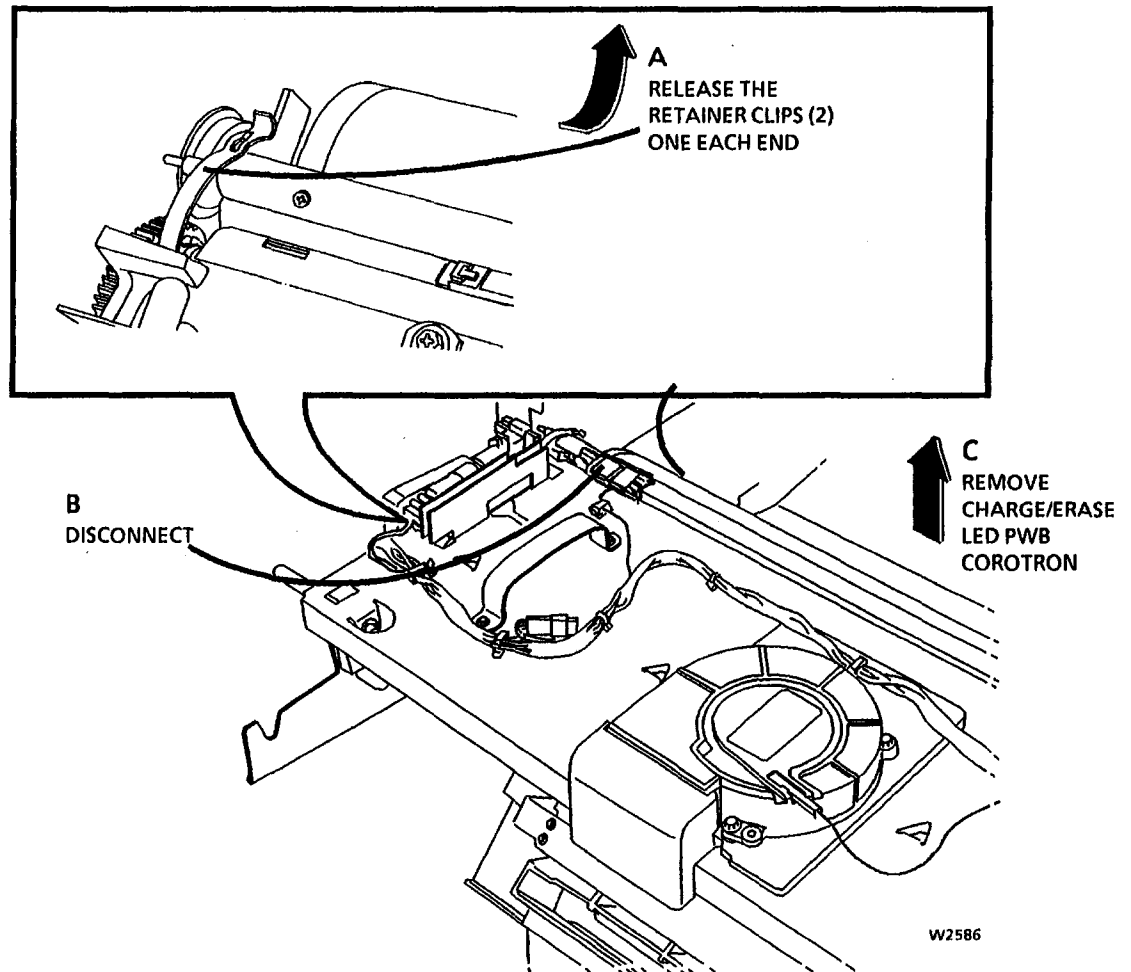
Figure 1. Remove the Charge Corotron/Erase Lamp

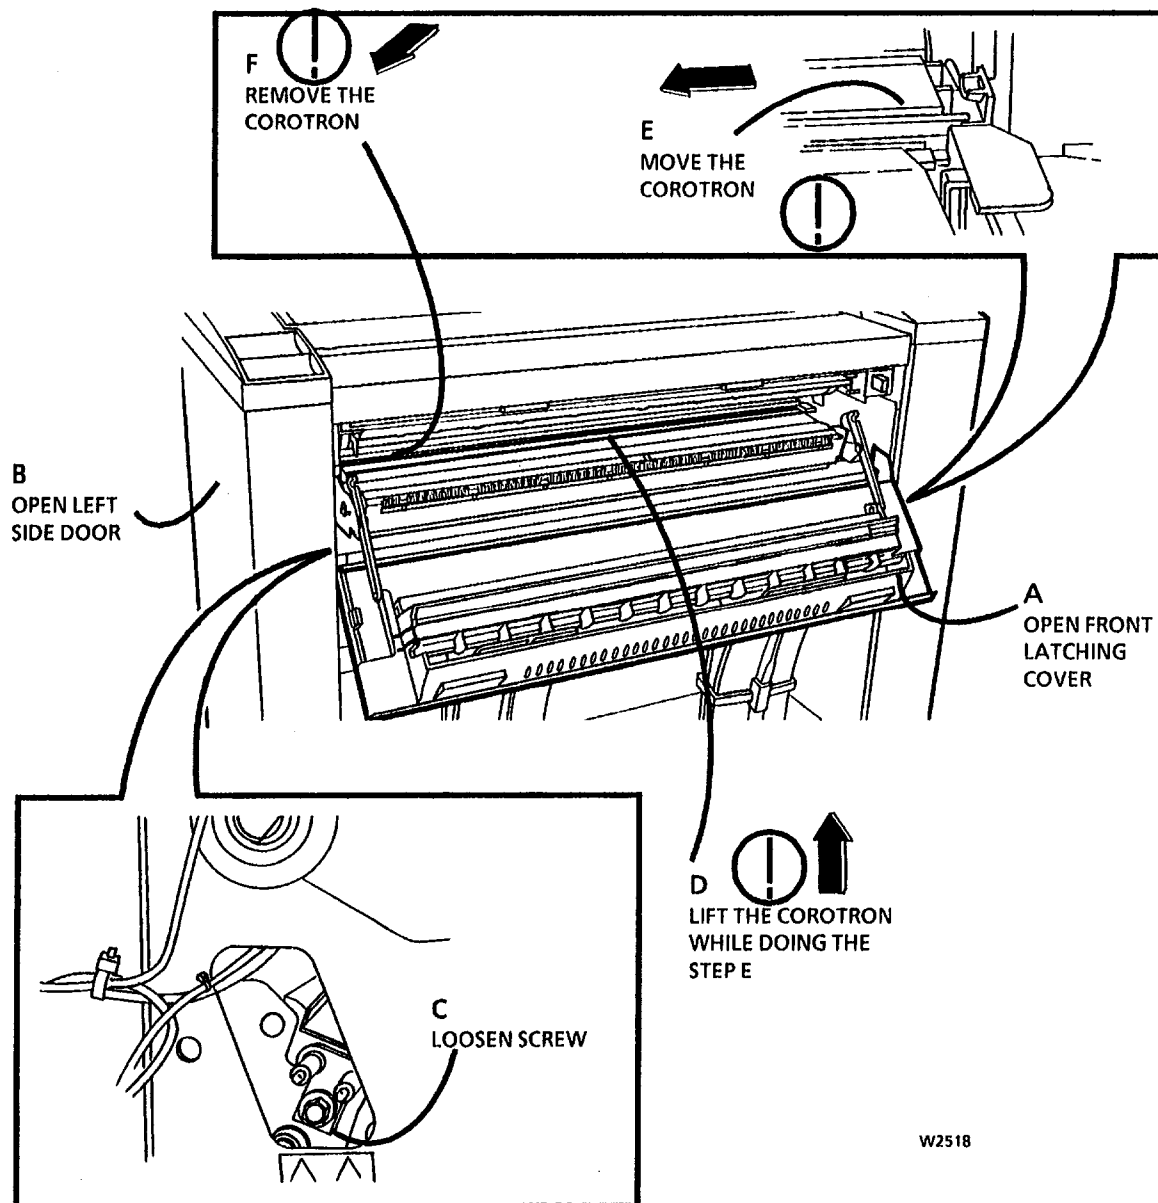
STEP 1 D, E, AND F: Use caution and do not damage the drum when removing the transfer/ detack corotron.

1. (Figure 1): Remove the Transfer/ Detack Corotron.

Figure 1. Remove the Transfer/ Detack Corotron

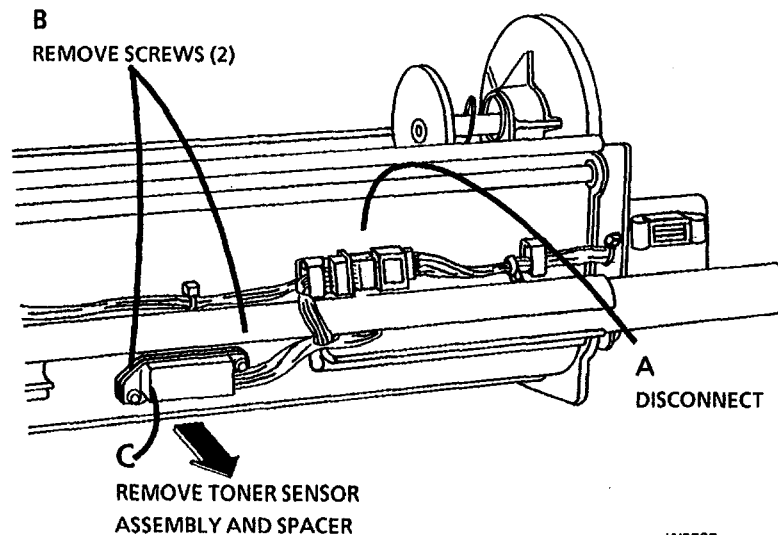
1. Remove the Developer Module (REP 9.5).
2. Remove the Developer Material (REP 9.7).
3. (Figure 1): Remove the Toner Sensor.
4. Remove the spacer from behind the Toner Sensor.

Figure 1. Remove the Toner Sensor

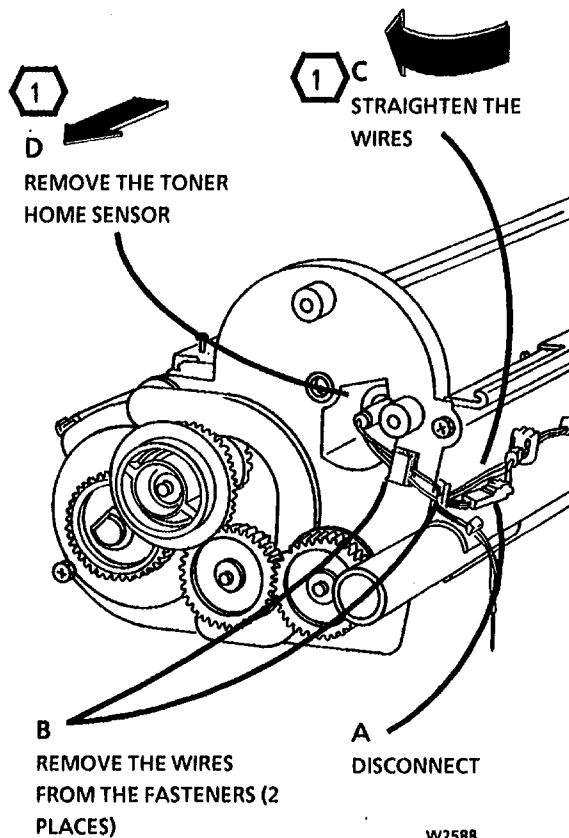
1 *STEPS 2 C and D: The toner home sensor is threaded. The wires need to be straightened to rotate the sensor for removal.*

2. (Figure 1): Remove the Toner Home Sensor.

Figure 1. Remove the Toner Home Sensor

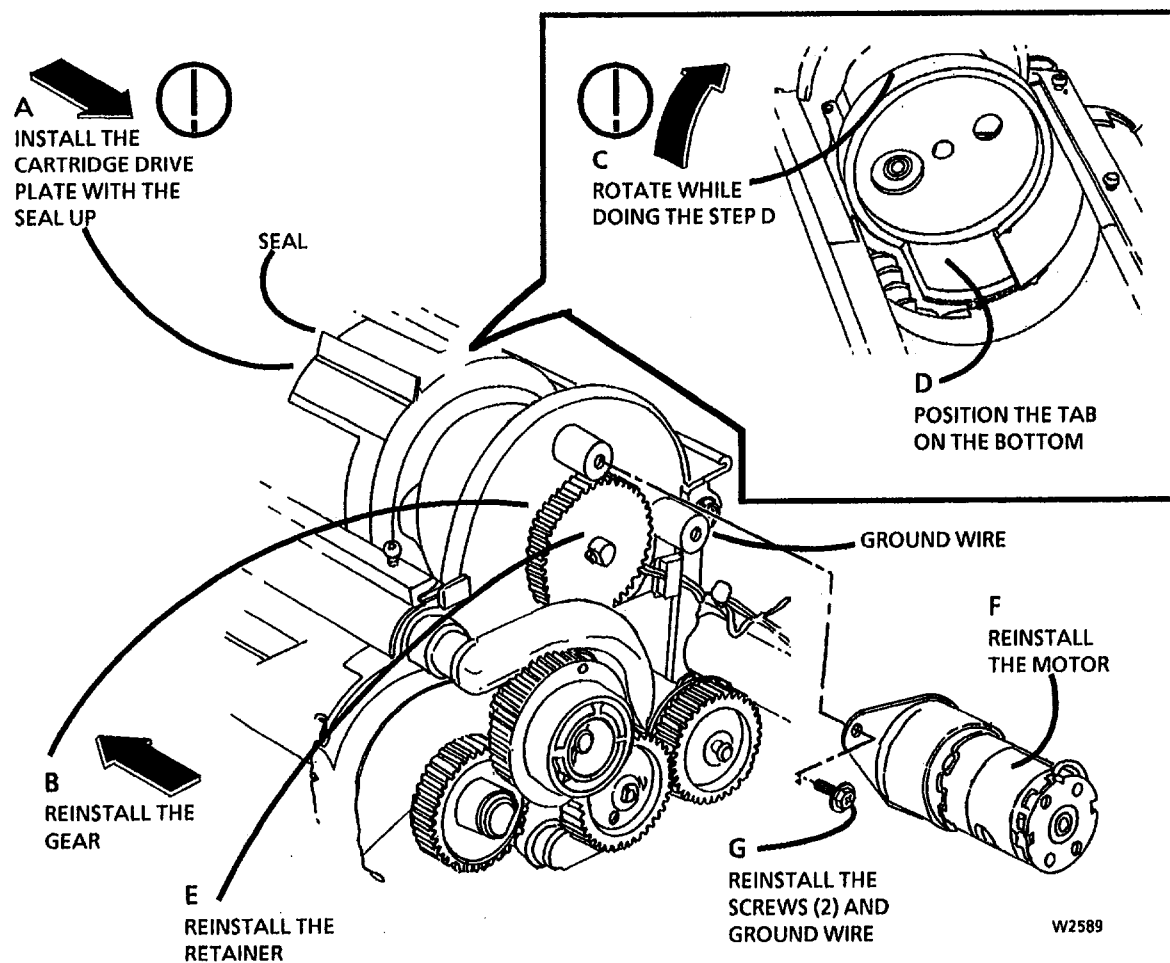
Figure 2. Install the Cartridge Drive Plate

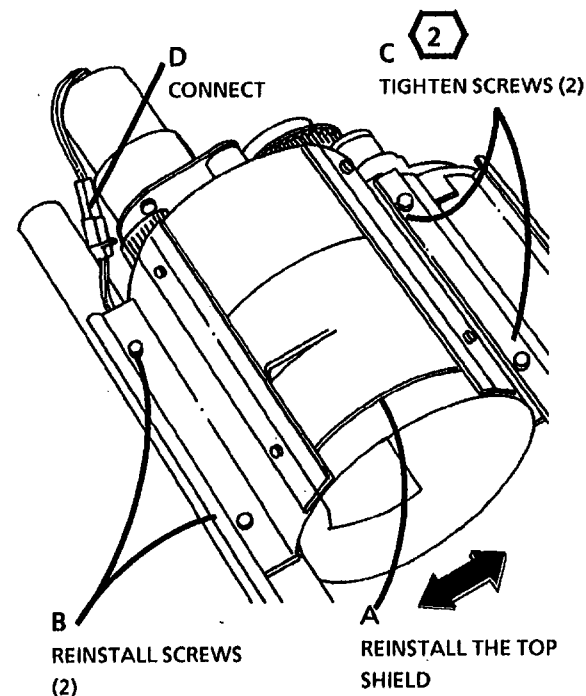
4. (Figure 3): Reinstall the Top Shield.
5. Reinstall the Developer Module.

Figure 3. Reinstall the Top Shield
