- **Call Flow Diagram** - This diagram outlines the major activities that are performed when a service call is made. The **Initial Actions** assist the Service Representative through the customer interface and help to identify the problem. The diagram also directs the Representative to verify, classify, repair the problem and perform the correct Maintenance Procedure.

2. Status Indicator Repair Analysis Procedures

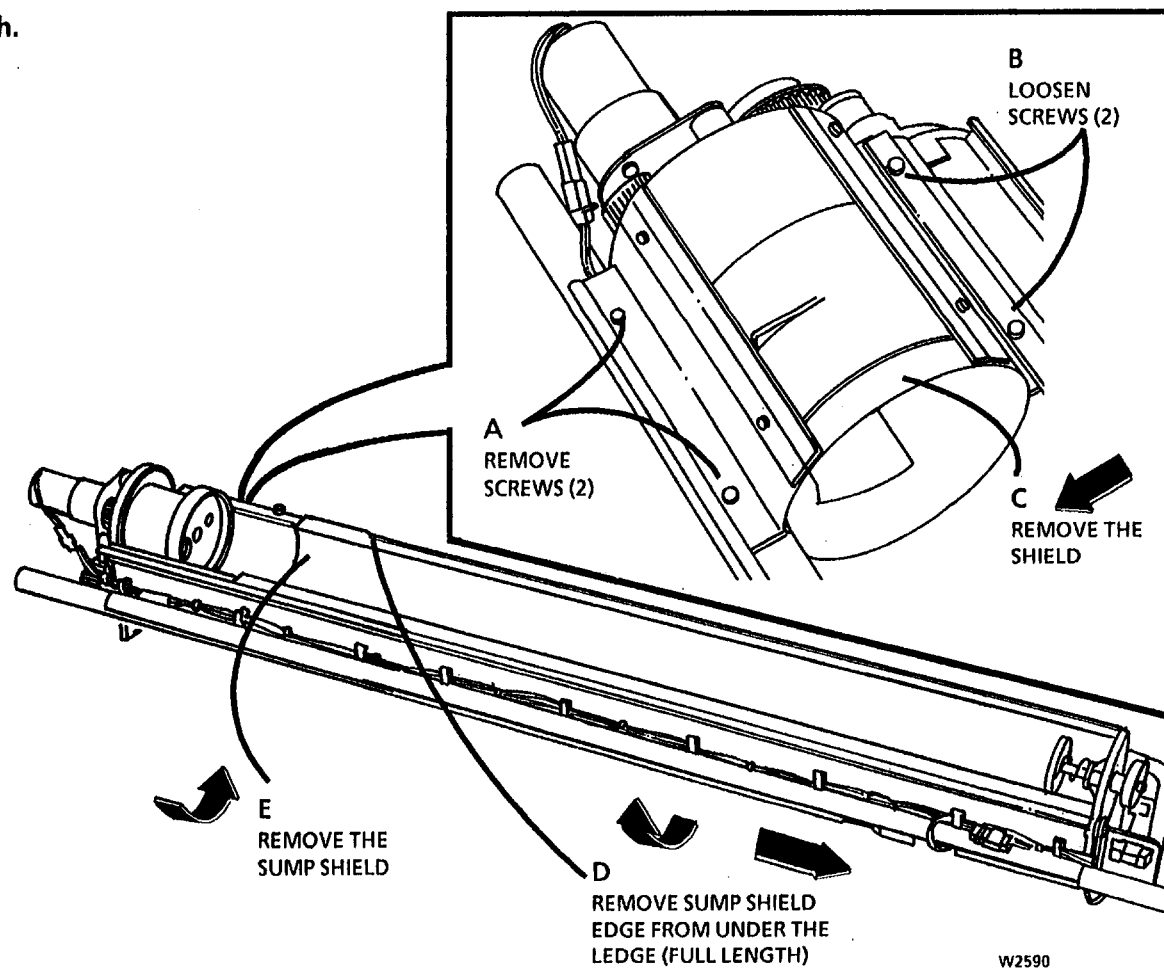
1. Remove the Developer Module (REP 9.5).
2. (Figure 1): Remove the Sump Shield.

Figure 1. Remove the Sump Shield

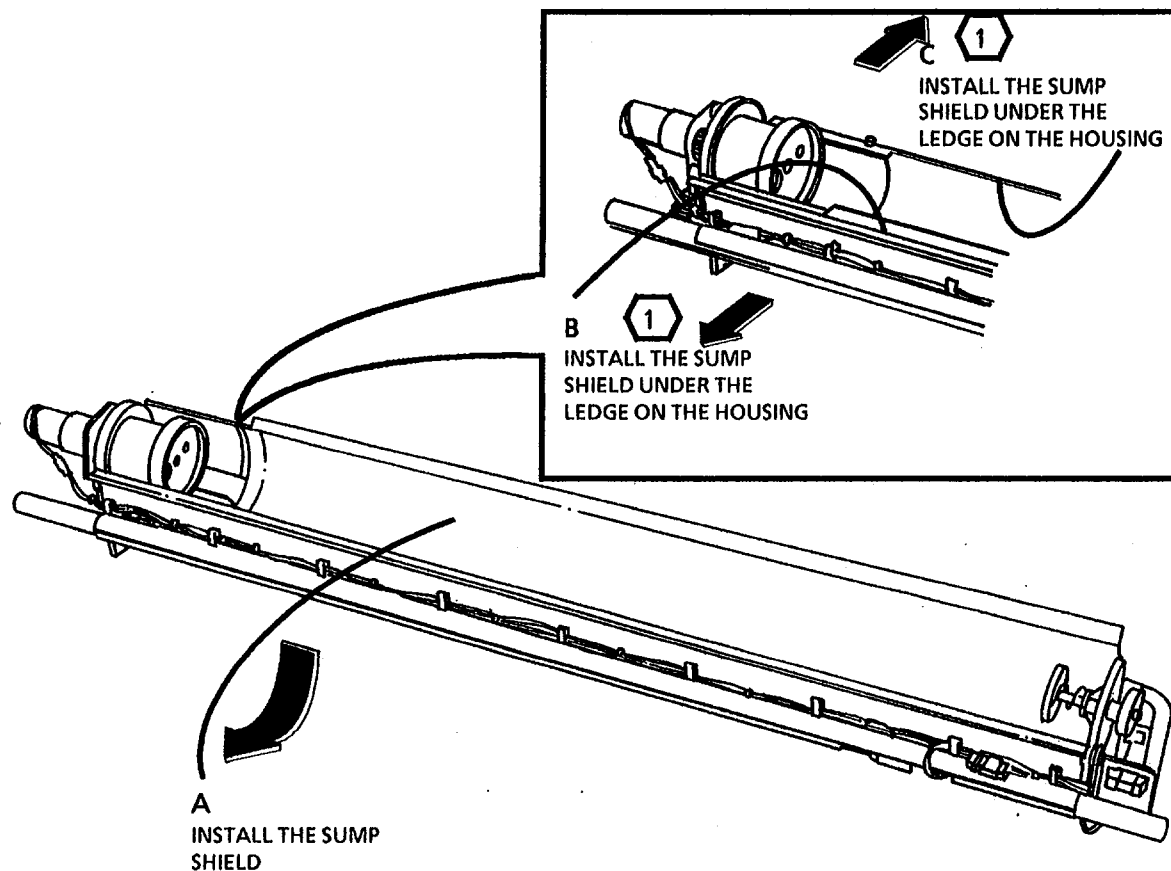
W2584

- 1** STEP 1 B AND C: *Ensure that the full length of the edge of the shield is under the edge of the housing.*

1. (Figure 2): Install the Sump Shield in the Developer Module.
2. The remainder of the replacement is a reversal of the removal.

Figure 2. Install the Sump Shield in the Developer Module

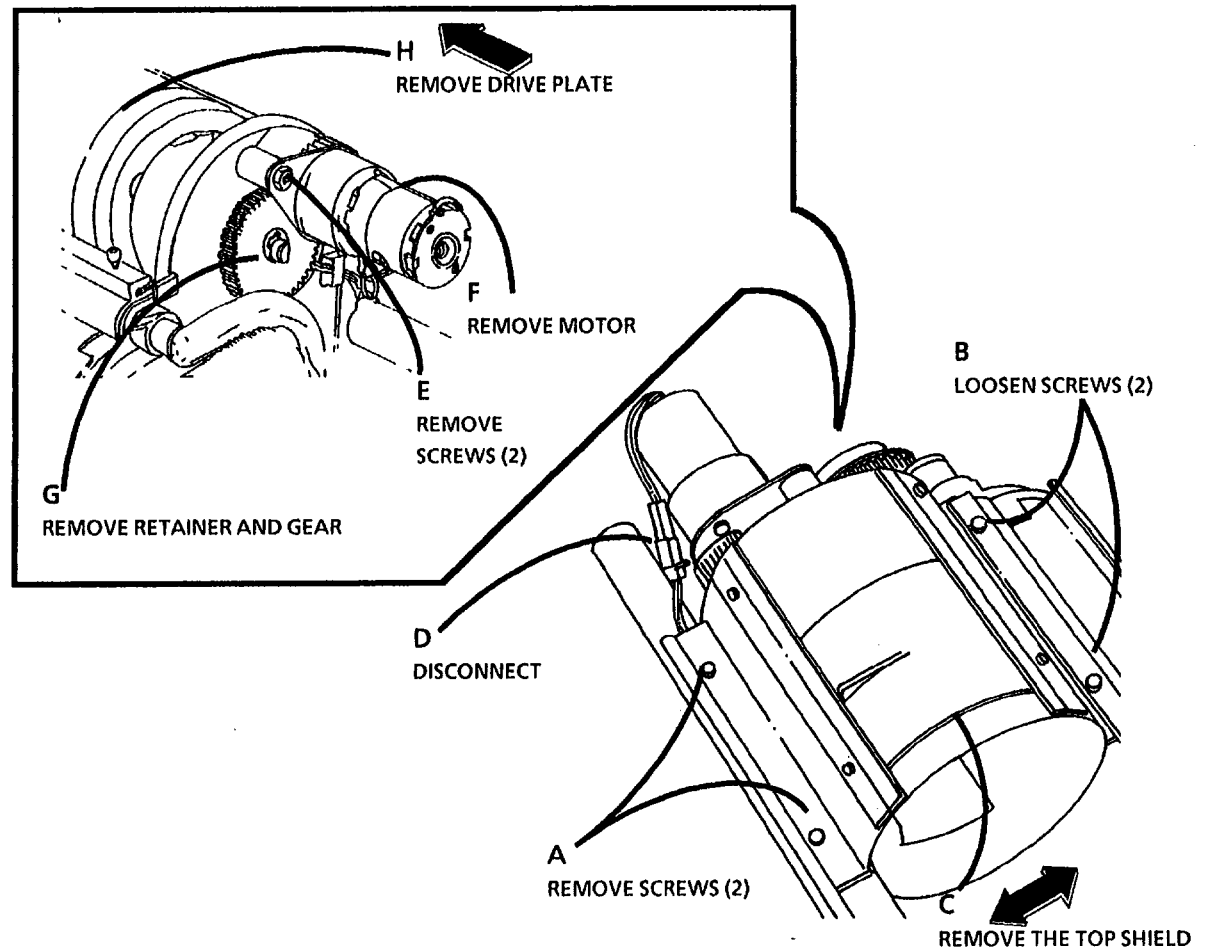
W2591

1. Remove the Developer Module (REP 9.5).
2. (Figure 1): Remove the Cartridge Drive Plate.

Figure 1. Remove the Cartridge Drive Plate

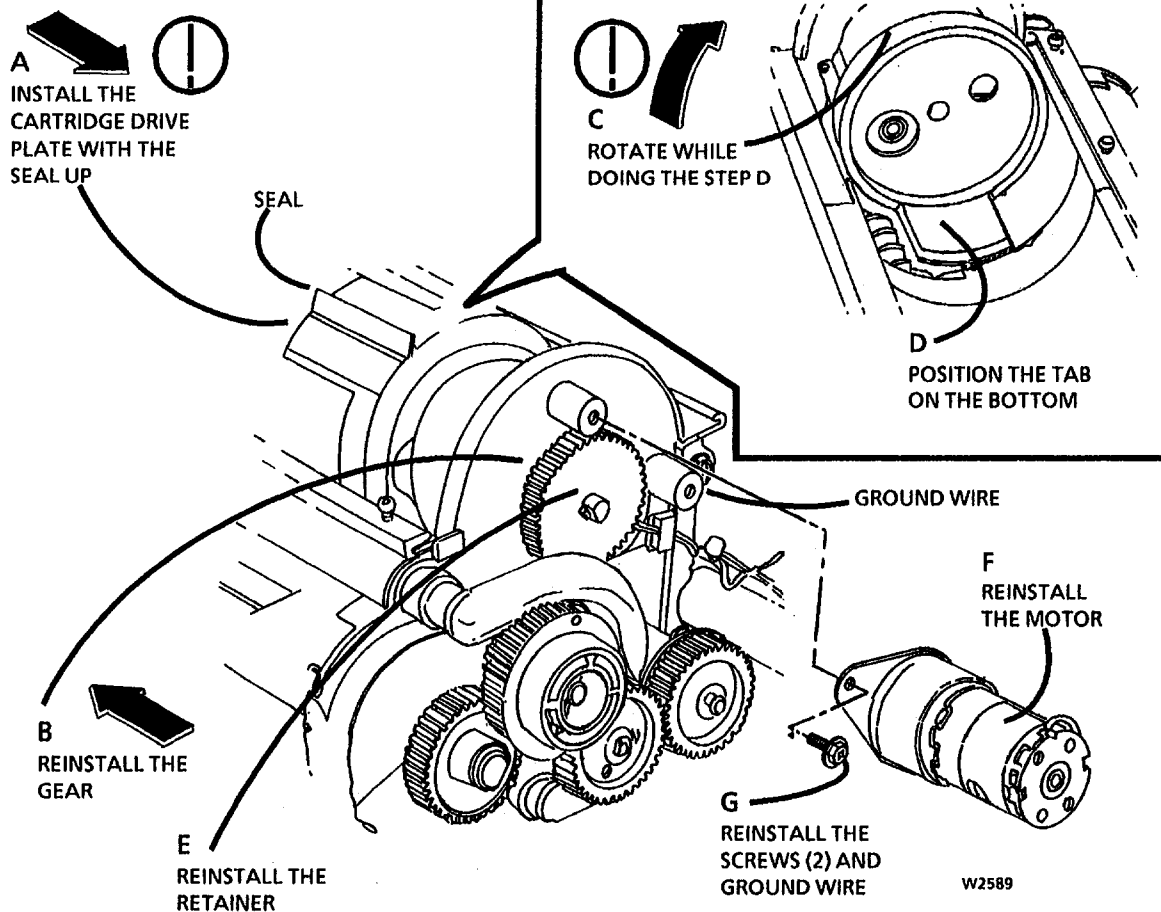
⚠ STEP 1 C: To avoid damage to the drive plate seal, always rotate the drive plate in the direction shown in Figure 2.

Figure 2. Install the Cartridge Drive Plate

1. (Figure 2): Reinstall the Cartridge Drive Plate.

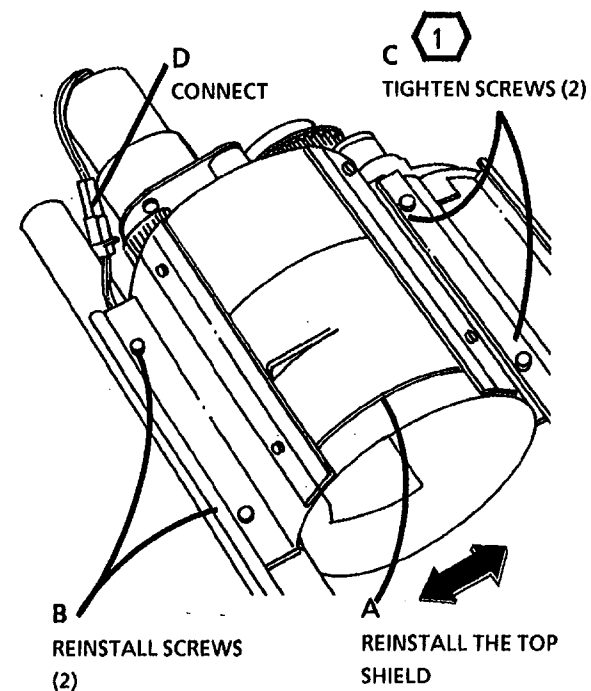
2. (Figure 3): Reinstall the Top Shield.

Figure 3. Reinstall the Top Shield

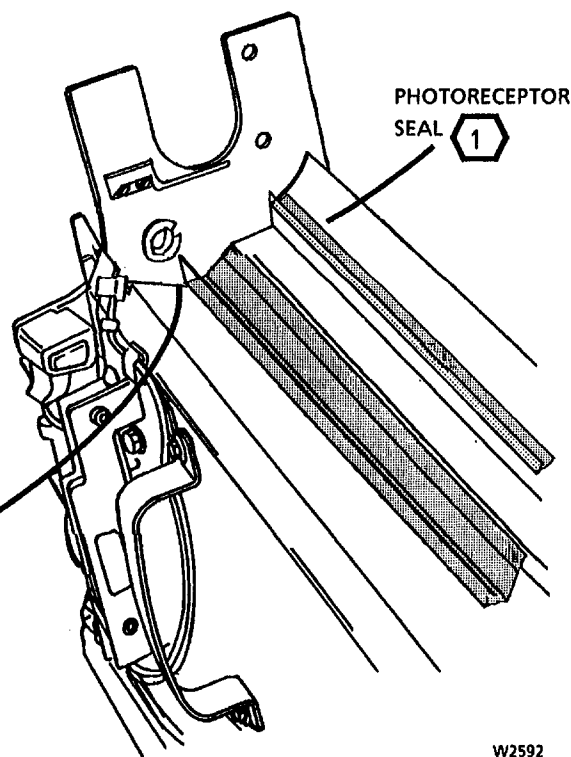
W2592

A **1**
REMOVE THE
CONTAMINATION SEAL

2. (Figure 1): Remove the Contamination Seal.
3. Vacuum the Waste Toner Auger and the area where the Contamination Seal will be installed.

Figure 1. Remove the Contamination Seal

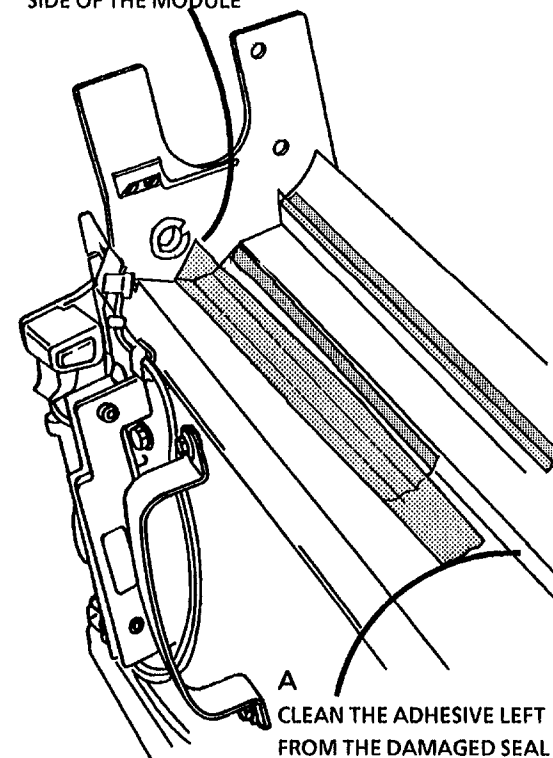
W2593

1. (Figure 2): Place the new Contamination Seal in the Xerographic Module.

B
PLACE THE SEAL IN THE
MODULE AND AGAINST THE
SIDE OF THE MODULE

A
CLEAN THE ADHESIVE LEFT
FROM THE DAMAGED SEAL

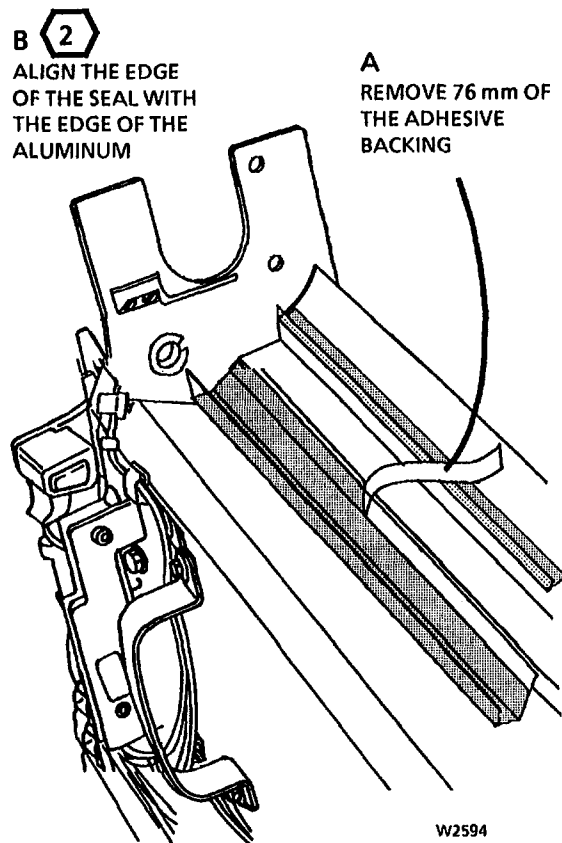
- 2** **STEP 2 B:** Ensure that the seal stays against the side of the xerographic module.

2. (Figure 3): Install the Contamination Seal.

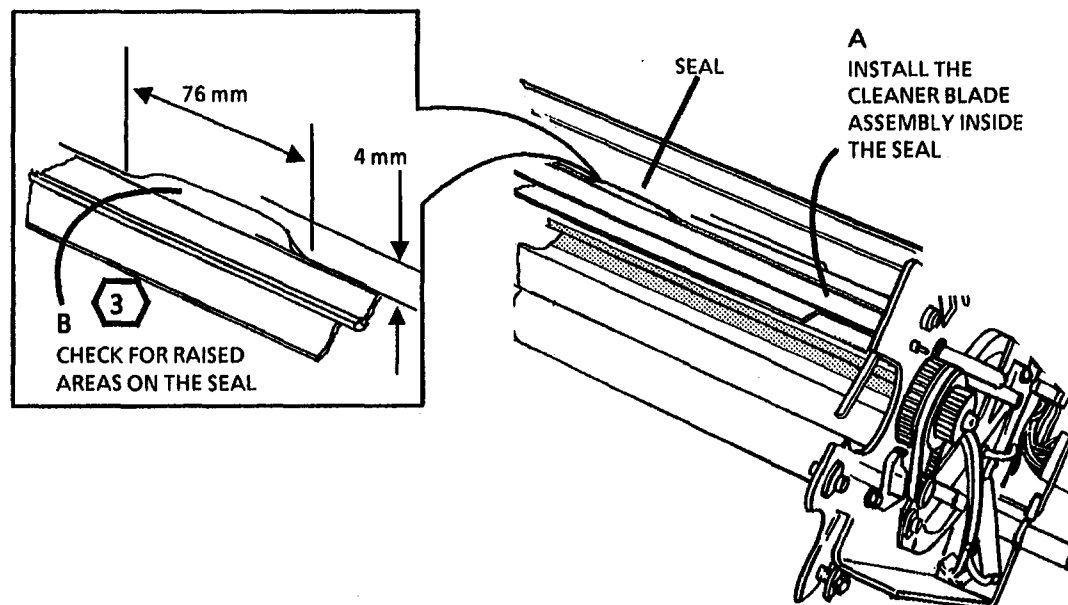
- 3** **STEP 3 B:** Areas of the seal raised off the cleaner blade should be less than 76 mm long and 4 mm high. There should be no raised areas within 300 mm from either end of the cleaner blade.

3. (Figure 4): Check the seal for correct installation.

4. Remove any raised areas by moving your finger across the top of the seal and push the raised area to either end of the Cleaner Blade Assembly.

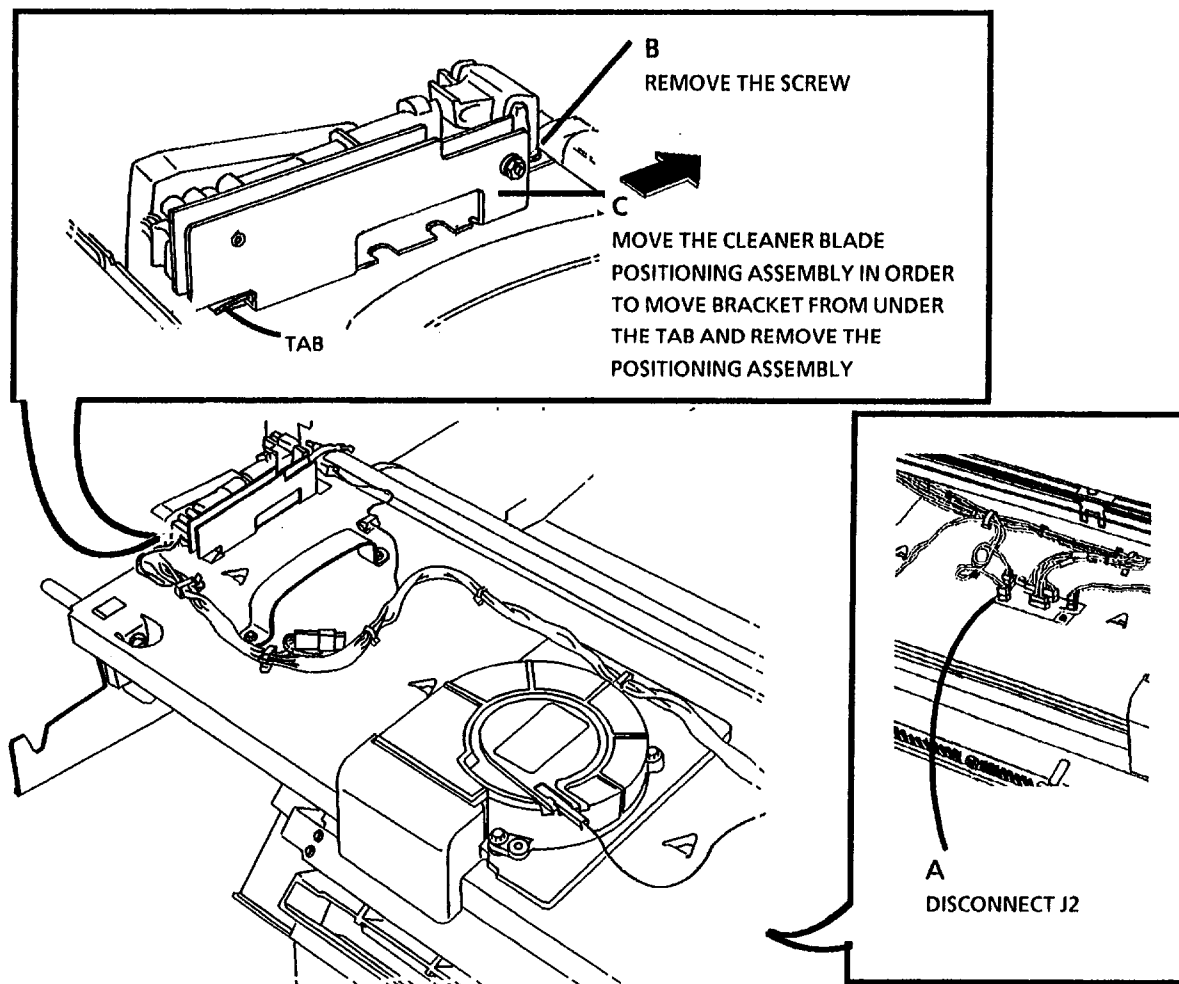
W2519B

3. (Figure 1): Remove the Cleaning Blade Positioning Assembly.

Figure 2. Remove the Cleaner Blade Positioning Assembly

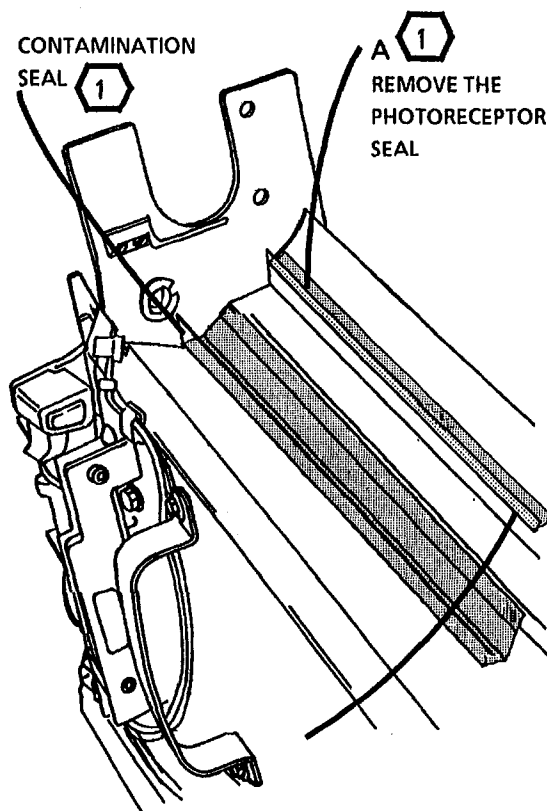
W2592

1 STEP 2A : Do not remove the Contamination Seal.

2. (Figure 1): Remove the Contamination Seal.
3. Vacuum the Waste Toner Auger and the area where the Contamination Seal will be installed.

Figure 1. Remove the Photoreceptor Seal

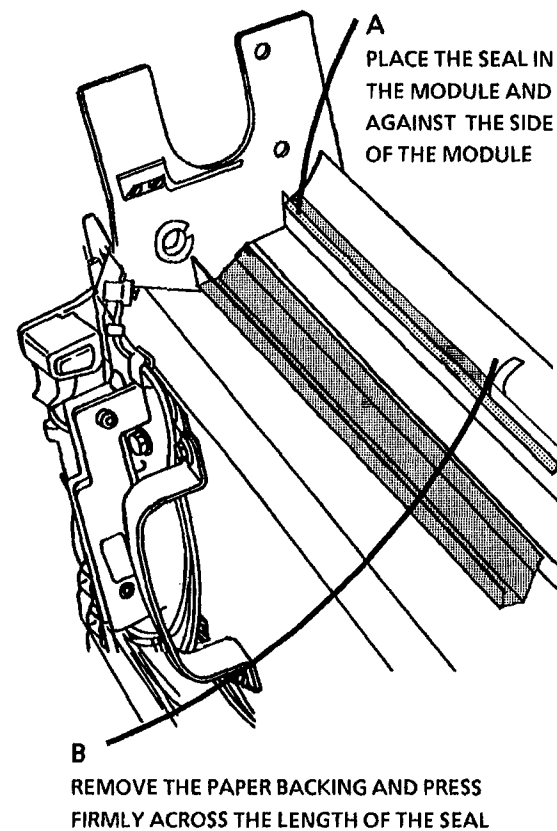
W2594B

1. (Figure 2): Place the new Photoreceptor Seal in the Xerographic Module.
2. Apply stearate to the seal and ensure the seal is not damaged and is against the photoreceptor when the photoreceptor is installed.

Figure 2. Place the Photoreceptor Seal in the Module

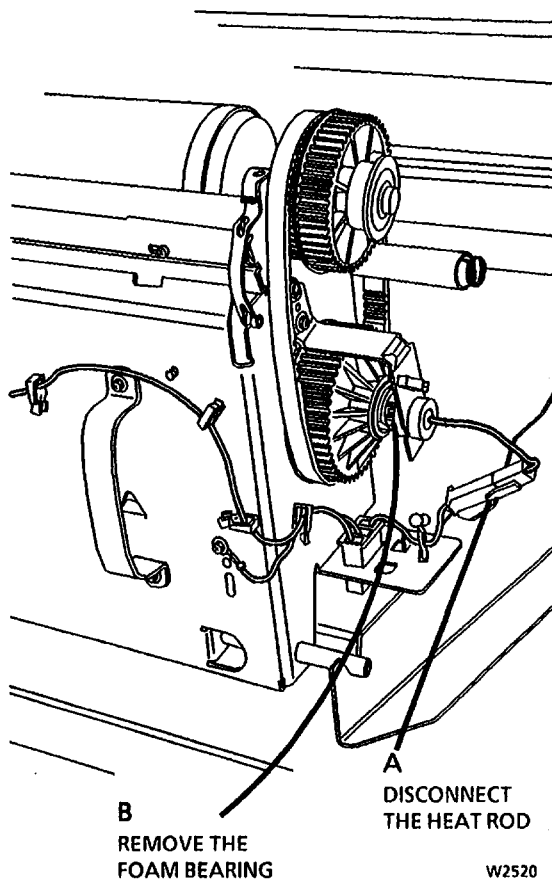
- a. Right and Left Side Door (REP 14.1).
- b. Xerographic Module (REP 9.1).
- c. Stripper Finger Assembly (REP 10.6).
- d. Oil Dispense Assembly (REP 10.7).

Figure 1. Prepare to Remove the Heat Rod

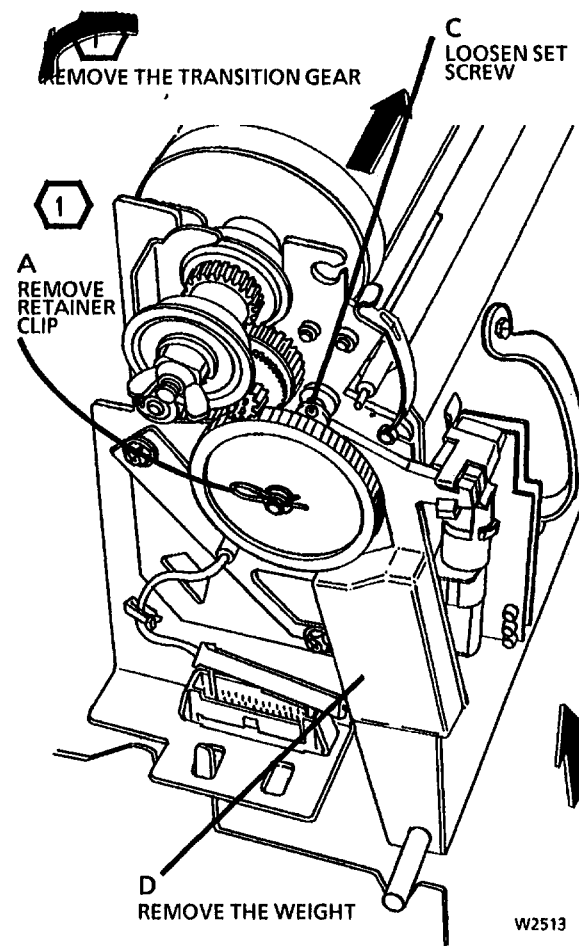
STEP 3 A and B: Use care when
removing the retainer clip and the
transition gear. The cleaner blade
assembly is spring-loaded.

3. (Figure 2): Remove the Transition Gear and Weight.

Figure 2. Remove the Transition Gear and
Weight

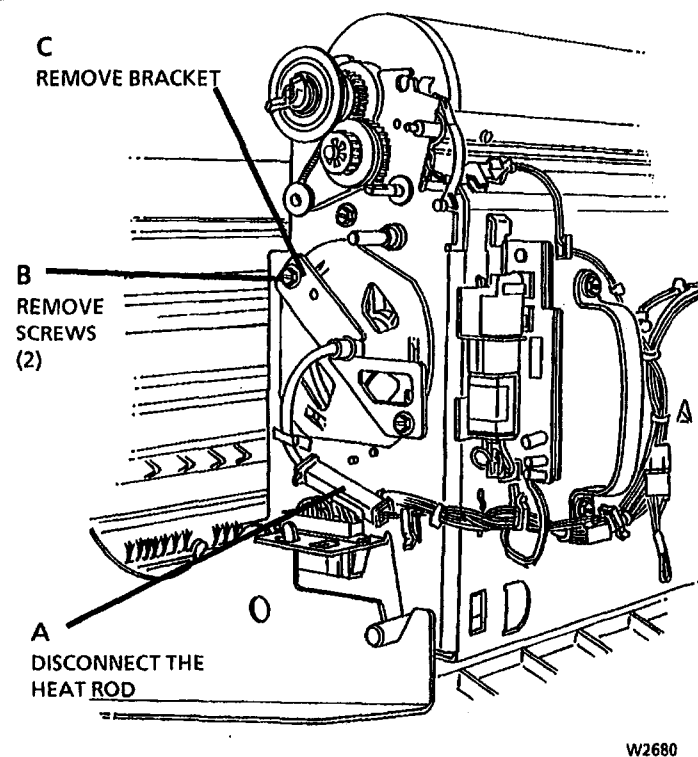
Figure 3. Preparing to Remove the Heat Rod

4. (Figure 3): Prepare to remove the Heat Rod.

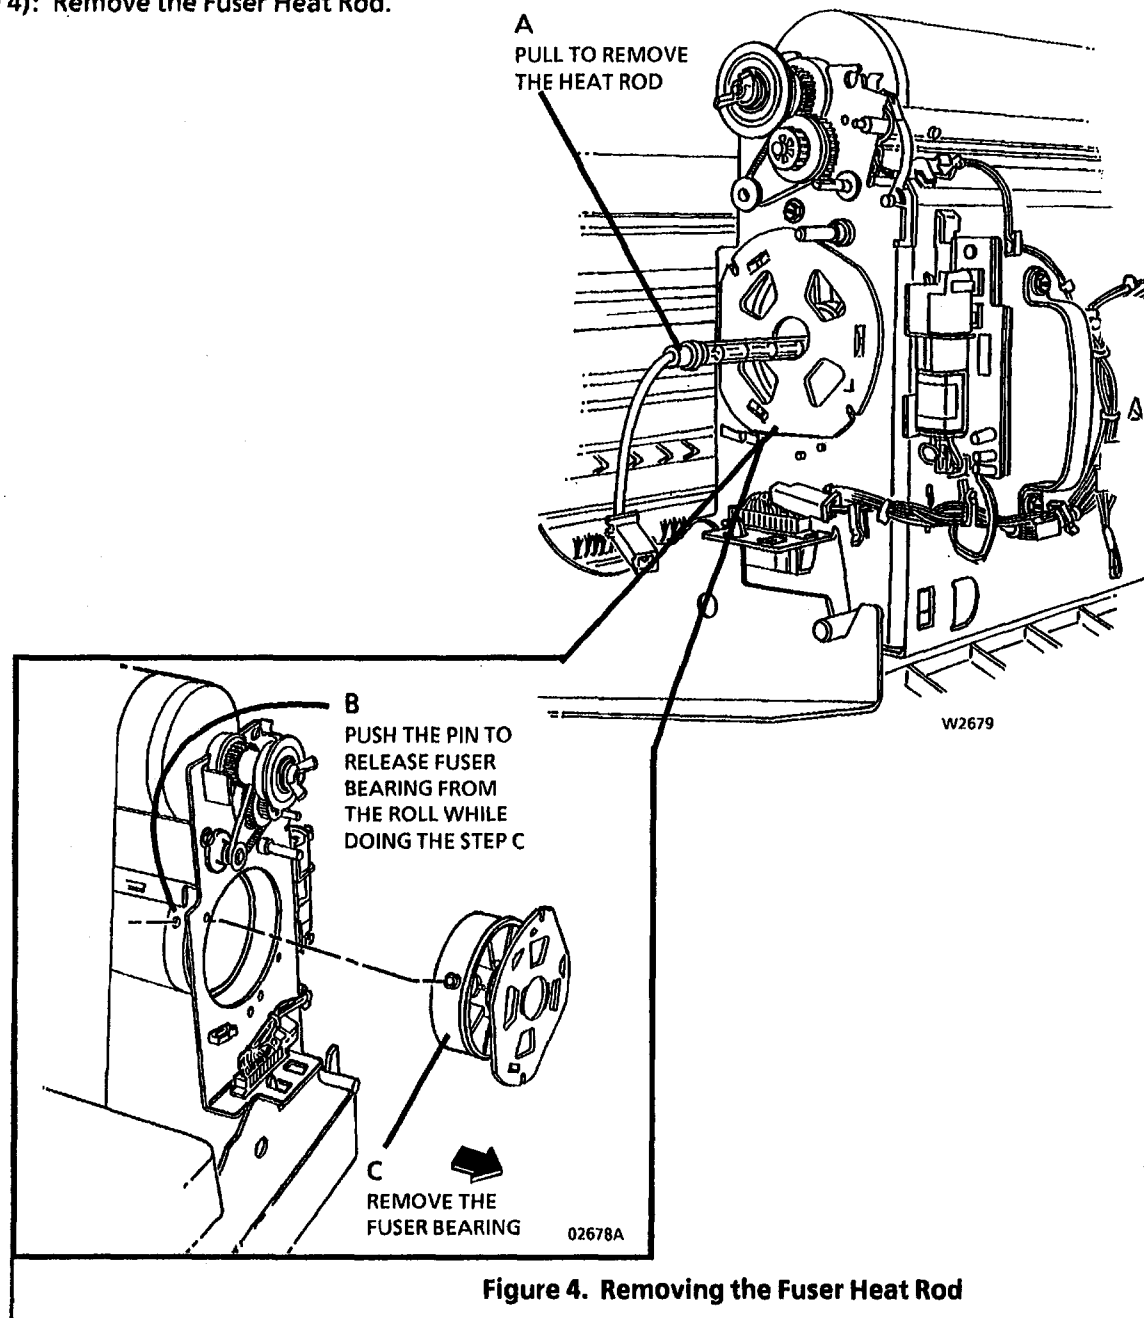
Figure 4. Removing the Fuser Heat Rod

5. (Figure 4): Remove the Fuser Heat Rod.

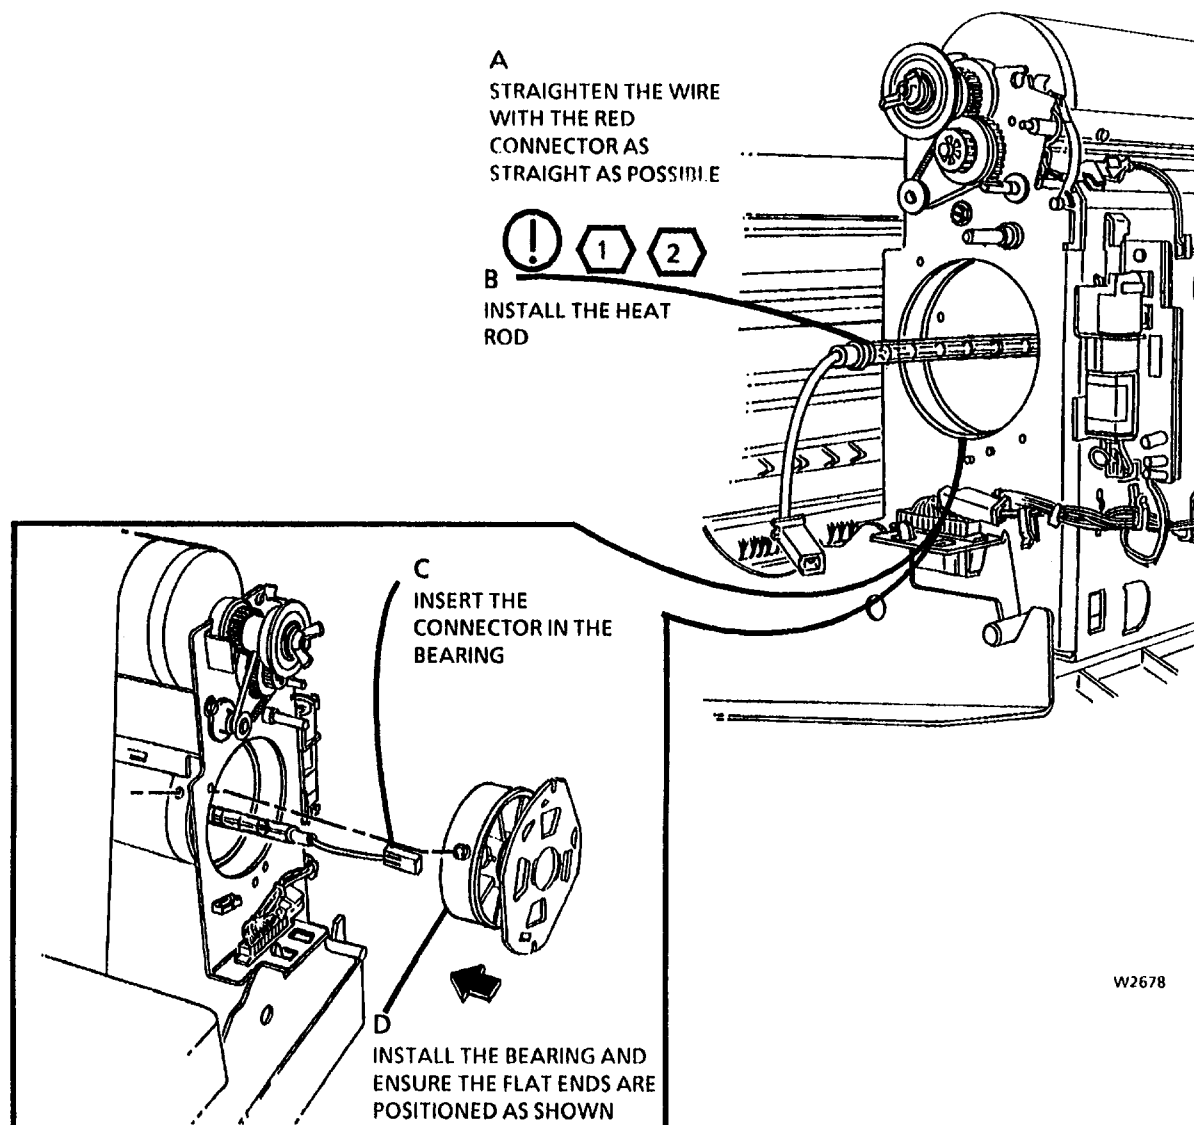
Figure 5. Install the Heat Rod

STEP 1 A: Wear gloves or wrap a sheet of paper around the Heat Rod when handling the heat rod. Oil from your fingers can damage the Heat Rod.

STEP 1 A: Insert the red connector into the fuser roll. while looking into the roll, align the red connector with the hole in the fuser drive gear and insert the connector through the gear. If the connector will not go through, use the rod that secures the fabric guide. Insert the rod through the right side of the xerographic module. Secure the red connector to the rod and pull the heat rod into the fuser roll.

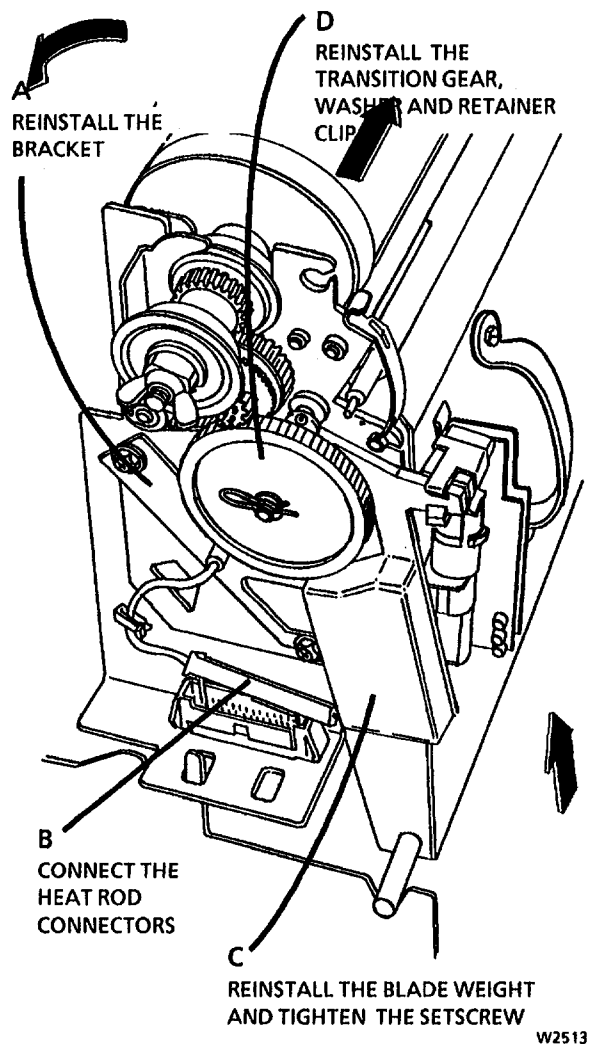
Figure 6. Completing the Installation

2. (Figures 6 and 7): Complete the installation of the heat rod.

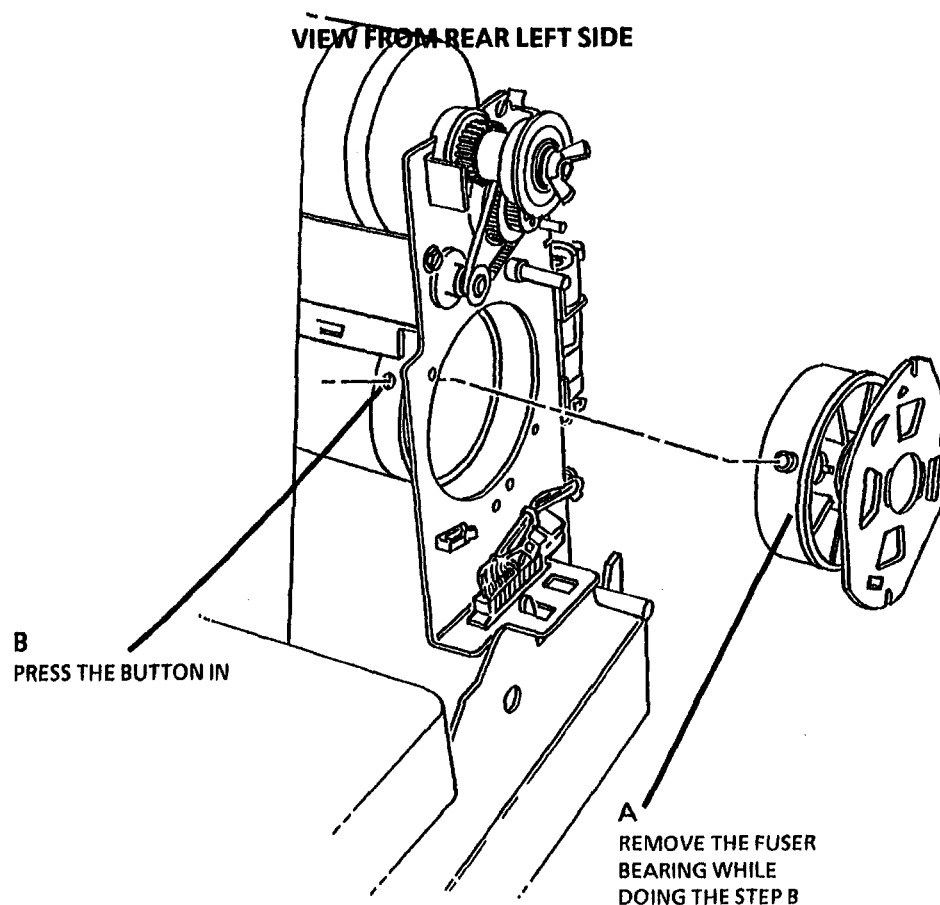
Figure 1. Prepare to Remove the Fuser Roll

- a. Right and Left Side Doors (REP 14.1).
- b. Xerographic Module (REP 9.1).
- c. Stripper Finger Assembly (REP 10.6).
- d. Oil Dispense Assembly (REP 10.7).
- e. Heat Rod (REP 10.1).

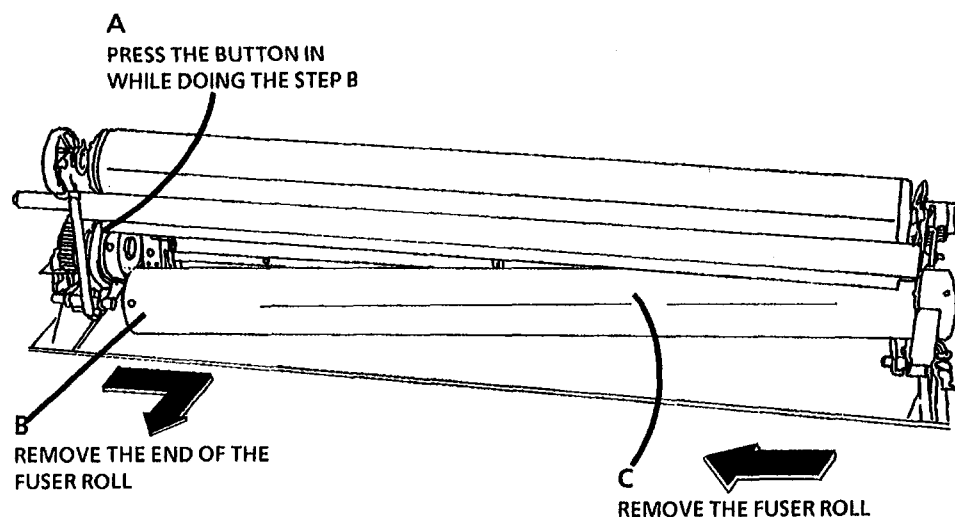
Figure 2. Remove the Fuser Roll

5. Clean the thermistor contact where it contacts the fuser roll with a clean dry cloth to remove any loose dirt.

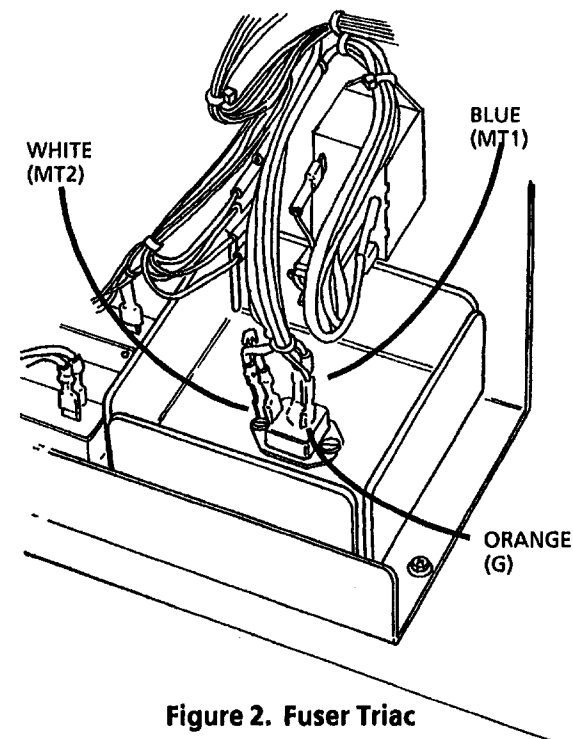
1. Cover the entire surface where the triac mounts to the frame with a film of thermal compound.
2. (Figure 2): Fuser Triac.

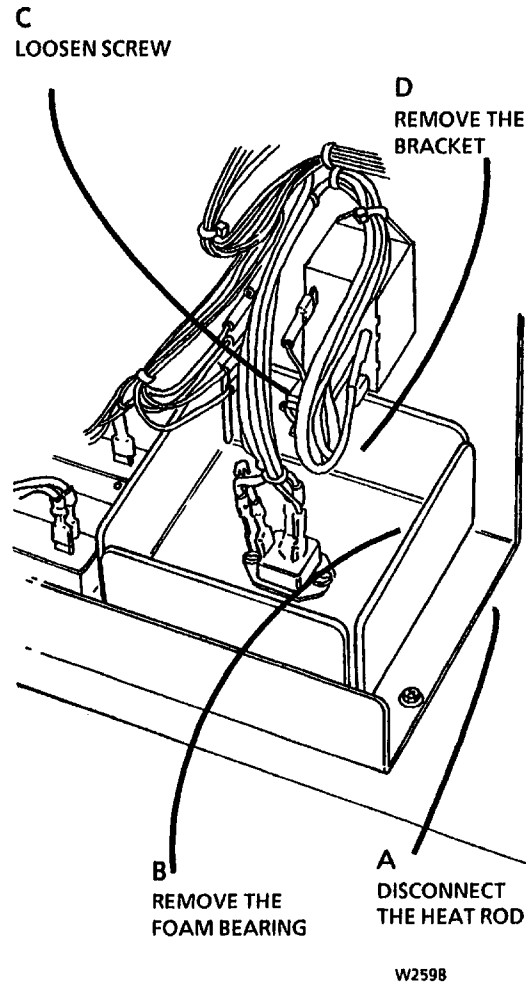
Figure 1. Remove the Bracket

2. (Figure 1): Remove the Lamp Bracket.

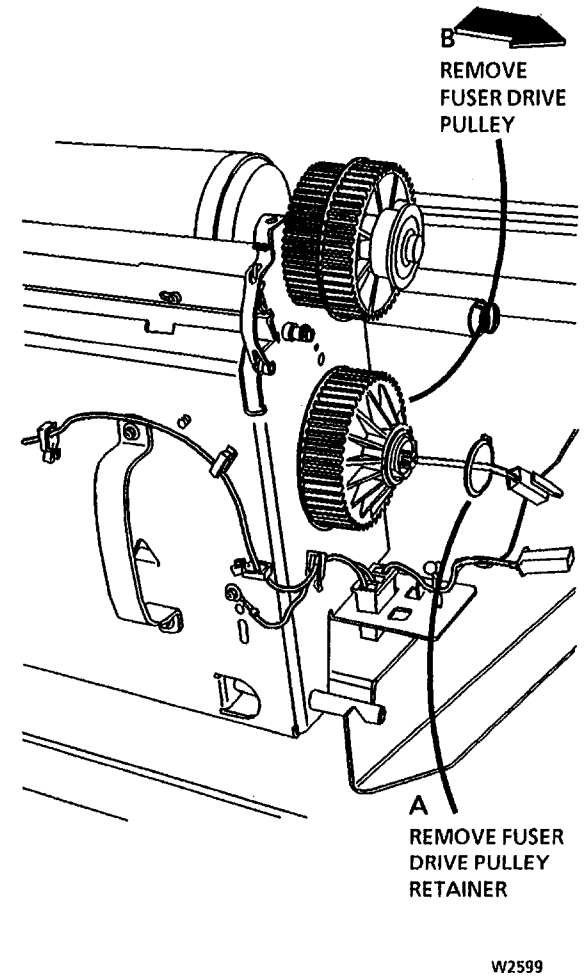
Figure 2. Remove the Fuser Drive Pulley

3. (Figure 2): Remove the Fuser Drive Pulley.

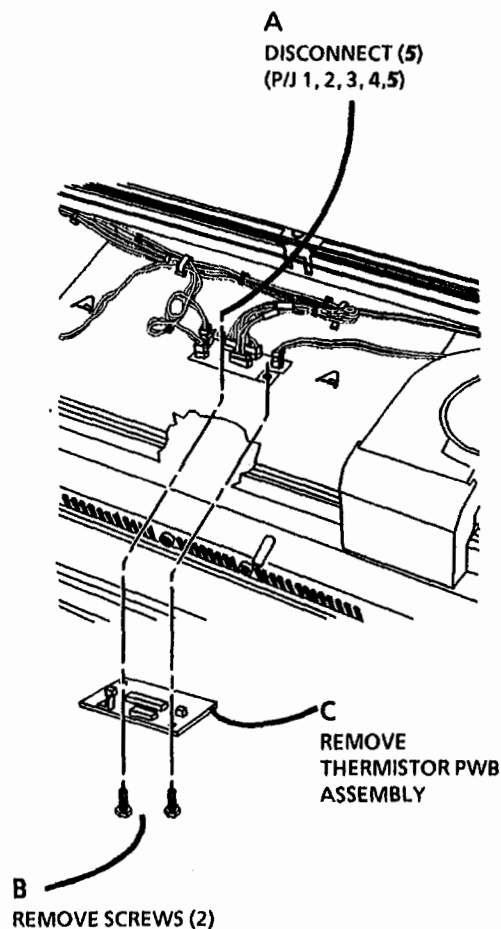
3. (Figure 1): Remove the Thermistor Assembly PWB (RT1).

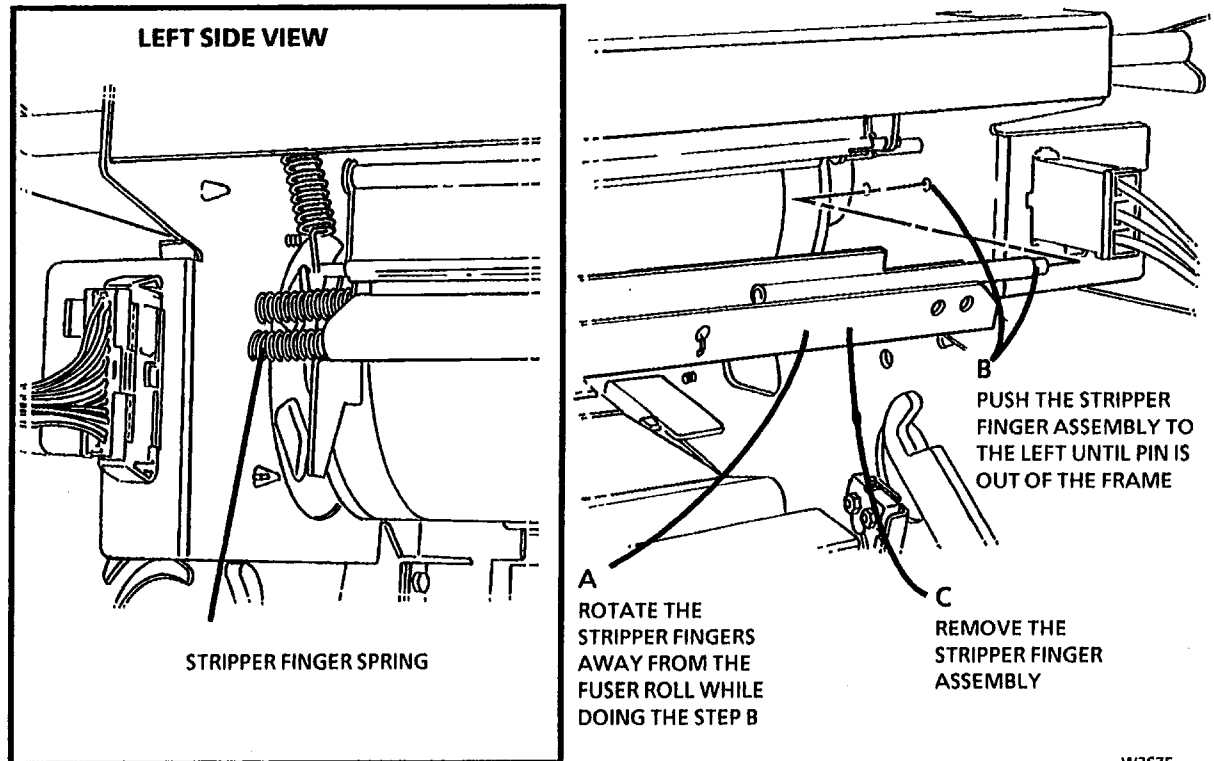
Figure 1. Remove the Stripper Finger Assembly

1. Open the Front Cover.
2. (Figure 1): Remove the Stripper Finger Assembly.

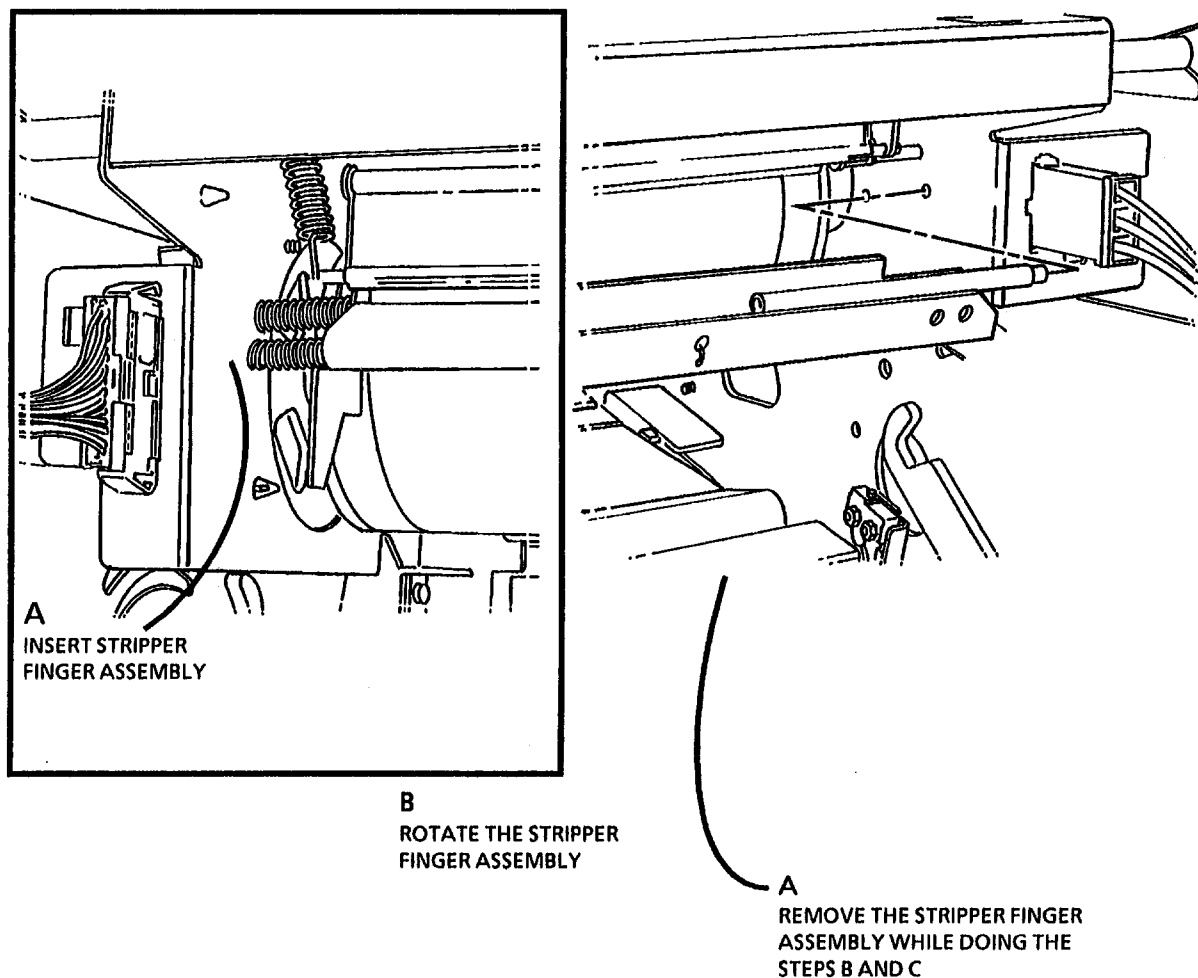
Figure 2. Remove the Stripper Finger Assembly

ⓘ **Step 1 A:** To avoid damage to the stripper fingers and the fuser roll, ensure that the stripper fingers are away from the fuser roll when reinstalling the Stripper Finger Assembly.

1. (Figure 2): Reinstall the Stripper Finger Assembly.

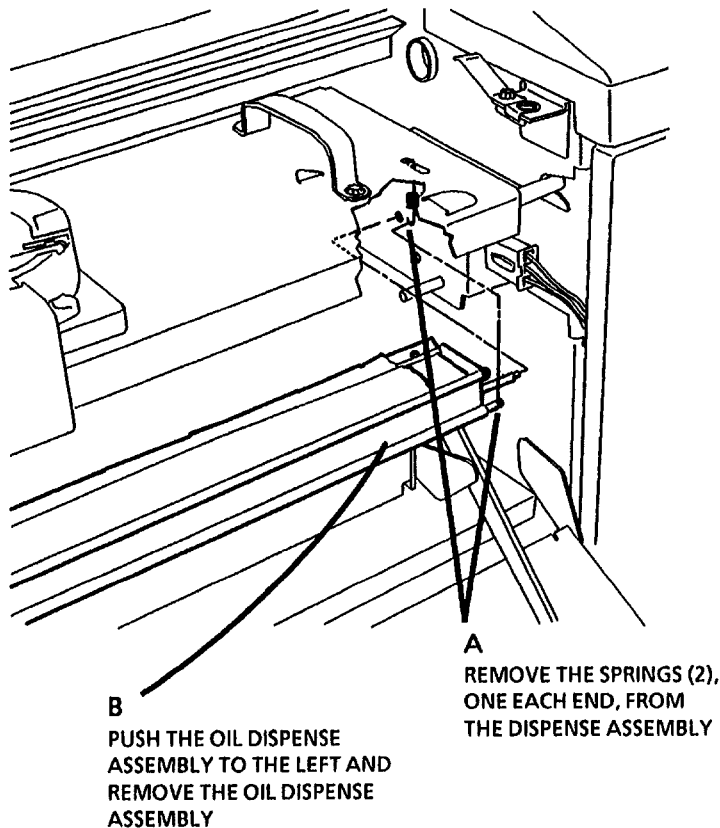
Figure 1. Removing the Oil Dispense Assembly

2. Lower the Front Latching Cover.
3. Remove the Stripper Finger Assembly (REP 10.6)
4. (Figure 1): Remove the Oil Dispense Assembly.

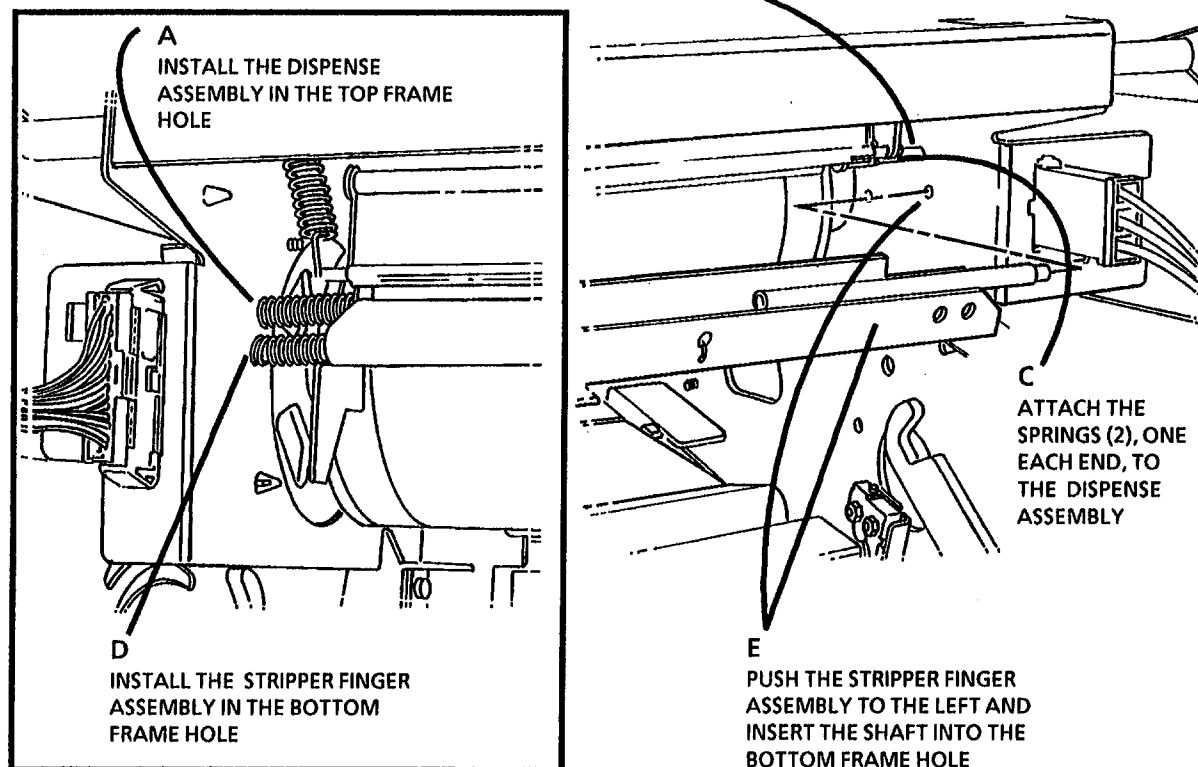
Figure 2. Installing the Oil Dispense Assembly

ⓘ *Step 1 A: To avoid damage to the stripper fingers and the fuser roll, ensure that the stripper fingers are away from the fuser roll when reinstalling the Stripper Finger Assembly.*

1. (Figure 2): Install the Oil Dispense Assembly and Stripper Finger Assembly.

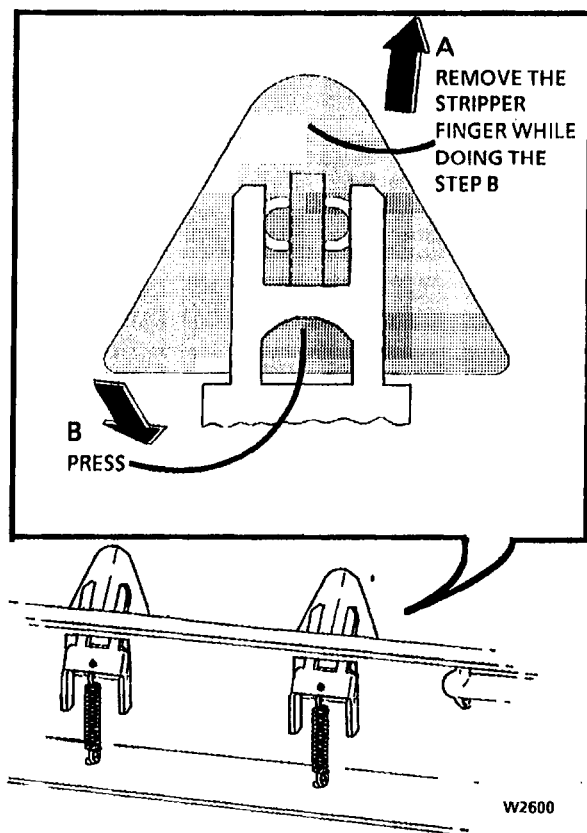
Figure 1. Remove the Stripper Fingers

1. Remove the Stripper Finger Assembly (REP 10.6)
2. (Figure 1): Remove the Stripper Fingers.
