- **Call Flow Diagram** - This diagram outlines the major activities that are performed when a service call is made. The **Initial Actions** assist the Service Representative through the customer interface and help to identify the problem. The diagram also directs the Representative to verify, classify, repair the problem and perform the correct Maintenance Procedure.

2. Status Indicator Repair Analysis Procedures

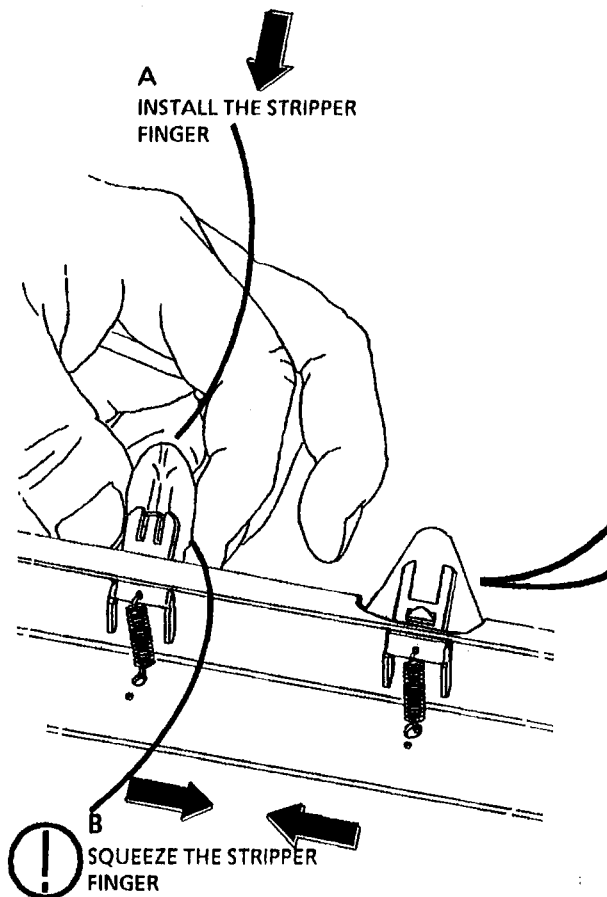
Figure 2. Install the Stripper Fingers

STEP 1 B: To avoid damage to the stripper fingers, do not bend them too far causing them to fold.

1. (Figure 2): Install the Stripper Fingers.
2. The remainder the the replacement is a reversal of the removal procedure.

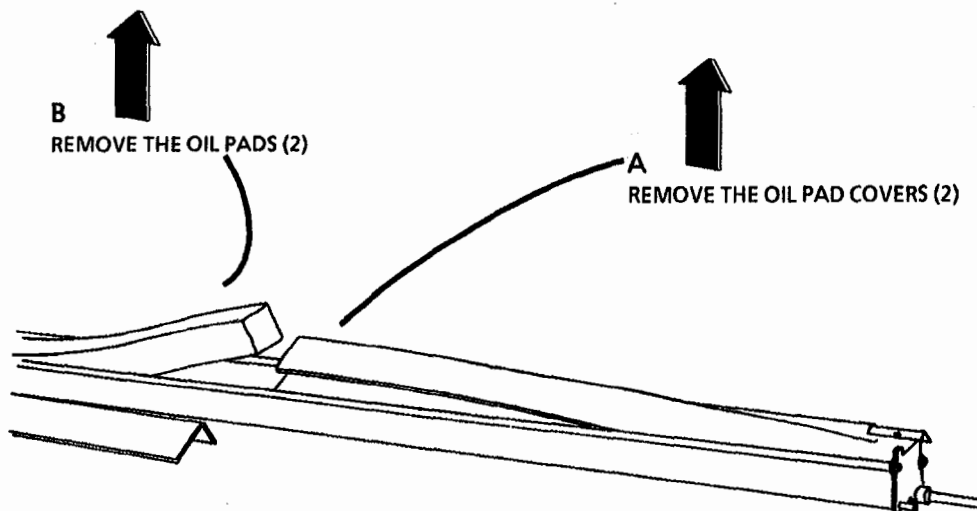
Figure 1. Remove the Oil Pads

2. Remove the following:
 - a. Stripper Finger Assembly (REP 10.6)
 - b. Oil Dispense Assembly (REP 10.7)
3. (Figure 1): Remove the Oil Pads.

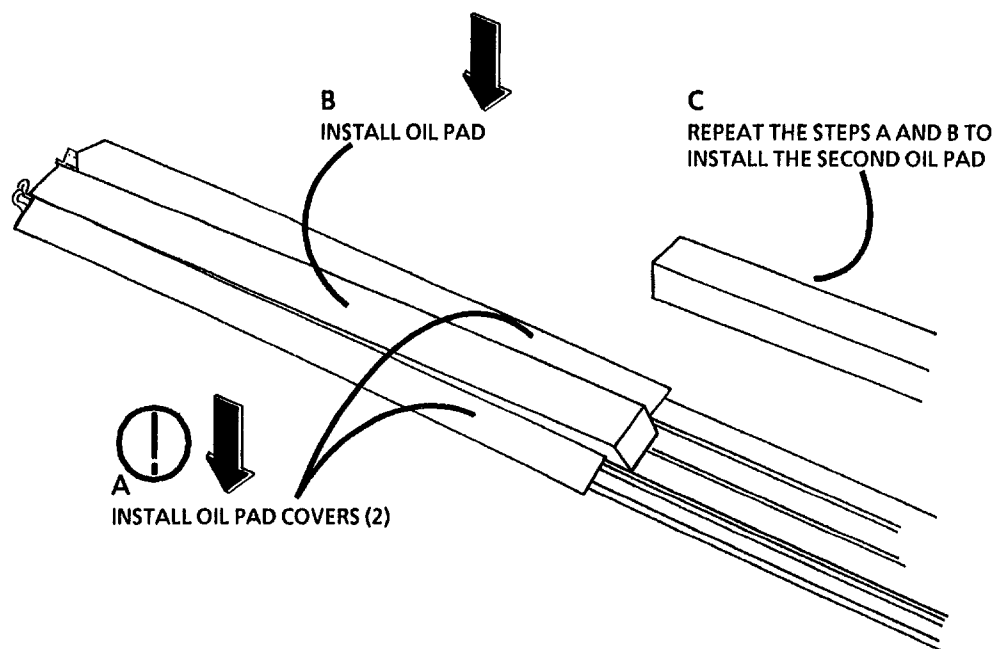
Figure 2. Install the Oil Pads

⚠ STEP 1 A: To avoid folding the wick or pulling the wick too tight, use the oil pad covers as guides when installing the oil pads.

1. (Figure 2): Install the Oil Pads.
2. Reinstall the Oil Pad Covers.

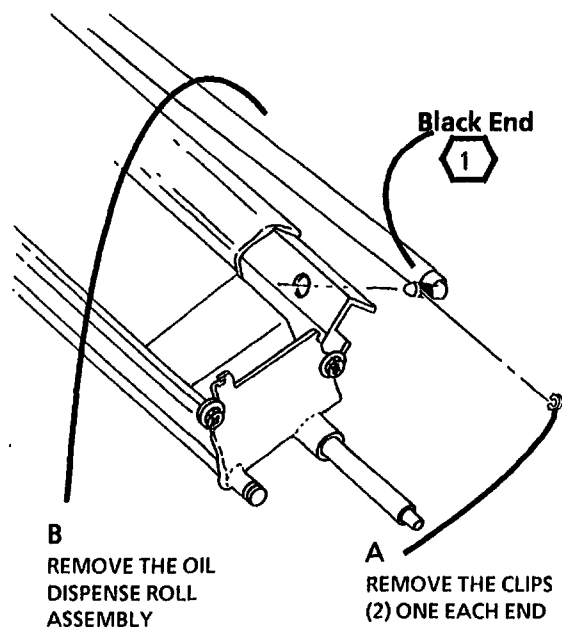
Figure 1. Remove the Oil Dispense Roll Assembly

Install the Oil Dispense Roll with the black end on the right end of the Oil Dispense Assembly as shown in Figure 1 of the removal procedure.

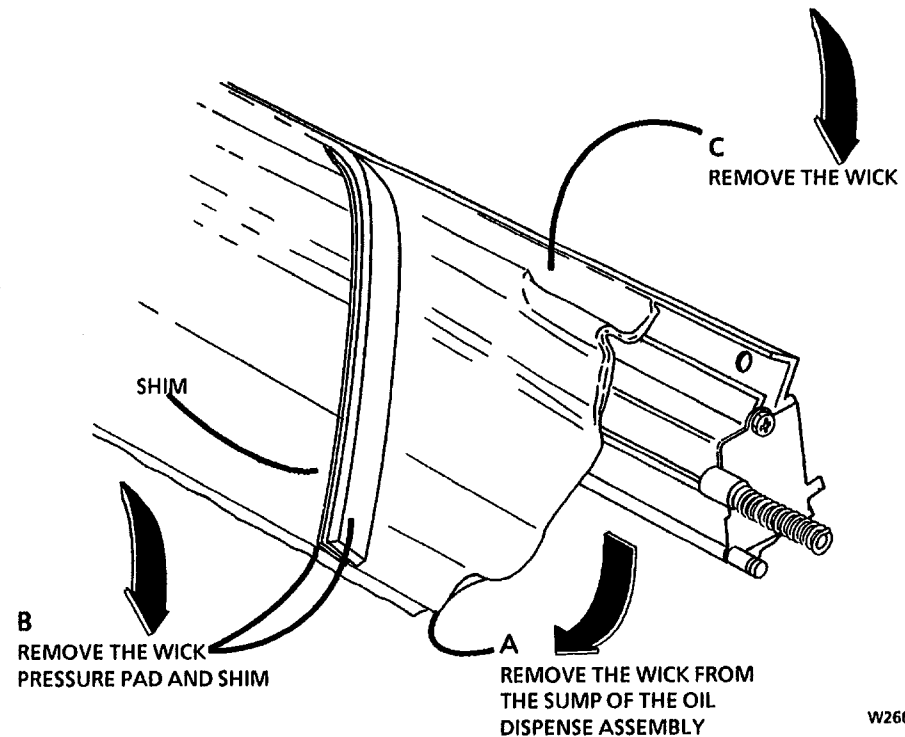
Figure 1. Removing the Wick

1. Lower the Front Latching Cover.
2. Remove the following:
 - a. Stripper Finger Assembly (REP 10.6)
 - b. Oil Dispense Assembly (REP 10.7)
 - c. Oil Dispense Roll Assembly (REP 10.10)
 - d. Oil Pads (REP 10.9)
3. (Figure 1): Remove the Wick.

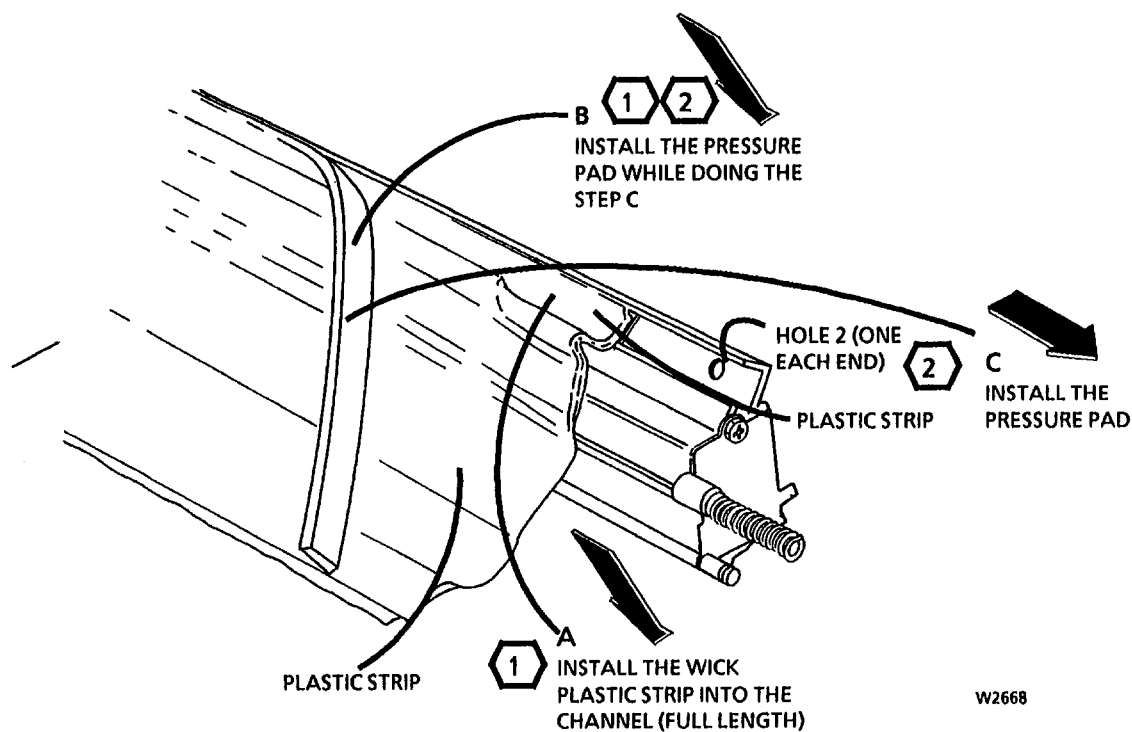
Figure 2. Prepare to Install the Wick

- 1** *STEPS 1 A and B: Ensure that the pressure pad does not stretch while installing it. The length of the pressure pad should not exceed the length of the wick. Trim any extra length off.*
- 2** *STEPS 1 B and C: Center the Wick. Ensure that the holes at each end are not covered.*

1. (Figure 2): Prepare to install the Wick.

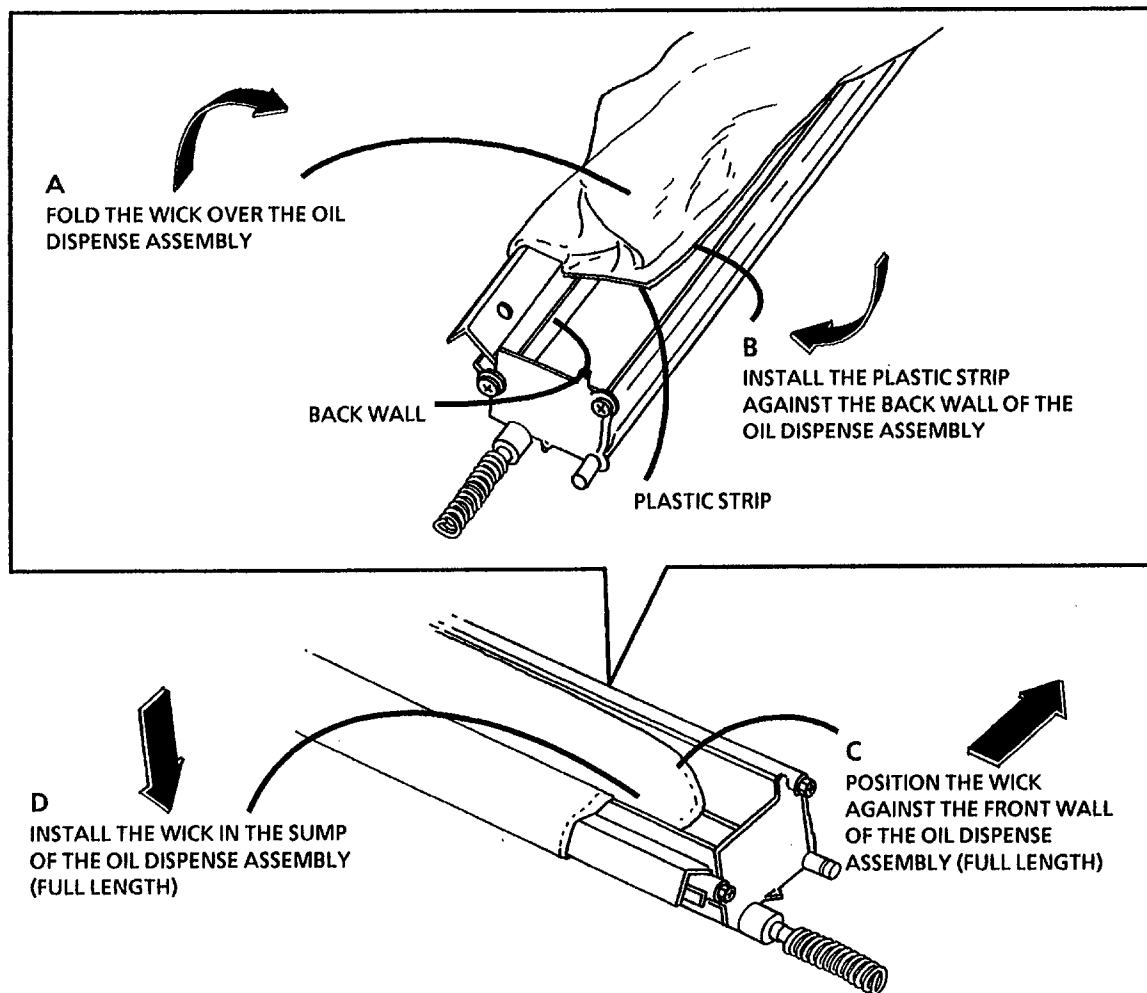
Figure 3. Install the Wick

2. (Figure 3): Install the Wick.

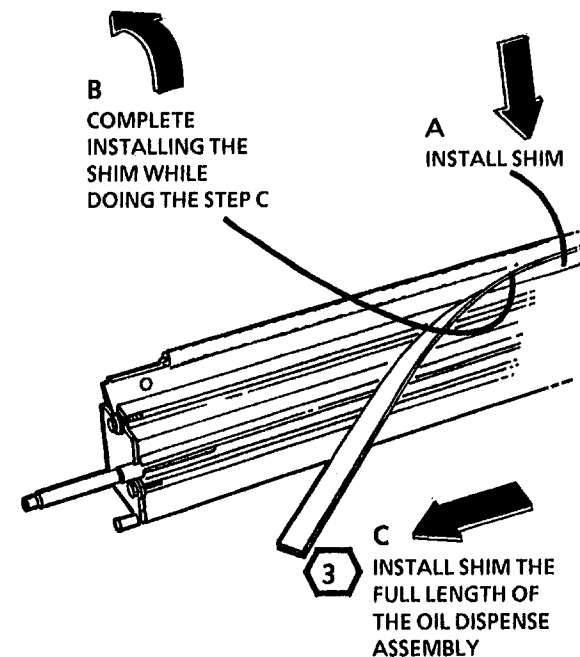
Figure 4. Install the Shim

3 STEP 4 C: Ensure that the holes at each end are not blocked by the wick after installing the shim.

4. (Figure 4): Install the Shim.

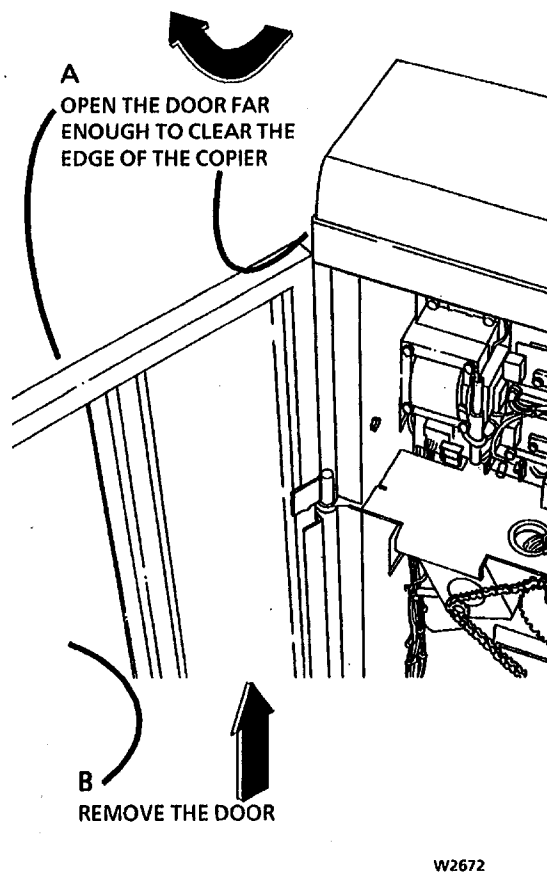
Figure 1. Remove the Left Side Door

This procedure shows the removal of the Left Side Door. Use the same technique to remove the Right Side Door.

1. (Figure 1): Remove the Left Side Door.

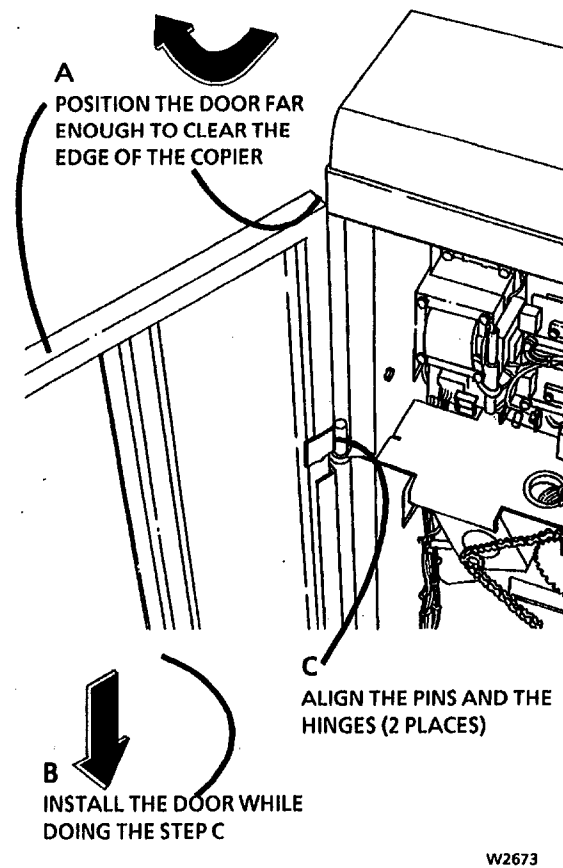
Figure 2. Install the Left Side Door

1. (Figure 2): Install the Left Side Door.

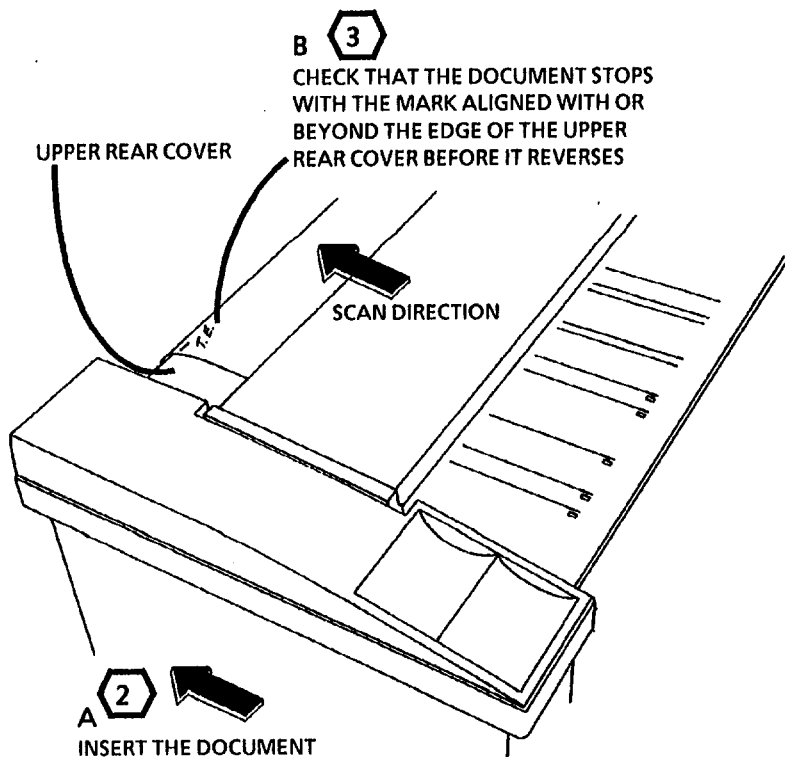
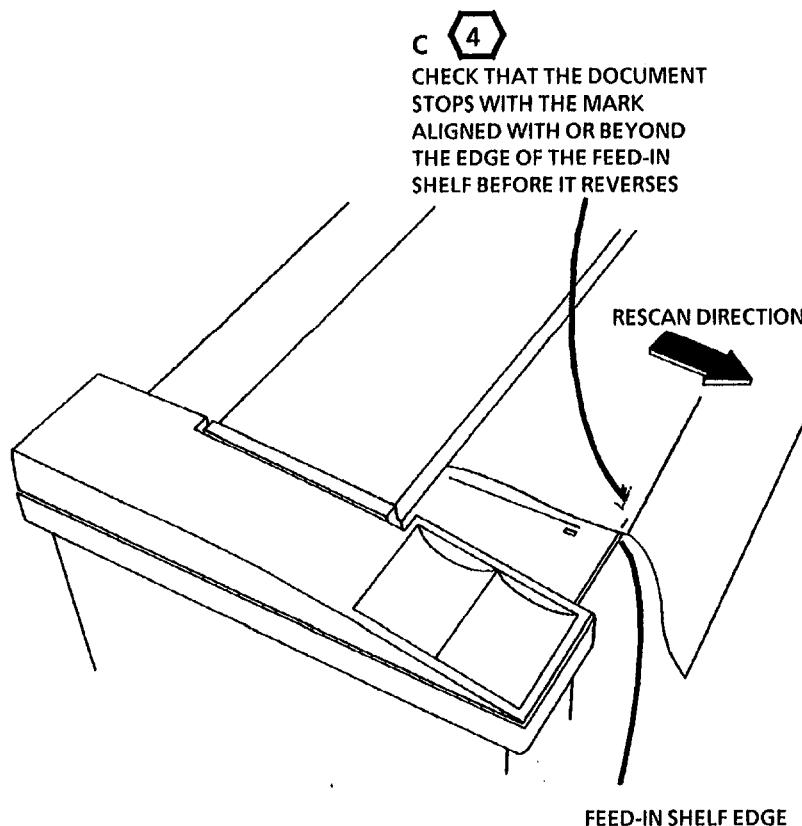
Figure 2. Check the trail edge position and the lead edge position

2 **STEP 5 A:** Before inserting the document, read steps B and C in figure 2. The check will be made while the document is moving.

4 **STEP 5 C:** The leading edge mark made in the step 2 must be at the edge of the feed-in shelf or beyond.

5. (Figure 2): Check the trail edge position and the lead edge position..

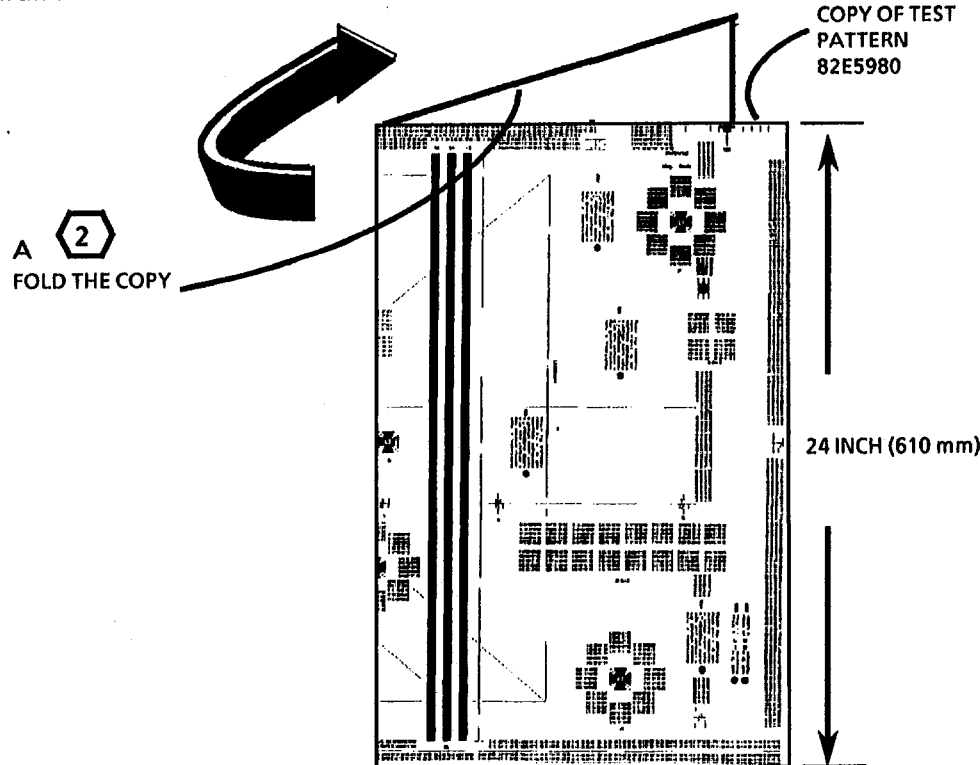
Figure 1. Fold the Copy

1. The test pattern **82E5980** must be fed long edge first. Keep the copy media within the **USO MAX (RX A0/A1)** marks on the feed-in shelf.
1. Make 3 copies of the test pattern **82E5980**, using bond media.
2. STEP 3 A: Folding the copy in half will allow measuring the length of the copy media in the middle.
2. (Figure 1): Fold the copy.

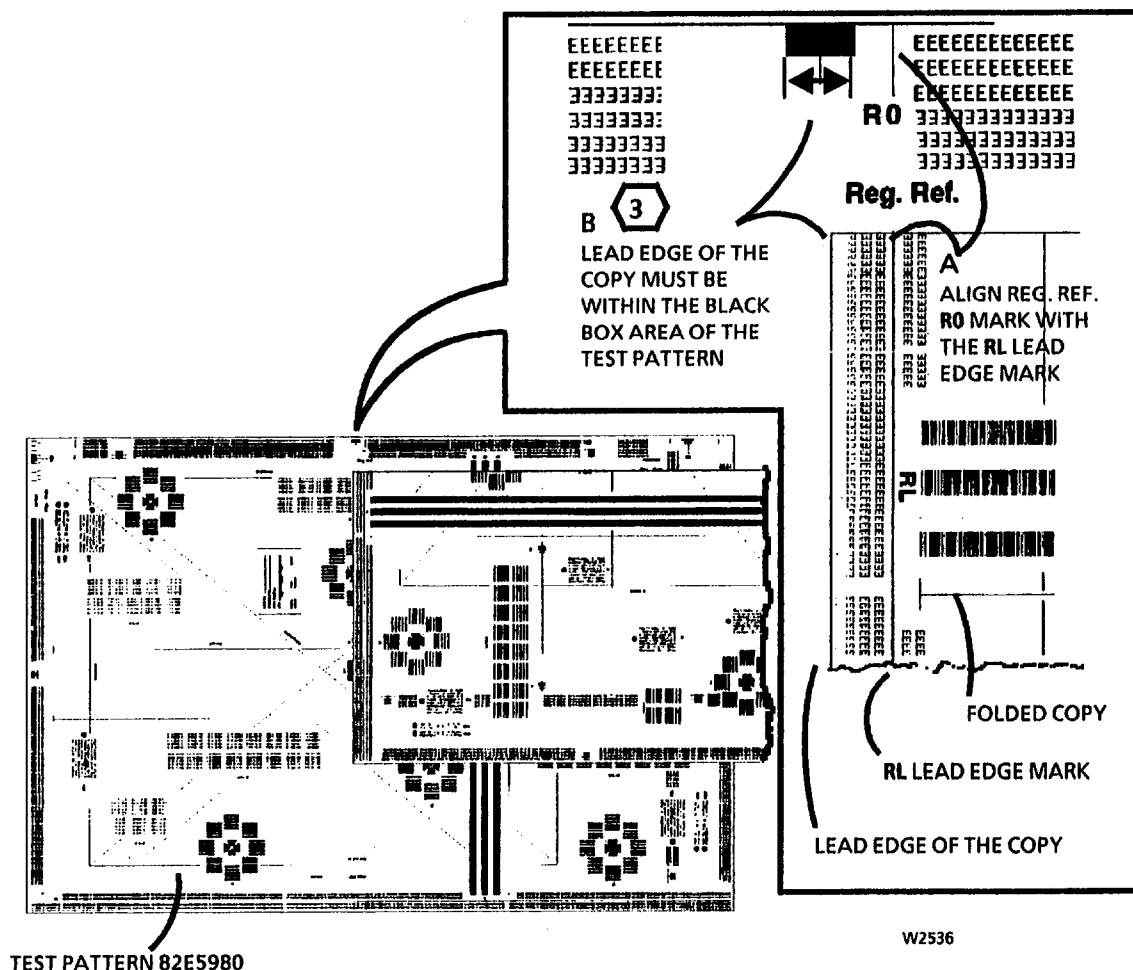
3 **STEP 3 B:** *The Lead Edge at the center of the copy must be within the black box area of the test pattern.*

3. (Figure 2): Check the image registration of the copy.

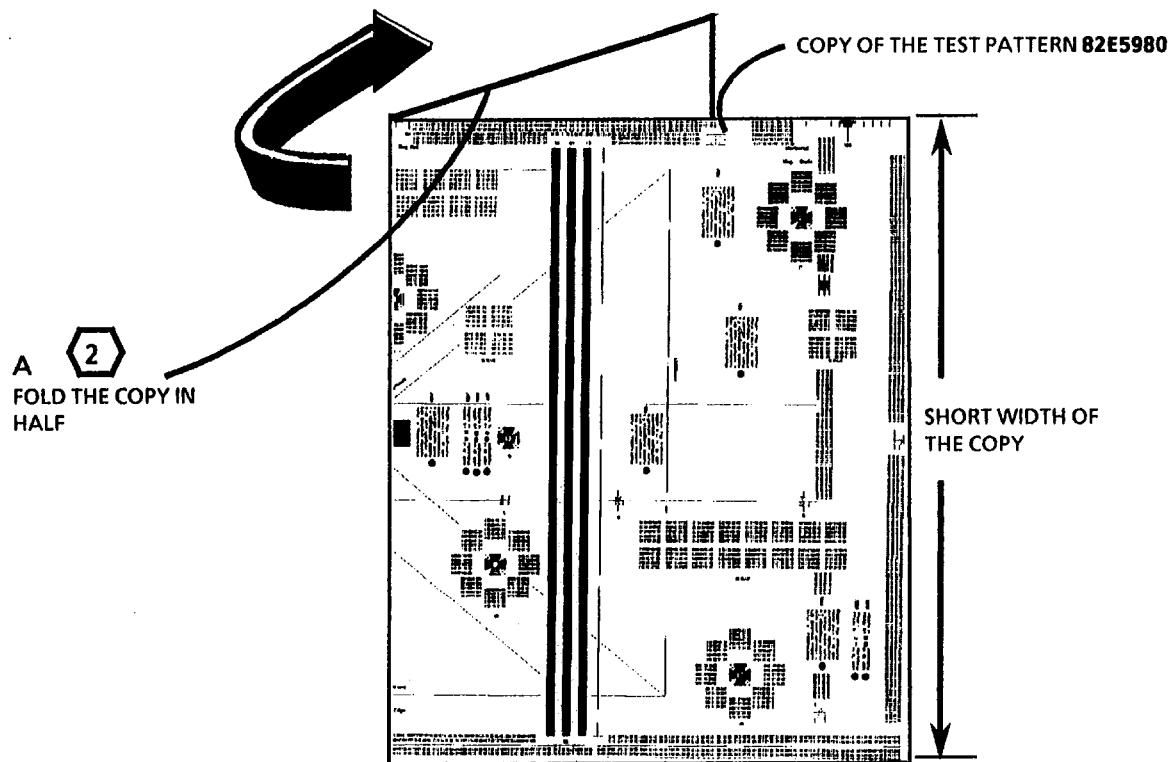
Figure 1. Folding the Copy in Half

2 STEP 2 A: Folding the copy in half will allow measuring the length of the copy media in the middle.

2. (Figure 1): Fold the copy in half.

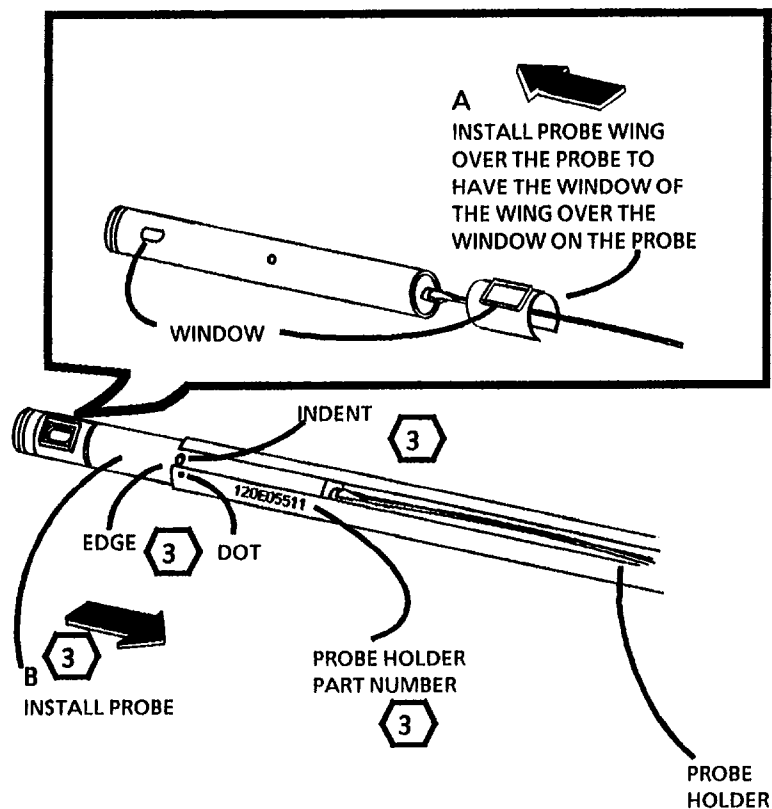
Figure 1. Install the Electrometer Probe in the Probe Holder

- 3** *STEP 4 B: Install the probe into the end of the probe holder that has part number of the probe holder on the side. When installing the probe, align the indent on the probe with the edge of the probe holder. Ensure that the indent is adjacent to the corner with the dot.*

4. (Figure 1): Install Electrometer Probe in the Probe Holder.

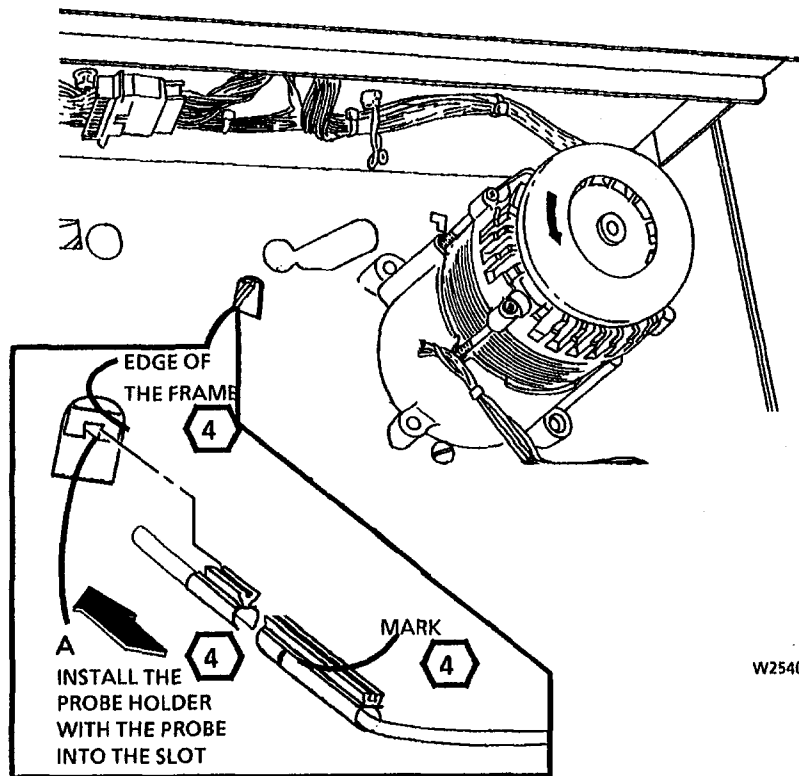
Figure 2. Install the Electrometer Probe

5. (Figure 2): Install the Electrometer Probe.

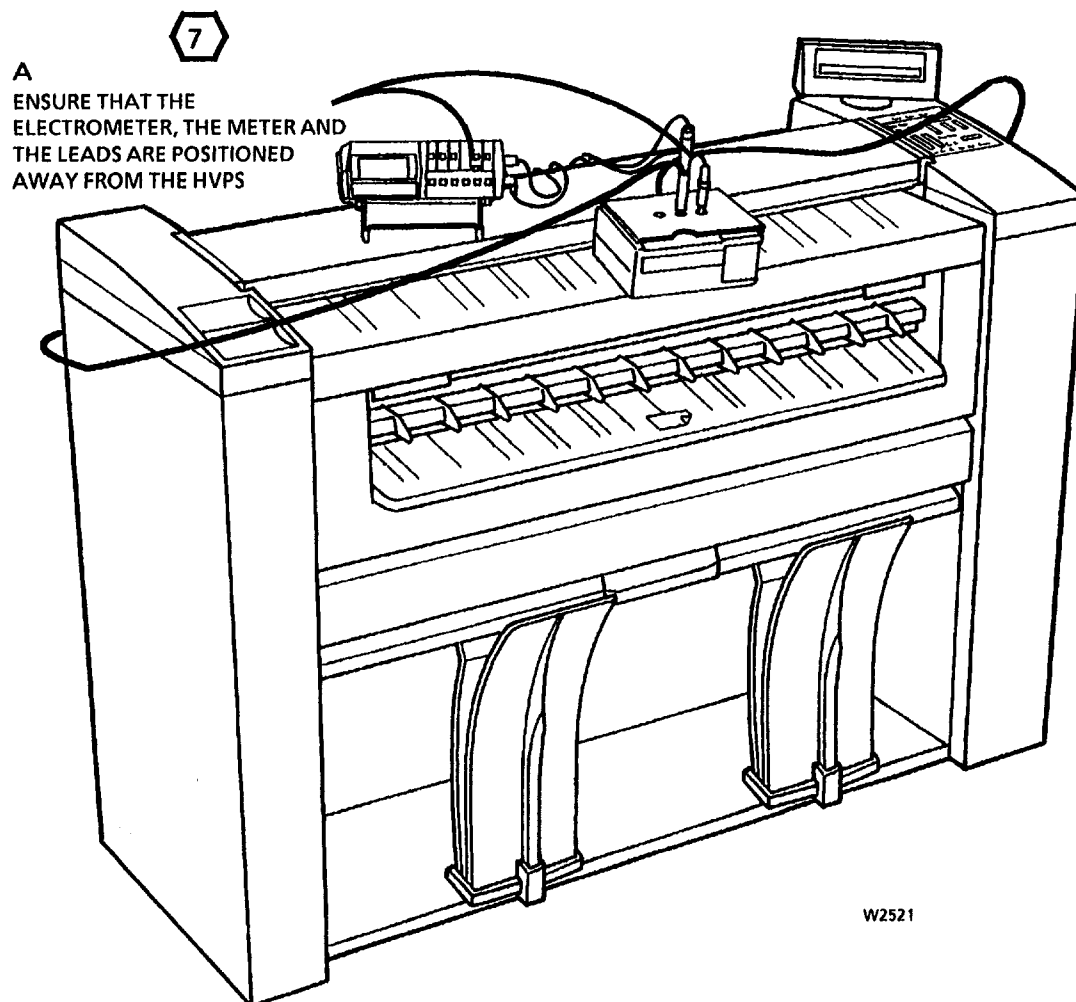
Figure 3. The Correct Position of the Electrometer, Meter and the Leads

8. (Figure 3): The correct position of the electrometer, meter and the leads.

7 **STEP 8 A:** The electrometer, meter and the leads must be positioned away from the HVPS in order to obtain the correct voltage measurement. The meter and electrometer must also be separated as shown in Figure 3. Position the electrometer, meter, and the leads in this way for the remainder of the procedure. Do not connect the meter and the electrometer at this time. The purpose of this illustration is to show the correct position. Attach the components as needed in subsequent steps.

- 9 The Electrometer, meter, and the leads are shown in this position only for clarity. Figure 3 of this procedure shows the correct position when the Electrostatic Series is performed.

- 11 The Electrometer, meter, and the leads are shown in this position only for clarity. Figure 3 of this procedure shows the correct position when the Electrostatic Series is performed.

13 The Electrometer, meter, and the leads are shown in this position only for clarity. Figure 3 of this procedure shows the correct position when the Electrostatic Series is performed.

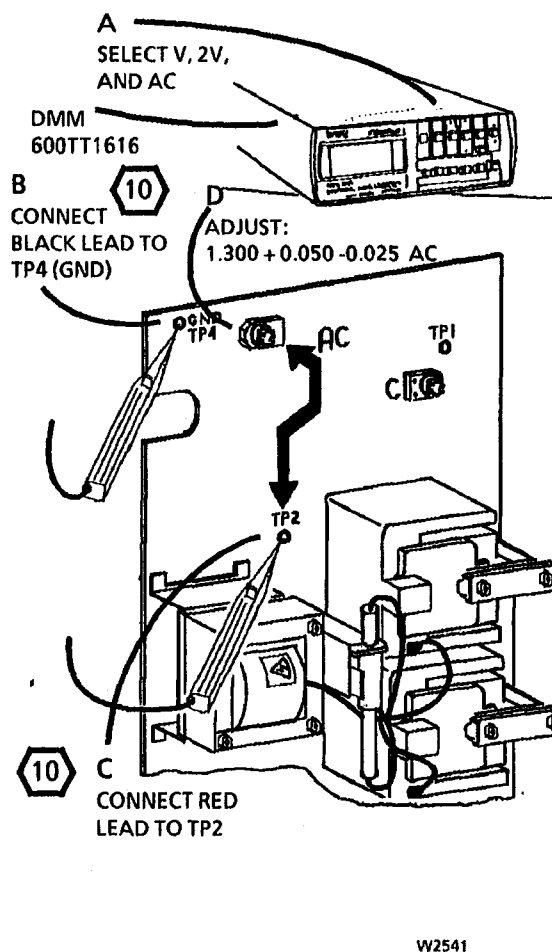
Figure 4. Adjustment of the Detack Corotron

- 10 STEPS 11 B and C and 12 B: Ensure that the probe tips do not touch the machine frame. Touching the machine will result in no readings.

11. (Figure 4): Adjust the detack corotron voltage.

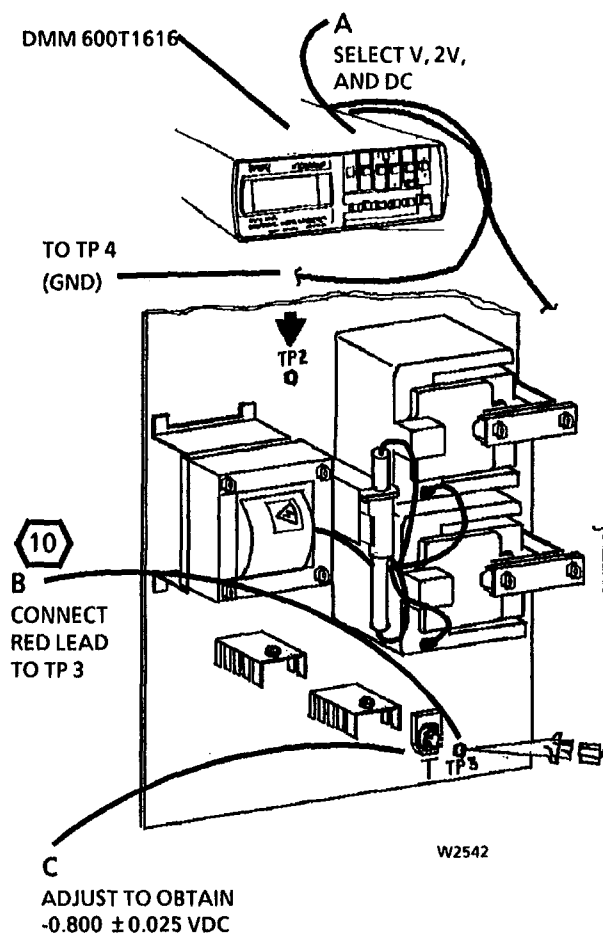
12. (Figure 5): Adjust the transfer corotron voltage.

Figure 5. Adjust the Transfer Corotron

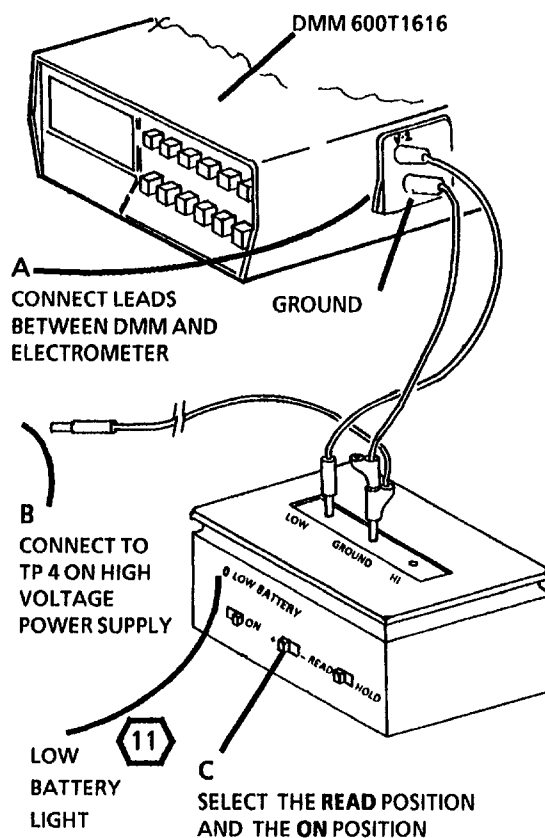
Figure 6. Connecting the Electrometer

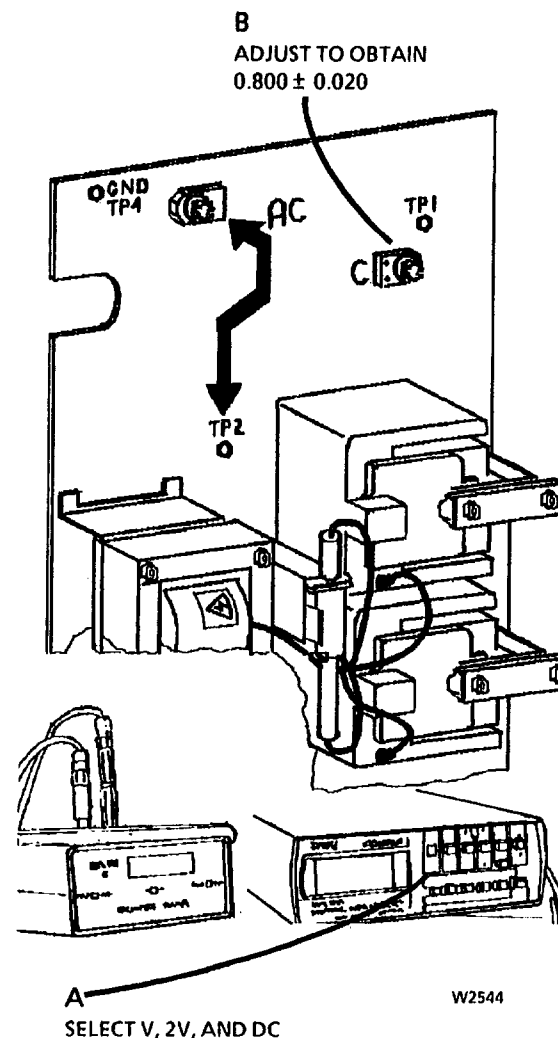
15. (Figure 7): Adjust the charge voltage.

Figure 7. Adjust the Charge Voltage

- C. Scroll down from [9] stopping at each setpoint (8,7,6,...). At each setpoint wait 15 seconds and note the meter reading. At the first setpoint that displays an average reading of 0.020 to 0.050 VDC over the average reading noted at set point [9], press the Start button to enter this setpoint value into NVM.

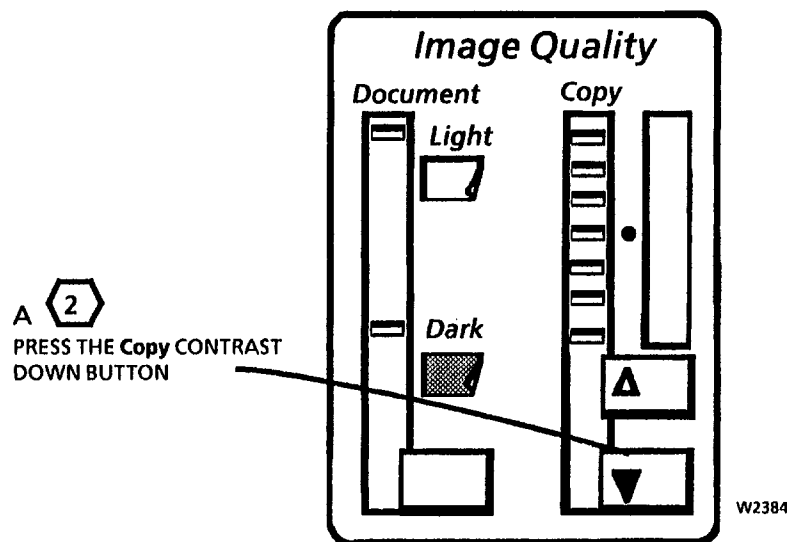
2 *STEP 3 B: Each time the Copy contrast down button is pressed, the next lower LED will be lit, indicating a lower Control Point setting. A control point of 4.8 is the lowest sensor voltage that can be attained. Do not move more than (2) increments at one time. This may result in a fault.*

3. (Figure 1): Increase the image density.

Figure 1. Increase the image density

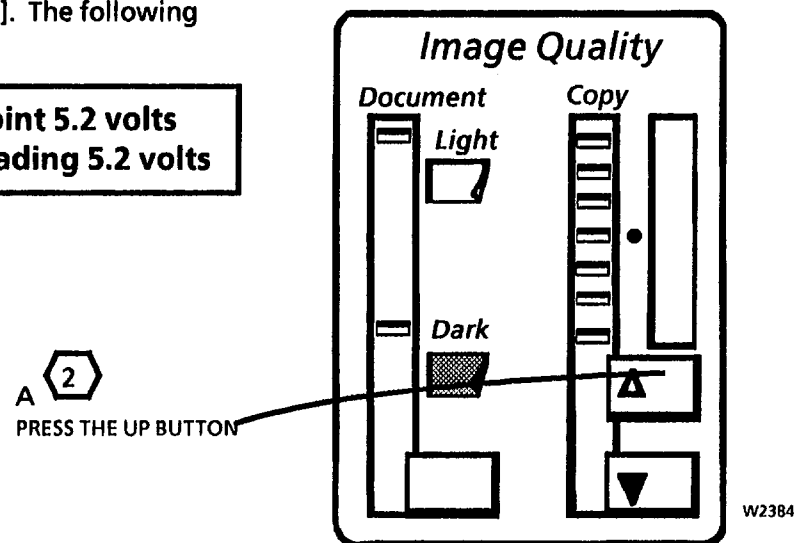
STEP 3 B: Each time the Copy up arrow button is pressed, the next higher LED will be lit, indicating a higher Control Point setting. Do not move more than (2) increments at one time. This may result in a fault.

3. (Figure 1): Decrease the image density.

Figure 1. Decrease the Image Density

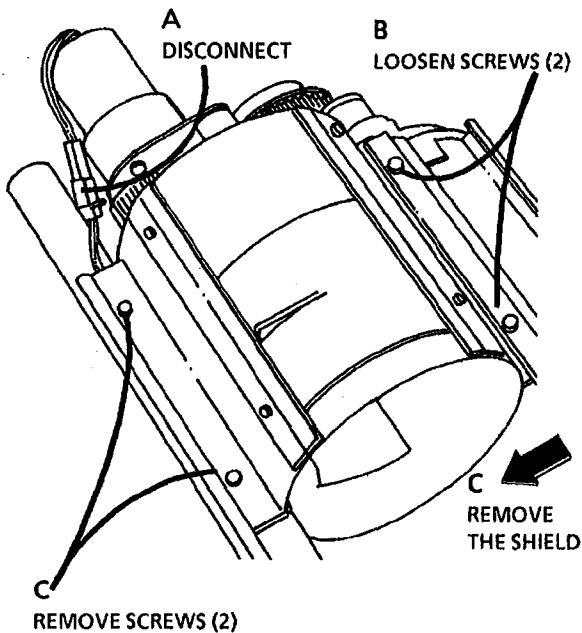
Figure 1. Remove the Top Shield

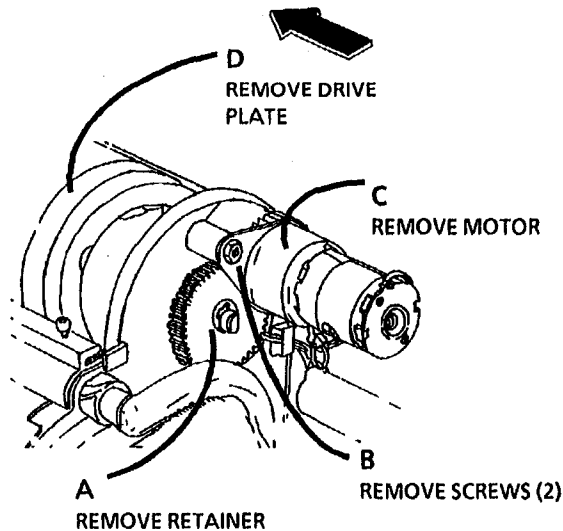
Figure 2. Remove the Cartridge Drive Plate

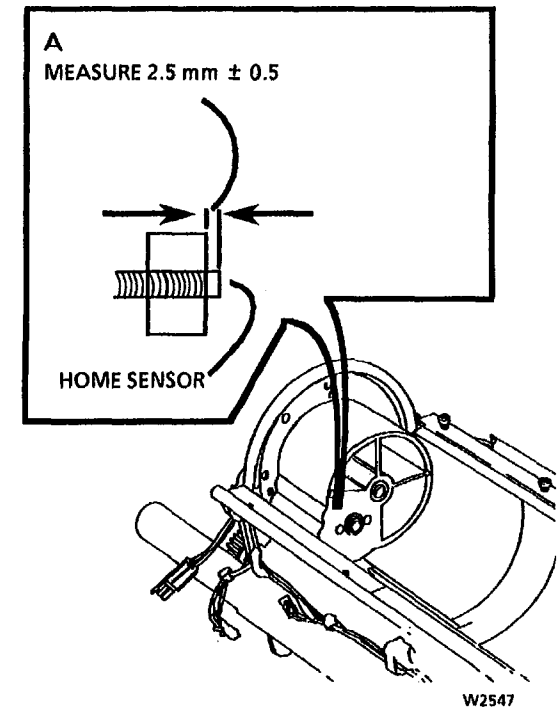
5. (Figure 3): Check the Toner Home Sensor adjustment.

Figure 3. Check the Toner Home Sensor Adjustment

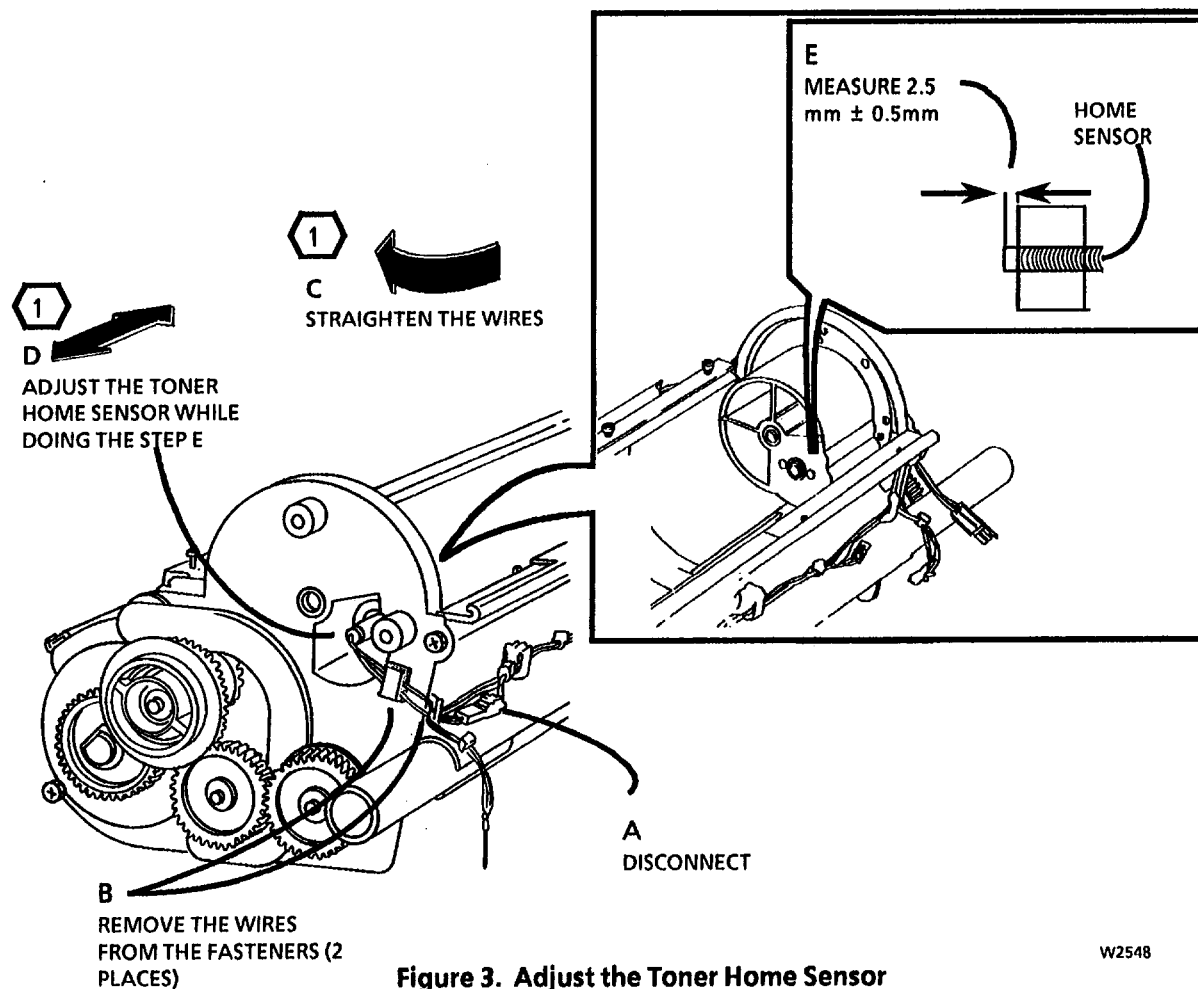
W2548

1. (Figure 3): Adjust the Toner Home Sensor.

Figure 3. Adjust the Toner Home Sensor

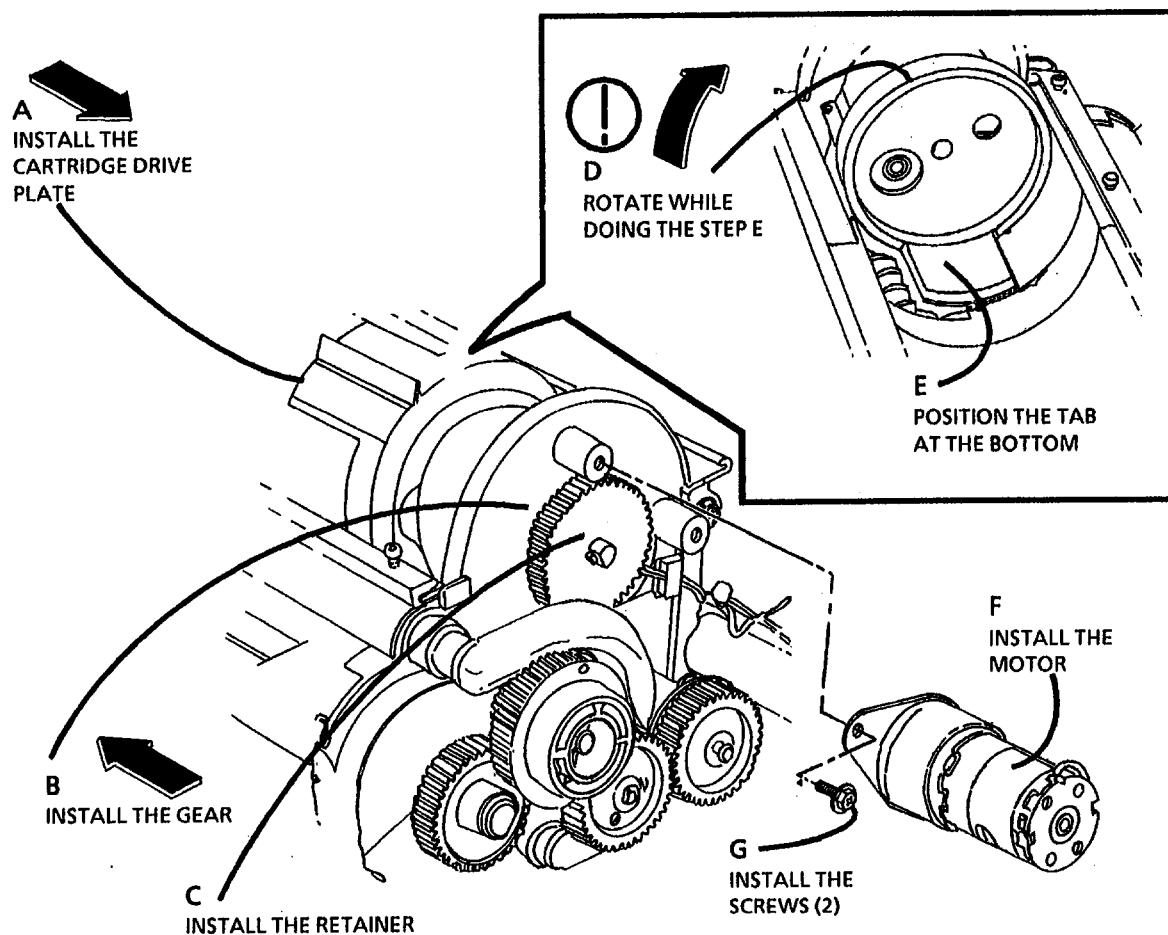
W2549

STEP 3 D: To avoid damage to the drive plate seal, always rotate the drive plate in the direction shown in Figure 4.

3. (Figure 4): Reinstall the Cartridge Drive Plate.

Figure 4. Install the Cartridge Drive Plate

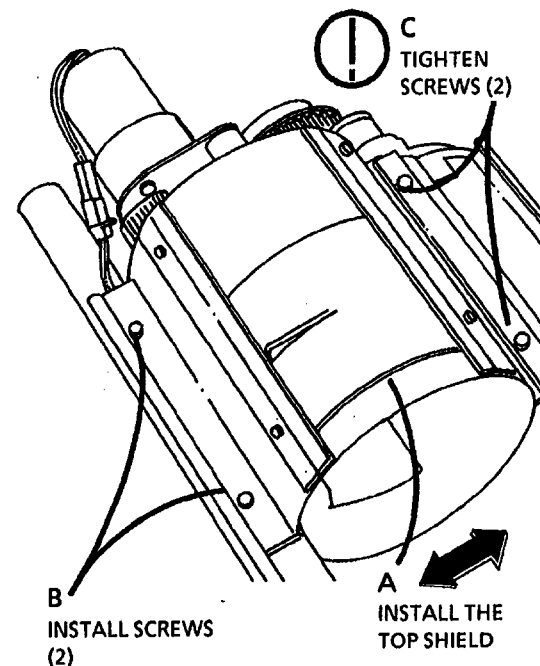
W2550

STEP 4 C: Do not overtighten the screws.

Figure 5. Reinstall the Top Shield

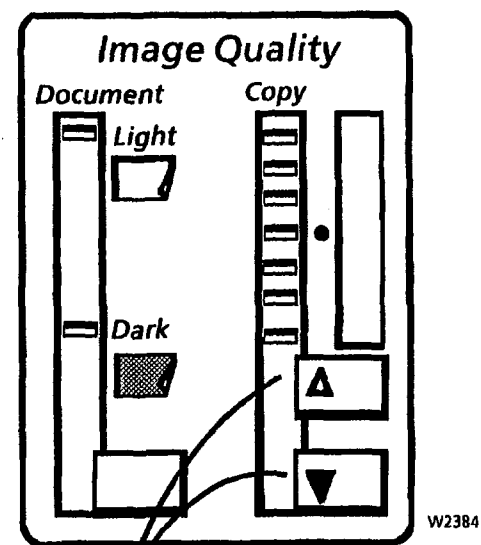
2. (Figure 2): Adjust the Bond fusing temperature.

- A** PRESS THE UP BUTTON TO RAISE THE FUSER TEMPERATURE PRESS THE DOWN BUTTON TO LOWER THE FUSER TEMPERATURE
- B** PRESS THE Start BUTTON
- C** PRESS THE Stop BUTTON TWO TIMES

Figure 2. Adjust the Fuser Temperature Setpoint

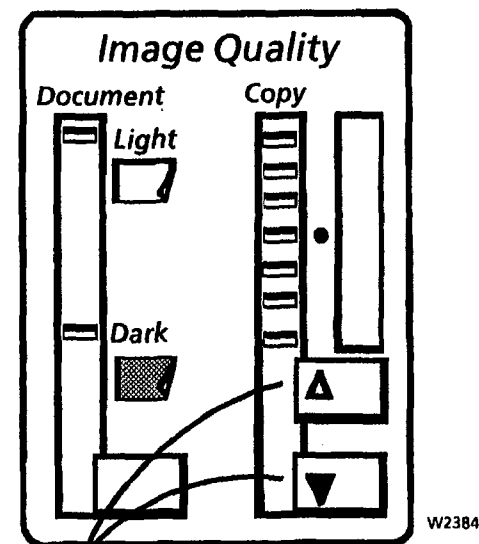
4. (Figure 3): If the setpoint is not 25, adjust setpoint to 25.

- A** PRESS THE UP BUTTON TO RAISE THE ADJUST VALUE PRESS THE DOWN BUTTON TO LOWER THE ADJUST VALUE
- B** PRESS THE Start BUTTON
- C** PRESS THE Stop BUTTON TWO TIMES

Figure 3. Adjust the Vellum Fusing Setpoint

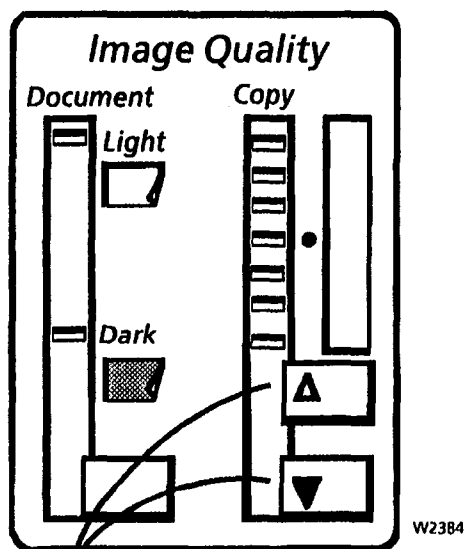
6. (Figure 3): If the set point is not 35, adjust the setpoint to 35.

PRESS THE UP BUTTON TO
RAISE THE ADJUST VALUE
PRESS THE DOWN
BUTTON TO LOWER THE
ADJUST VALUE

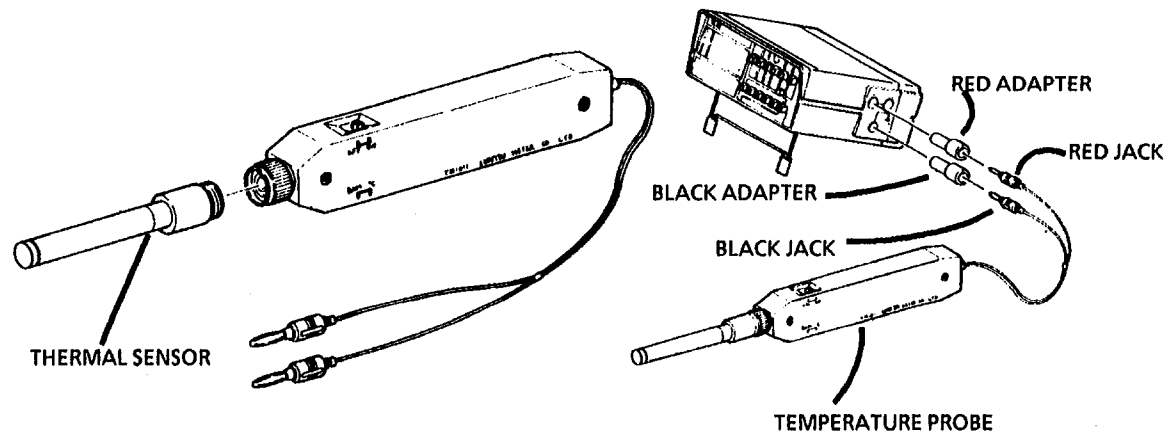
W2557

1. (Figure 1): Connect the Thermal Sensor to the Temperature Probe.

Figure 2. Connect Temperature Probe to DMM
