- **Call Flow Diagram** - This diagram outlines the major activities that are performed when a service call is made. The **Initial Actions** assist the Service Representative through the customer interface and help to identify the problem. The diagram also directs the Representative to verify, classify, repair the problem and perform the correct Maintenance Procedure.

2. Status Indicator Repair Analysis Procedures

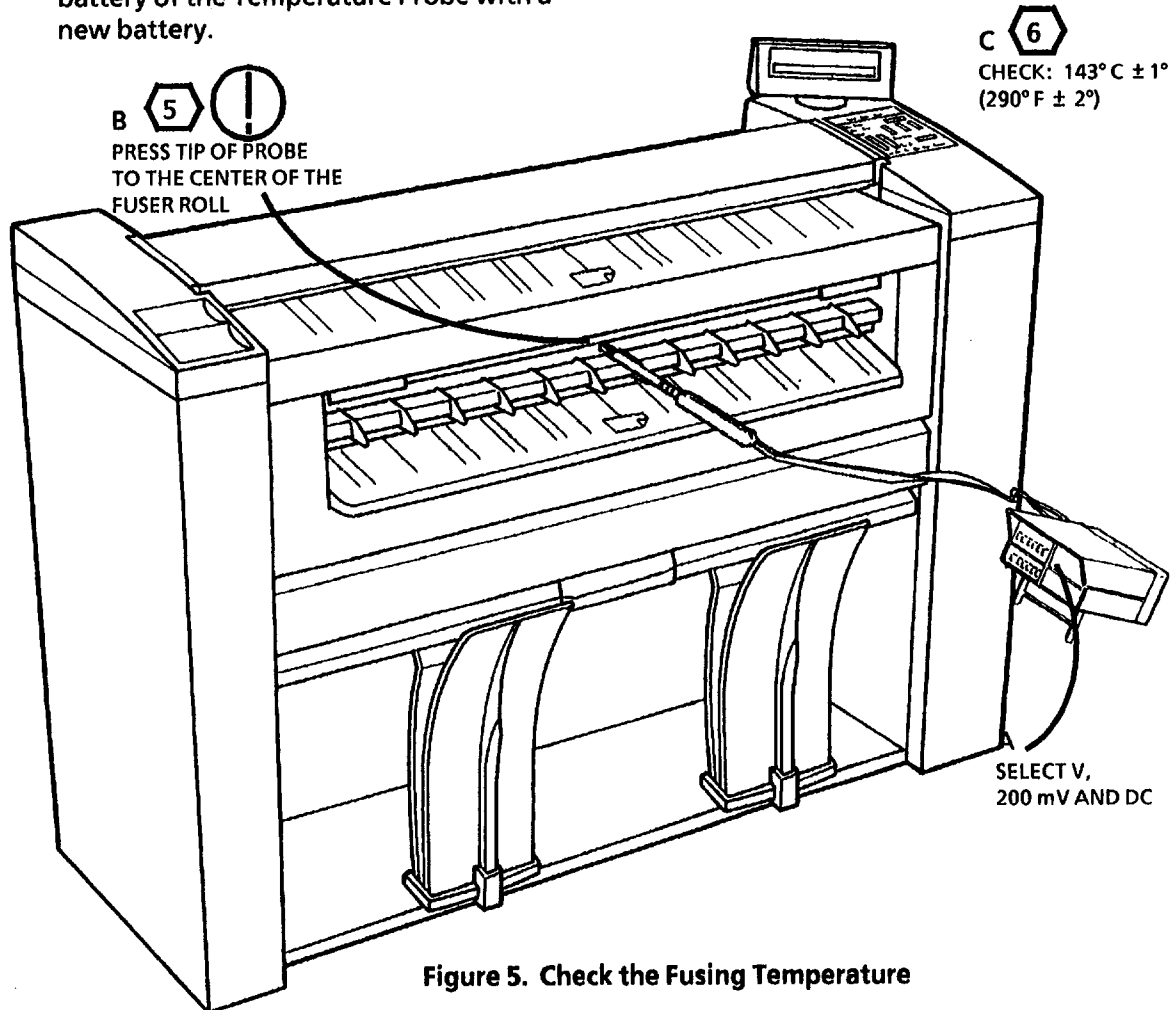
3 You are now ready to check the temperature after you expose the fuser roll for easy access.

Figure 5. Check the Fusing Temperature

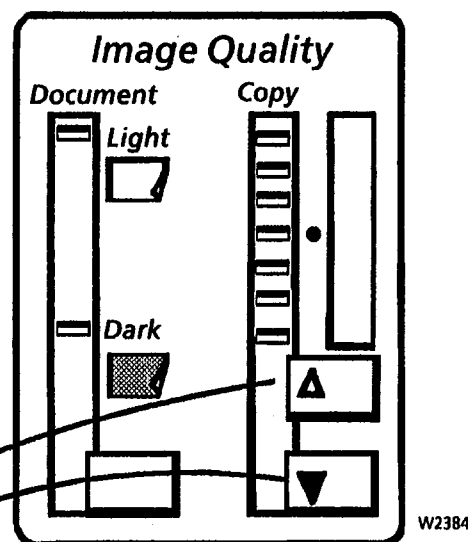
2. (Figure 6): Adjust the Bond fusing temperature to $143^{\circ}\text{C} \pm 1^{\circ}$ ($290^{\circ}\text{F} \pm 2^{\circ}$).

PRESS THE UP BUTTON TO RAISE THE FUSER TEMPERATURE
PRESS THE DOWN BUTTON TO LOWER THE FUSER TEMPERATURE

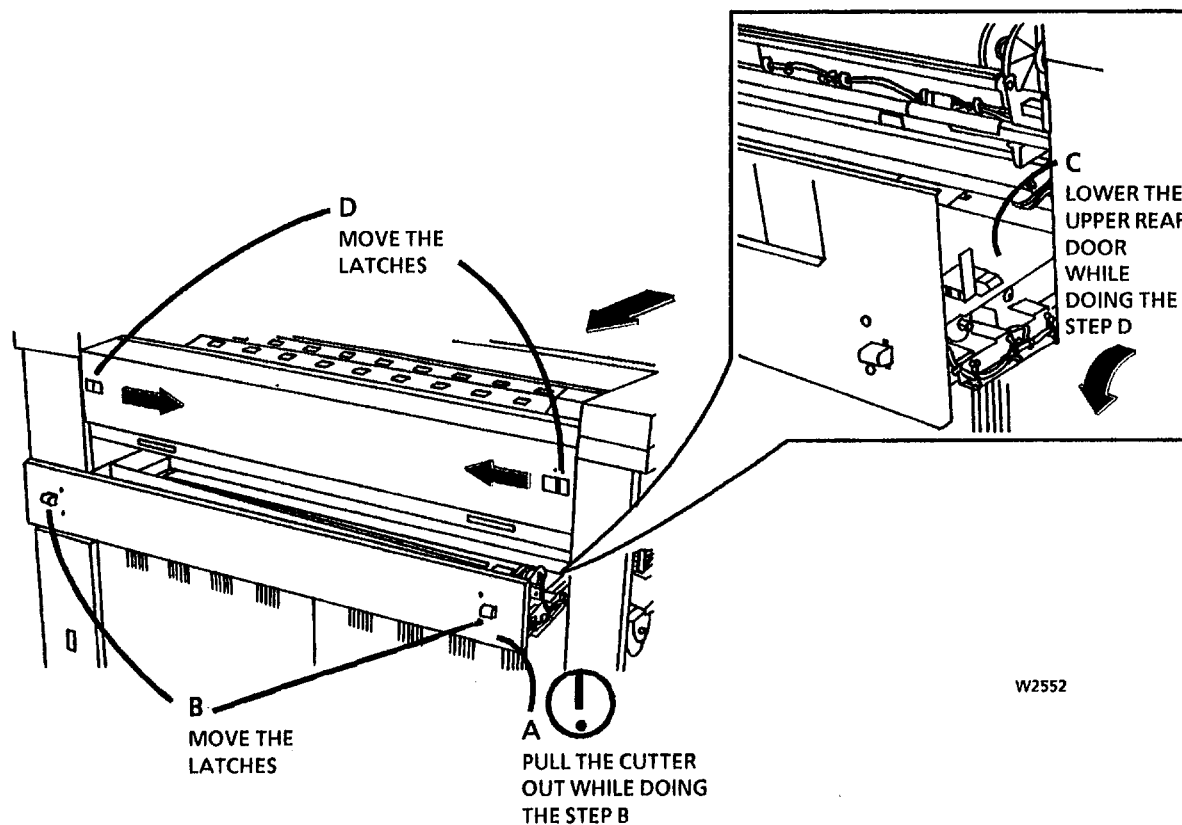
⚠ STEP 1A: To avoid damage to the hinges on the upper rear door, pull the cutter out to support the upper rear door.

Figure 1. Lower the Upper Rear Door

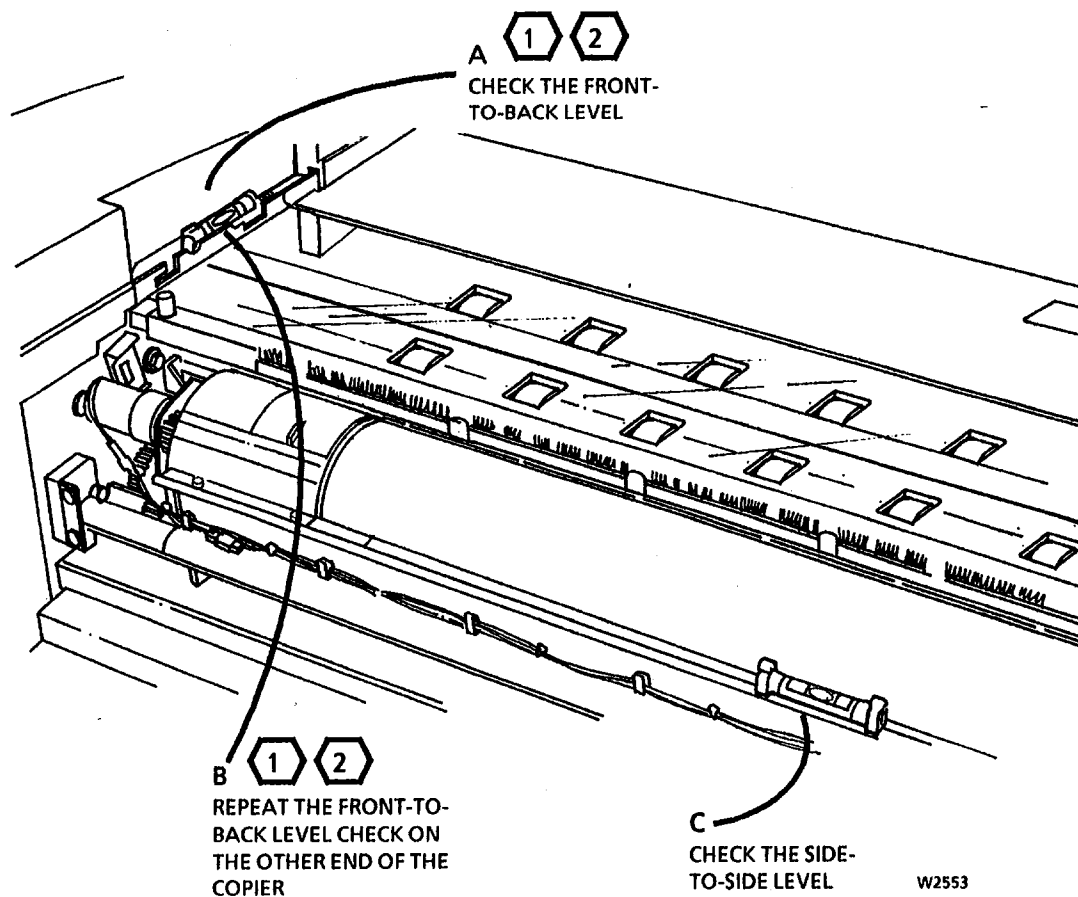
1 *STEPS 4 A and B: To ensure that the copier is not twisted, perform the front-to-back check on both ends of the copier.*

4. (Figure 2): Check the level of the copier.

Figure 2. Check the level of the copier

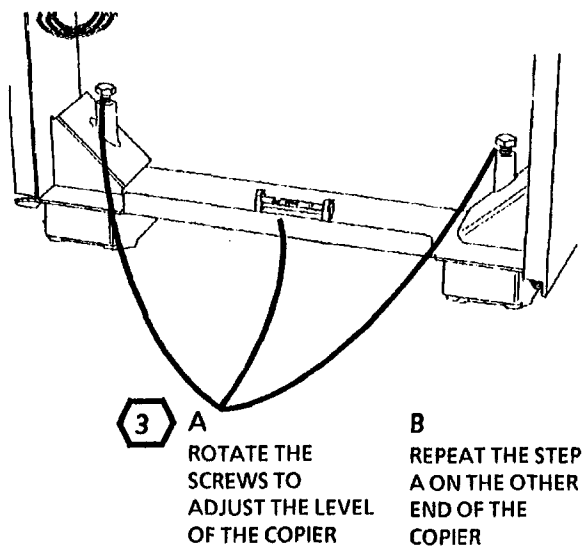
W2554

3 *STEPS 1 A and 2 B: The bubble must be centered between the lines on the level.*

2. (Figure 3): Adjust the Front-to-back Level.

Figure 3. Adjust the Front-to-back Level

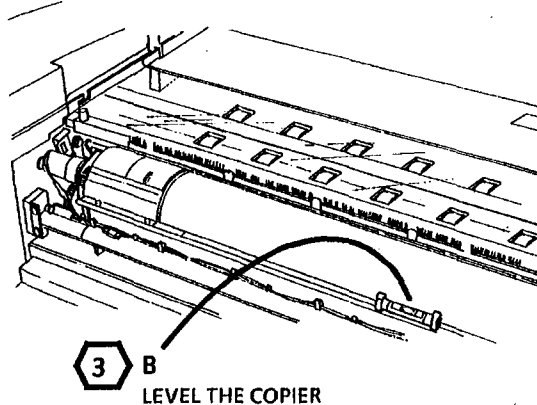
W2555

Figure 4. Adjust the Side-to-side Level

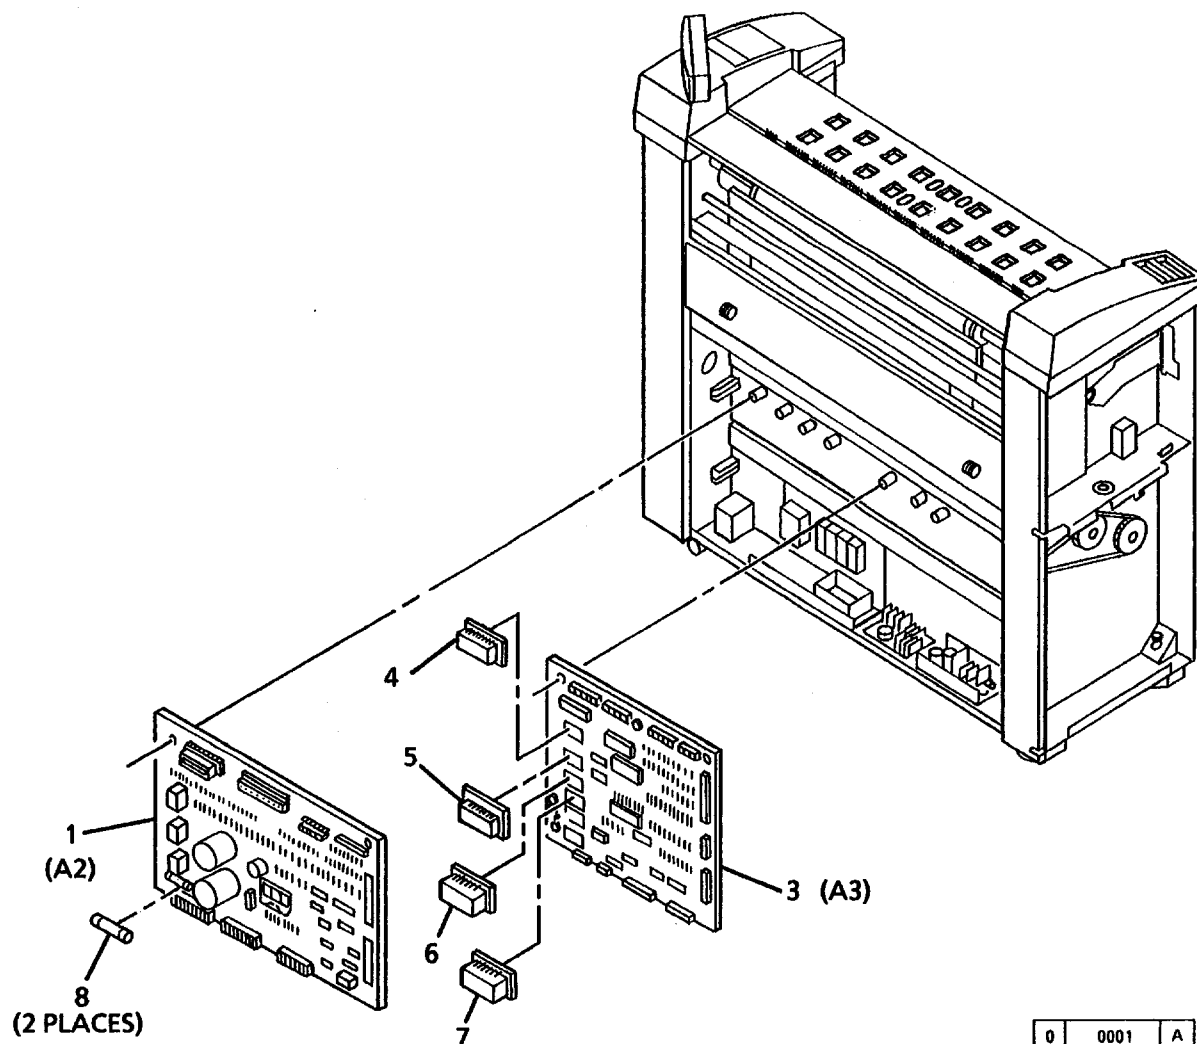
PL 1.1 ELECTRICAL CONTROL COMPONENTS/DC POWER GENERATION

ITEM	PART	DESCRIPTION
1	140K27489	LOW VOLTAGE POWER SUPPLY DRIVER PWB (A2)
2	--	CONTROLLER ASSEMBLY (TO BE AVAILABLE AT LATER DATE)
3	140K69980	CONTROL PWB (A3) (REP 3.1)
4	--	CONTROL EPROM NO.2 (P/O ITEM 9)
5	--	CONTROL EPROM NO.1 (P/O ITEM 9)
6	--	PRIMARY LANGUAGE EPROM (P/O ITEM 9)
7	537K6920	NVM EPROM
8	708W4001	FUSE (1 AMP) (60HZ)
-	708W3901	FUSE (0.5AMP) (50HZ)
9	133K9501	CIRCUIT ASSEMBLY KIT (60HZ)
-	133K9510	CIRCUIT ASSEMBLY KIT (50HZ)

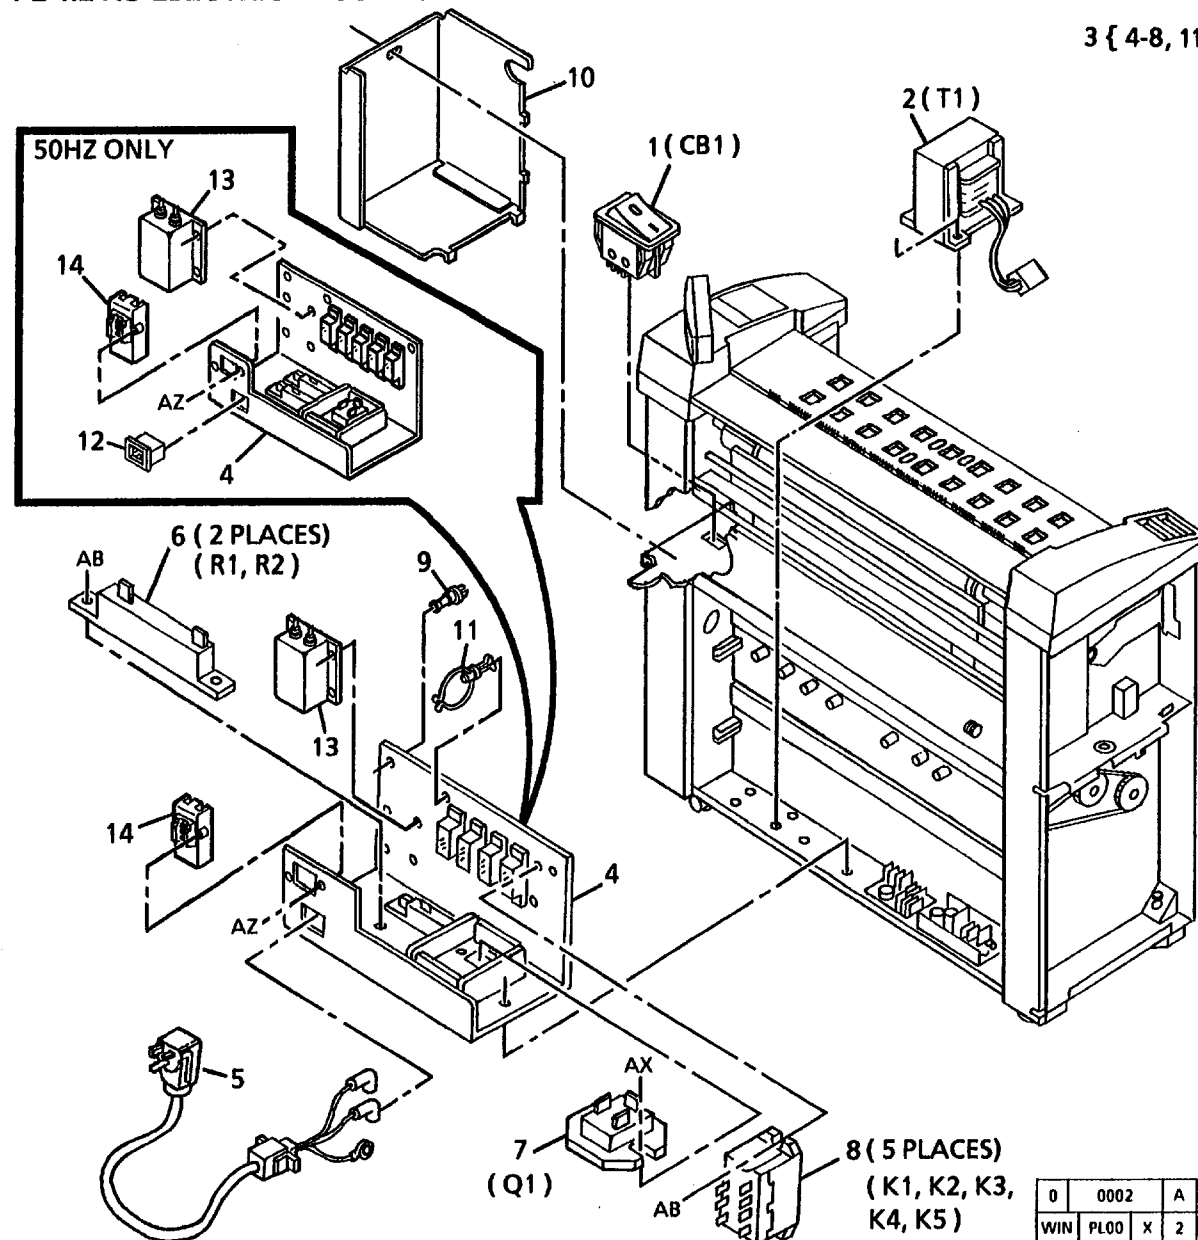
ITEM	PART	DESCRIPTION
1	110E6330	MAIN POWER SWITCH (CB1)
2	105K833	MAIN TRANSFORMER
-	105K1084	(60HZ) (T1)
3	--	MAIN TRANSFORMER
4	--	(50HZ) (T1)
5	117K10591	AC MODULE (60HZ) (50HZ)
6	103E2721	(TO BE AVAILABLE
-	103E2731	AT LATER DATE)
7	707W1652	AC COMPONENT
8	109E1040	(60HZ) (50HZ)
9	3P25202	(P/O ITEM 3)
10	2E40132	POWER CORD (60HZ ONLY)
11	120E2150	BALLAST RESISTOR (60HZ)
12	114K491	(R1, R2)
13	142E440	BALLAST RESISTOR (50HZ)
-	142E1131	(R1, R2)
14	108E1761	FUSER TRIAC (Q1)
		(REP 10.3)
		AC RELAY
		(K1, K2, K3, K4, K5)
		STANDOFF
		COVER
		TWIST CLAMP
		INLET CONNECTOR
		(50HZ ONLY)
		FILTER (60HZ)
		FILTER (50HZ)
		GROUND FAULT PANEL

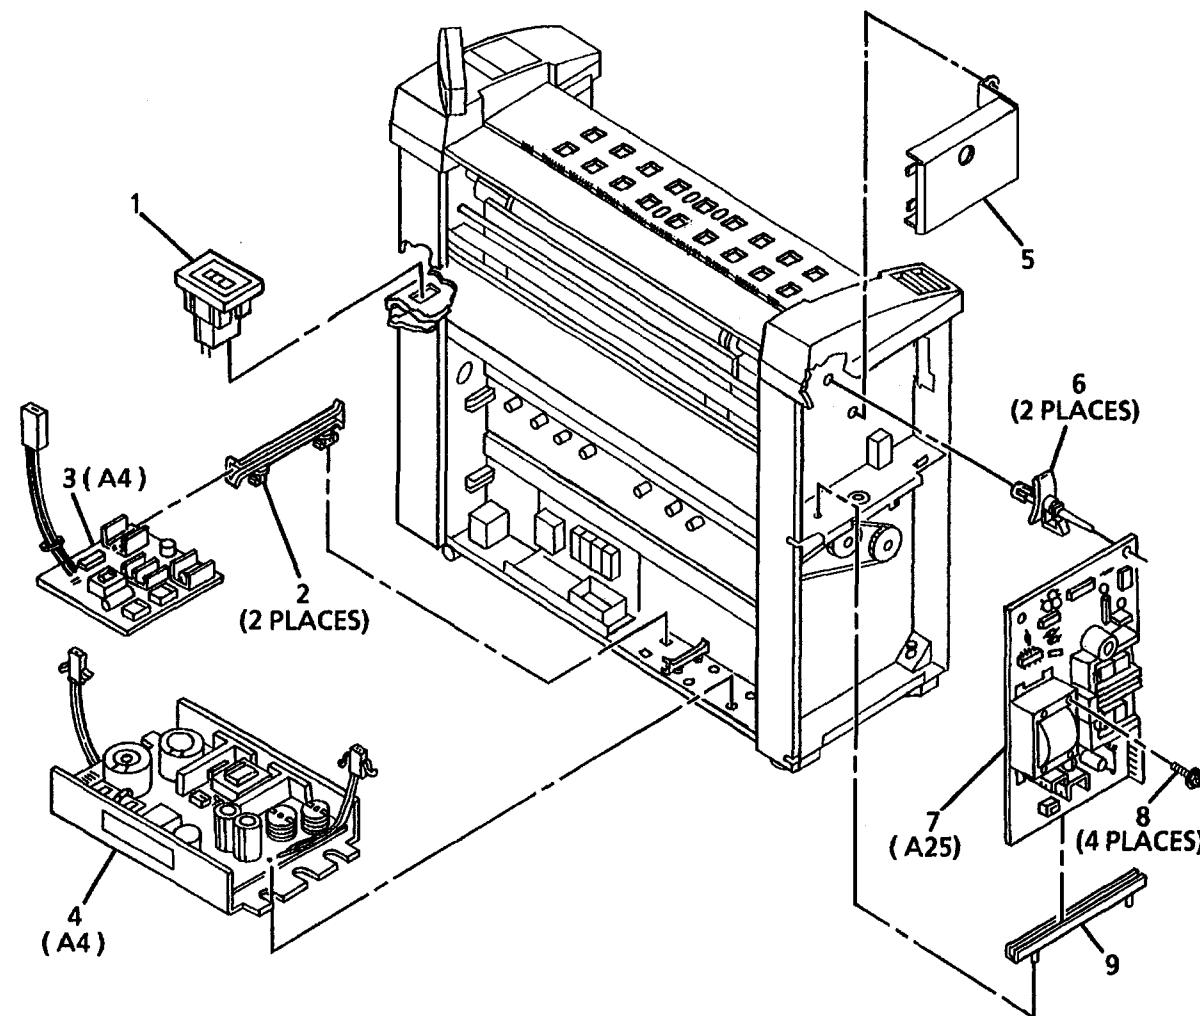
PL 1.3 DC ELECTRICAL COMPONENTS

ITEM	PART	DESCRIPTION
1	111K21	MEDIA COUNTER
2	101E1020	CIRCUIT BOARD GUIDE
3	104K430	EXPOSURE LAMP BALLAST (A4)
4	105K5273	BULK POWER SUPPLY (+ 26VDC) (60HZ) (A4)
-	105K5552	BULK POWER SUPPLY (+ 26VDC) (50HZ) (A4)
5	55K14940	SHIELD (50HZ ONLY)
6	--	STANDOFF (NOT SPARED)
7	105K5480	HIGH VOLTAGE POWER SUPPLY (A25)
8	26E3460	LOCKING SCREW
9	101E7930	PWB GUIDE

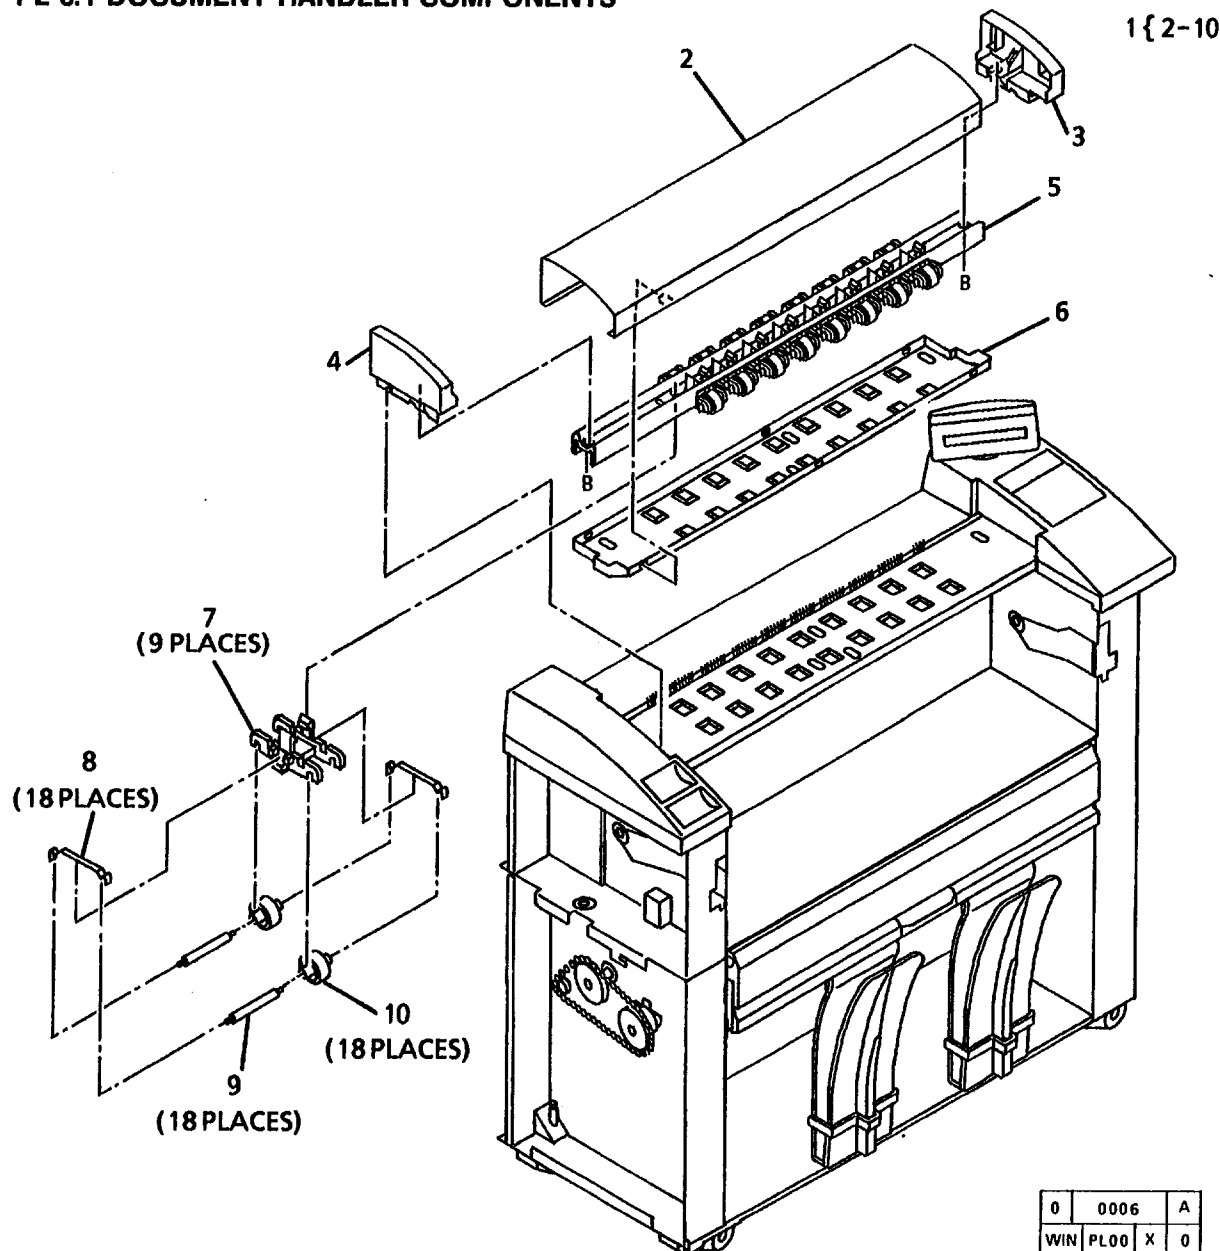
PL 5.1 DOCUMENT HANDLER COMPONENTS

ITEM	PART	DESCRIPTION
1	22K37721	DOCUMENT HANDLER ASSEMBLY
2	--	DOCUMENT HANDLER COVER (P/O ITEM 1)
3	21E6210	RH END CAP
4	21E6220	LH END CAP
5	--	PINCH ROLL SUPPORT (P/O ITEM 1)
6	38E13162	DOCUMENT PLATEN
7	31E3561	PINCH ROLL YOKE
8	9E21410	ROLL LOAD SPRING (REP 5.1)
9	6E19570	PINCH ROLL SHAFT (REP 5.1)
10	22E7280	DOCUMENT PINCH ROLL (REP 5.1)

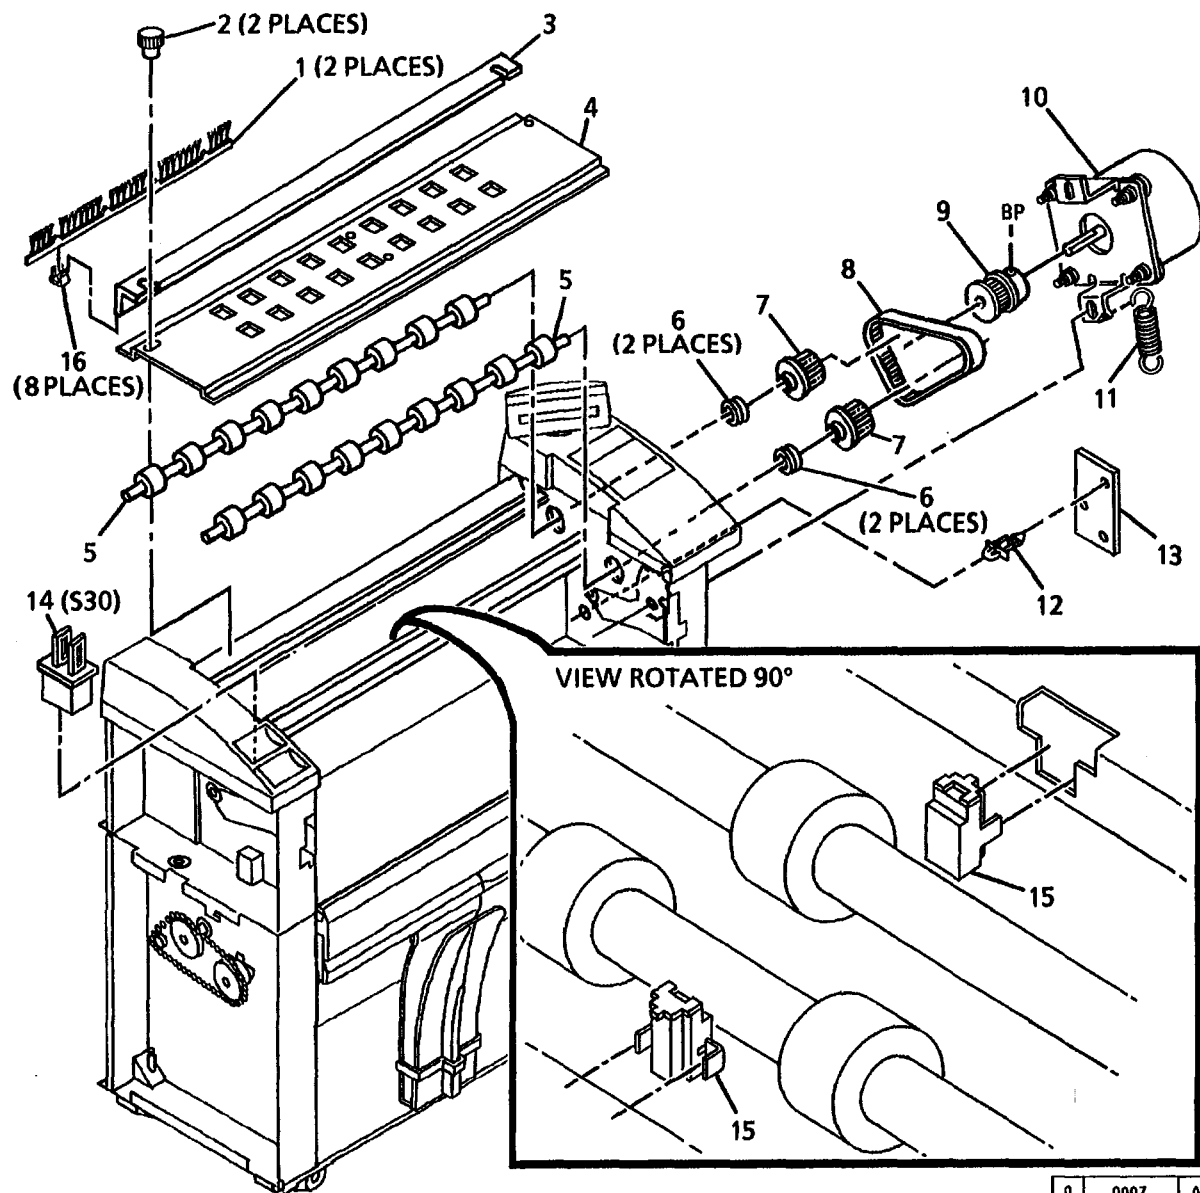
PL 5.2 DOCUMENT DRIVE COMPONENTS

ITEM	PART	DESCRIPTION
1	115E3100	STATIC ELIMINATOR
2	27E2251	PLATEN NUT
3	--	PLATEN RETAINER BRACKET (NOT SPARED)
4	90E1690	DOCUMENT BOTTOM PLATEN (REP 5.4)
5	22K16301	DOCUMENT DRIVE ROLL (REP 5.2)
6	413W30853	DOCUMENT DRIVE BEARING
7	20E10561	DOCUMENT DRIVE PULLEY
8	23E6570	DOCUMENT DRIVE BELT
9	20E14550	PULLEY (28T)
10	127K8861	DOCUMENT DRIVE MOTOR (REP 5.3)
11	9E50070	SPRING
12	--	STANDOFF (NOT SPARED)
13	140K15952	DRIVE MOTOR PWB
14	110E2640	DOCUMENT HANDLER INTERLOCK SWITCH (S30)
15	130E6720	DOCUMENT SENSOR
16	19E15041	CLIP

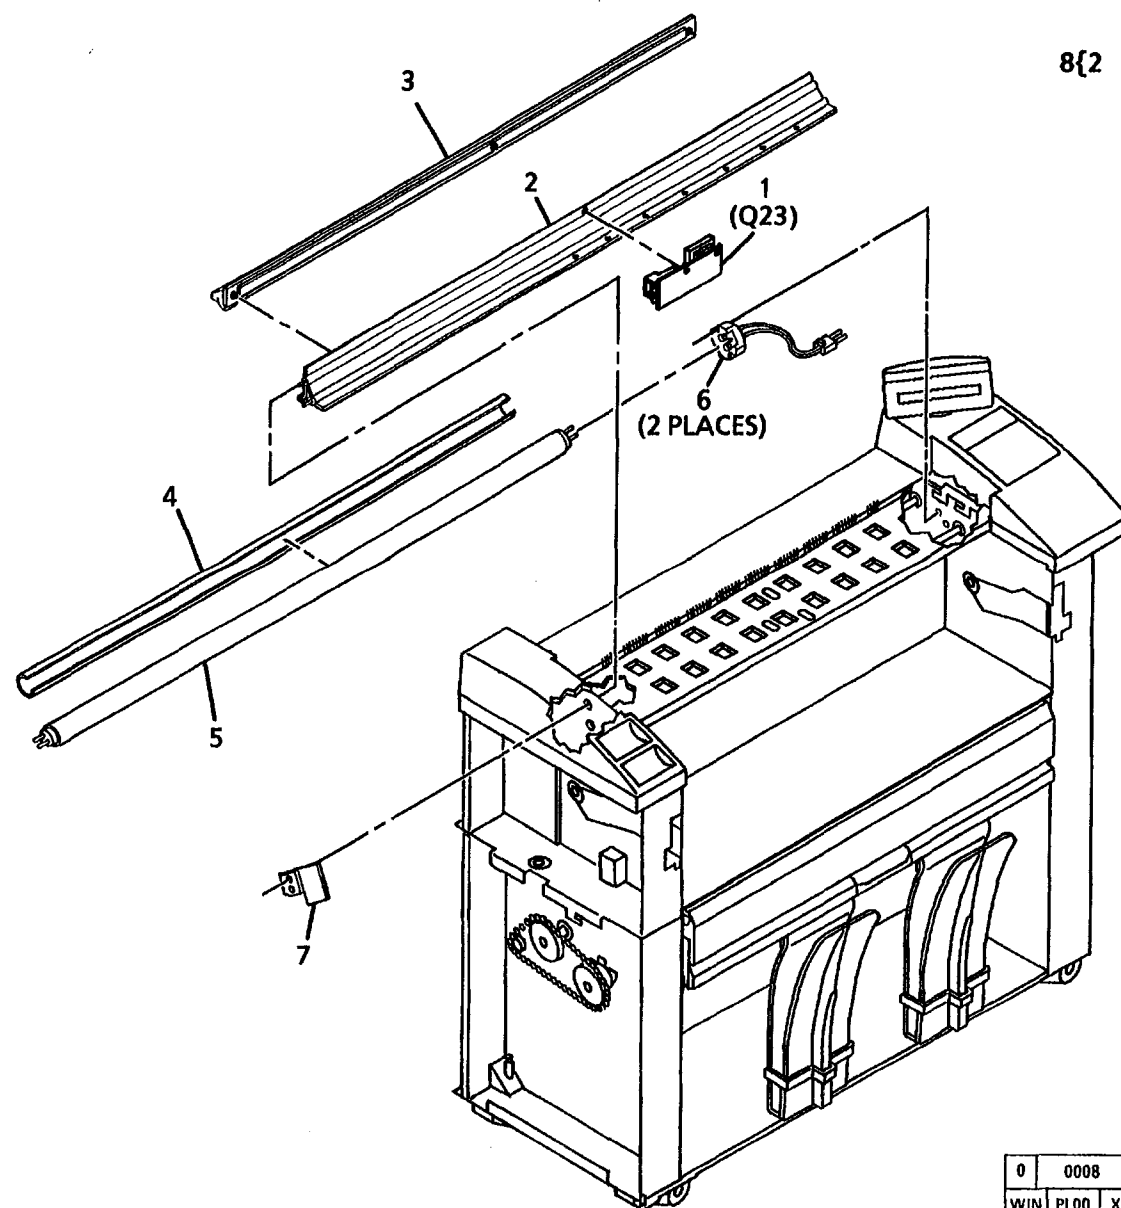
PL 6.1 OPTICS COMPONENTS

ITEM	PART	DESCRIPTION
1	130K53940	ILLUMINATION SENSOR (Q23) (REP 6.3, ADJ 9.2)
2	--	REFLECTOR (P/O ITEM 8)
3	62K4841	LENS (REP 6.2)
4	113E7881	LAMP SHIELD
5	122E302	EXPOSURE LAMP (REP 6.1)
6	113K1221	LAMP SOCKET
7	9E42461	OPTICS SPRING
8	62K5450	REFLECTOR ASSEMBLY (REP 6.1)

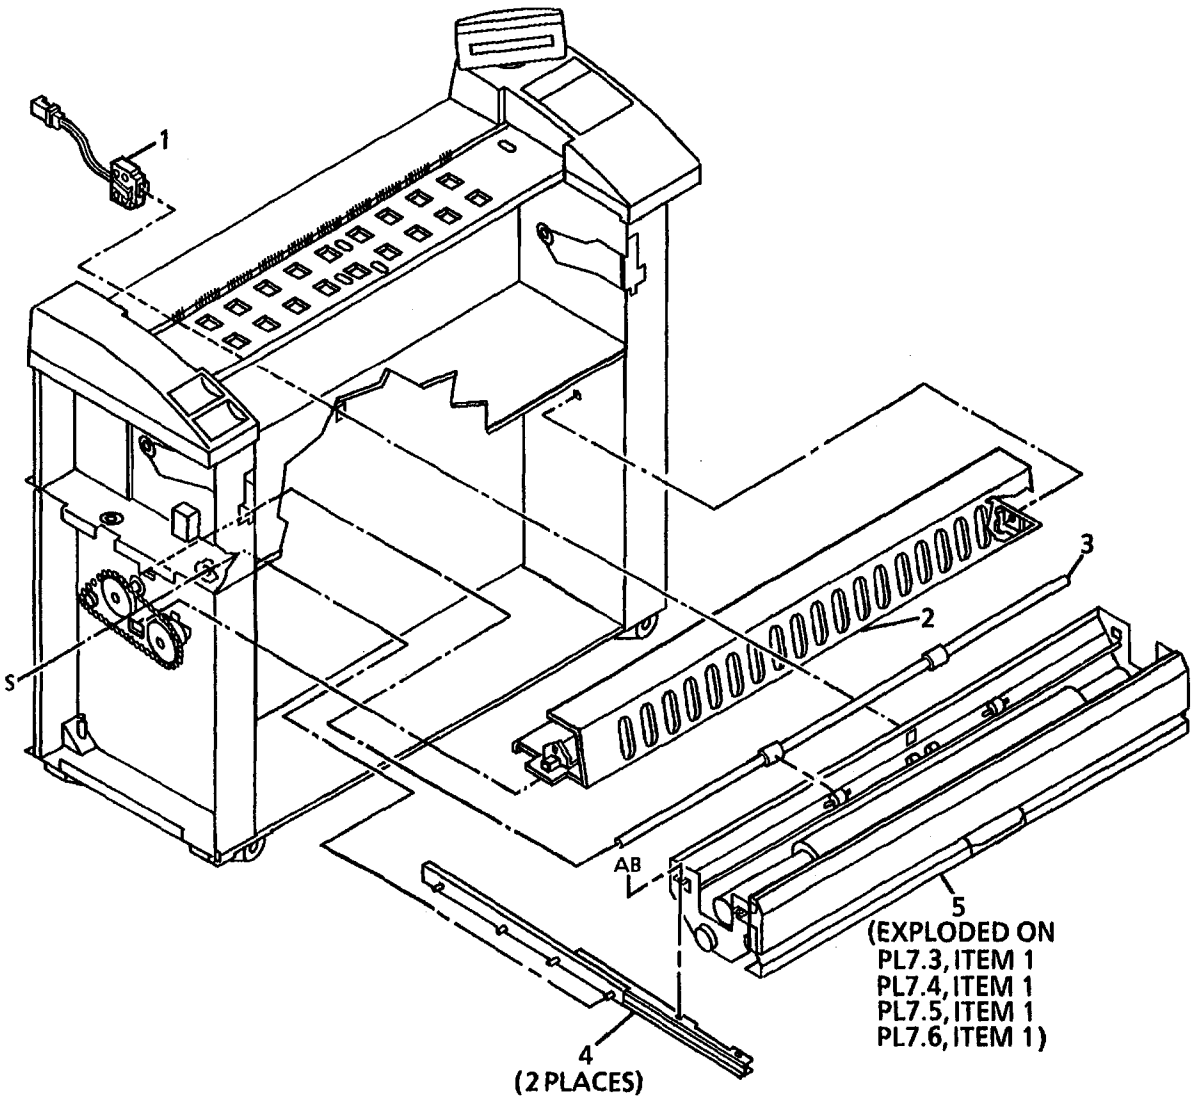
PL 7.1 ROLL SUPPLY FEED ASSEMBLY

ITEM	PART	DESCRIPTION
1	130K51801	POSITION SENSOR
2	126K4140	MEDIA ROLL HEATER
-	126K4130	MEDIA ROLL HEATER
3	22K28930	ROLL FEED DRIVE ROLL
4	10K1351	SLIDE
5	50K19610	ROLL SUPPLY DRAWER
		ASSEMBLY (REP 7.1)

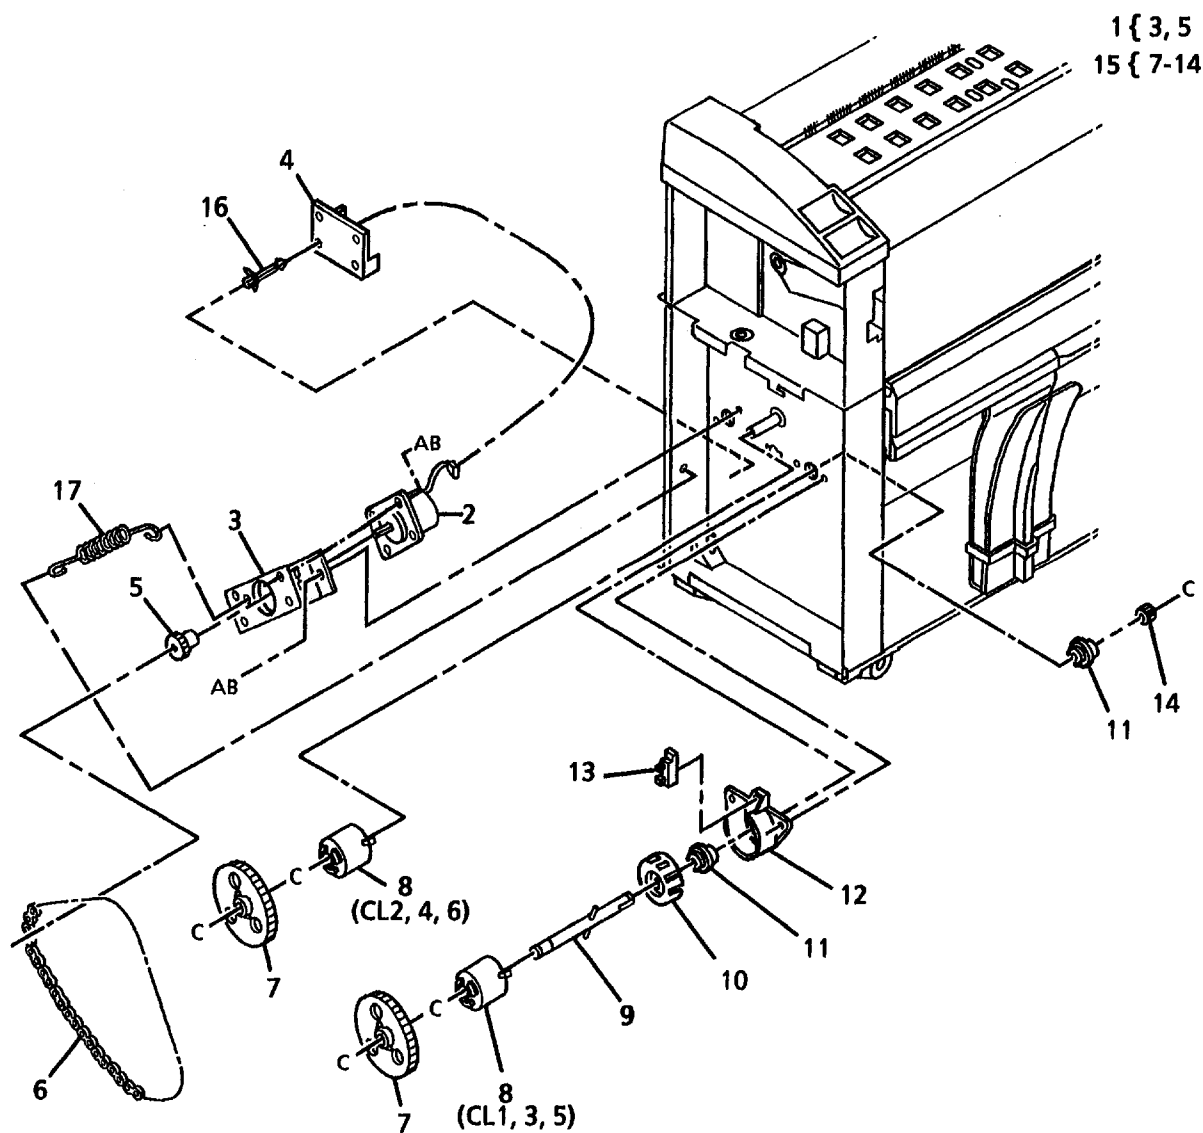
PL 7.2 ROLL SUPPLY DRIVES

ITEM	PART	DESCRIPTION
1	7K7561	ROLL DRIVE MOTOR ASSEMBLY
2	127K4293	ROLL DRIVE MOTOR (REP 7.9)
3	--	BRACKET (P/O ITEM 1)
4	140K15952	DRIVE MOTOR PWB
5	7E16410	MAIN DRIVE SPROCKET (10T)
6	423W70603	CHAIN
7	7E19071	SPROCKET (50T)
8	121E7510	FEED CLUTCH (REP 7.5)
9	--	REWIND CLUTCH (REP 7.6)
10	5E6810	REWIND SHAFT (P/O ITEM 15)
11	413W30854	ENCODER DISK (REP 7.11)
12	--	BEARING (P/O ITEM 15)
13	130E3250	REWIND HOUSING (REP 7.8)
14	--	MOTION SENSOR (REP 7.7)
15	7K5760	REWIND DRIVE GEAR (12T) (P/O ITEM 15)
16	--	REWIND DRIVE ASSEMBLY
17	9E43260	STANDOFF (NOT SPARED) MOTOR SPRING

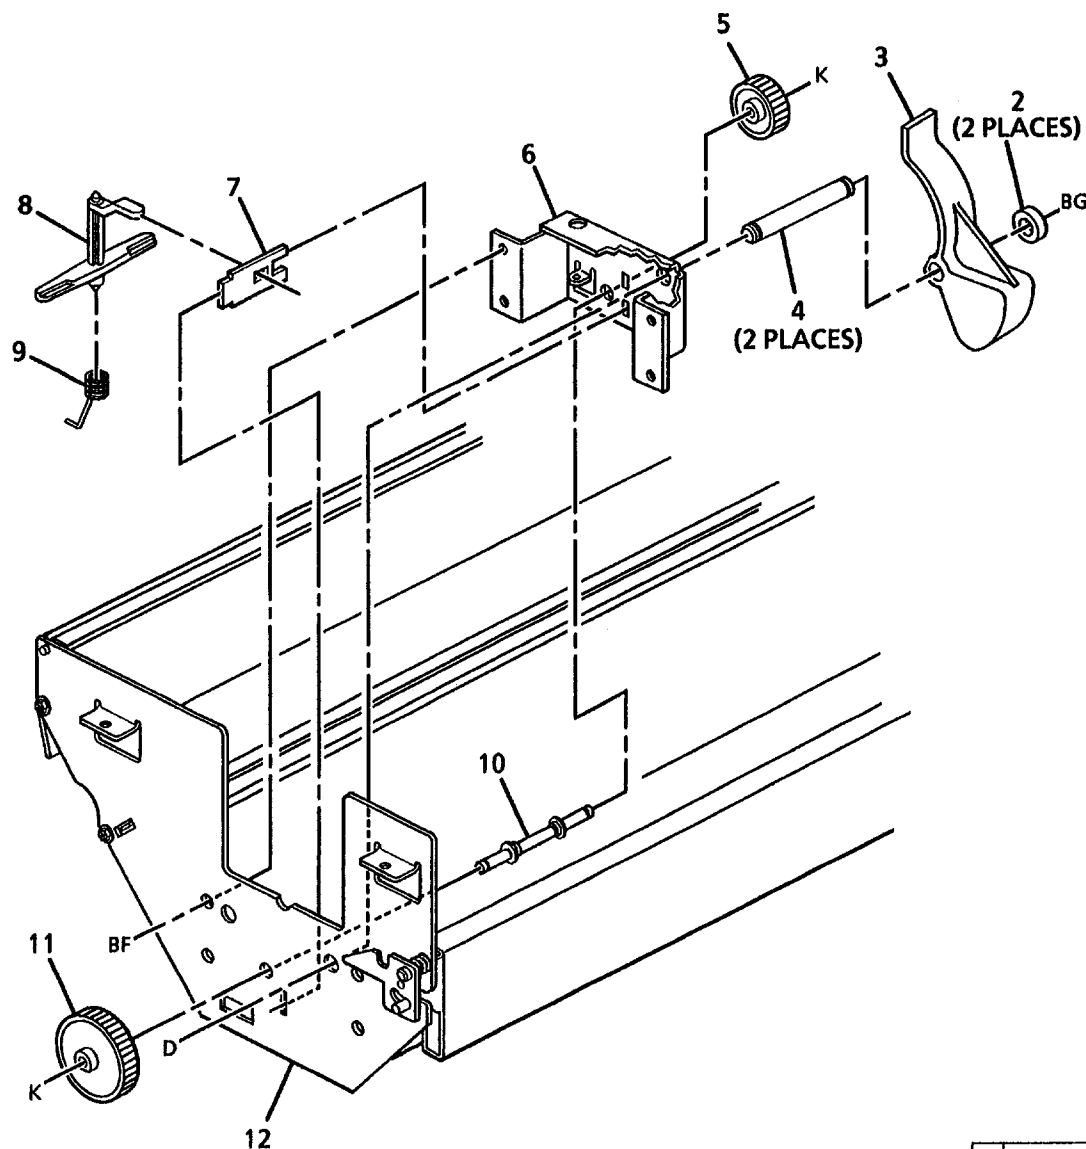
PL 7.3 ROLL SUPPLY DRAWER COMPONENTS (PART 1 OF 4)

ITEM	PART	DESCRIPTION
1	--	PART OF ROLL SUPPLY DRAWER ASSEMBLY (REF PL7.1, ITEM 5)
2	22E11540	SUPPORT ROLLER
3	55E23520	GEAR GUARD
4	29E14760	LH SUPPORT PIN
5	7E14650	REWIND INTERNAL GEAR (20T) (REP 7.2)
6	--	LH CRADLE BRACKET (P/O ITEM 1)
7	--	LH ROLL LOCK (P/O ITEM 1)
8	3E17610	ROLL LOCK
9	9E27340	ROLL LOCK SPRING
10	--	REWIND SHAFT (P/O ITEM 1)
11	7E14600	REWIND GEAR (32T) (REP 7.2)
12	--	DRAWER FRAME (P/O ITEM 1)

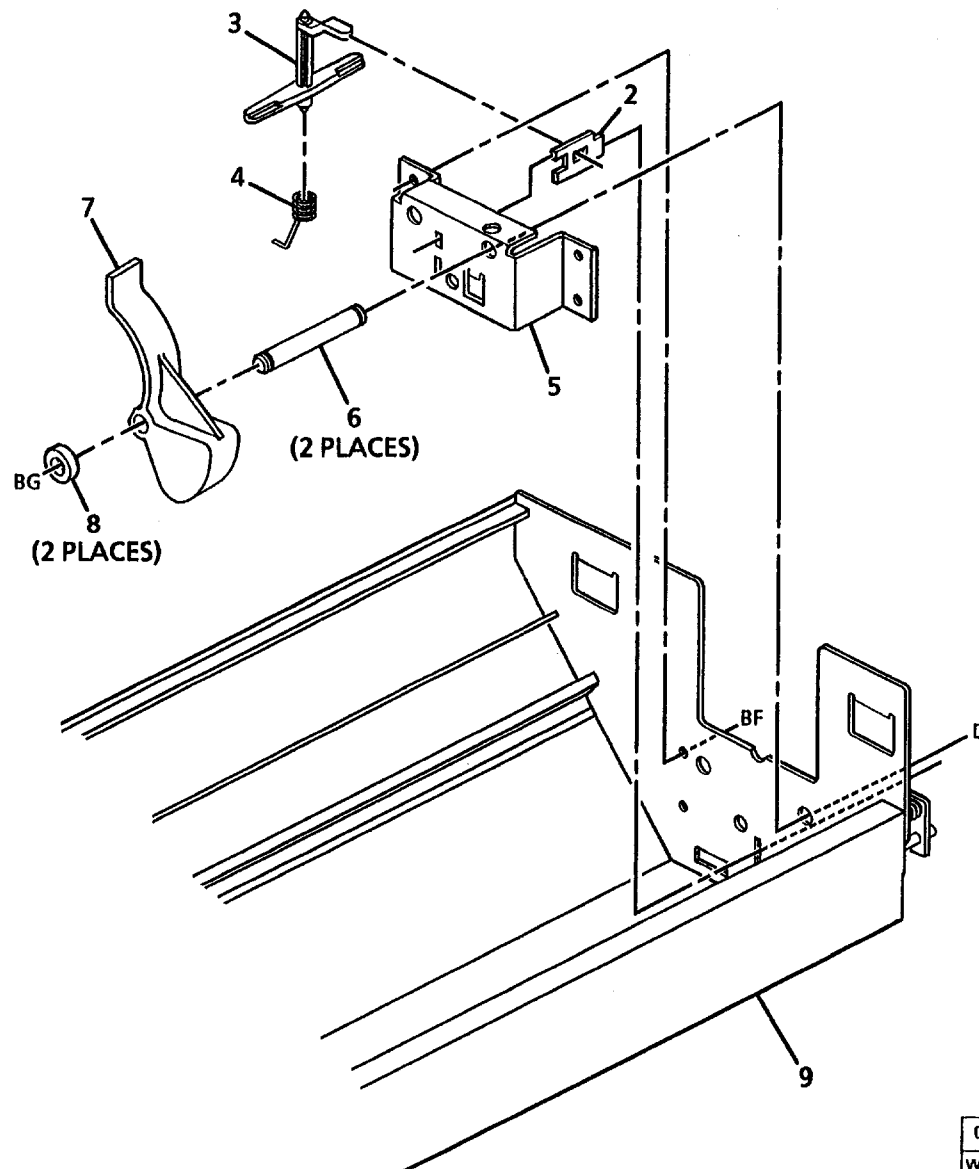
PL 7.4 ROLL SUPPLY DRAWER COMPONENTS (PART 2 OF 4)

ITEM	PART	DESCRIPTION
1	--	PART OF ROLL SUPPLY DRAWER ASSEMBLY (REF PL7.1, ITEM 5)
2	--	RH ROLL LOCK (P/O ITEM 1)
3	3E17610	ROLL LOCK
4	9E27340	ROLL LOCK SPRING
5	--	RH CRADLE BRACKET (P/O ITEM 1)
6	29E14750	RH SUPPORT PIN
7	55E23520	GEAR GUARD
8	22E11540	SUPPORT ROLLER
9	--	DRAWER FRAME (P/O ITEM 1)

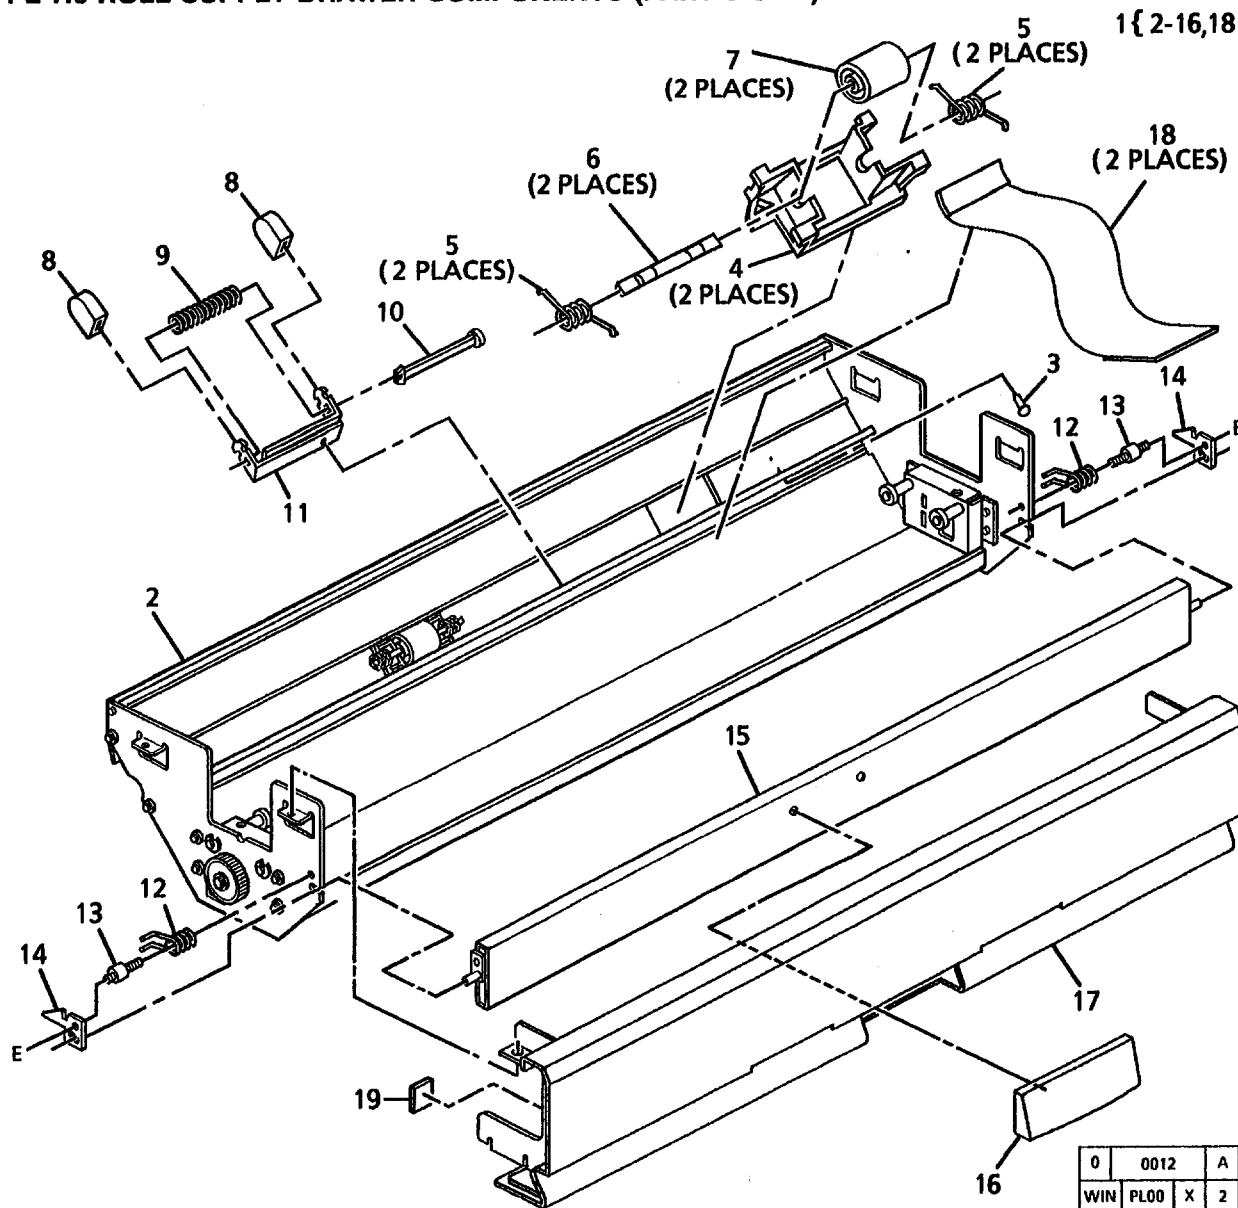
PL 7.5 ROLL SUPPLY DRAWER COMPONENTS (PART 3 OF 4)

ITEM	PART	DESCRIPTION
1	--	PART OF ROLL SUPPLY DRAWER ASSEMBLY (REF PL7.1, ITEM 5)
2	--	DRAWER FRAME (P/O ITEM 1)
3	17E4250	BAFFLE STOP
4	68E17221	BRACKET
5	9E27351	PINCH ROLL SPRING
6	--	PINCH ROLL SHAFT (P/O ITEM 1)
7	22E10060	ROLL FEED PINCH ROLL (REP 7.3)
8	--	LOCK RELEASE HANDLE (P/O ITEM 1)
9	9E32790	LOCK SPRING
10	29E14460	RETAINER
11	--	LATCH (P/O ITEM 1)
12	9E27330	DRAWER LATCH SPRING
13	--	LATCH PIN (P/O ITEM 1)
14	--	SUPPLY DRAWER LATCH (P/O ITEM 1)
15	3K7580	HANDLE
16	3E26570	DRAWER HANDLE
17	48K14560	DRAWER COVER
18	38K9190	PAPER GUIDE
19	121E7680	MAGNET

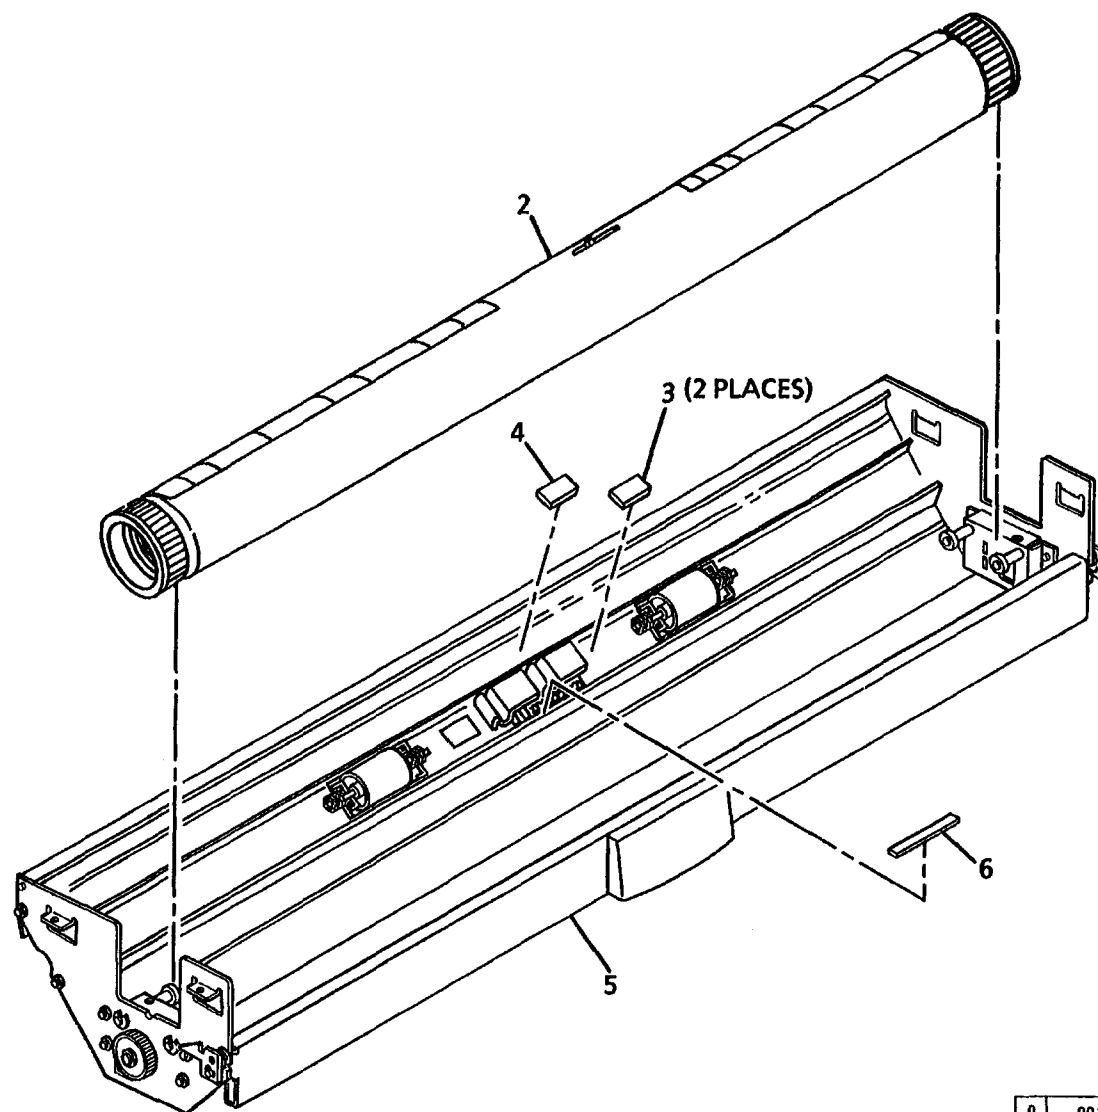
PL 7.6 ROLL SUPPLY DRAWER COMPONENTS (PART 4 OF 4)

ITEM	PART	DESCRIPTION
1	--	PART OF ROLL SUPPLY DRAWER ASSEMBLY (REF PL7.1, ITEM 5)
2	52K1861	ROLL SUPPORT TUBE ASSEMBLY (60HZ)
-	52K2081	ROLL SUPPORT TUBE ASSEMBLY (50HZ)
3	92E22541	LABEL (PUSH HERE)
4	92E36430	LABEL (MEDIA LEAD)
5	--	DRAWER FRAME (P/O ITEM 1)
6	92E22560	LABEL (PINCH ARROWS)
