- **Call Flow Diagram** - This diagram outlines the major activities that are performed when a service call is made. The **Initial Actions** assist the Service Representative through the customer interface and help to identify the problem. The diagram also directs the Representative to verify, classify, repair the problem and perform the correct Maintenance Procedure.

2. Status Indicator Repair Analysis Procedures

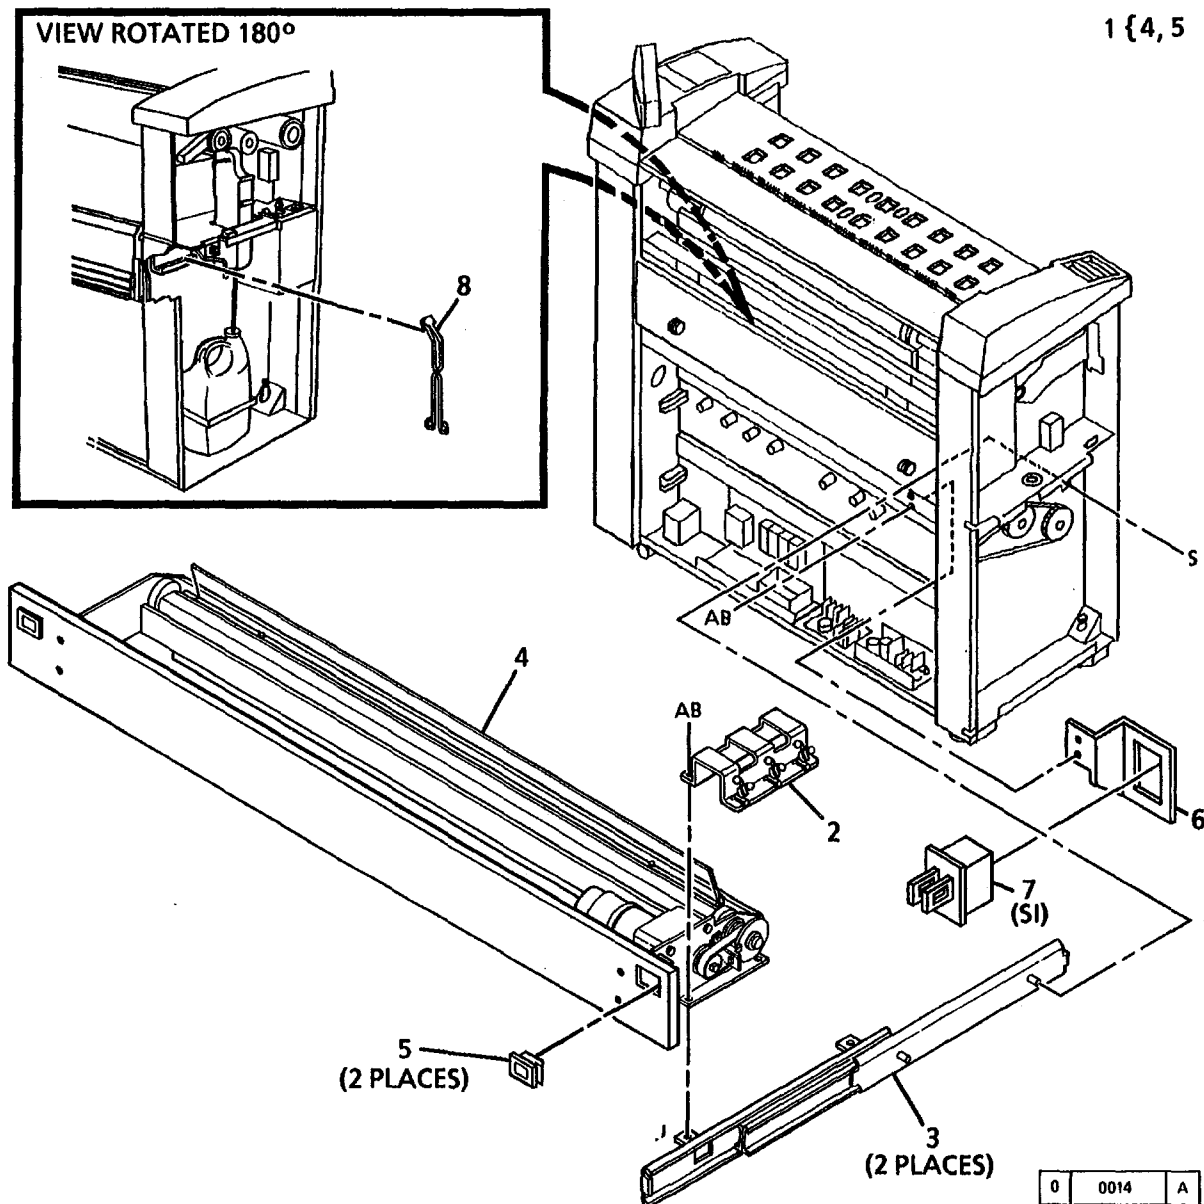
PL 7.7 MEDIA CUTTER ASSEMBLY

ITEM	PART	DESCRIPTION
1	--	MEDIA CUTTER ASSEMBLY (TO BE AVAILABLE AT LATER DATE)
2	--	BRACKET (NOT SPARED)
3	10K1360	MEDIA CUTTER SLIDE
4	--	MEDIA CUTTER (P/O ITEM 1)
5	3E18781	LATCH
6	--	BRACKET (NOT SPARED)
7	110E2640	MEDIA CUTTER COVER INTERLOCK SWITCH (S1)
8	--	TONGS (NOT SPARED)

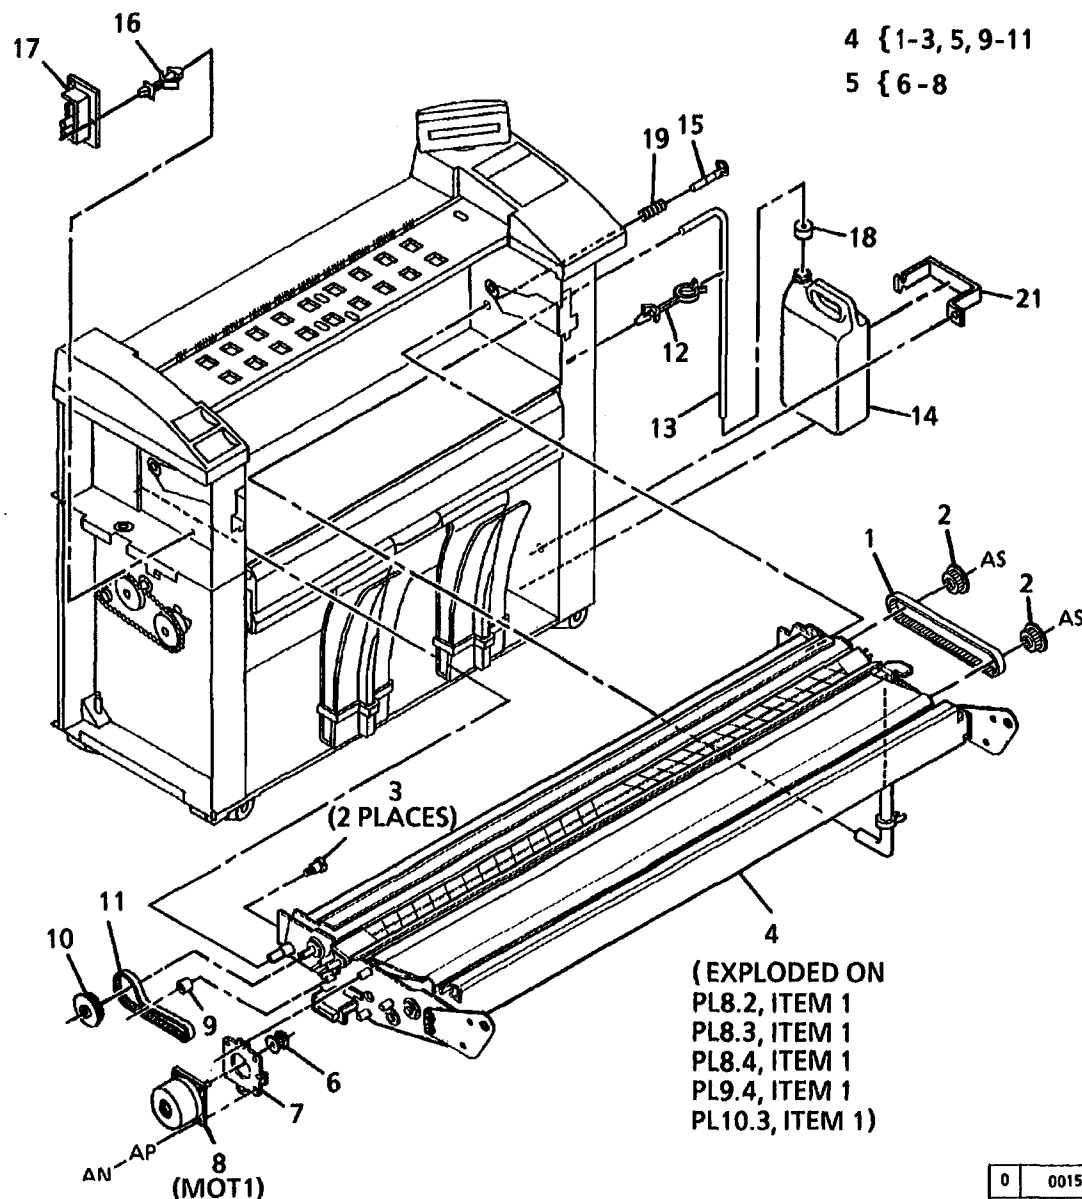
PL 8.1 MEDIA TRANSPORT ASSEMBLY

ITEM	PART	DESCRIPTION
1	423W72201	SHEET DRIVE BELT
2	20E13853	SHEET DRIVE PULLEY
3	26E11970	SHOULDER SCREW
4	22K30592	MEDIA TRANSPORT ASSEMBLY (REP 8.1)
5	--	TRANSPORT DRIVE MOTOR ASSEMBLY (NOT SPARED)
6	20E13603	DRIVE MOTOR PULLEY
7	--	MOTOR MOUNTING PLATE (P/O ITEM 5)
8	127K4293	TRANSPORT DRIVE MOTOR (MOT1) (REP 8.10)
9	22E11441	IDLER ROLLER
10	20E12353	REGISTRATION DRIVE PULLEY
11	423W64001	REGISTRATION DRIVE BELT (REP 8.13)
12	--	TWIST CLAMP (NOT SPARED)
13	52E7910	MOISTURE COLLECTION TUBE
14	93E1501	MOISTURE COLLECTION BOTTLE
15	29K1111	PIN
16	--	STANDOFF (NOT SPARED)
17	140K15952	DRIVE MOTOR PWB
18	--	BOTTLE CAP (NOT SPARED)
19	9E32510	COMPRESSION SPRING

Exploded view diagram of a mechanical assembly. The diagram shows the following components and their assembly locations:

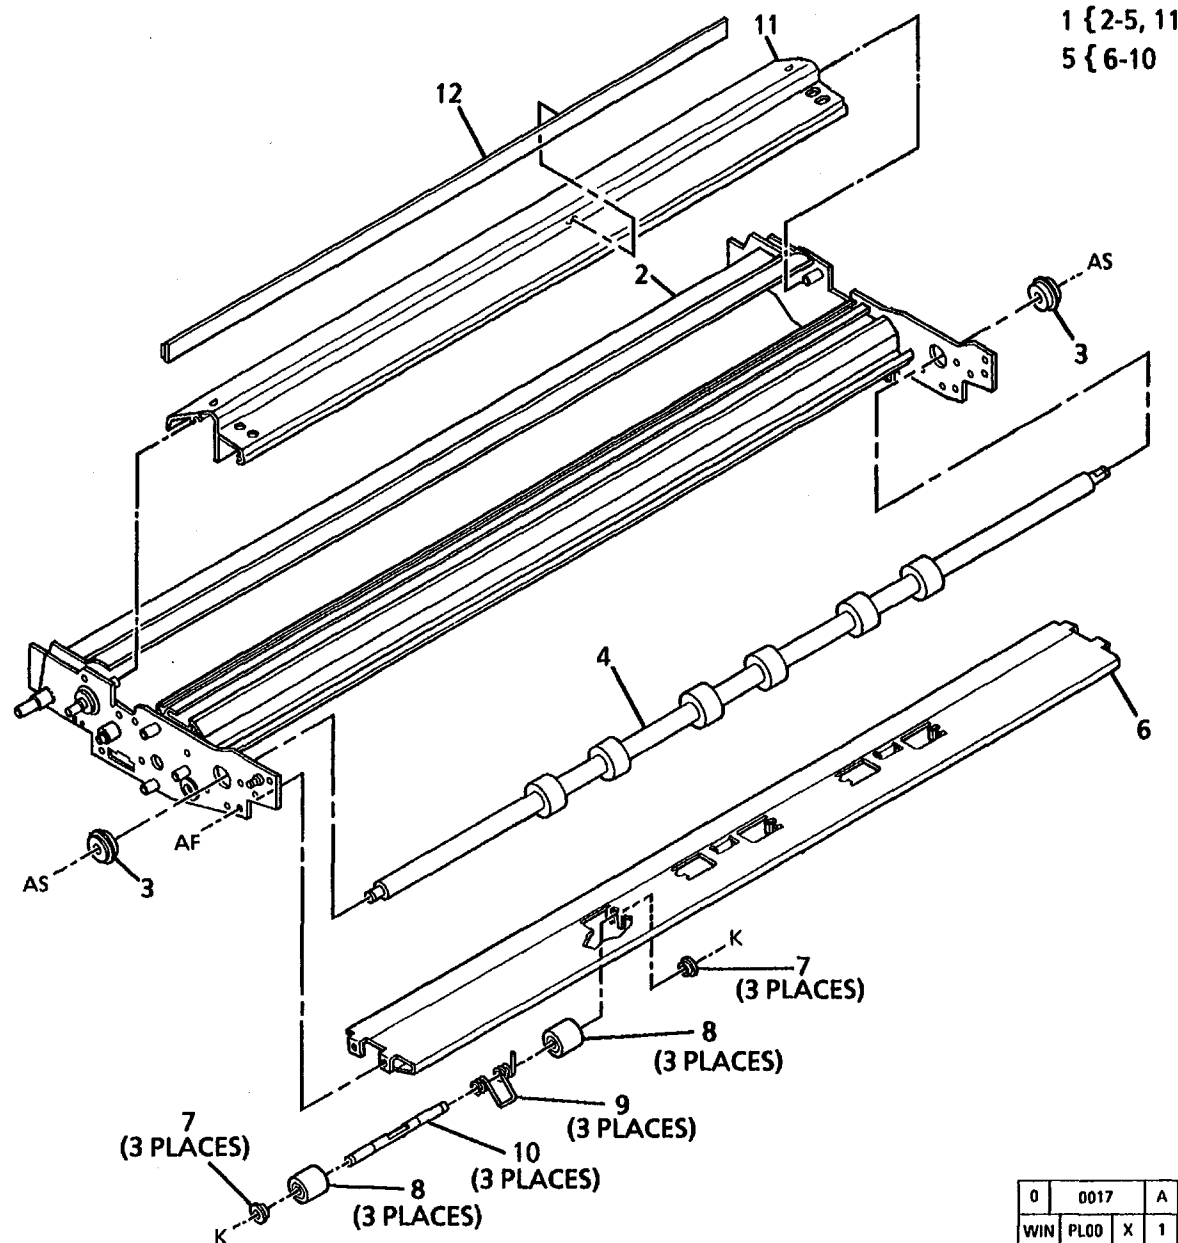
PL 8.3 CUT SHEET FEED COMPONENTS

ITEM	PART	DESCRIPTION
1	--	PART OF MEDIA TRANSPORT ASSEMBLY (REF PL8.1, ITEM 4)
2	--	MEDIA TRANSPORT FRAME (P/O ITEM 1)
3	413W31054	BEARING
4	6K9731	SHEET DRIVE ROLL (REP 8.6)
5	--	SHEET SUPPORT ASSEMBLY (P/O ITEM 1)
6	--	SHEET LOWER Baffle (P/O ITEM 1)
7	16E6020	BUSHING
8	22E9390	SHEET PINCH ROLL (REP 8.7)
9	9E32490	SHEET PINCH SPRING (REP 8.7)
10	6E23540	SHEET PINCH SHAFT (REP 8.7)
11	--	TOP GUIDE (P/O ITEM 1)
12	55K16960	SHIELD

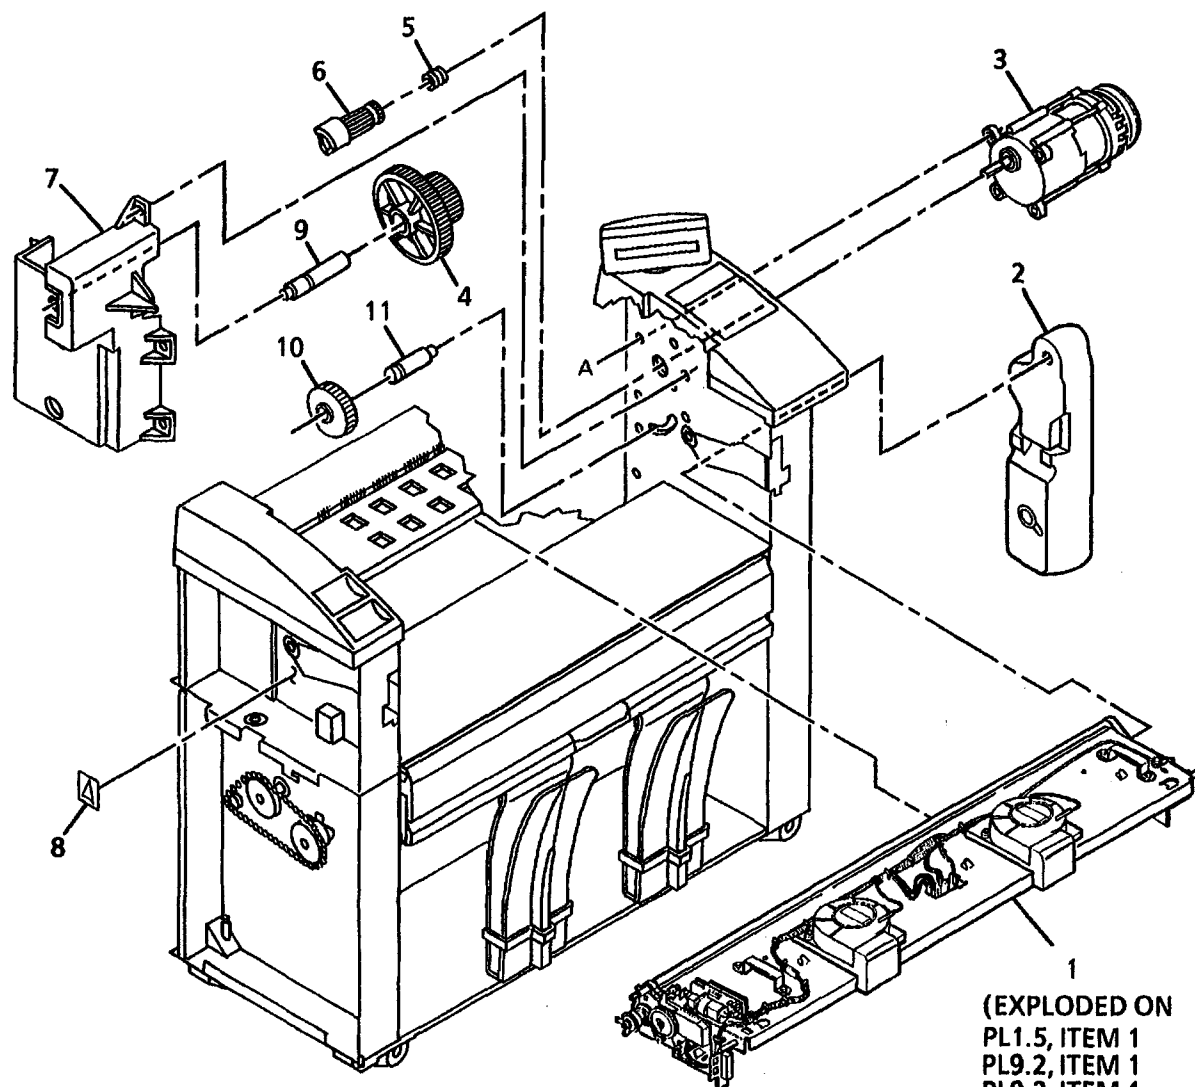
PL 9.1 XEROGRAPHIC MODULE ASSEMBLY

ITEM	PART	DESCRIPTION
1	126K4150	XEROGRAPHIC MODULE ASSEMBLY (60HZ) (REP 9.11)
-	126K4160	XEROGRAPHIC MODULE ASSEMBLY (50HZ) (REP 9.11)
2	--	TONER WASTE BOTTLE (NOT SPARED)
3	127E5073	DRUM/DEVELOPER DRIVE MOTOR (60HZ)
-	127E6891	DRUM/DEVELOPER DRIVE MOTOR (50HZ)
4	7E29510	DRUM DRIVE GEAR (36T/68T)
5	9E41251	COUPLING SPRING
6	7E29520	DRIVE GEAR/COUPLING GEAR HOUSING (NOT SPARED)
7	--	GEAR HOUSING (NOT SPARED)
8	92E36450	LABEL (RED ARROW)
9	6E23761	IDLER SHAFT
10	7K7570	GEAR (48T)
11	29E13641	DRUM/DEVELOPER DRIVE PIN

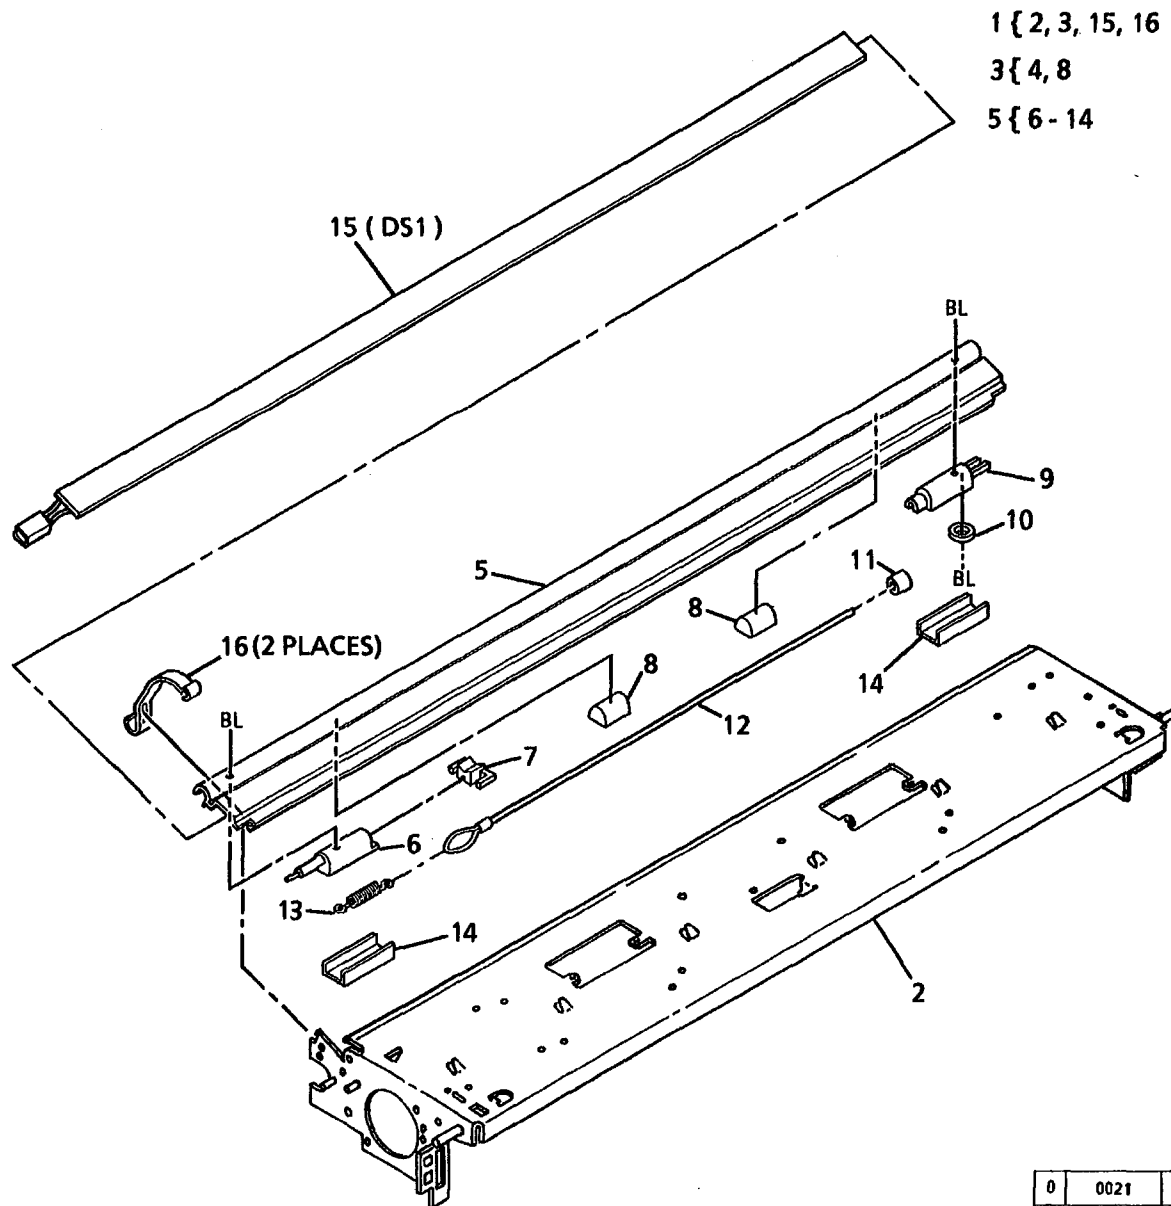
PL 9.3 CHARGE COROTRON AND ERASE LED PWB

ITEM	PART	DESCRIPTION
1	--	PART OF XEROGRAPHIC MODULE ASSEMBLY (REF PL9.1, ITEM 1)
2	--	XEROGRAPHIC FRAME (P/O ITEM 1)
3	125K1412	CHARGE COROTRON/ERASE LAMP ASSEMBLY (REP 9.8, ADJ 9.2)
4	--	SHIELD (P/O ITEM 3)
5	600K37740	COROTRON REPAIR KIT
6	--	REAR BLOCK (P/O ITEM 5)
7	--	WIRE GUIDE (P/O ITEM 5)
8	4E502	FOAM DAMPER
9	--	FRONT BLOCK (P/O ITEM 5)
10	--	CLAMP (P/O ITEM 5)
11	--	FERRITE BEAD (P/O ITEM 5)
12	--	WIRE (GOLD)(P/O ITEM 5)
13	--	SPRING (P/O ITEM 5)
14	--	ARC SHIELD (P/O ITEM 5)
15	101K18880	ERASE LED PWB (DS1)
16	9E34222	COROTRON RETAINER

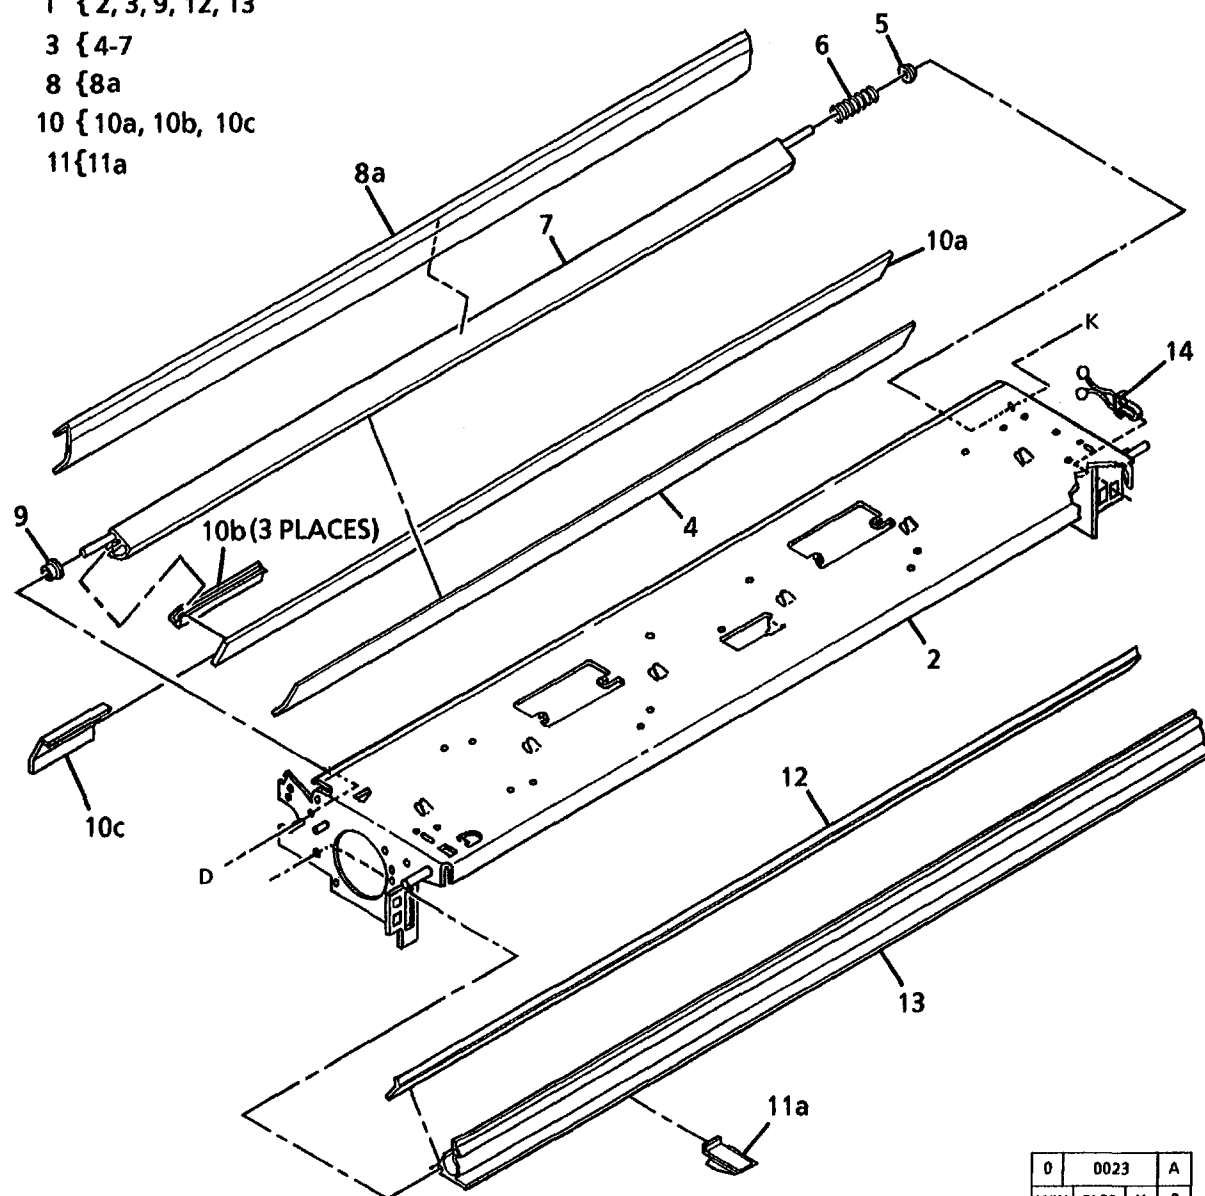
PL 9.5 PHOTORECEPTOR DRUM CLEANING (PART 1 OF 2)

ITEM	PART	DESCRIPTION
1	--	PART OF XEROGRAPHIC MODULE ASSEMBLY (REF PL9.1, ITEM 1)
2	--	XEROGRAPHIC FRAME (P/O ITEM 1)
3	42K1390	CLEANER BLADE ASSEMBLY (REP 9.4)
4	35E3580	BLADE SEAL
5	13E1571	BEARING
6	9E6960	SPRING
7	--	CLEANER HOUSING (P/O ITEM 3)
8	600K29981	CONTAMINATION SEAL KIT
8a	--	CONTAMINATION SEAL (REP 9.15)
9	13E7161	BEARING
10	600K25780	CLEANER BLADE REPAIR KIT
10a	--	CLEANER BLADE
10b	--	CLEANER BLADE RETAINER
10c	--	CLEANER BLADE SEAL
11	600K8481	MEDIA DEFLECTOR KIT (7/KIT)
11a	--	MEDIA GUIDE
12	35K1222	PHOTORECEPTOR SEAL
13	--	HOUSING (P/O ITEM 1)
14	120E6510	TWIST CLAMP

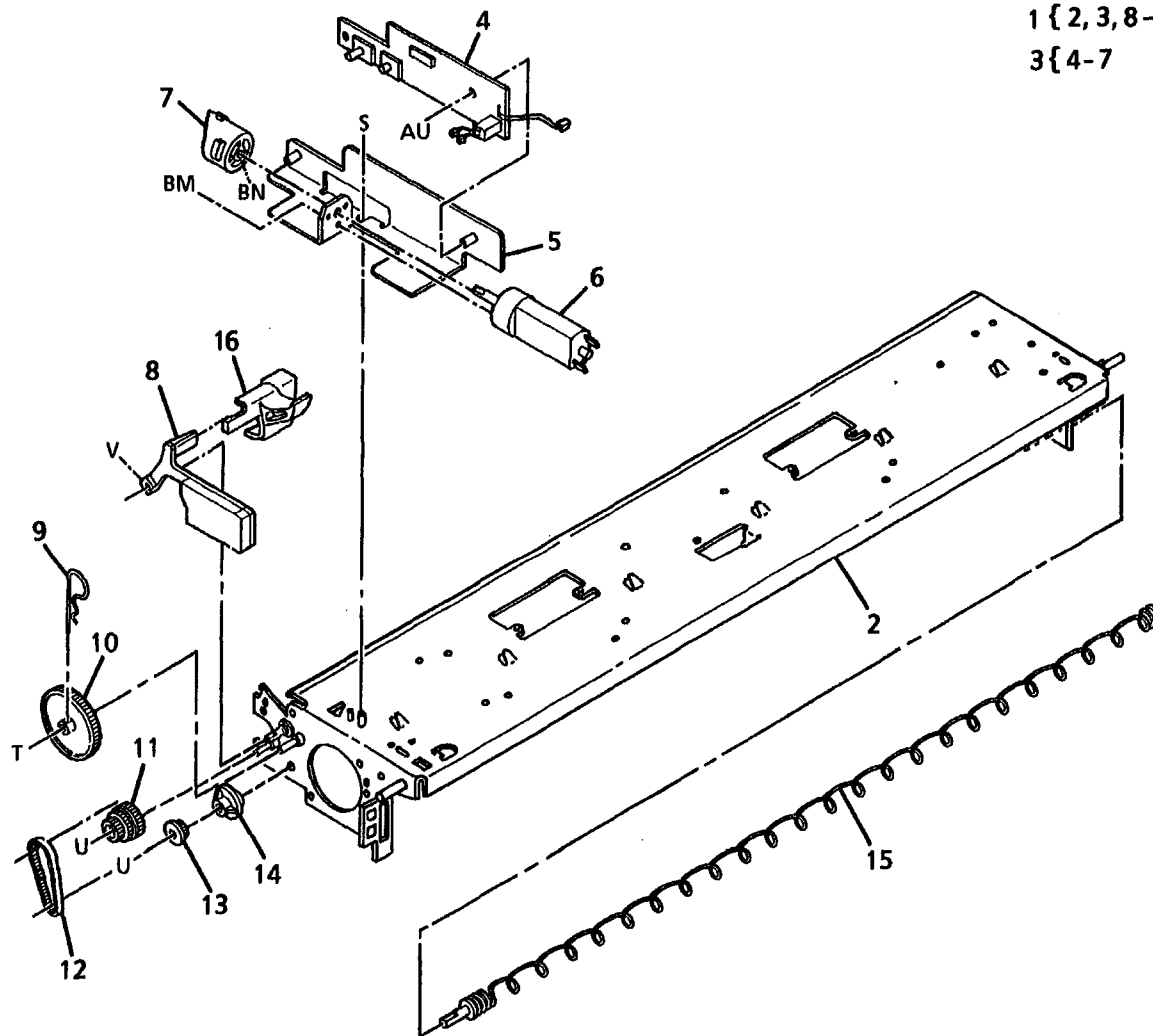
PL 9.6 PHOTORECEPTOR DRUM CLEANING (PART 2 OF 2)

ITEM	PART	DESCRIPTION
1	--	PART OF XEROGRAPHIC MODULE ASSEMBLY (REF PL9.1, ITEM 1)
2	--	XEROGRAPHIC FRAME (P/O ITEM 1)
3	127K11322	CLEANER BLADE MOTOR ASSEMBLY (REP 9.16)
4	--	BLADE MOTOR PWBA (P/O ITEM 3)
5	--	BRACKET (P/O ITEM 3)
6	--	MOTOR (P/O ITEM 3)
7	--	CAM (P/O ITEM 3)
8	36E93	BLADE WEIGHT
9	29E3560	COTTER PIN
10	7E1331	TRANSITION GEAR
11	7E5221	GEAR PULLEY
12	23E1620	AUGER DRIVE BELT
13	20E4350	AUGER PULLEY
14	13E803	AUGER BEARING
15	94K85	WASTE TONER AUGER
16	16E8641	BLADE WEIGHT ADAPTER

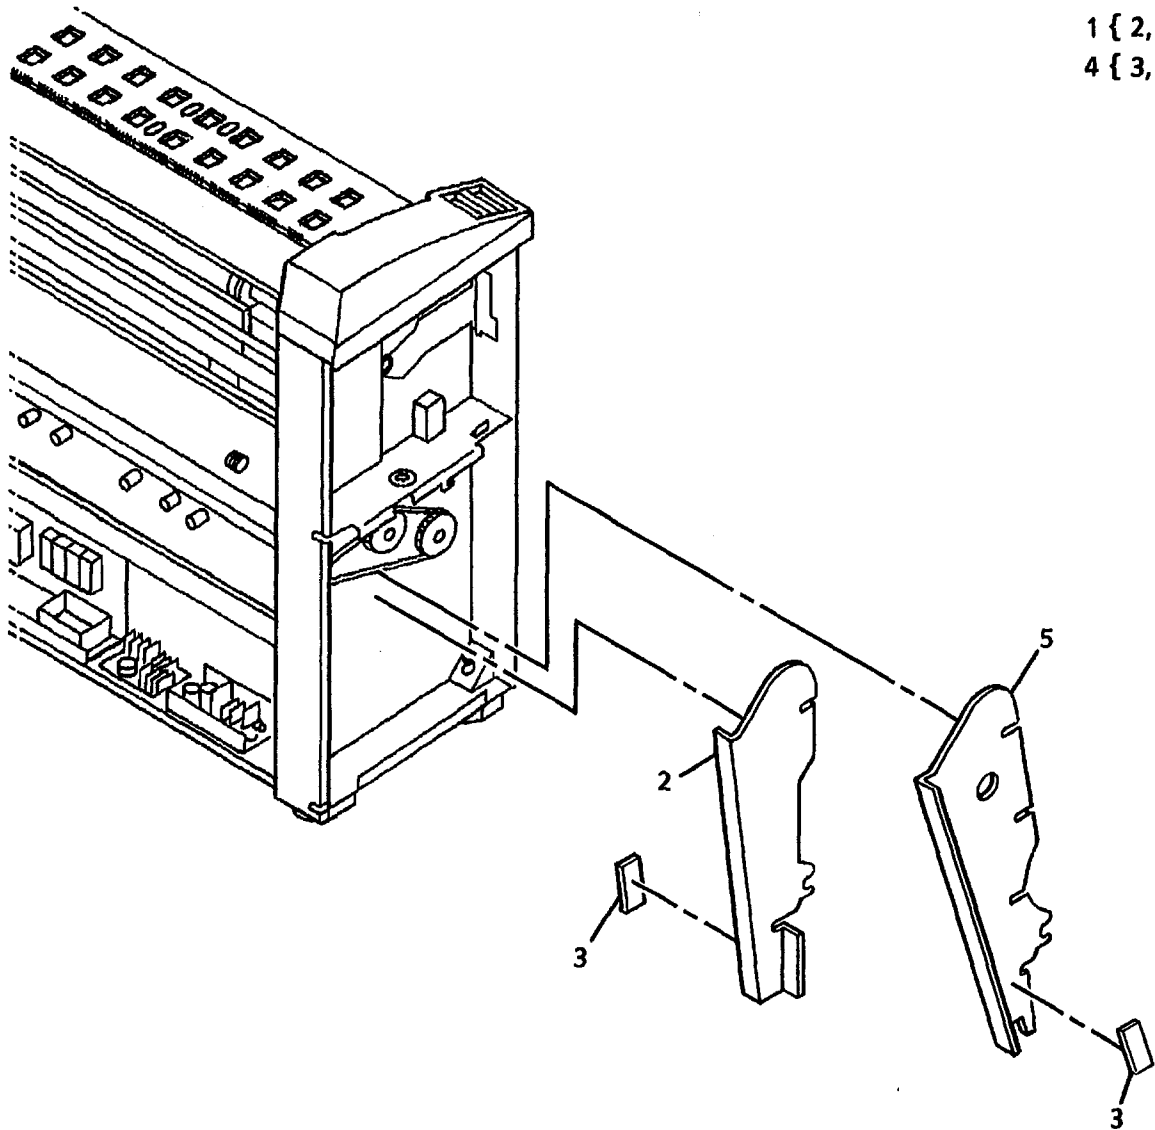
PL 9.7 XEROGRAPHIC MODULE SERVICE RAILS

ITEM	PART	DESCRIPTION
1	68K6750	RH SERVICE RAIL ASSEMBLY
2	--	RH SERVICE RAIL (P/O ITEM 1)
3	--	LABEL (CAUTION) (P/O ITEMS 1 AND 4)
4	68K6760	LH SERVICE RAIL ASSEMBLY
5	--	LH SERVICE RAIL (P/O ITEM 4)

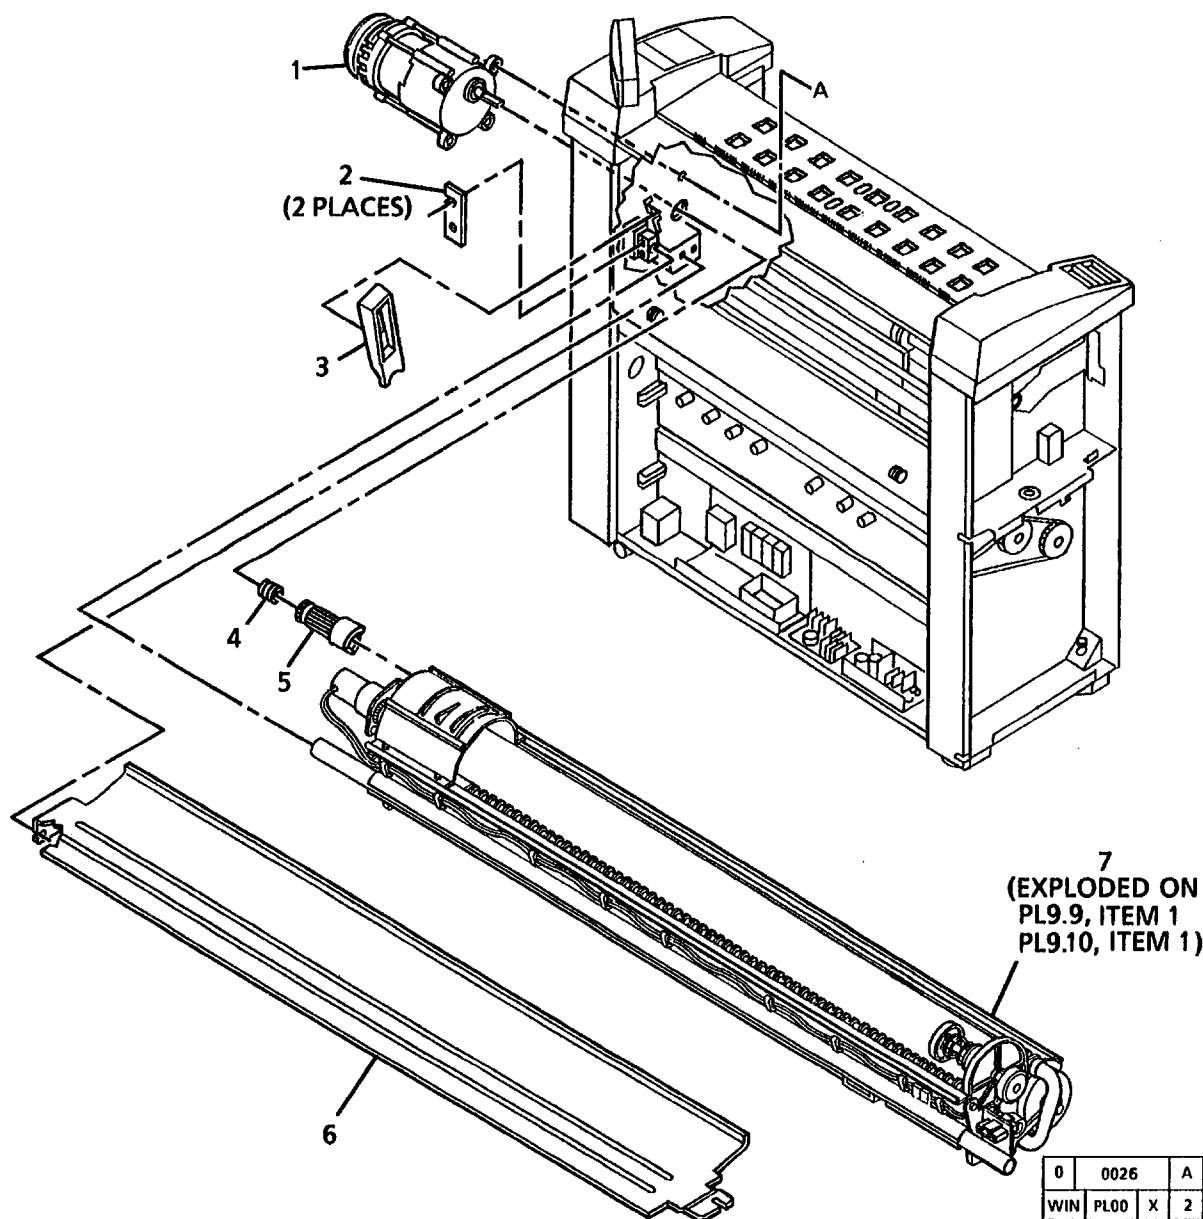
PL 9.8 DEVELOPER MODULE ASSEMBLY

ITEM	PART	DESCRIPTION
1	127E5073	DRUM/DEVELOPER DRIVE MOTOR (60HZ)
-	127E6891	DRUM/DEVELOPER DRIVE MOTOR (50HZ)
2	19E16240	CLAMP
3	28E7771	RETAINER
4	9E41251	COUPLING SPRING
5	7E29520	DRIVE GEAR/COUPLING
6	55E16352	DEVELOPER BAFFLE
7	121K8730	DEVELOPER MODULE ASSEMBLY (REP 9.5, ADJ 9.3, 9.4, 9.6)

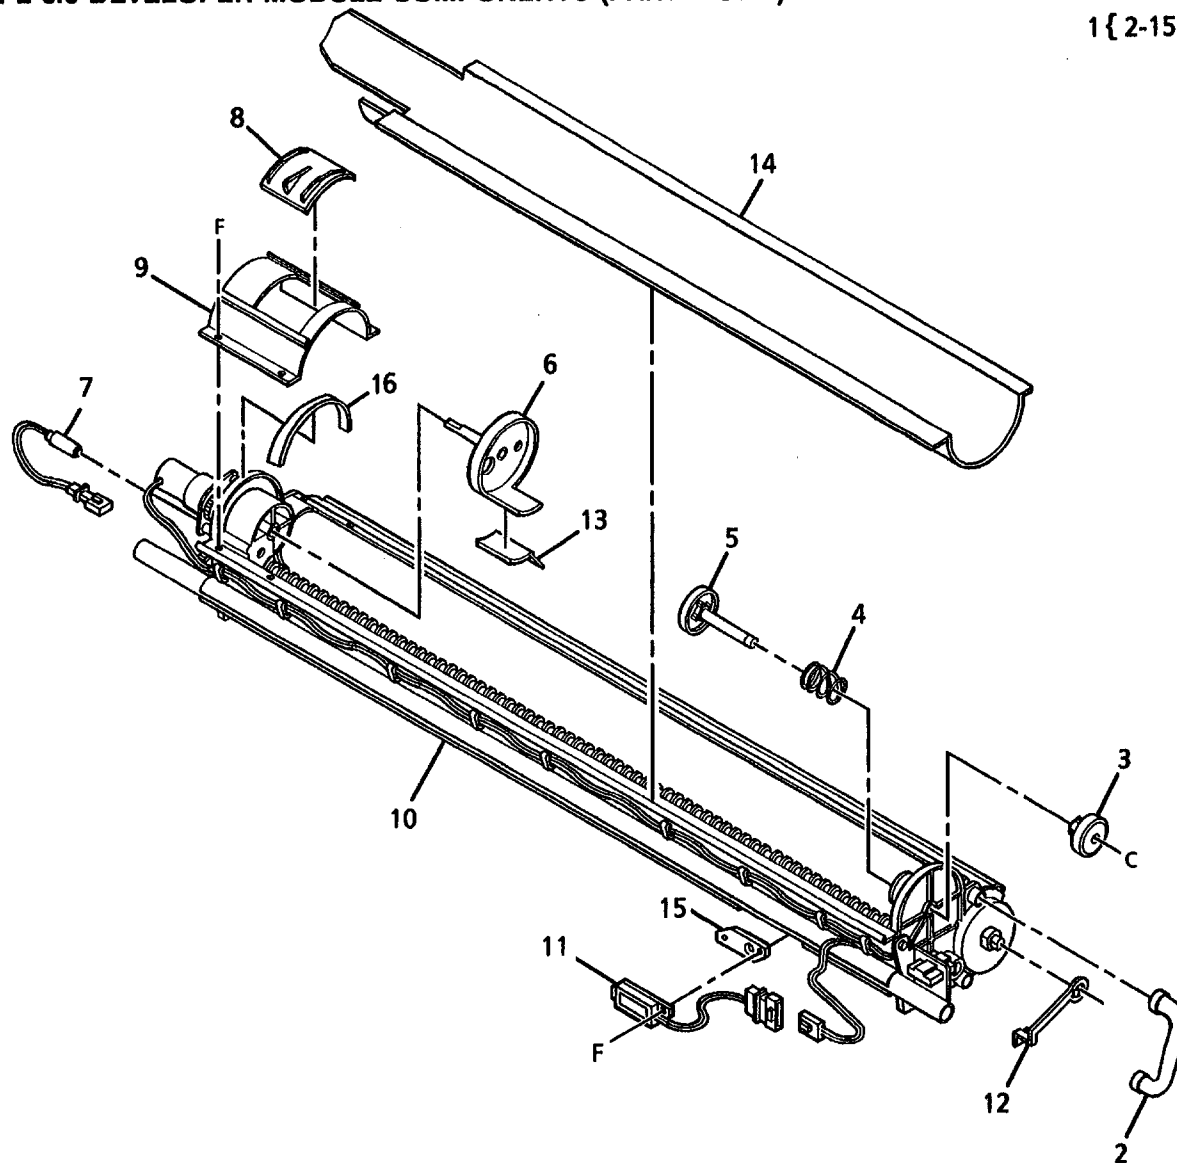
PL 9.9 DEVELOPER MODULE COMPONENTS (PART 1 OF 2)

ITEM	PART	DESCRIPTION
1	--	PART OF DEVELOPER MODULE ASSEMBLY (REF PL9.7, ITEM 7)
2	54E3181	PRESSURE EQUALIZER TUBE
3	3E19330	CARTRIDGE KNOB
4	--	SPRING (P/O ITEM 1)
5	5K1350	CARTRIDGE HUB
6	6K9871	CARTRIDGE DRIVE PLATE (REP 9.14)
7	130K30381	TONER HOME SENSOR (REP 9.12, ADJ 9.5)
8	2E40470	TOP SHIELD DOOR
9	55K13840	TOP SHIELD
10	--	DEVELOPER FRAME (P/O ITEM 1)
11	130K53300	TONER SENSOR (REP 9.11, ADJ 9.5)
12	19E15551	BIAS CLIP
13	1E23080	TONER STRIP
14	55K13830	SUMP SHIELD (REP 9.13)
15	--	SENSOR SPACER (P/O ITEM 1)
16	35E12210	SEAL

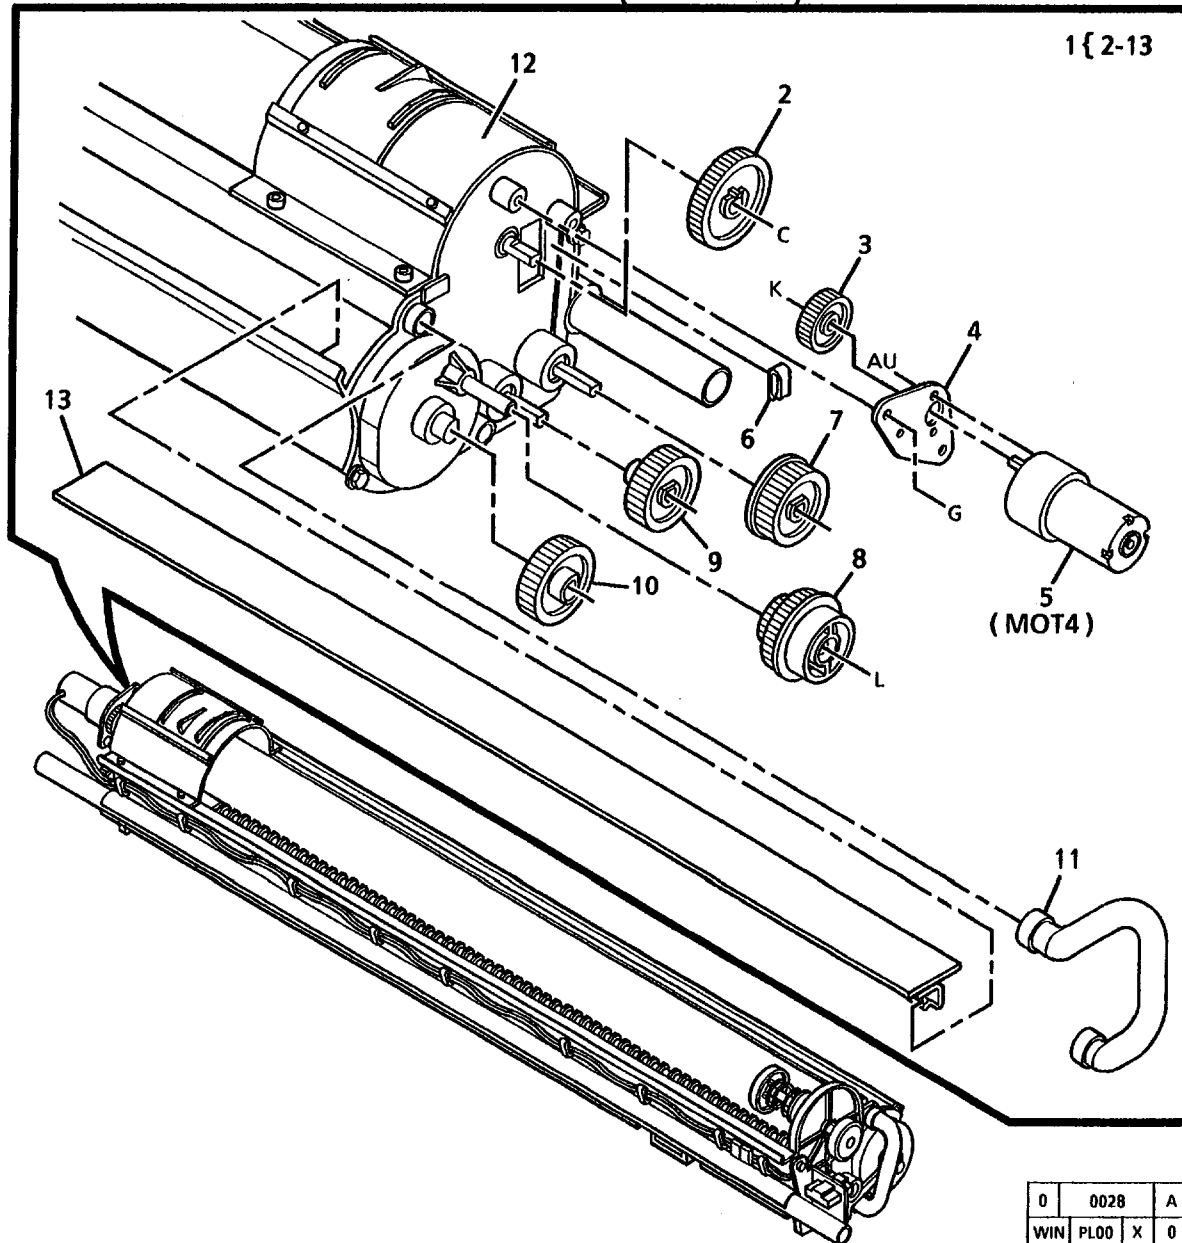
PL 9.10 DEVELOPER MODULE COMPONENTS (PART 2 OF 2)

ITEM	PART	DESCRIPTION
1	--	PART OF DEVELOPER MODULE ASSEMBLY (REF PL9.7, ITEM 7)
2	7E16330	CARTRIDGE GEAR (44T)
3	7E16340	CARTRIDGE DRIVE GEAR (26T)
4	15E17790	MOTOR MOUNTING PLATE
5	127K8920	CARTRIDGE DRIVE MOTOR (MOT4) (REP 9.6)
6	120E4750	CABLE CLIP
7	7E14690	AUGER DRIVE GEAR (37T)
8	7K5260	DEVELOPER DRIVE GEAR (43T/25T)
9	7E14700	AUGER DRIVE GEAR (37T)
10	7E14710	MAGNETIC ROLL DRIVE GEAR (40T)
11	54E3491	PRESSURE EQUILIZER TUBE
12	--	DEVELOPER FRAME (P/O ITEM 1)
13	35K4581	SEAL

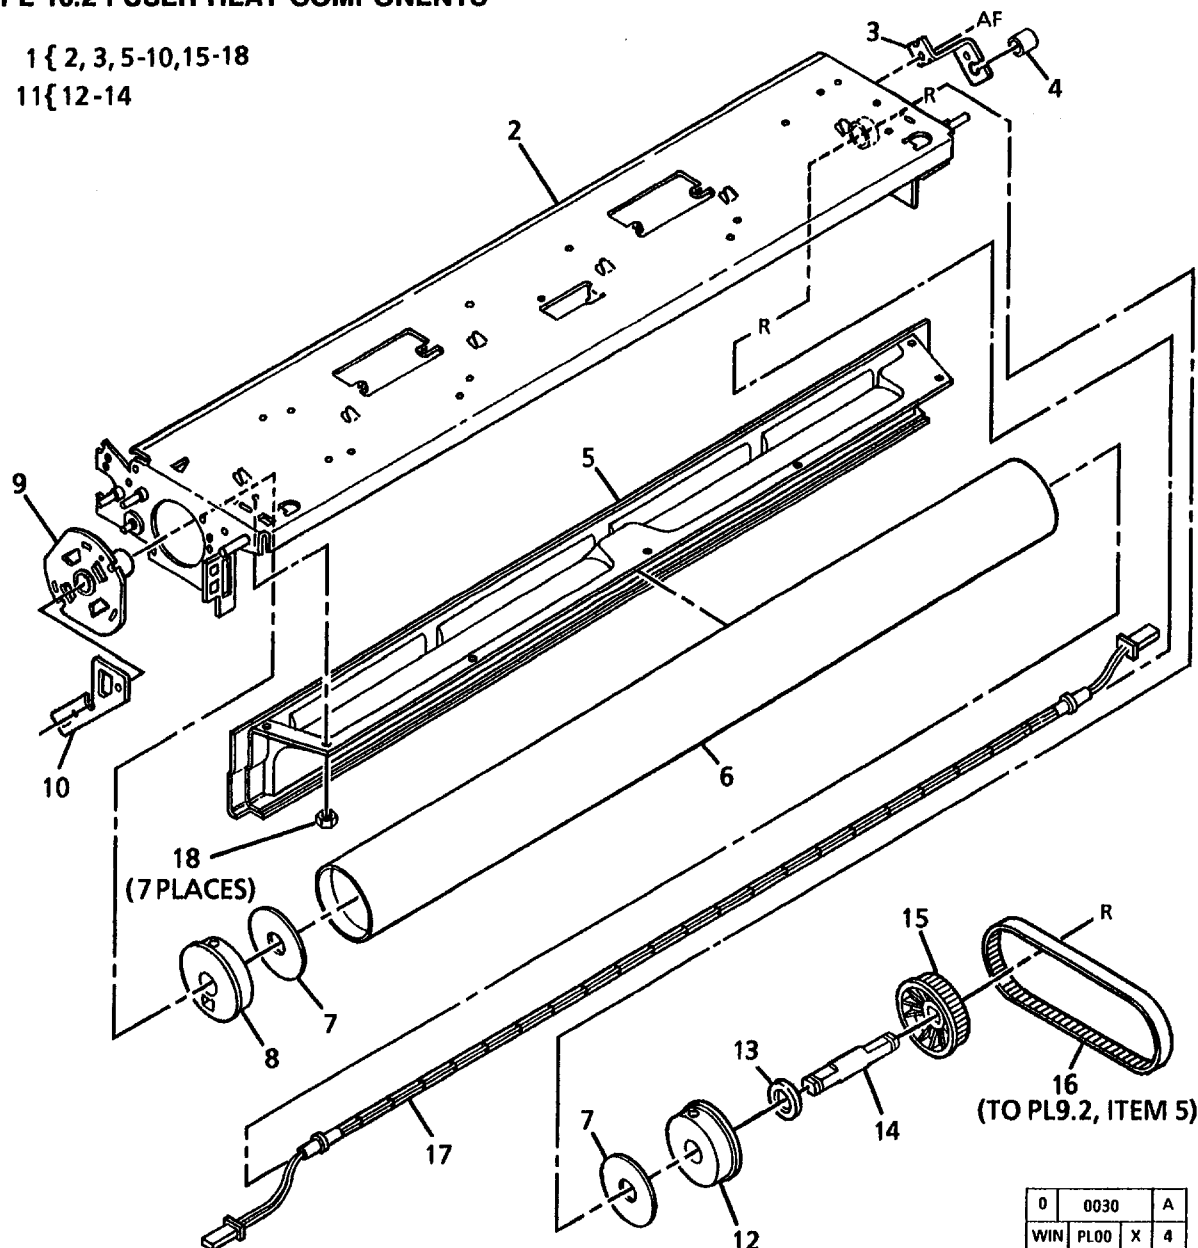
PL 10.2 FUSER HEAT COMPONENTS

ITEM	PART	DESCRIPTION
1	--	PART OF XEROGRAPHIC MODULE ASSEMBLY (REF PL10.1, ITEM 1)
2	--	XEROGRAPHIC FRAME (P/O ITEM 1)
3	49E6460	RH LAMP BRACKET
4	16E8080	GROMMET
5	54K1841	AIR MANIFOLD/ HEATSHIELD
6	22K40050	FUSER HEAT ROLL (REP 10.2, ADJ 10.2)
7	62E5461	REFLECTOR
8	5K2613	LH FUSER BEARING
9	5K3430	FUSER HUB
10	--	LH LAMP BRACKET (P/O ITEM 1)
11	600K45270	FUSER DRIVE SHAFT KIT
12	--	RH FUSER BEARING (P/O ITEM 11)
13	115E2231	GROUND RING
14	--	FUSER DRIVE SHAFT (P/O ITEM 11)
15	20E12832	FUSER DRIVE PULLEY (REP 10.4)
16	23E11181	FUSER DRIVE BELT
17	126E492	FUSER HEAT ROD (60HZ) (REP 10.1, ADJ 10.2)
-	126E821	FUSER HEAT ROD (50HZ) (REP 10.1, ADJ 10.2)
18	--	NUT (NOT SPARED)

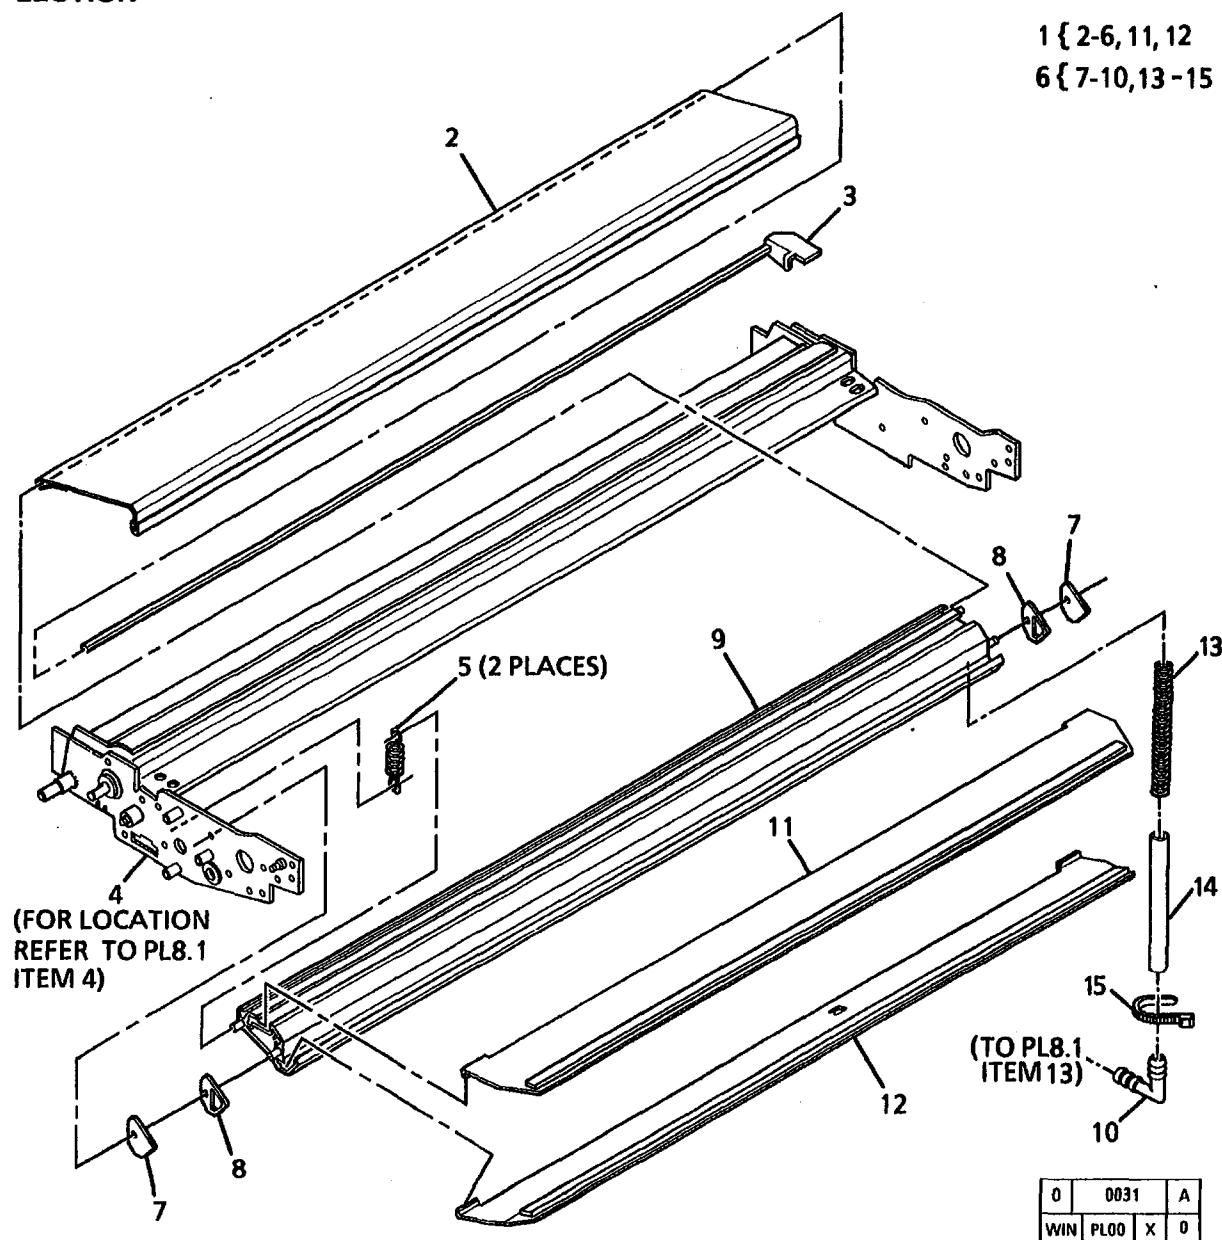
PL 10.3 FUSER PRESSURE COMPONENTS AND MOISTURE COLLECTION

ITEM	PART	DESCRIPTION
1	--	PART OF MEDIA TRANSPORT ASSEMBLY (REF PL8.1, ITEM 4)
2	23K471	FABRIC GUIDE ASSEMBLY (REP 8.9)
3	3K6360	FABRIC GUIDE
4	--	RETAINER HANDLE TRANSPORT FRAME (P/O ITEM 1)
5	9E32480	SPRING
6	2K55230	HOUSING ASSEMBLY
7	21E4990	END CAP
8	35E15280	GASKET
9	--	HOUSING (P/O ITEM 6)
10	--	ADAPTER (P/O ITEM 6)
11	33K1271	PRESSURE PLATE A
12	33K1281	PRESSURE PLATE B
13	9E46870	DRAIN TUBE SPRING
14	52E7900	MOISTURE DRAIN TUBE
15	--	CABLE TIE (P/O ITEM 6)

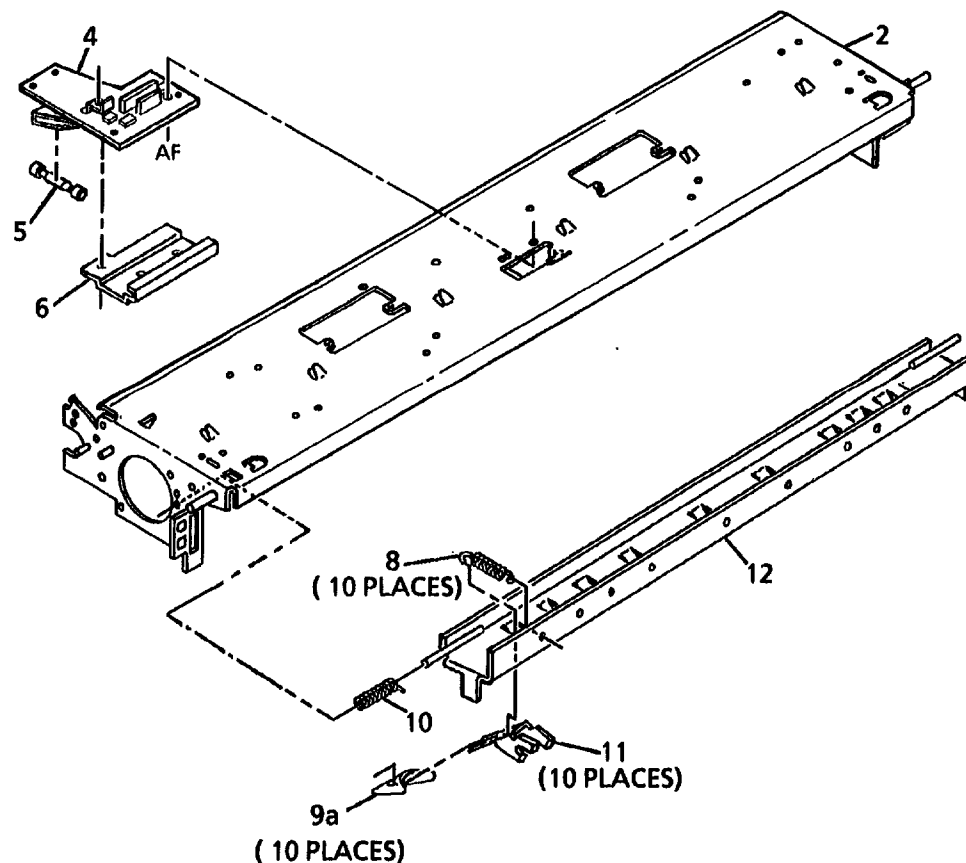
PL 10.4 FUSER HEAT CONTROL AND STRIPPER FINGERS

ITEM	PART	DESCRIPTION
1	--	PART OF XEROGRAPHIC MODULE ASSEMBLY (REF PL10.1, ITEM 1)
2	--	XEROGRAPHIC FRAME (P/O ITEM 1)
3	130K52351	THERMISTOR ASSEMBLY (REP 10.5)
4	--	THERMISTOR (P/O ITEM 3)
5	108E1830	THERMAL FUSE
6	118E7492	INSULATOR
7	30K51120	STRIPPER BRACKET ASSEMBLY
8	9E57010	SPRING
9	600K35880	STRIPPER FINGER SPARE KIT
9a	--	STRIPPER FINGER (REP 10.8)
10	9E38060	SPRING
11	68E38113	STRIPPER FINGER BRACKET
12	--	STRIPPER FINGER SUPPORT (P/O ITEM 7) (REP 10.6)

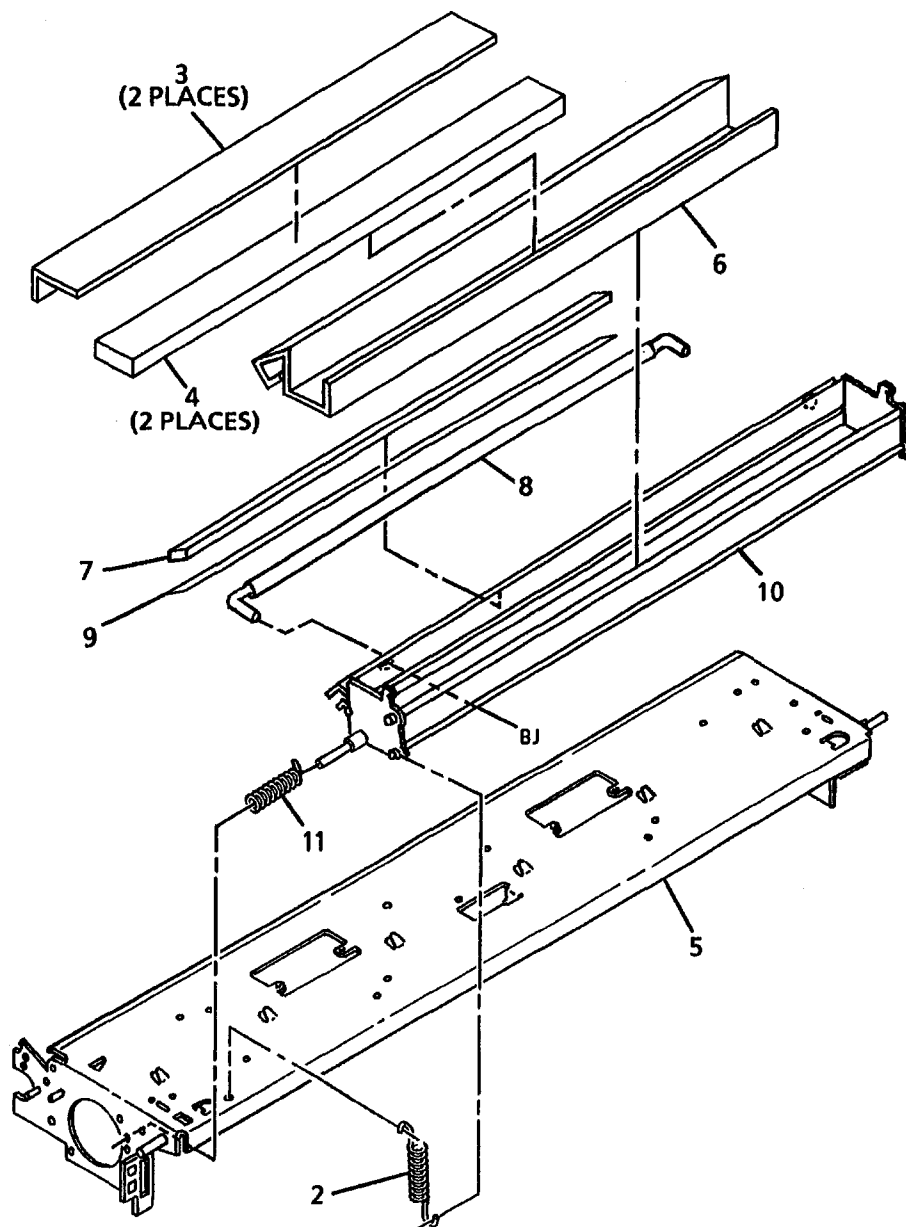
PL 10.5 FUSER OILER

ITEM	PART	DESCRIPTION
1	--	PART OF XEROGRAPHIC MODULE ASSEMBLY (REF PL10.1, ITEM 1)
2	9E54440	SPRING
3	--	OIL PAD COVER (TO BE AVAILABLE AT LATER DATE)
4	19K3310	OIL PAD (REP 10.9)
5	--	XEROGRAPHIC FRAME (P/O ITEM 1)
6	94K2660	WICK (REP 10.11)
7	19E24110	PRESSURE PAD
8	22K34060	OIL DISPENSE ROLL (REP 10.10)
9	1E27610	SHIM
10	48K22810	OIL DISPENSE HOUSING (REP 10.7)
11	9E38060	SPRING
