- **Call Flow Diagram** - This diagram outlines the major activities that are performed when a service call is made. The **Initial Actions** assist the Service Representative through the customer interface and help to identify the problem. The diagram also directs the Representative to verify, classify, repair the problem and perform the correct Maintenance Procedure.

2. Status Indicator Repair Analysis Procedures

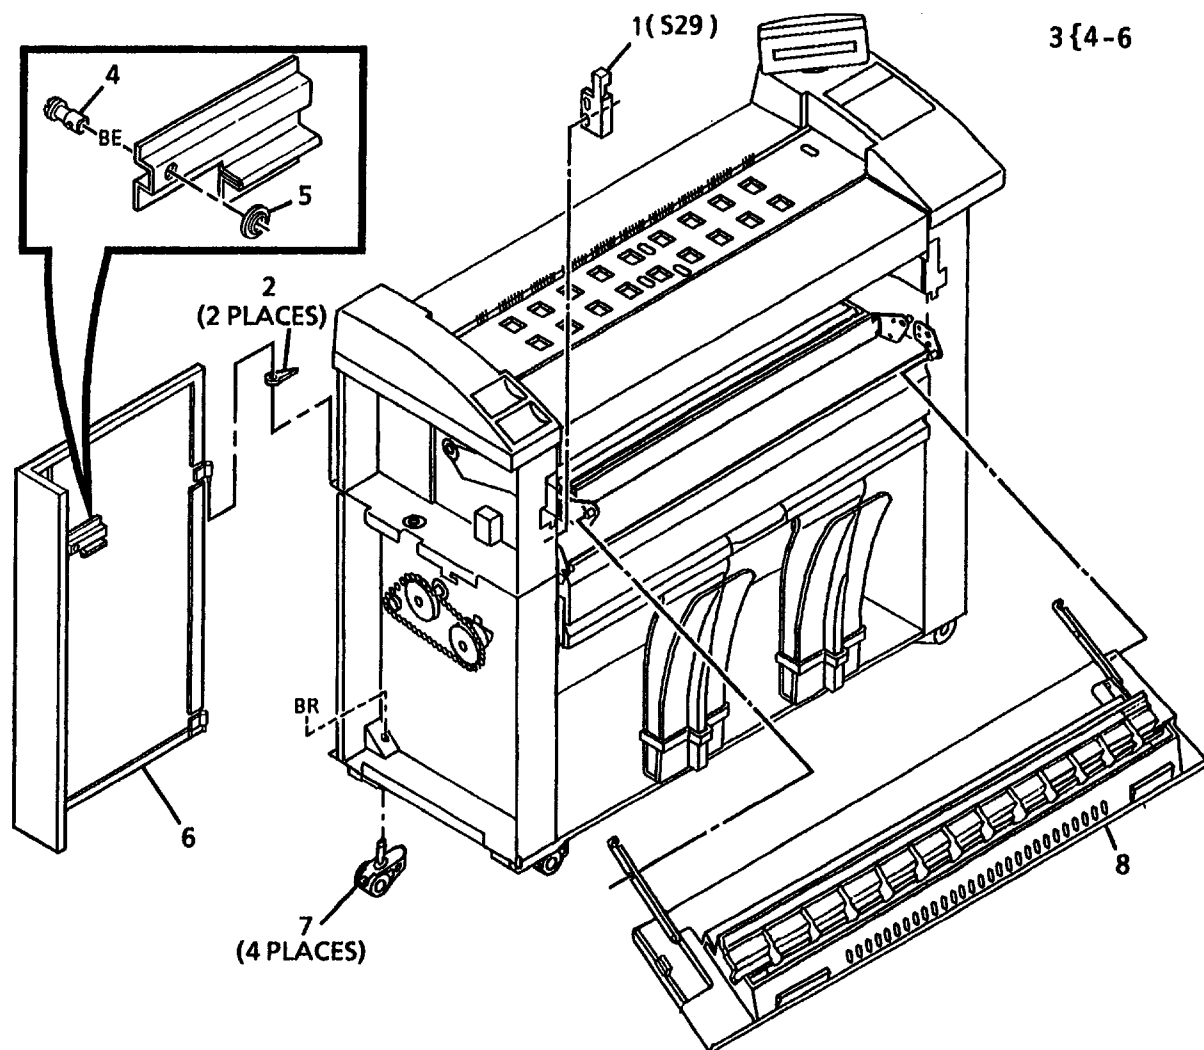
PL 14.1 CUT SHEET FEED-IN SHELF AND LEFT SIDE DOOR

ITEM	PART	DESCRIPTION
1	130E2271	CUT SHEET FEED-IN SHELF INTERLOCK SWITCH (S29)
2	14E20541	LEFT HINGE SPACER
3	48K18980	LEFT DOOR ASSEMBLY (REP 14.1)
4	29E15040	LEFT DOOR FASTENER
5	429W20350	GROMMET
6	--	LEFT DOOR (P/O ITEM 3)
7	17K1120	LOCKING CASTOR
8	30K52510	CUT SHEET FEED-IN SHELF ASSEMBLY (60HZ)
-	30K52500	CUT SHEET FEED-IN SHELF ASSEMBLY (50HZ)

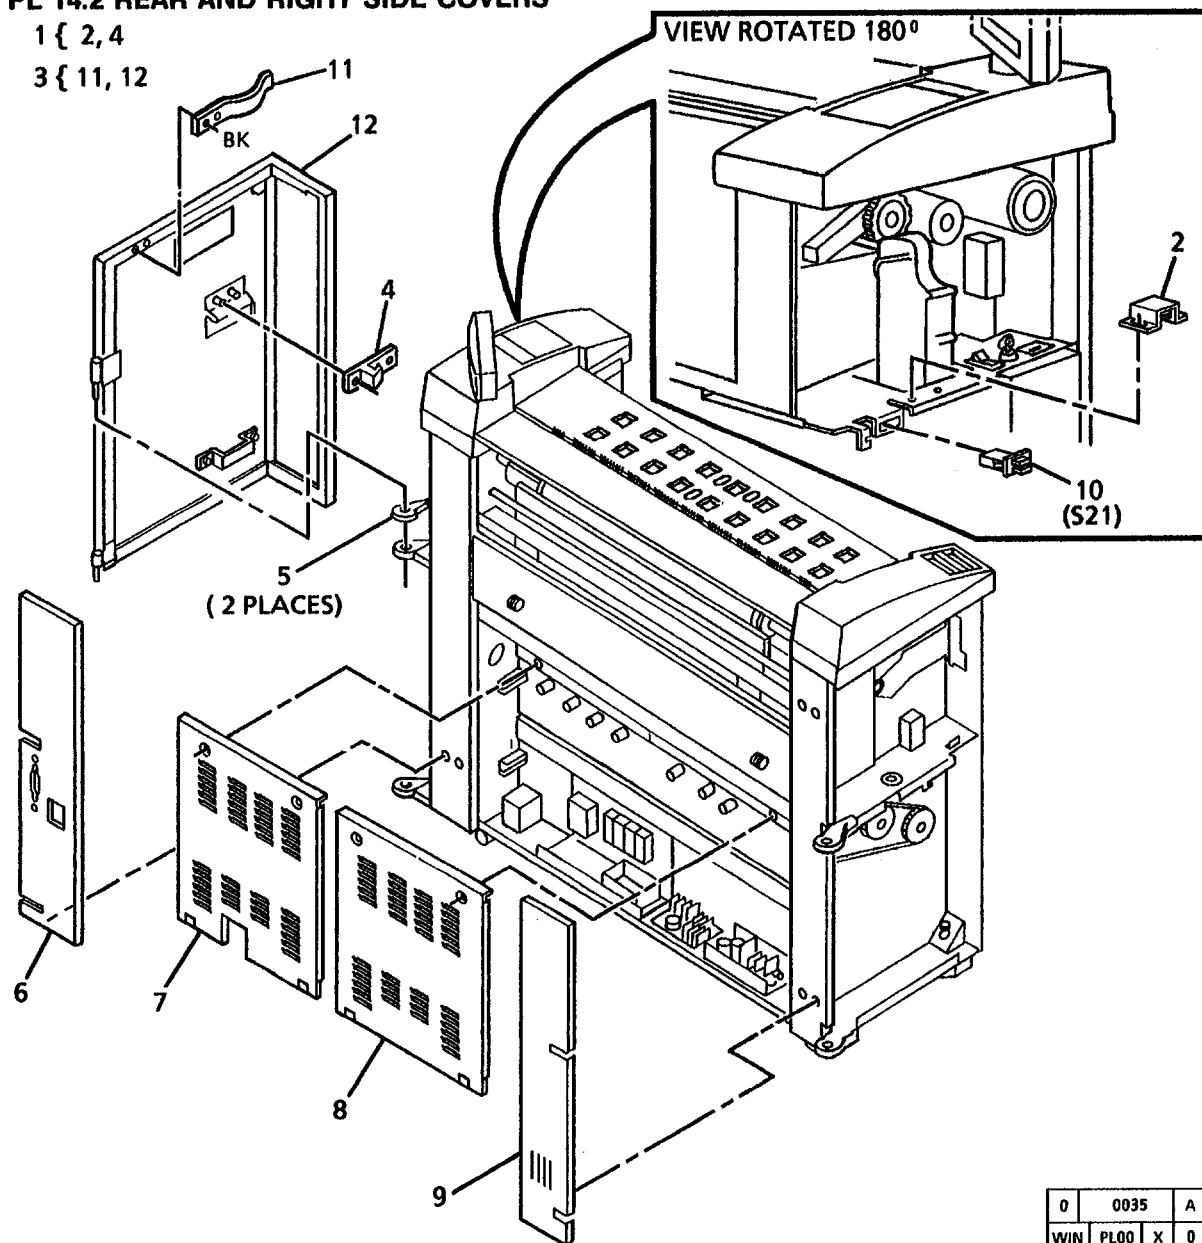
PL 14.2 REAR AND RIGHT SIDE COVERS

ITEM	PART	DESCRIPTION
1	3E18740	RIGHT DOOR
2	--	LATCH ASSEMBLY
3	48K18990	LATCH (P/O ITEM 1)
4	--	RIGHT SIDE DOOR
5	14E20551	ASSEMBLY (REP 14.1)
6	48K19000	KEEPER (P/O ITEM 1)
7	2K64491	RIGHT HINGE SPACER
8	48K10040	RIGHT REAR COVER
9	2K48982	LOWER RIGHT REAR COVER
10	110E2640	LOWER LEFT REAR COVER
11	--	LEFT REAR COVER
12	--	RIGHT SIDE DOOR
		INTERLOCK SWITCH (S21)
		GROUNDING SPRING
		(P/O ITEM 3)
		RIGHT SIDE DOOR
		(P/O ITEM 3)

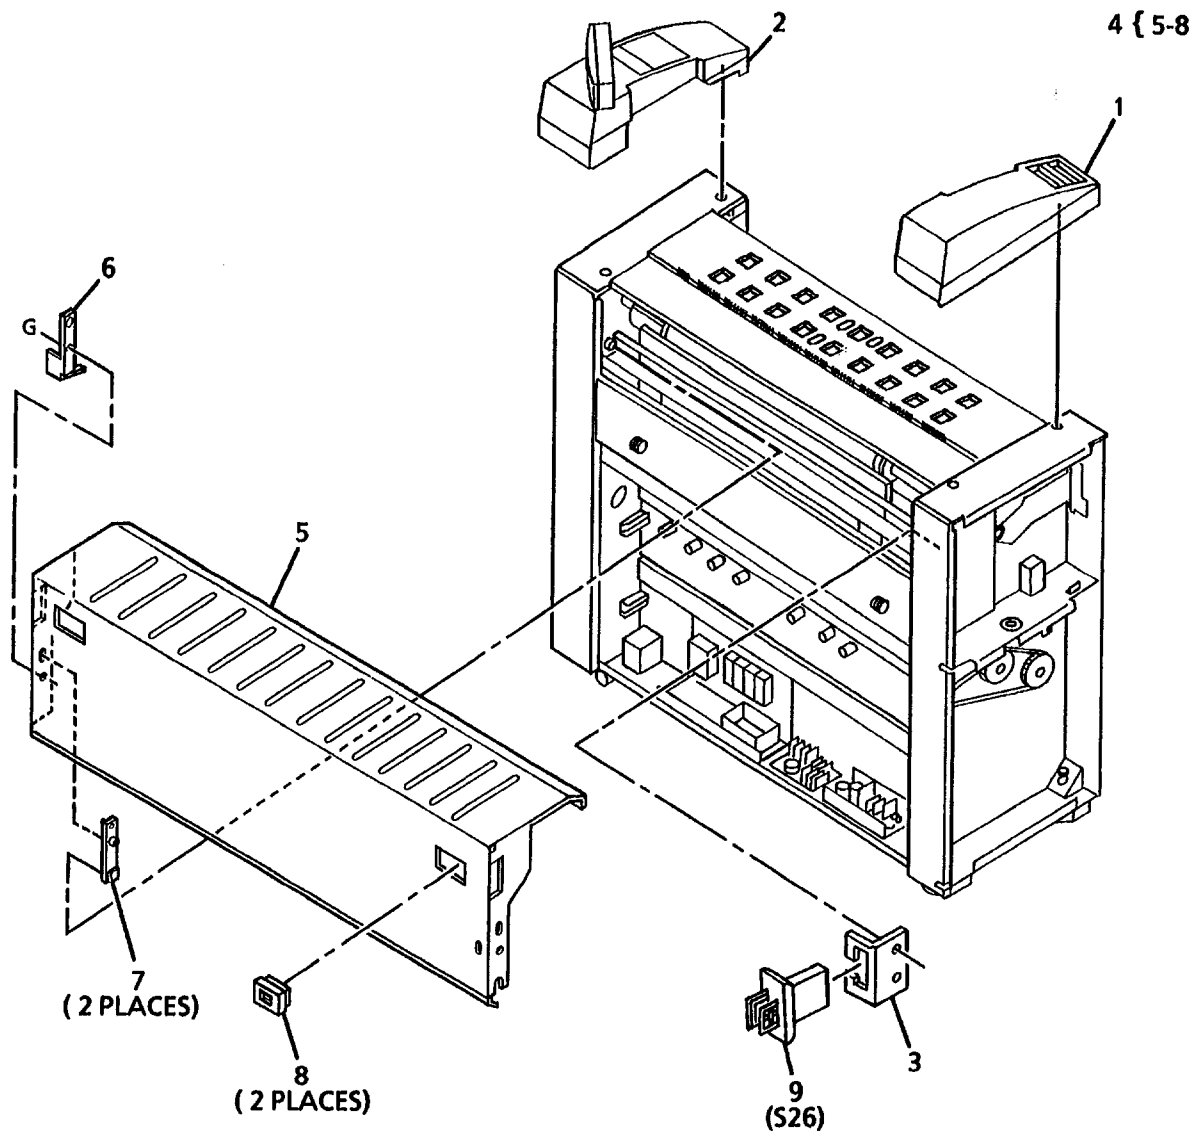
PL 14.3 LEFT AND RIGHT CAPS AND UPPER REAR DOOR

ITEM	PART	DESCRIPTION
1	21E4873	LEFT CAP
2	--	CONTROL CONSOLE HOUSING (RIGHT CAP) (REF PL1.4, ITEM 1) (NOT SPARED)
3	--	INTERLOCK BRACKET (NOT SPARED)
4	2K55982	UPPER REAR DOOR ASSEMBLY
5	--	UPPER REAR DOOR (P/O ITEM 4)
6	--	UPPER REAR DOOR SPRING
7	--	GROUND (P/O ITEM 4)
8	--	PIVOT GUIDE (P/O ITEM 4)
9	3E18781	LATCH
10	110E2640	DEVELOPER COVER (UPPER REAR DOOR)
		INTERLOCK SWITCH (S26)

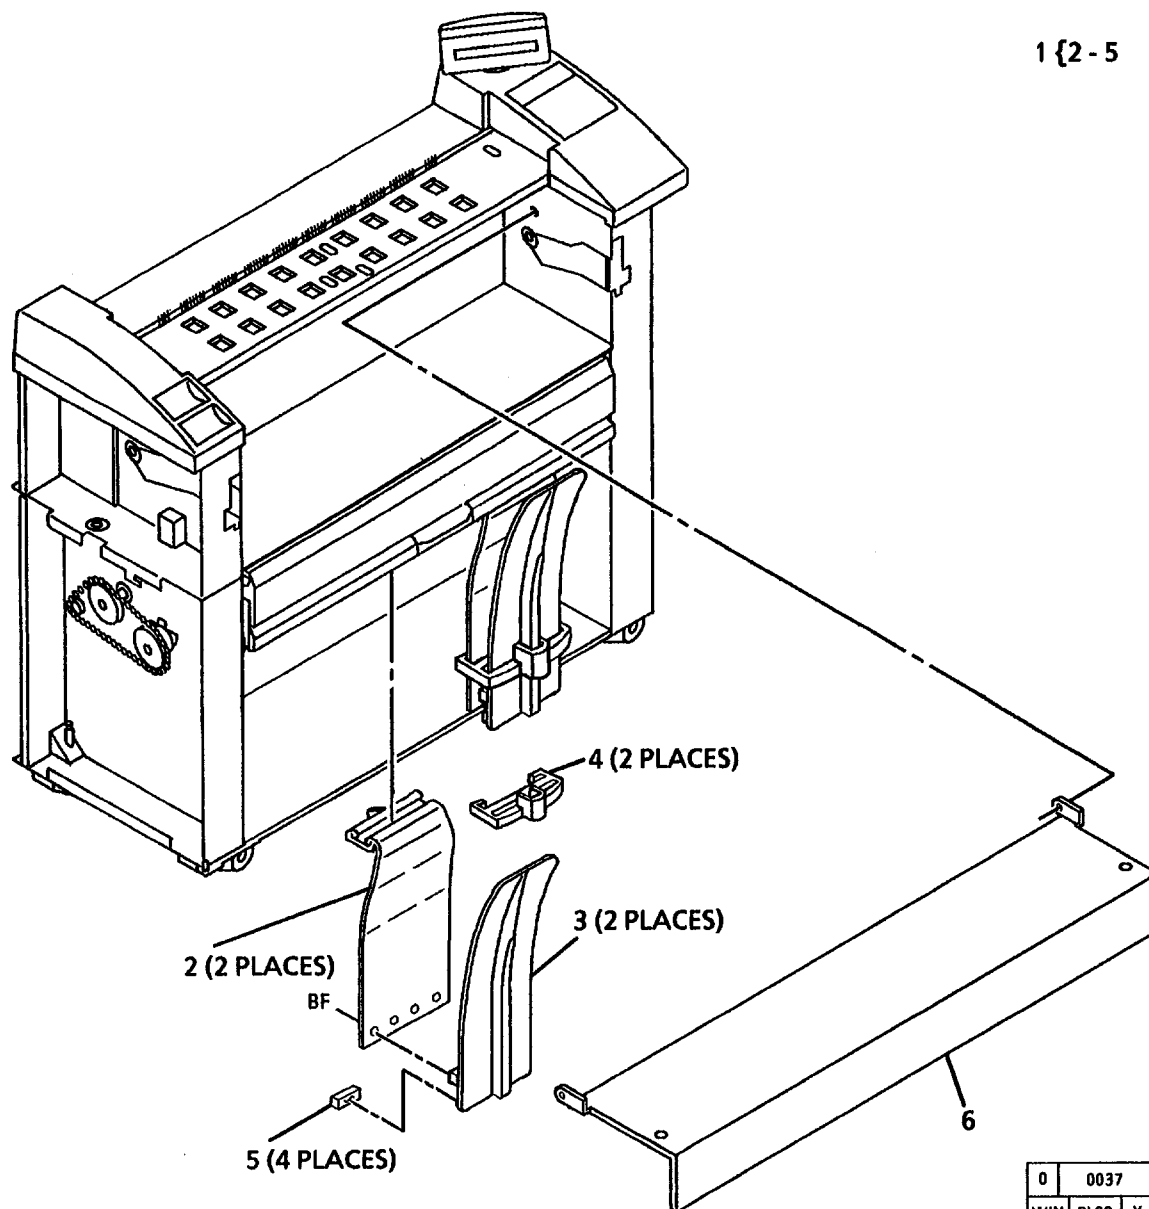
PL 14.4 DOCUMENT FEED-IN SHELF AND COPY CATCH SHIELDS

ITEM	PART	DESCRIPTION
1	50K21140	COPY CATCH SHIELD ASSEMBLY
2	--	REAR STACKER (P/O ITEM 1)
3	--	FRONT STACKER (P/O ITEM 1)
4	17E6010	COPY STOP
5	121E9040	MAGNET
6	30K52060	DOCUMENT FEED-IN SHELF ASSEMBLY (60HZ)
-	30K52040	DOCUMENT FEED-IN SHELF ASSEMBLY (50HZ)

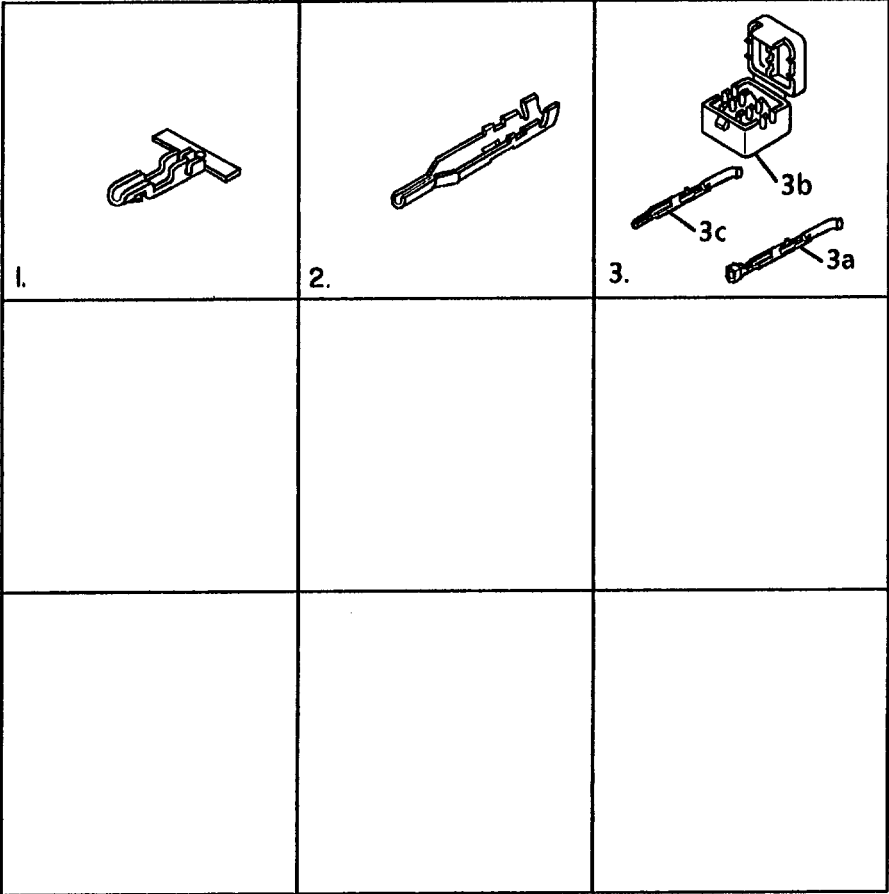
PL 15.1 MISCELLANEOUS ELECTRICAL CONNECTORS AND FASTENERS

ITEM	PART	DESCRIPTION
1	--	CONTACT SOCKET (20-26 AWG) (TO BE AVAILABLE AT LATER DATE)
2	--	CONTACT PIN (20-26 AWG) (TO BE AVAILABLE AT LATER DATE)
3	600K30680	WIRE AND CONNECTOR REPAIR KIT
3a	--	SOCKET WIRE (10/KIT)
3b	--	CONNECTOR (20/KIT)
3c	--	PIN WIRE (10/KIT)

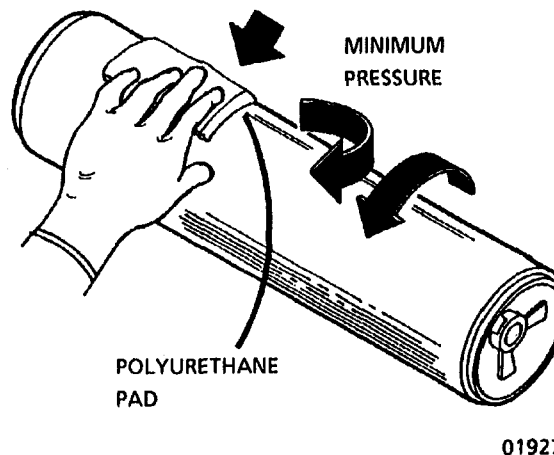
Figure 1. Washing the Drum

Ensure that the ends of the drum are washed.

6. Using the clean side of the polyurethane pad, continue washing the drum until the entire surface of the drum is covered with film remover.
7. Allow enough time for the air to dry the surface of the drum.
8. Use the dusting pouch to apply a thin layer of zinc stearate over the entire surface of the drum.
9. Buff the surface of the drum using the clean side of the dry polyurethane pad.

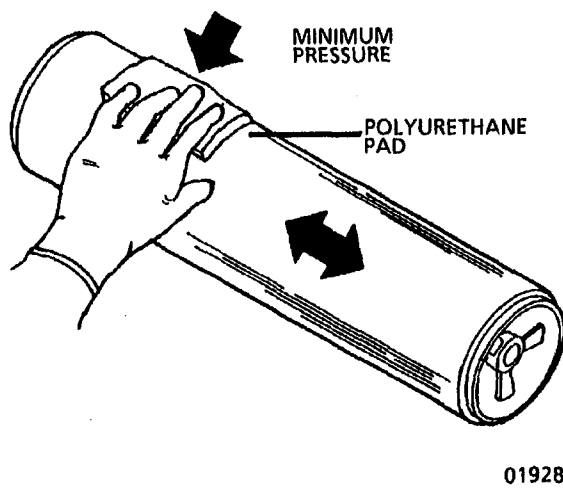
Figure 2. Polishing the Drum

2 Ensure that the entire surface of the drum is polished.

1. Remove the photoreceptor drum assembly from the xerographic module (REP 9.2).
2. Put on gloves.
3. Gently remove any dry ink / toner and developer from the surface of the drum, using a dry polyurethane pad.
4. Completely soak two sponges with water.
5. Using a paper towel, remove some water from one of the sponges until the sponge is only slightly damp.
6. Using another paper towel, remove some water from the second sponge until it is drier than the first sponge.
7. Shake the container of polish thoroughly.
8. Put a large amount of polish on a clean polyurethane pad.
9. (Figure 2): Polish the drum.

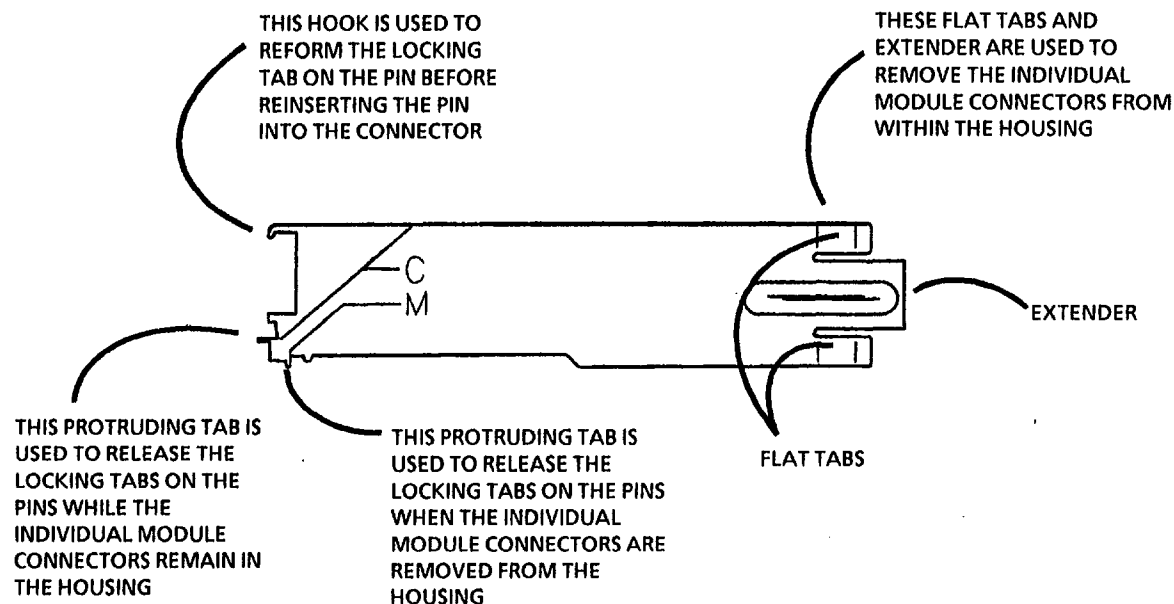
Figure 1. Molex Extraction Tool

600T1825 Extraction Tool

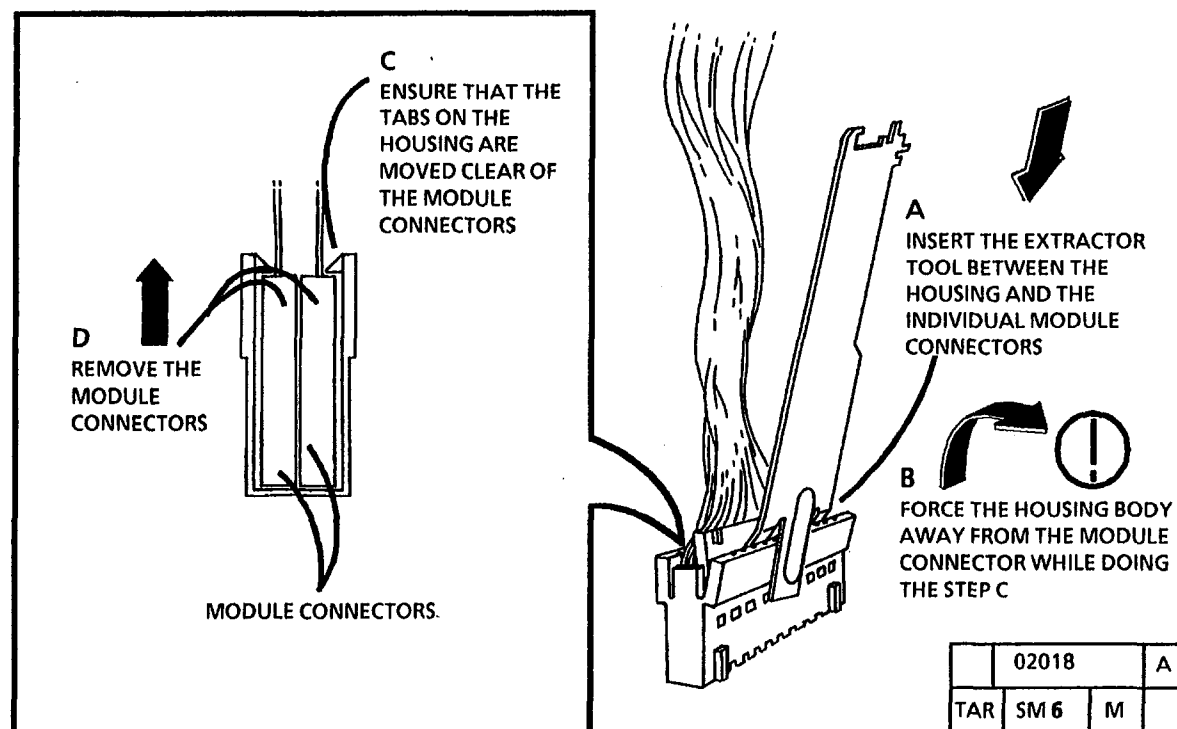
Figure 2. Remove the individual module connectors from the housing

⚠ *STEP 2 B: Use caution when forcing the housing body away from the module connector. Too much force could cause damage to the housing body.*

2. (Figure 2): Remove the individual module connectors from the housing.

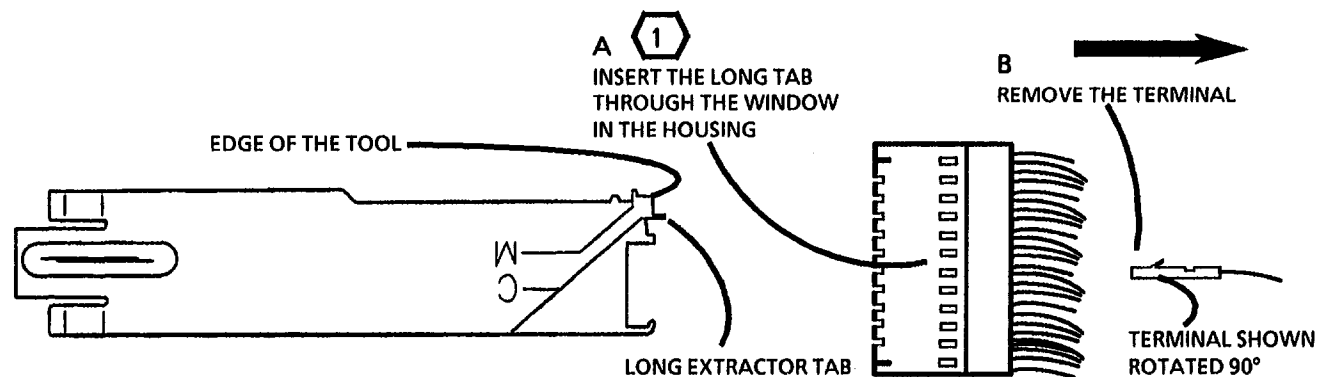
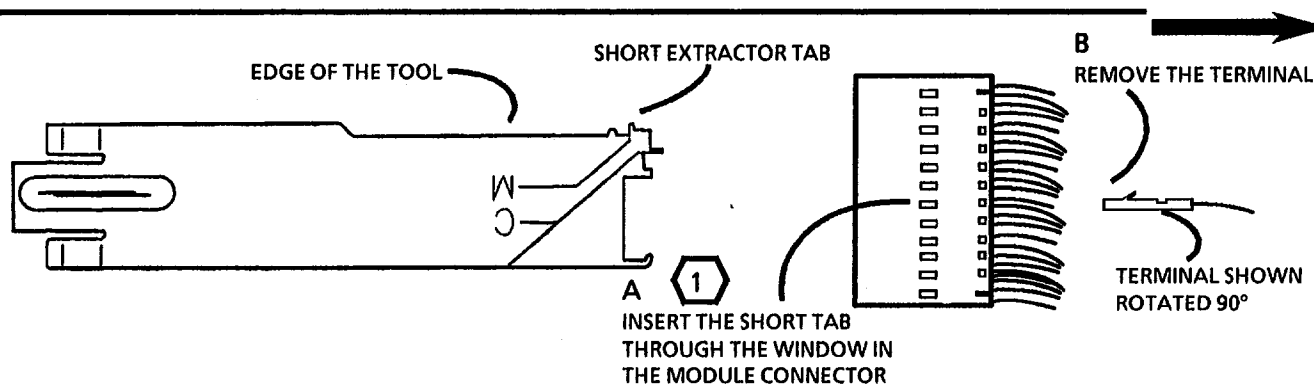
Figure 3. Remove the Terminals from the Connectors

1 STEP 3 A: Insert the extractor tabs until the face of the tool is flush with the connector housing.

3. (Figure 3): Remove the Terminals from the Connectors.

TERMINAL REMOVAL THROUGH THE HOUSING

TERMINAL REMOVAL FROM MODULE CONNECTOR REMOVED FROM THE HOUSING

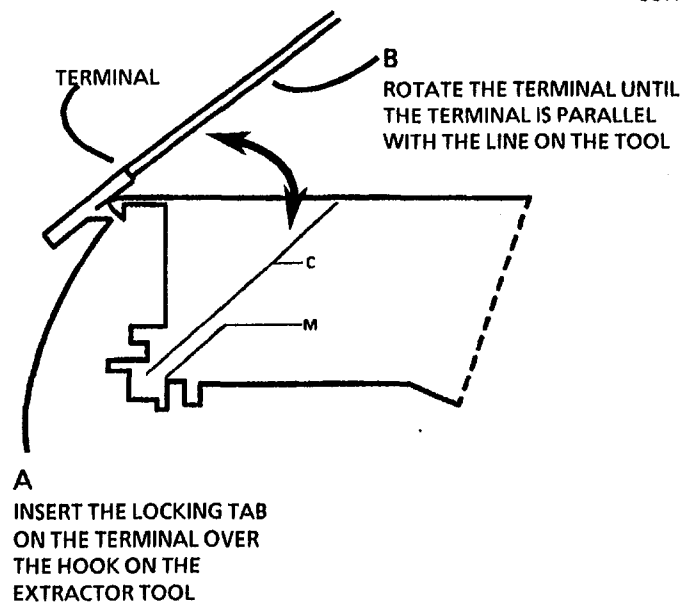
Figure 4. Reform the Terminal Locking Tab

4. (Figure 4): Reform the Terminal Locking Tab.

5. Reinstall the terminal to the pin position it was removed from.
6. Reinstall the individual module connectors to the correct locations noted at the beginning of this procedure. Refer to section 7 for detail of connector configuration

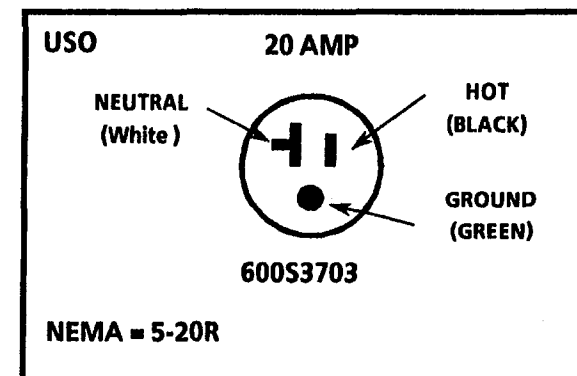
ⓘ Before installing the 3030 Copier, check for correct voltage, polarity and the grounding of the AC outlet that is provided by the customer. Use the Polarity Checker (600T467) or a multi-meter. Incorrect voltage applied to the 3030 could result in poor performance or damage to the copier.

1. Check the ground and the AC voltage.

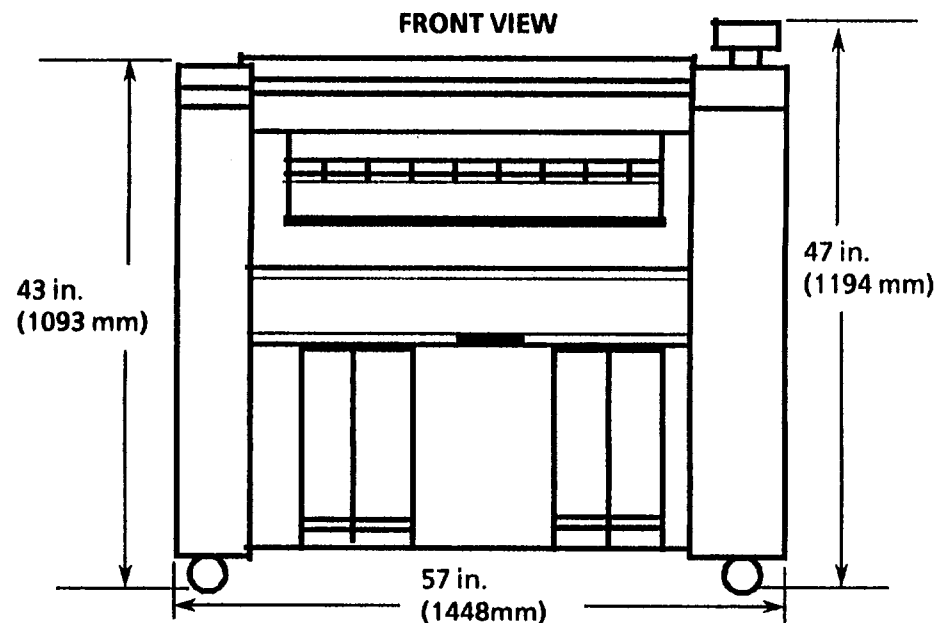
Figure 1. Minimum Space Requirements

105 inches X 86 inches (2667 mm X 2185 mm)

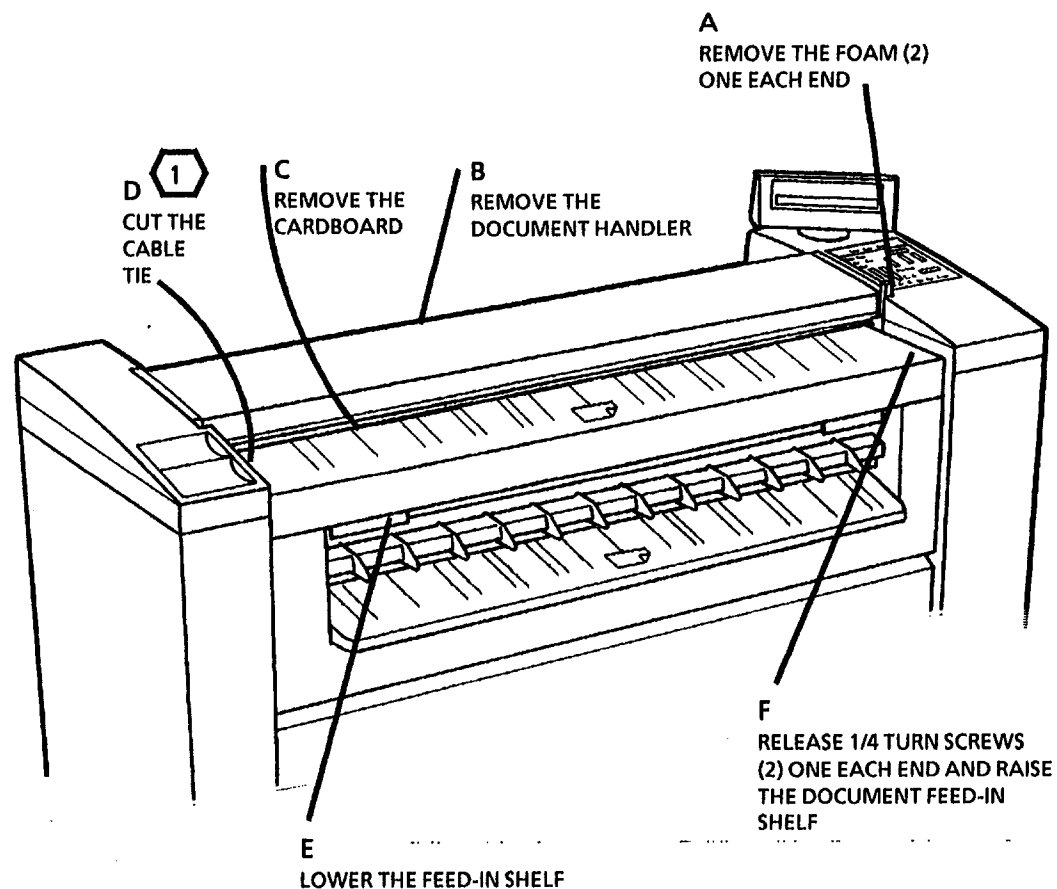
Figure 3. Remove Document Handler

STEP D: The cable tie is securing the Cleaning Blade Weight.

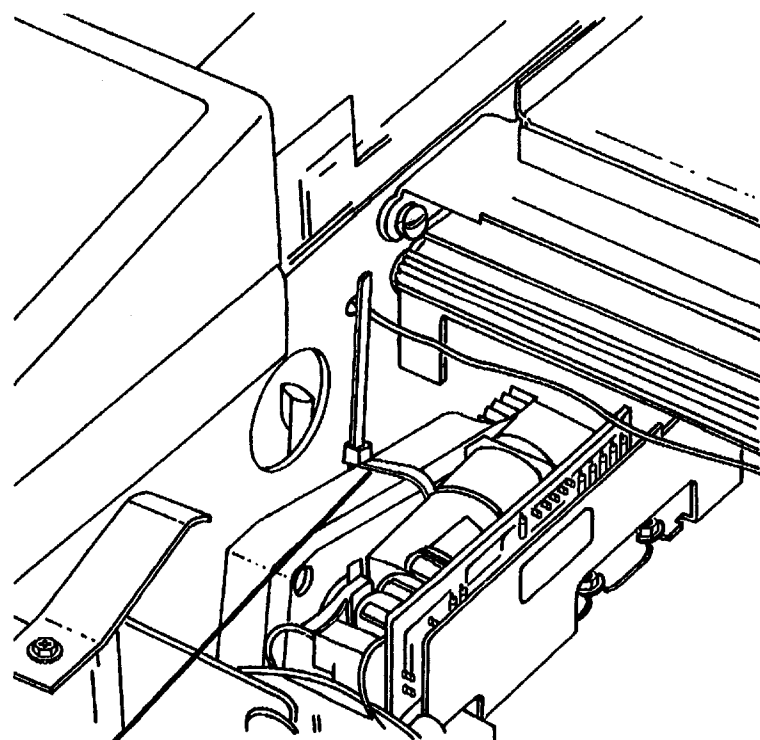
STEP B: Place your index finger on the head of the cable tie behind the bracket to ensure that the end of the cable tie does not fall into the copier.

A
CUT AND REMOVE THE CABLE
TIE FROM THE BLADE WEIGHT

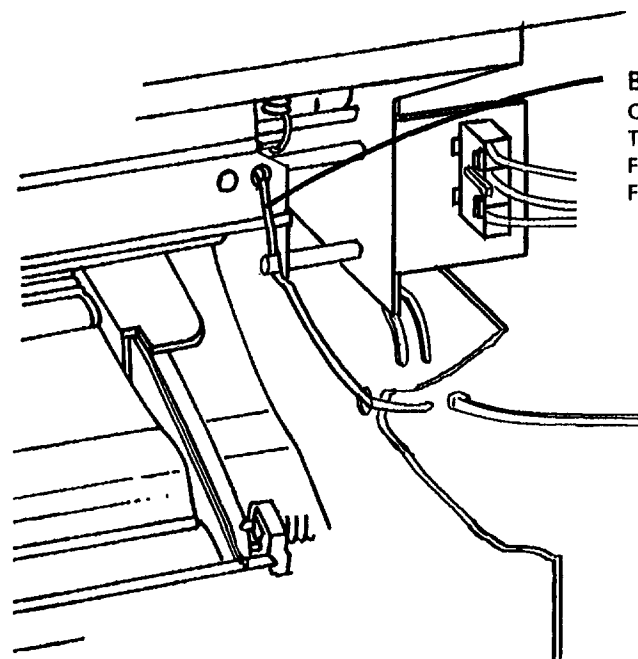
CUT AND REMOVE
THE CABLE TIES
FROM THE STRIPPER
FINGER BRACKET

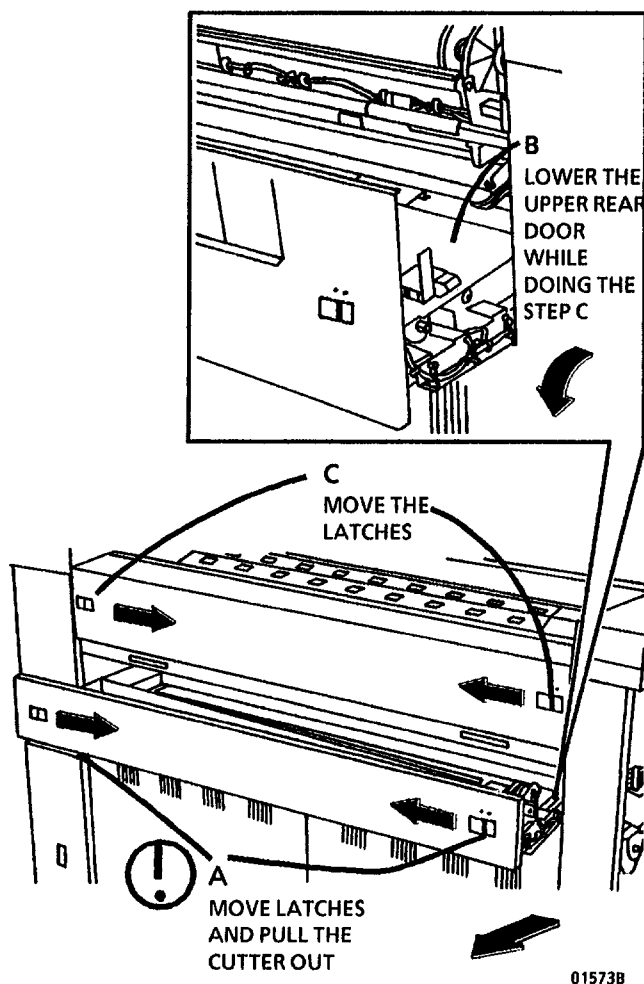
Figure 5. Prepare to Remove the Developer Module

STEP 3 A: To avoid damage to the hinges on the upper rear door, pull the cutter out to support the upper rear door.

3. (Figure 5): Prepare to Remove the Developer Module.

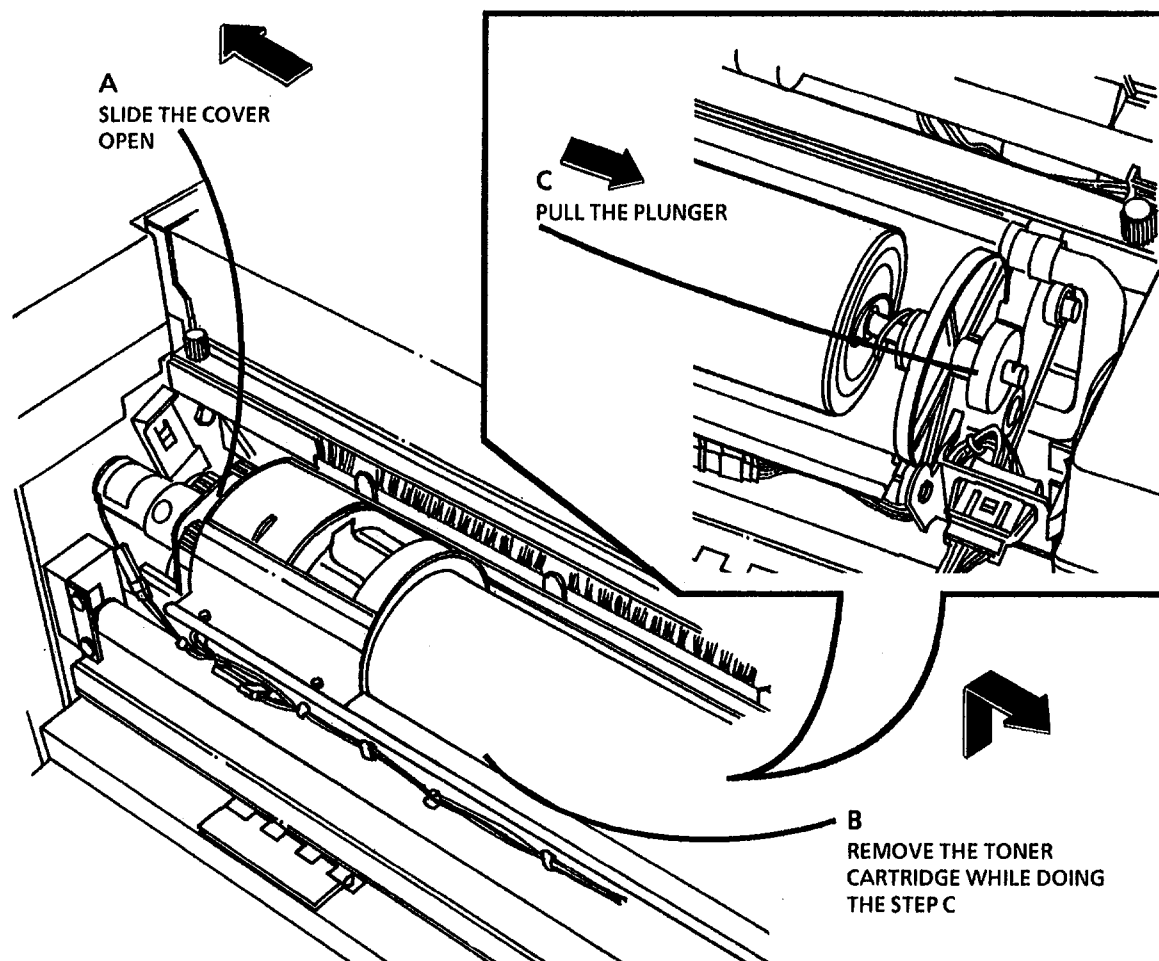
Figure 6. Remove the Toner Cartridge

4. (Figure 6): Remove the Toner Cartridge.

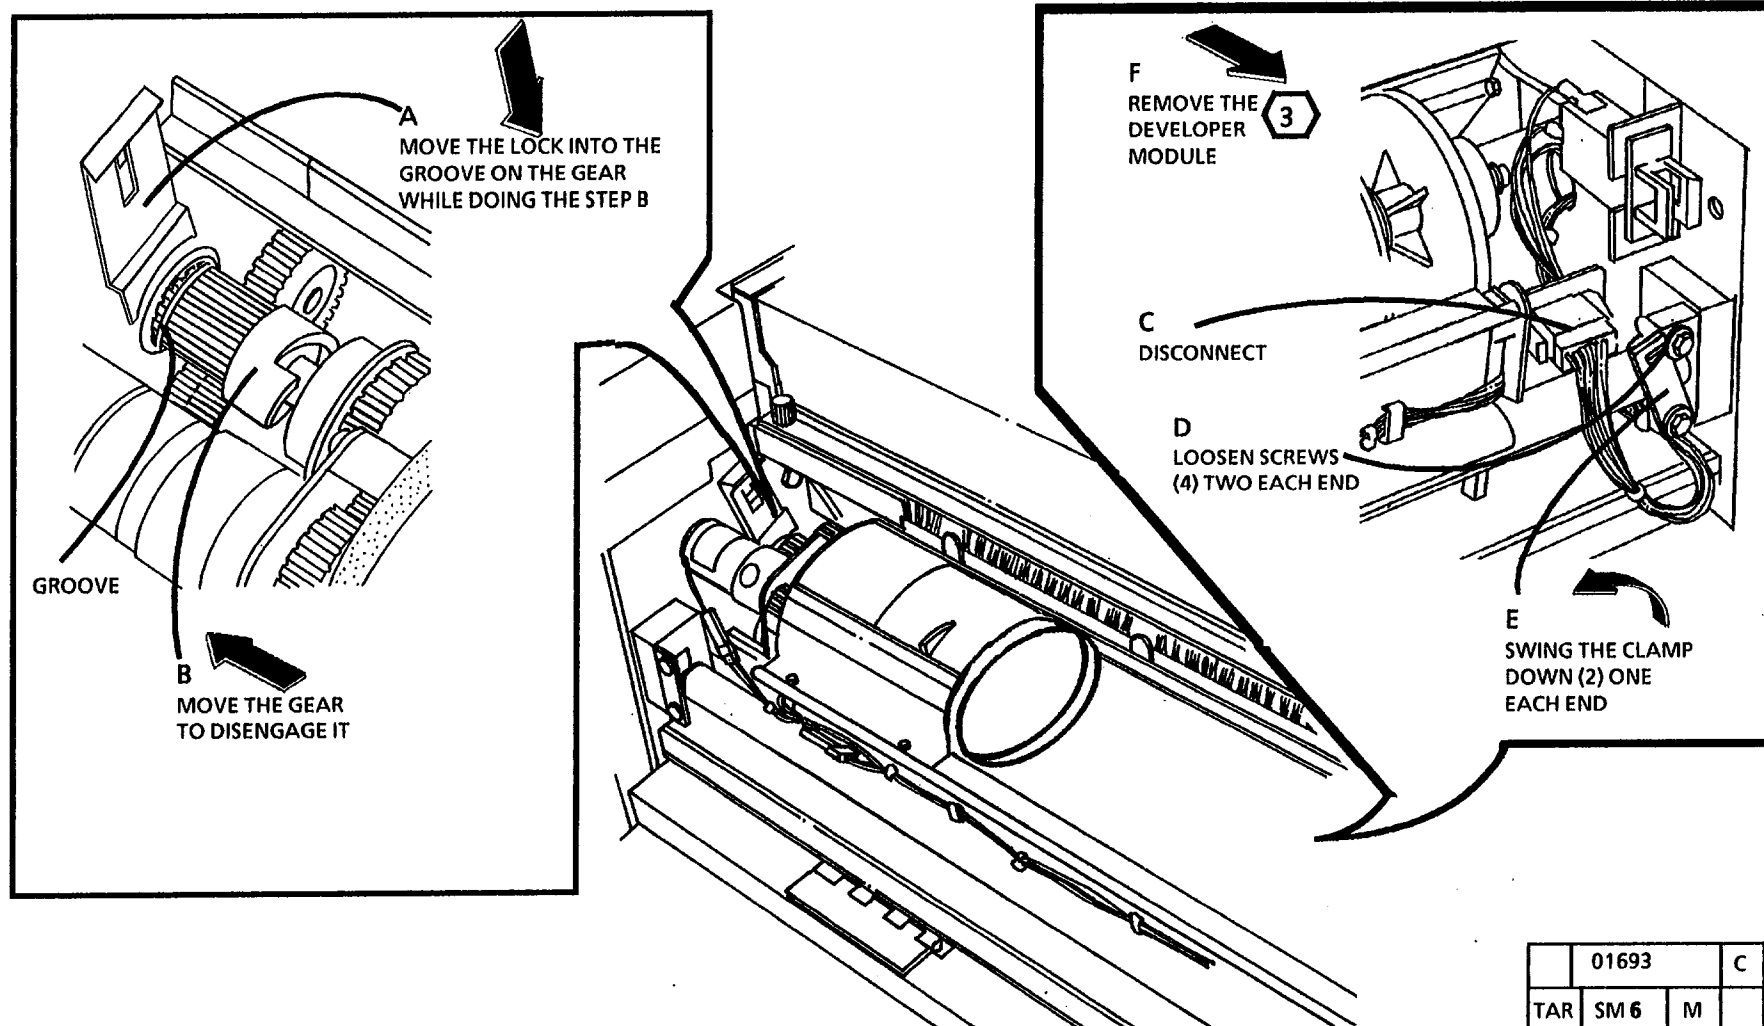
Figure 7. Remove the Developer Module

5. (Figure 7): Remove the Developer Module.

3 STEP 5 F: Before removing the developer module, ensure that there is a clean area to place the assembly.

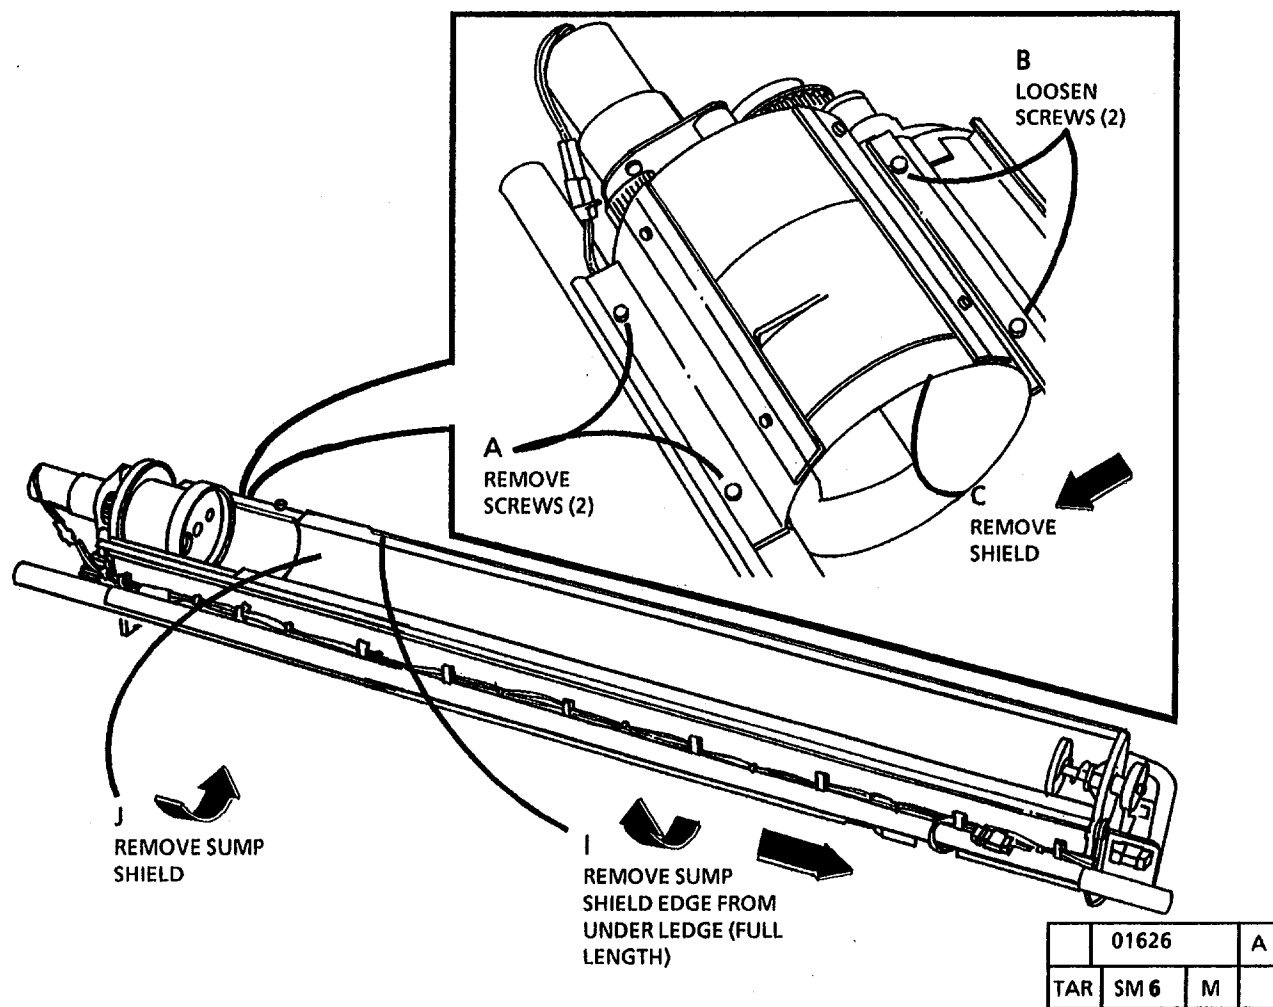
Figure 8. Remove the Sump Shield from Under the Toner Cartridge

6. (Figure 8): Remove the Sump Shield from under the toner cartridge.

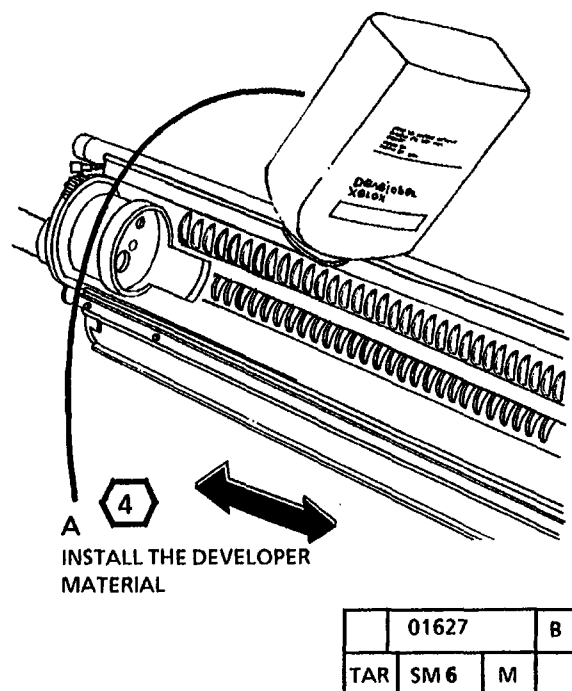
Figure 9. Install the Developer Material

4 STEP 7A: Pour the developer material evenly over the full length of the augers.

7. (Figure 9): Install the Developer Material and record the batch number on the machine log.

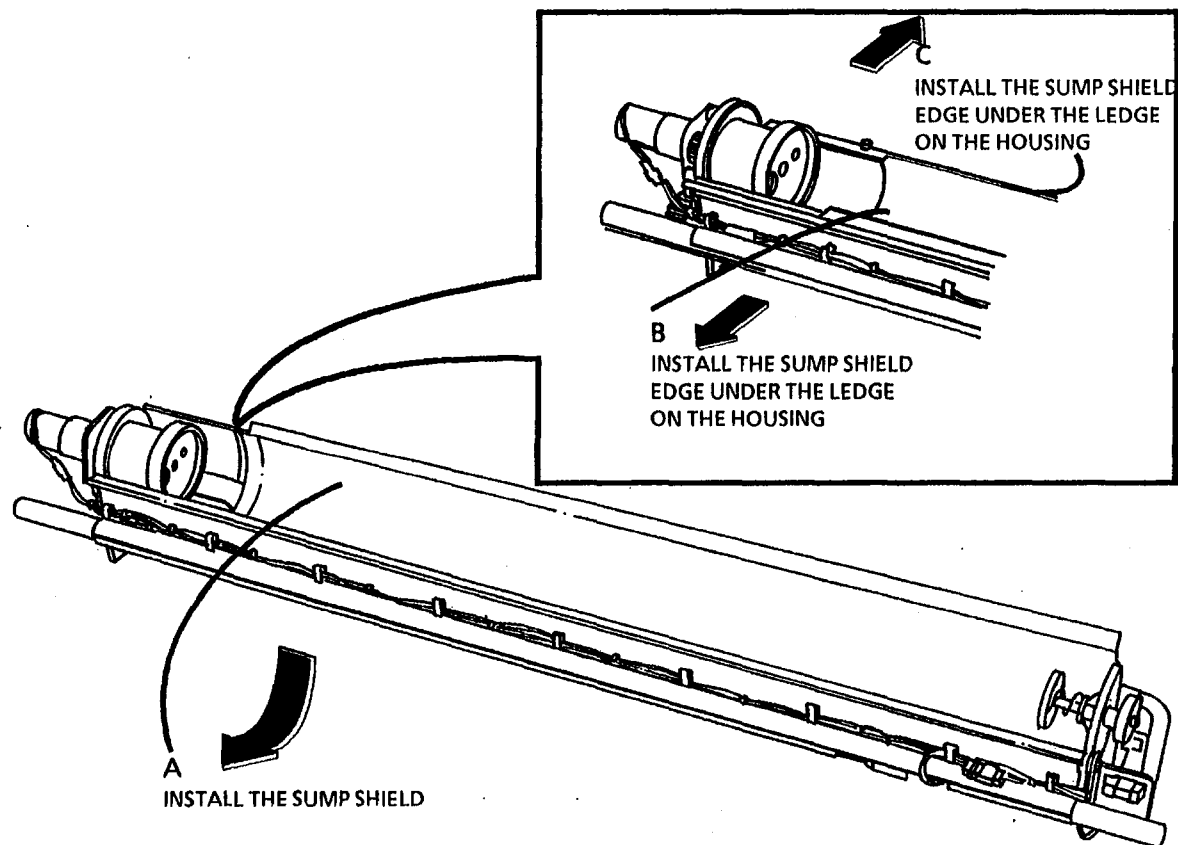
Figure 10. Reinstall the Sump Shield on the bottom of the Developer Module

8. (Figure 10): Reinstall the Sump Shield on the bottom of the Developer Module.

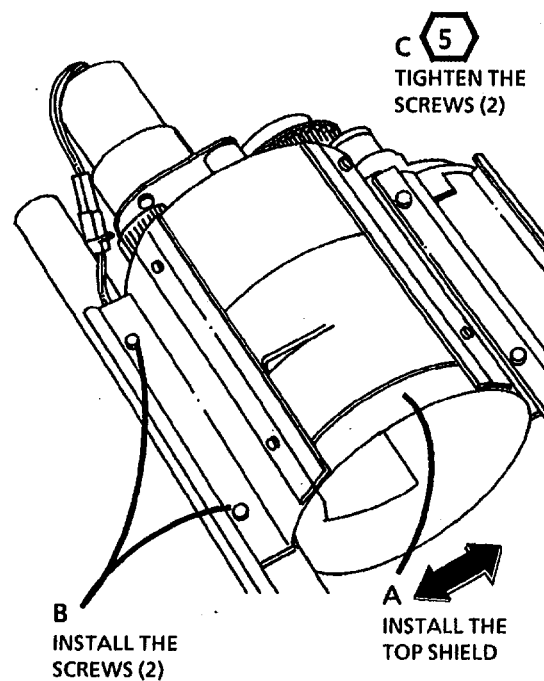
Figure 11. Reinstall the Top Shield

5 *STEP 9 C: Do not overtighten the screws.*

9. (Figure 11): Reinstall the Top Shield.

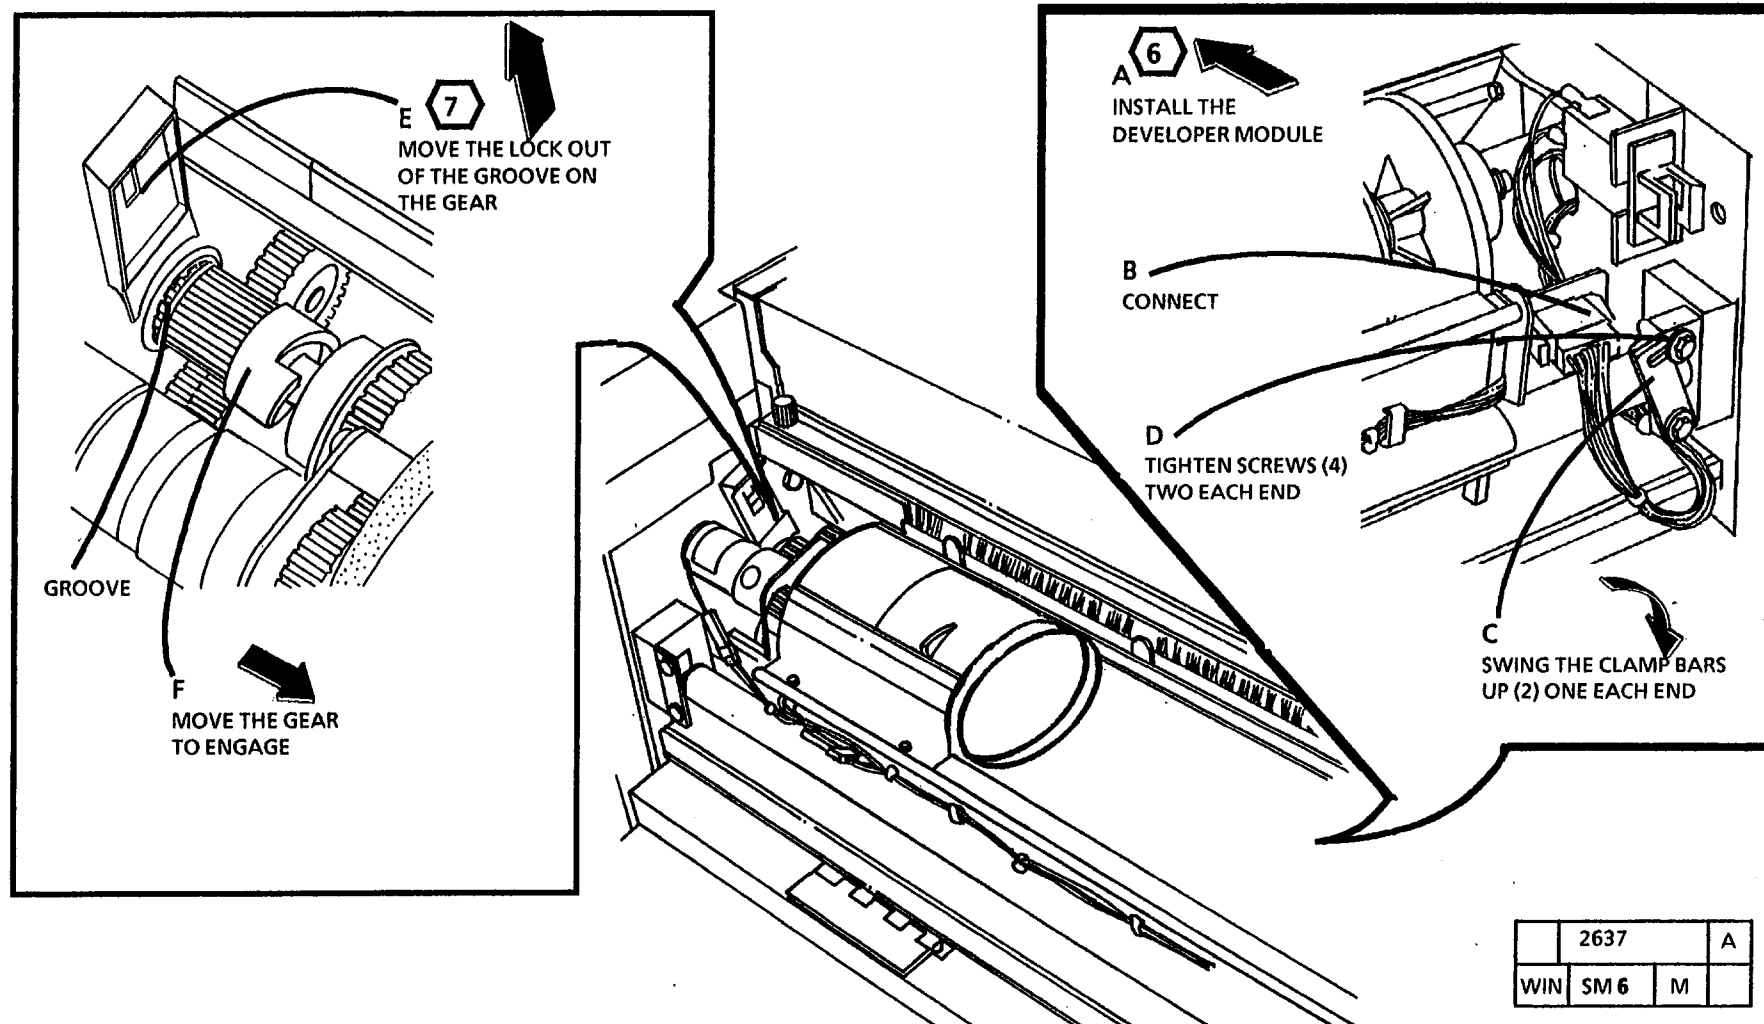
Figure 12. Reinstall the Developer Module

7 STEP 10 E: Ensure that the gear is free to engage with the developer module drive gears.

10. (Figure 12): Reinstall the Developer Module.

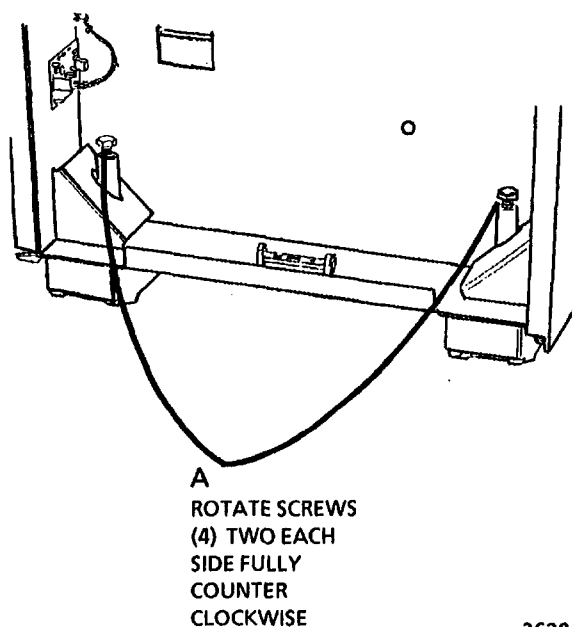
Figure 13. Lower the Copier to the Lowest Position

11. (Figure 13): Lower the copier to the lowest position.
