- **Call Flow Diagram** - This diagram outlines the major activities that are performed when a service call is made. The **Initial Actions** assist the Service Representative through the customer interface and help to identify the problem. The diagram also directs the Representative to verify, classify, repair the problem and perform the correct Maintenance Procedure.

2. Status Indicator Repair Analysis Procedures

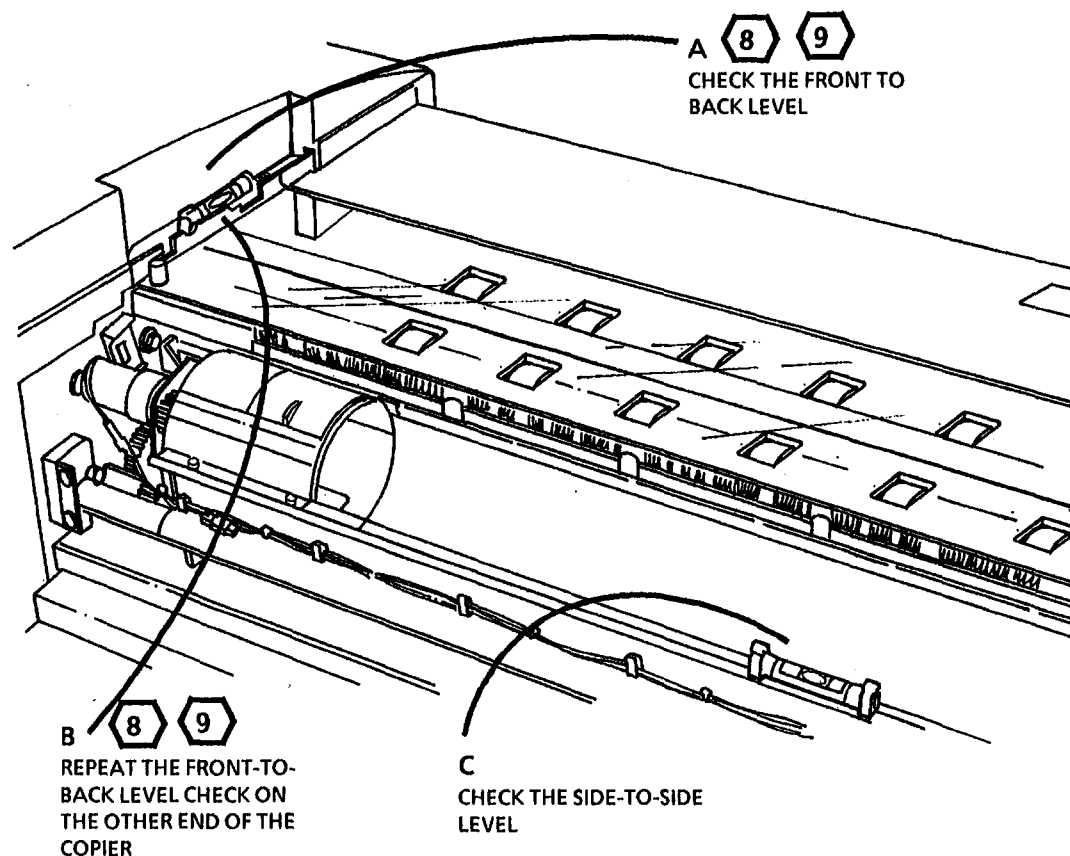
Figure 14. Check the Level of the Copier

- 8 STEPS 12 A and B: To ensure that the copier is not twisted, perform the front-to-back check on the frame at the ends of the copier.
- 9 STEPS 12 A and B: The bubble must be centered between the lines on the level.

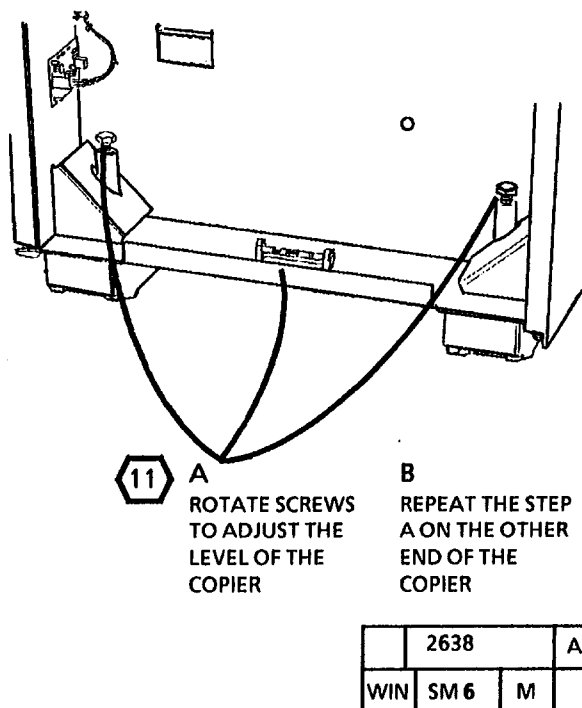
Figure 15. Adjust the front-to-back level

11 *STEP 14 A : The bubble must be centered between the lines on the level.*

14. (Figure 15): Adjust the front-to-back level.

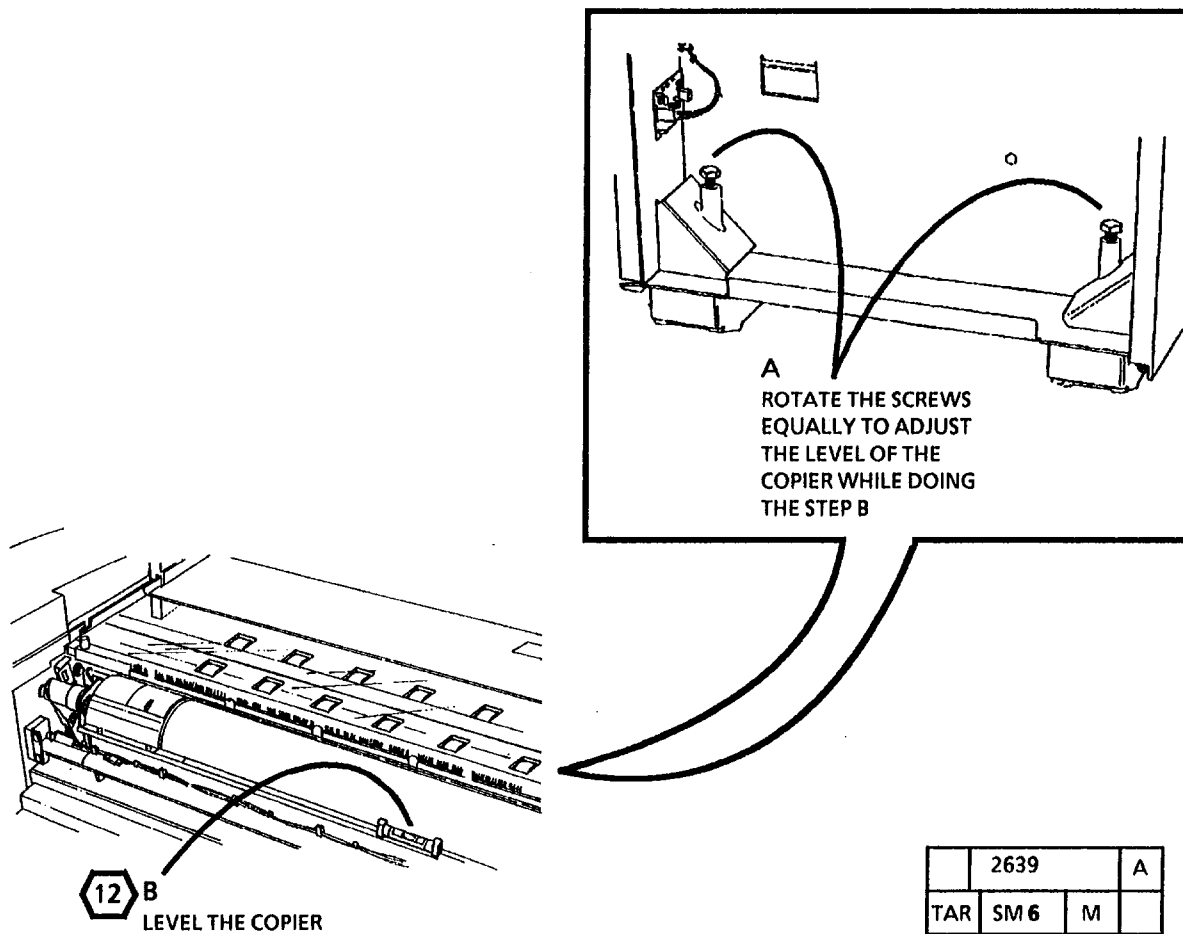
Figure 16. Adjust the side-to-side level

12 *STEP 15 B: The bubble must be centered between the lines on the level.*

15. (Figure 16): Adjust the side-to-side level.

16. Perform steps 11 through 14 until the level is within specification.

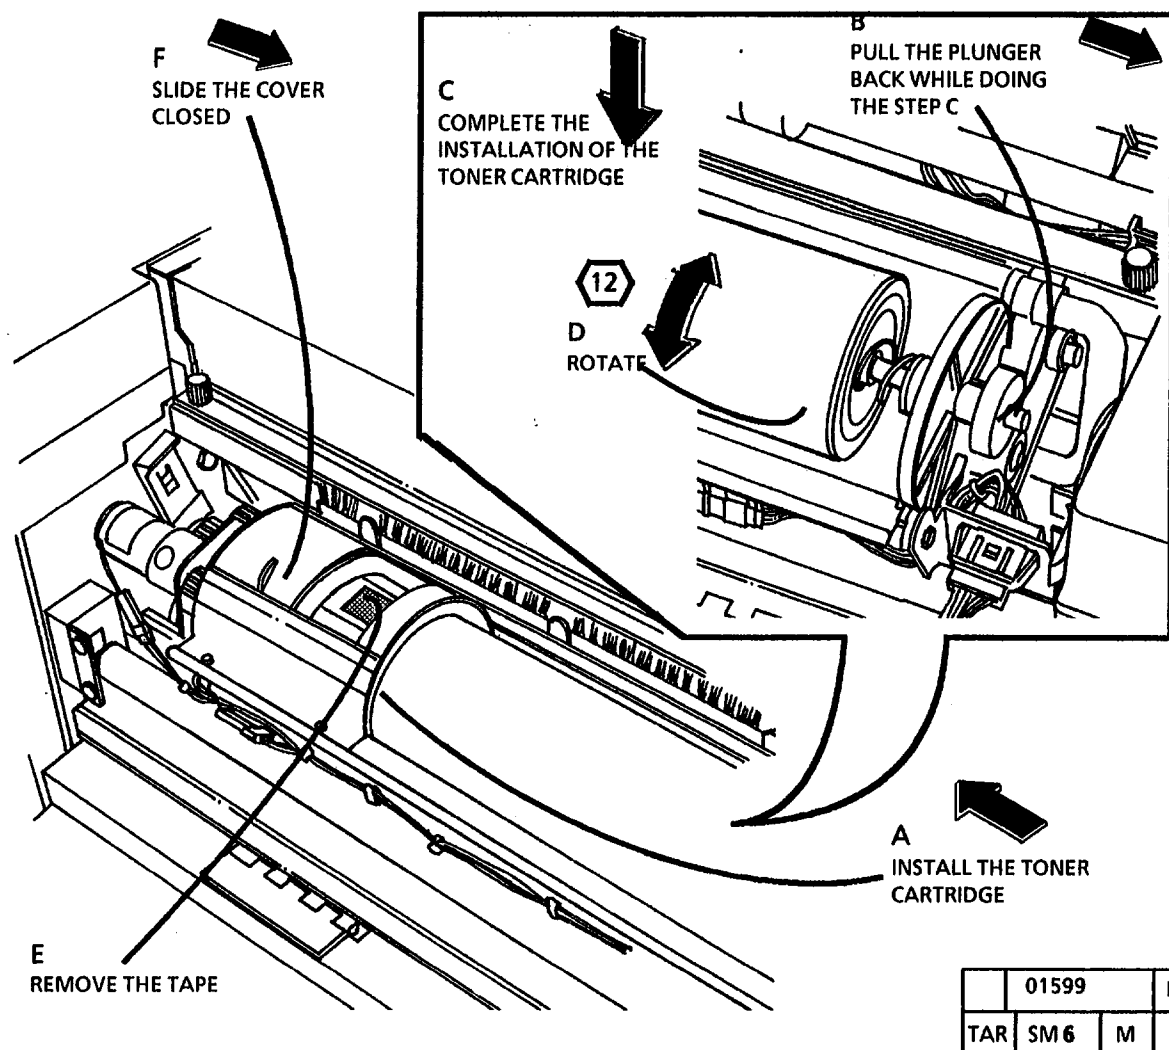
Figure 17. Install the Toner Cartridge.

17. (Figure 17): Install the Toner Cartridge.

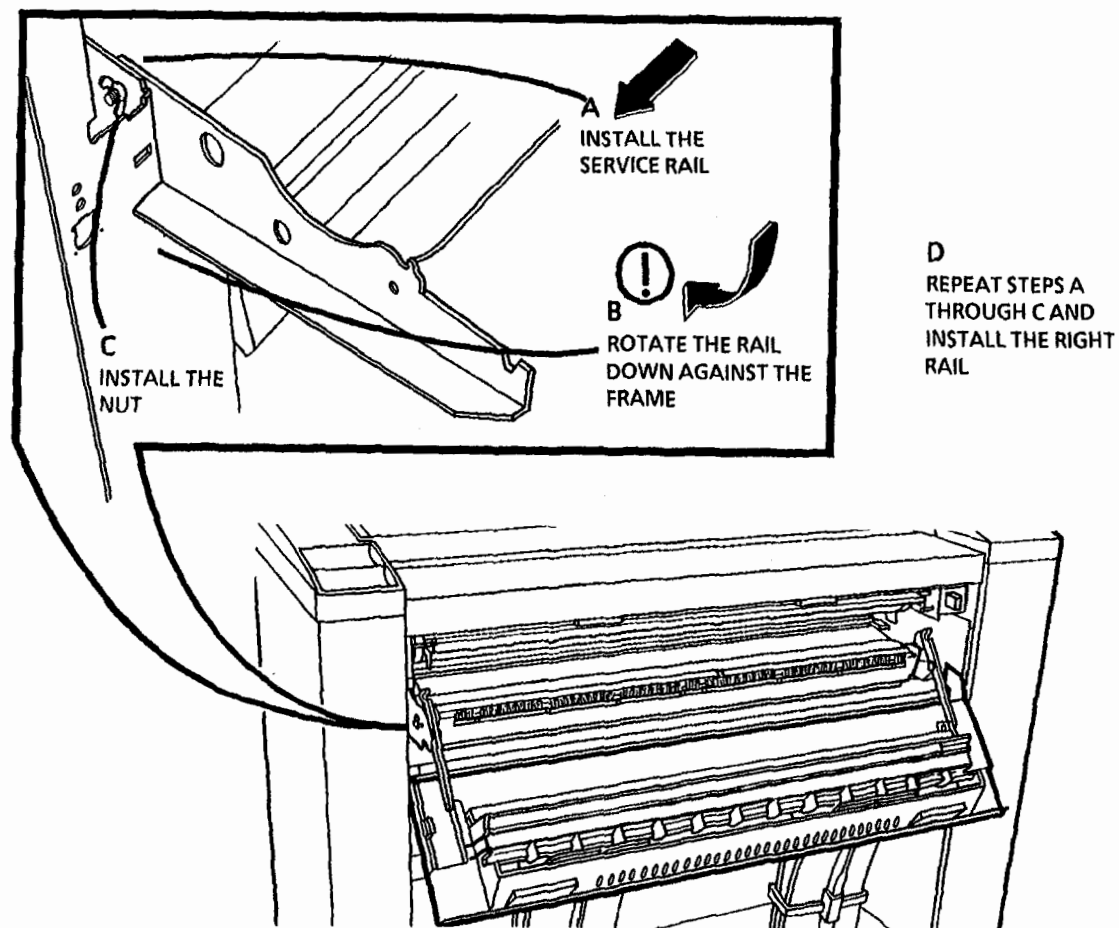
Figure 18. Installing the Service Rails

! **STEP 20:** The media supply drawer must remain closed when the service rails are in use. The tab on the bottom of the rail is there to ensure that the media supply doors remain closed.

20. (Figure 18): Install the Service Rails.

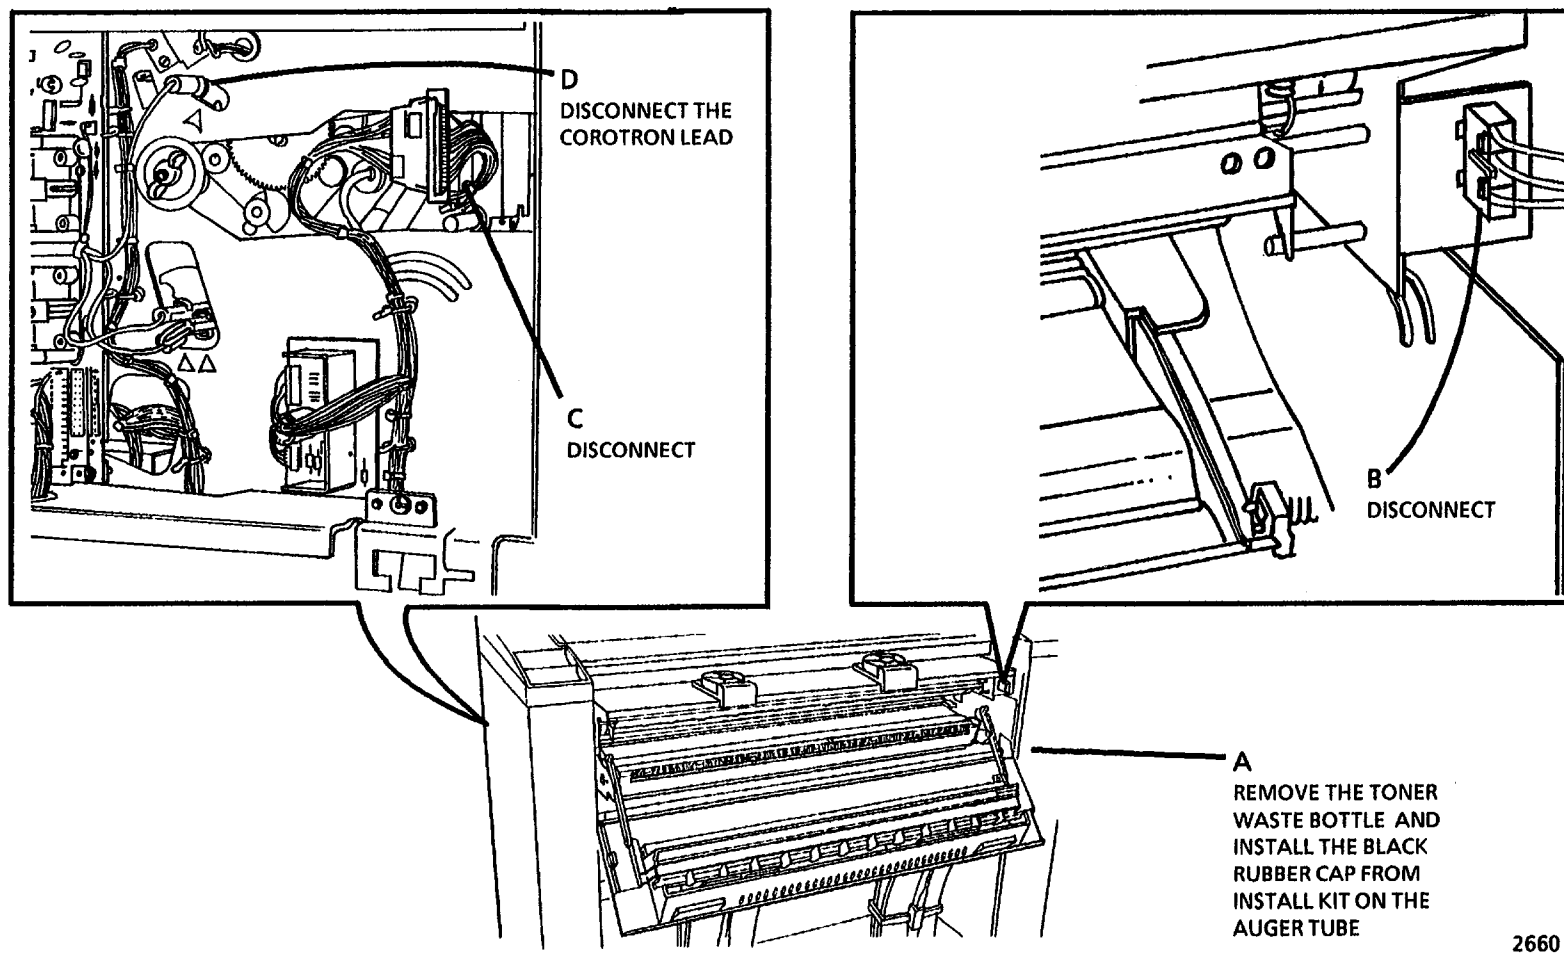
Figure 19. Prepare to Remove the Xerographic Module

21. (Figure 19): Prepare to Remove the Xerographic Module.

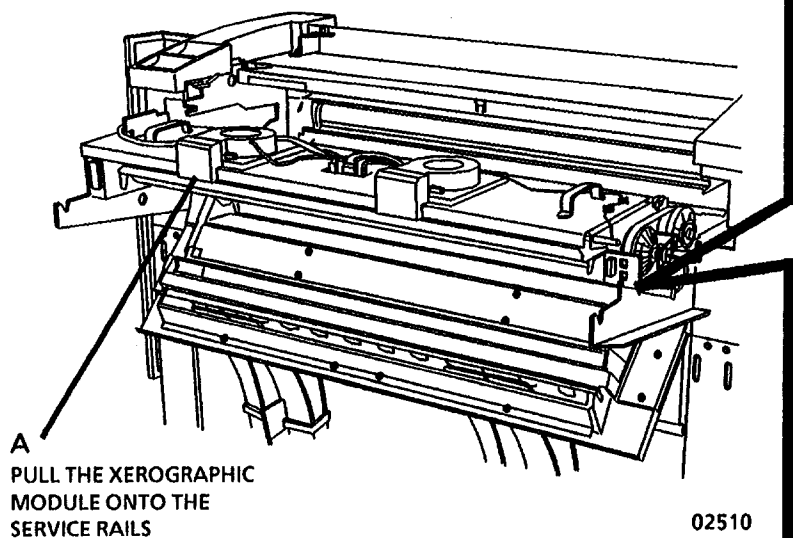
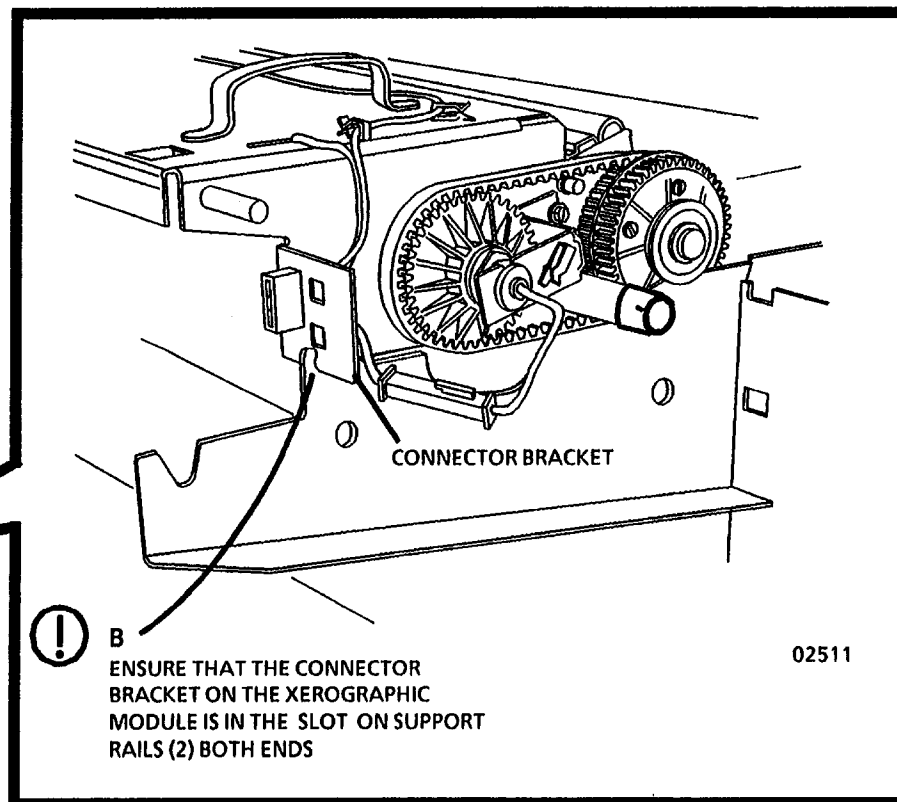
Figure 20. Remove the Xerographic Module

13 The xerographic module may remain on the service rails to install the photoreceptor.

22. (Figure 20): Remove the Xerographic Module

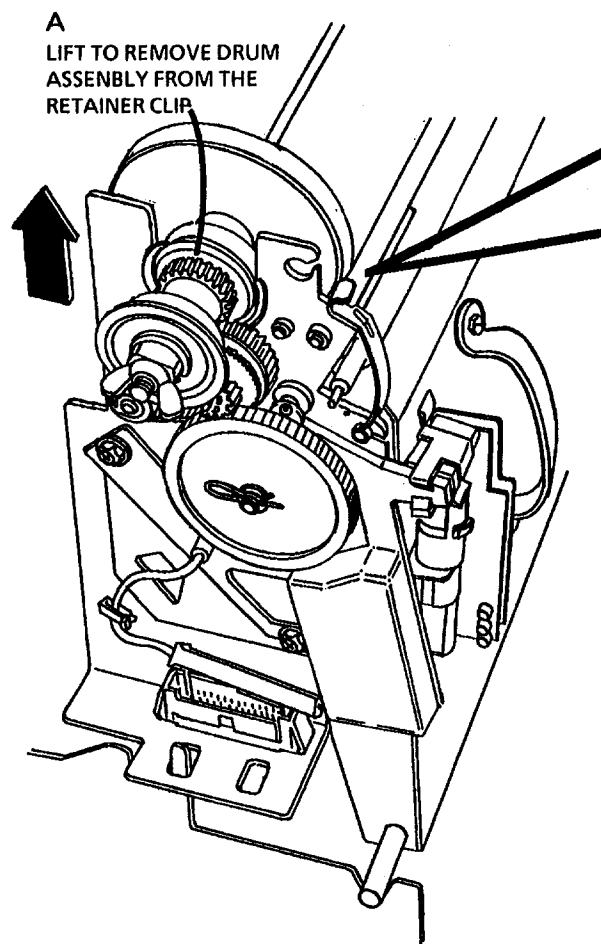
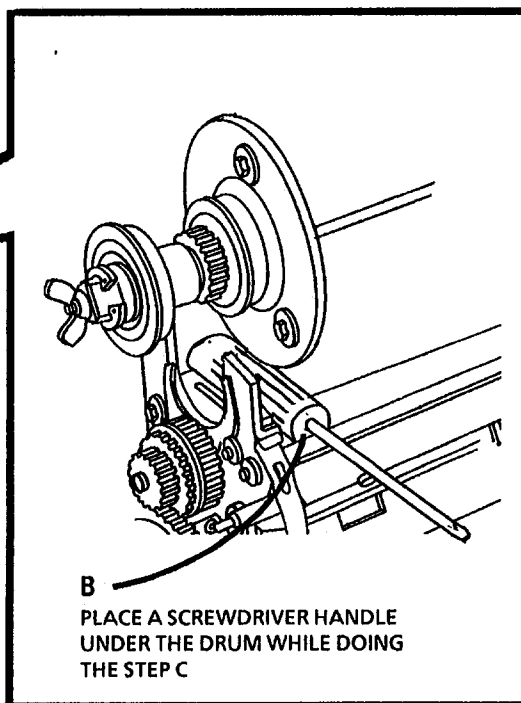
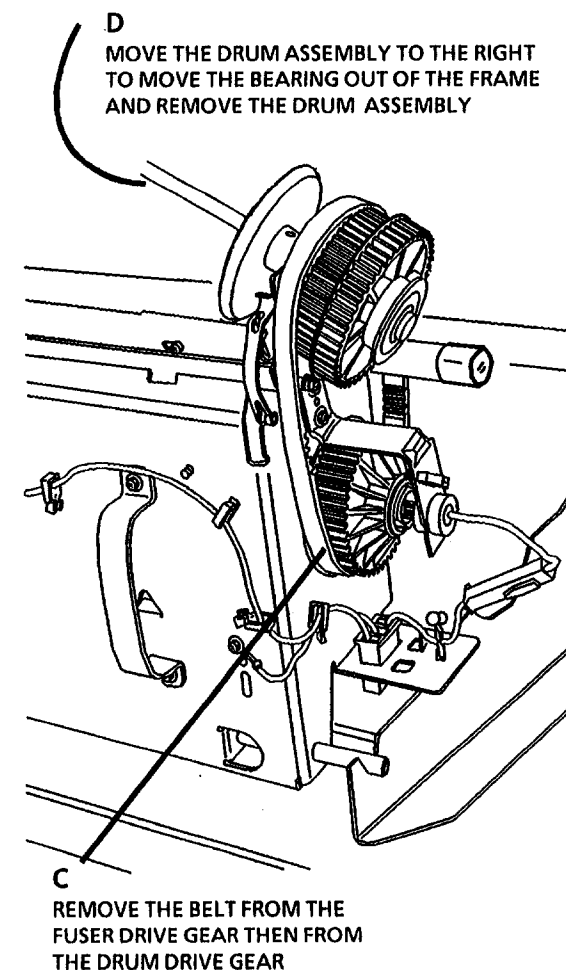
Figure 21. Removing Photoreceptor Drum Assembly

- 14 The photoreceptor for the copier is packed separately and will be installed in the next step.

23. (Figure 21): Remove the Photoreceptor Drum Assembly.

- 15 STEP 24: DO NOT perform the electrostatic series after installing the photoreceptor drum. It will be done later in the installation

24. Install the Photoreceptor Drum (REP 9.3).

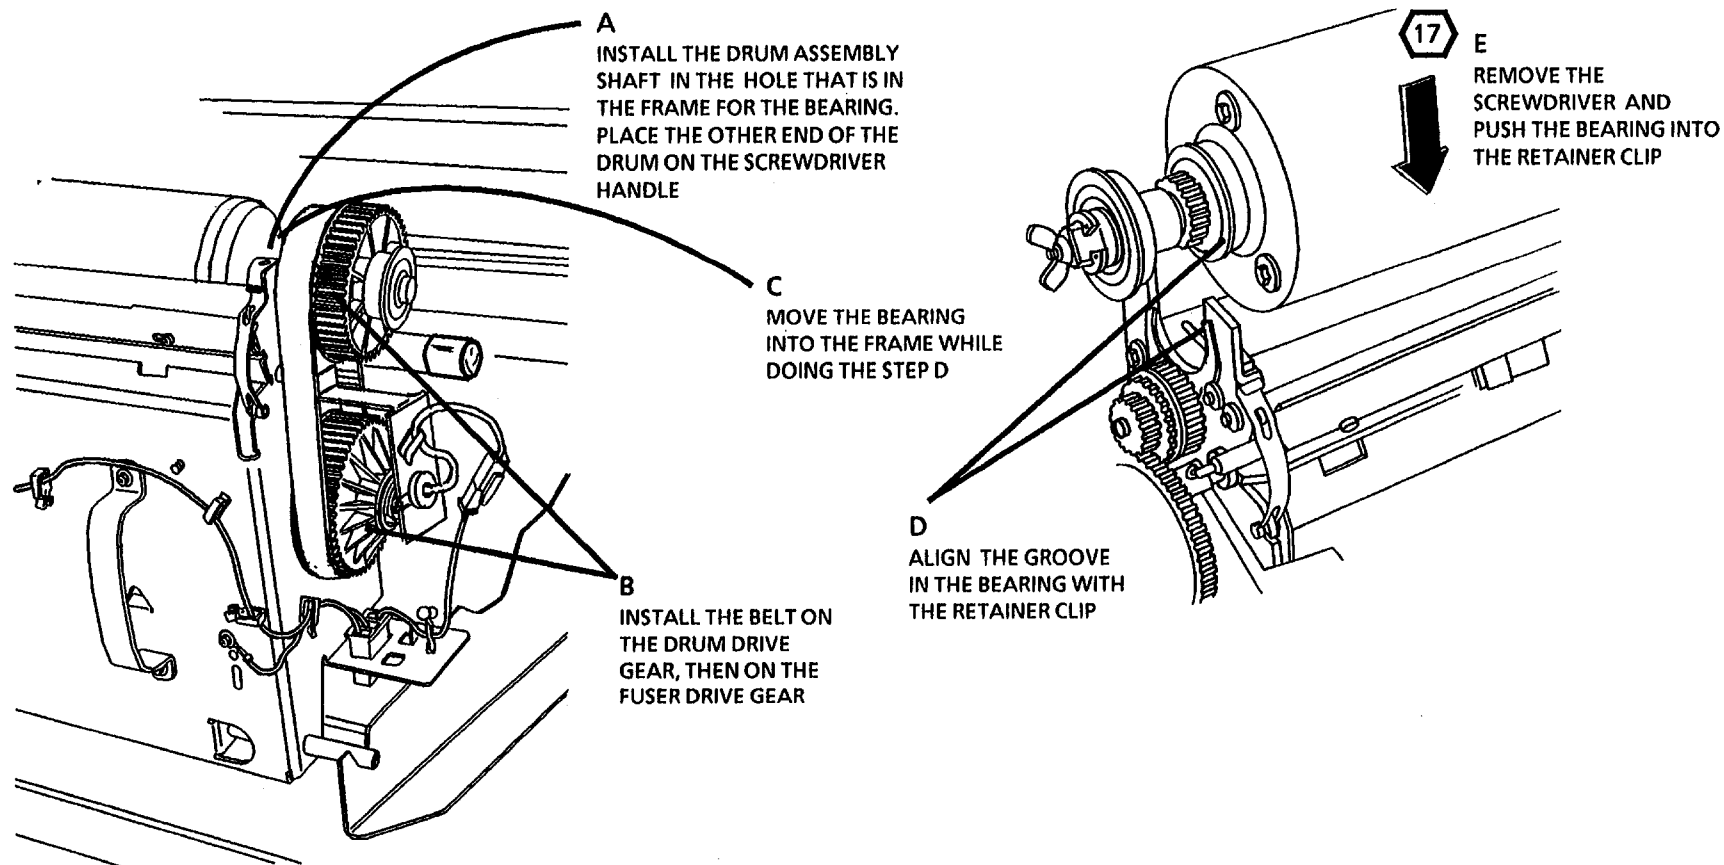
STEP E: If the ground clip does not touch the support shaft, reform the clip to make it touch the shaft.

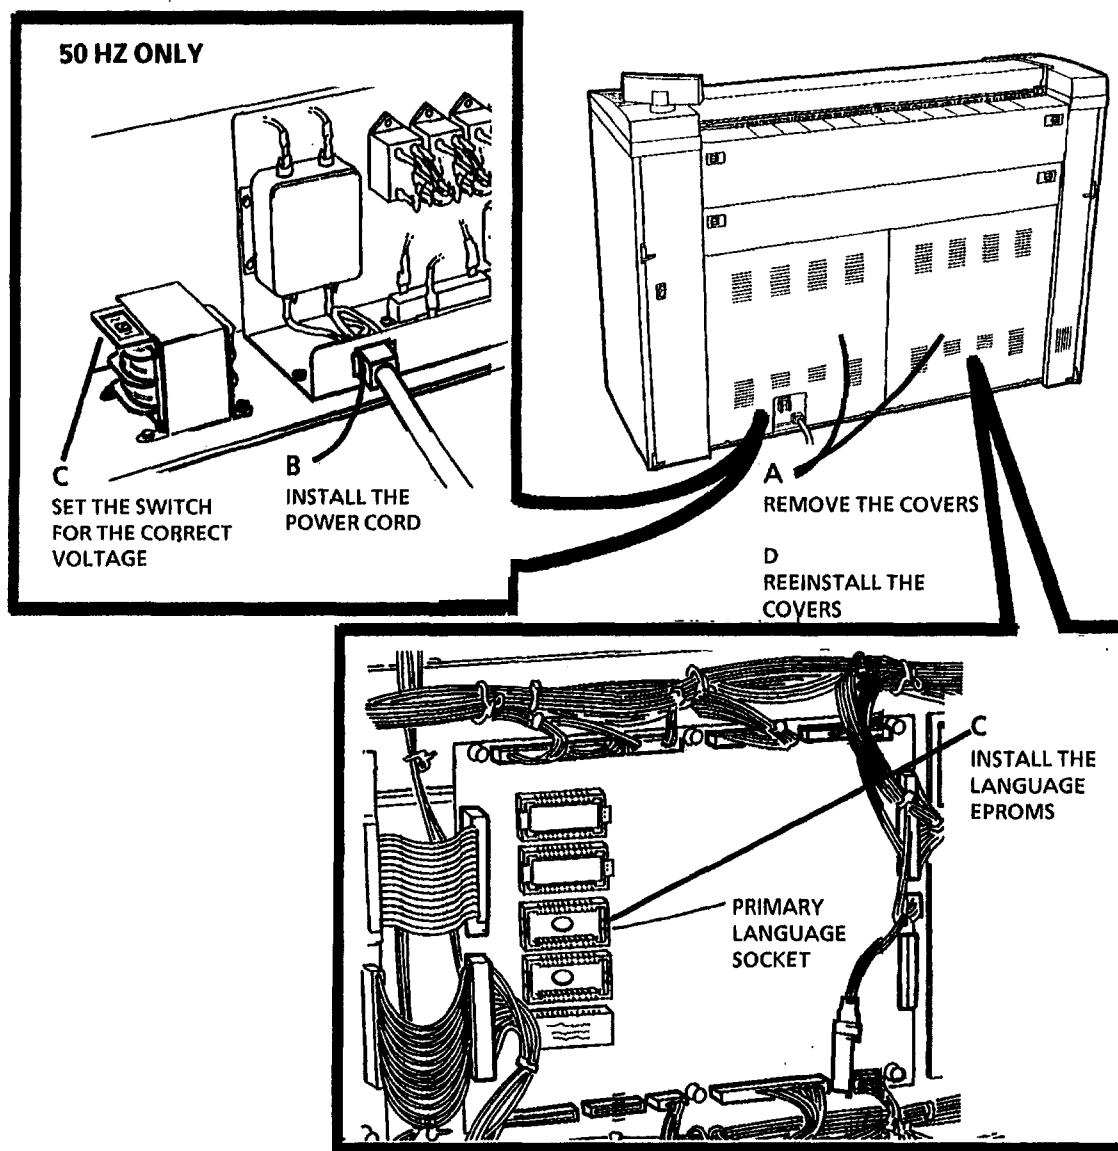
Figure 23. Installing the Language EPROMS

27. Reinstall the Xerographic Module and the perform the following:
 - a. reconnect all connectors at both ends of the xerographic module
 - b. remove the rubber cap and reinstall the toner waste bottle.
28. Remove the service rails and store them inside the Left Door.
29. Rotate the document feed in shelf closed.
30. (Figure 23): **RX ONLY:** Install the power cord and language EPROMS.

18 *The language EPROM are provide in a separate kit and may not be required on all installations.*

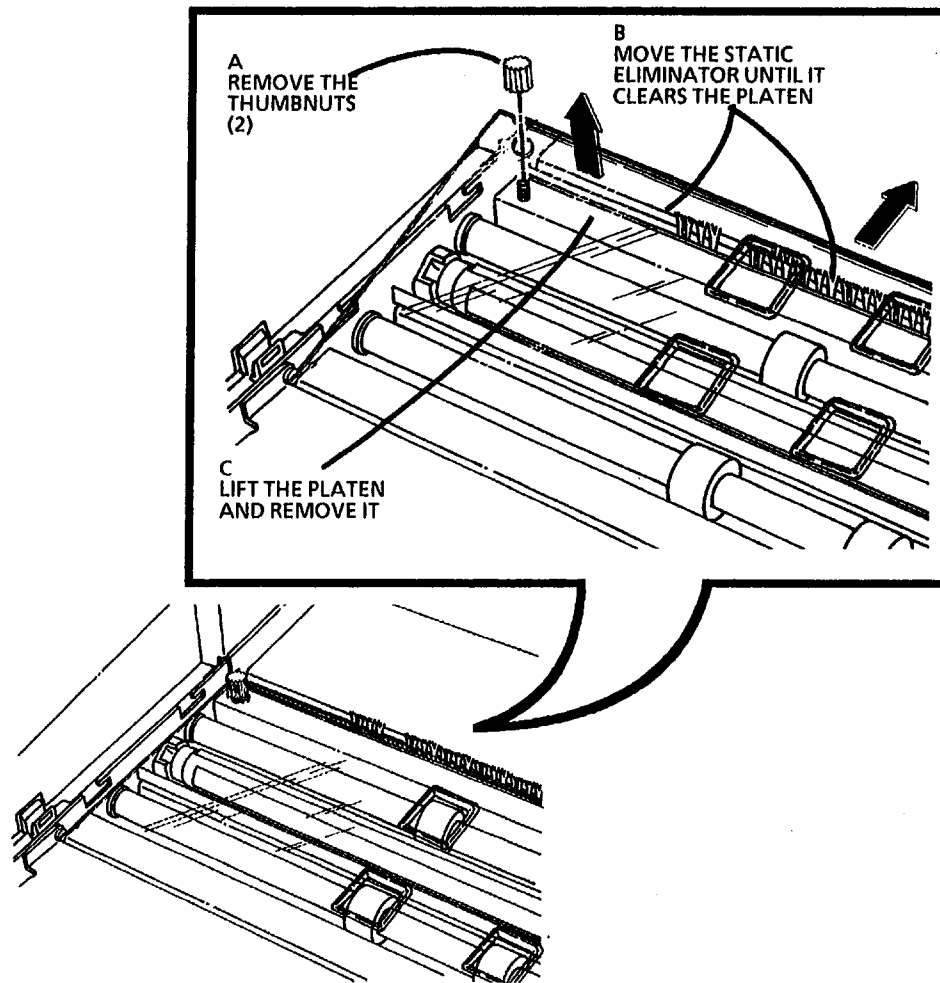
Figure 24. Remove the Platen

31. (Figure 24): Remove the platen.
32. Clean both sides of the platen with anti-static cleaner.
33. Reinstall the platen and document handler.

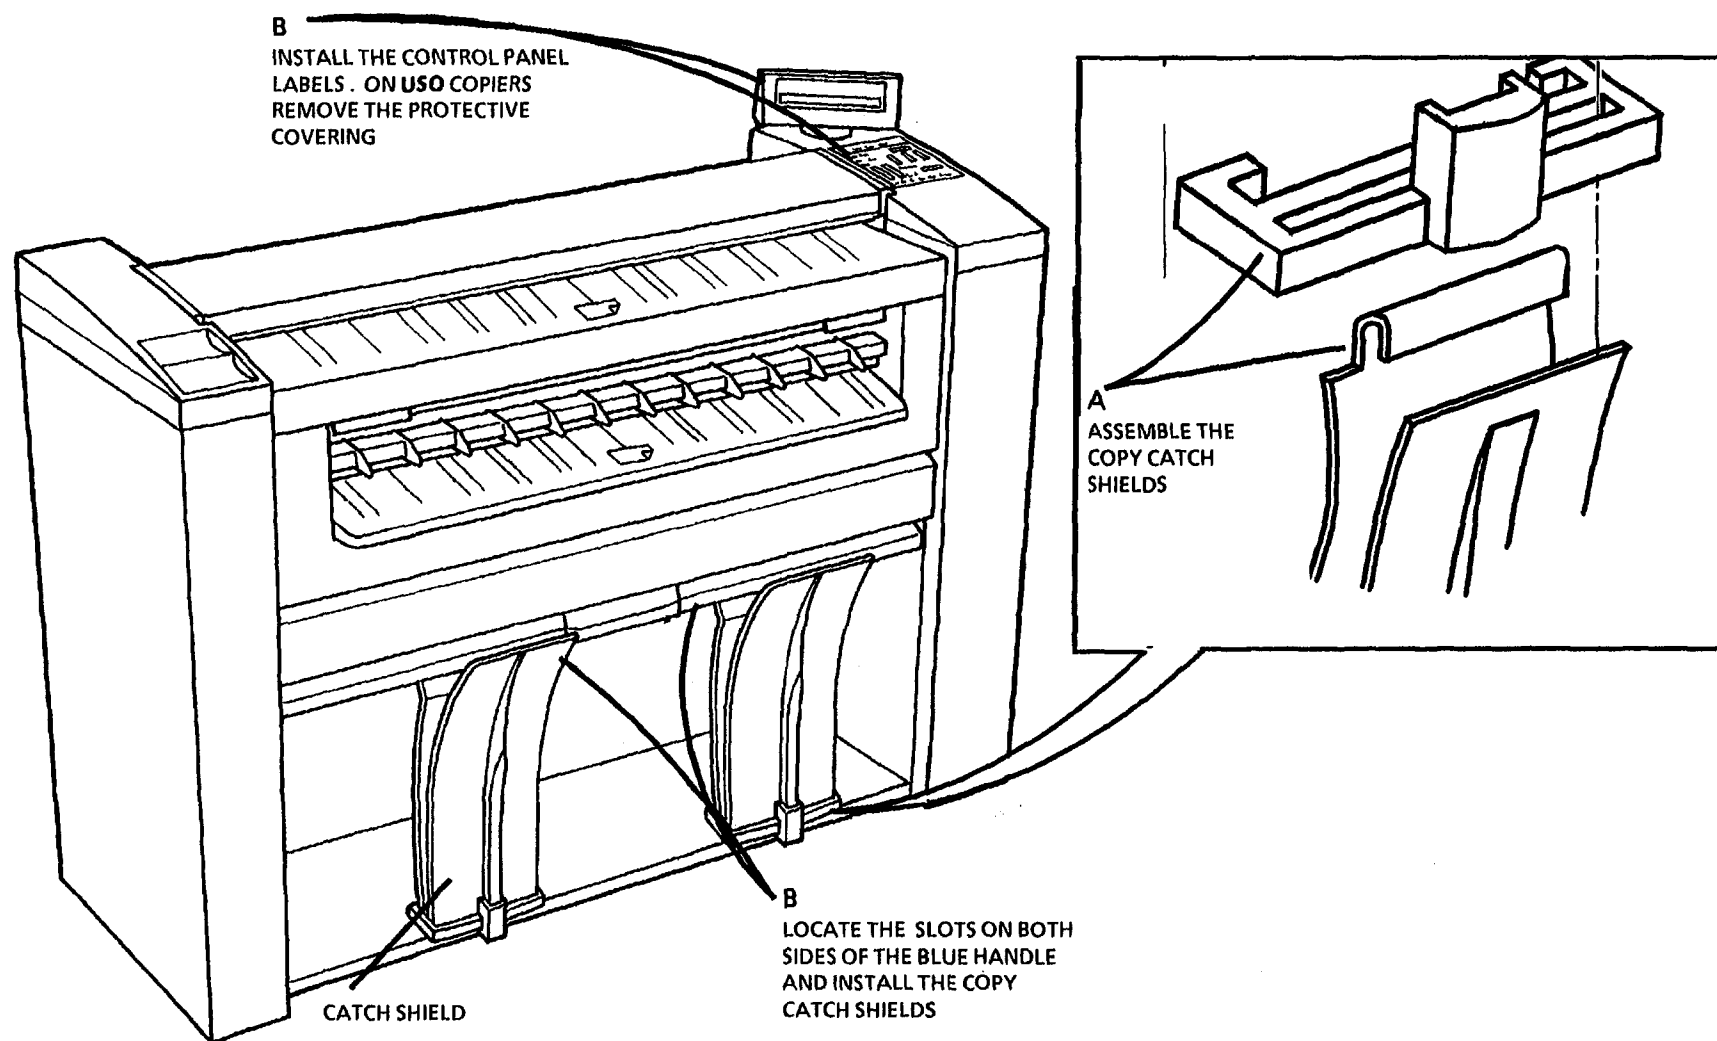
Figure 25. Install the Copy Catch Shields

34. (Figure 25): Install the Copy Catch Shields.

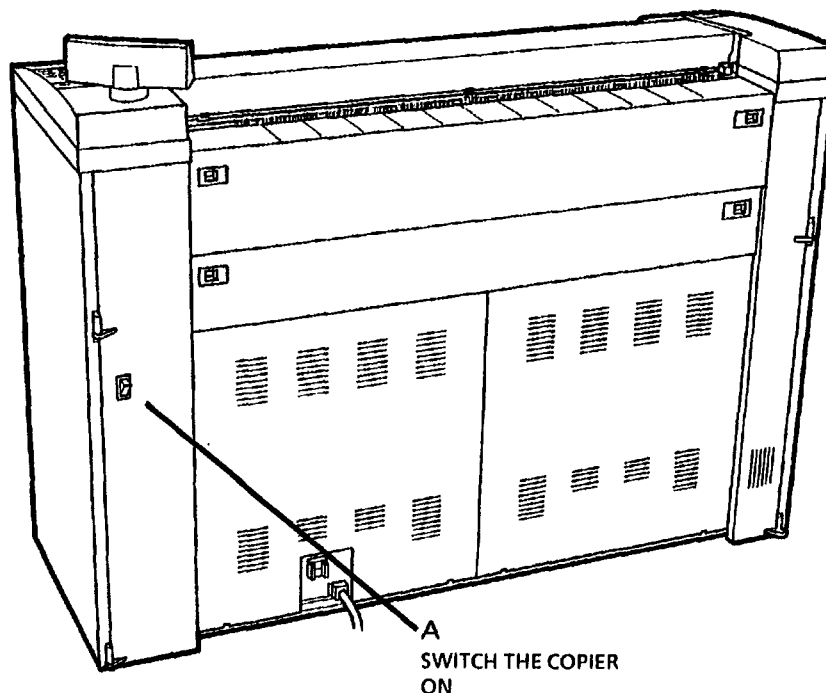
Figure 26. Switch the Copier On

2. (Figure 26): Switch the copier on and enter the diagnostic mode.
3. Refer to the Initialization of the Fuser Roll procedure at the beginning of Section 6 and do Steps 1 through 11.
4. Check/Adjust the following :
 - a. Country Configuration (ADJ 3.2)
 - b. Fuser Temperature (ADJ 10.1)

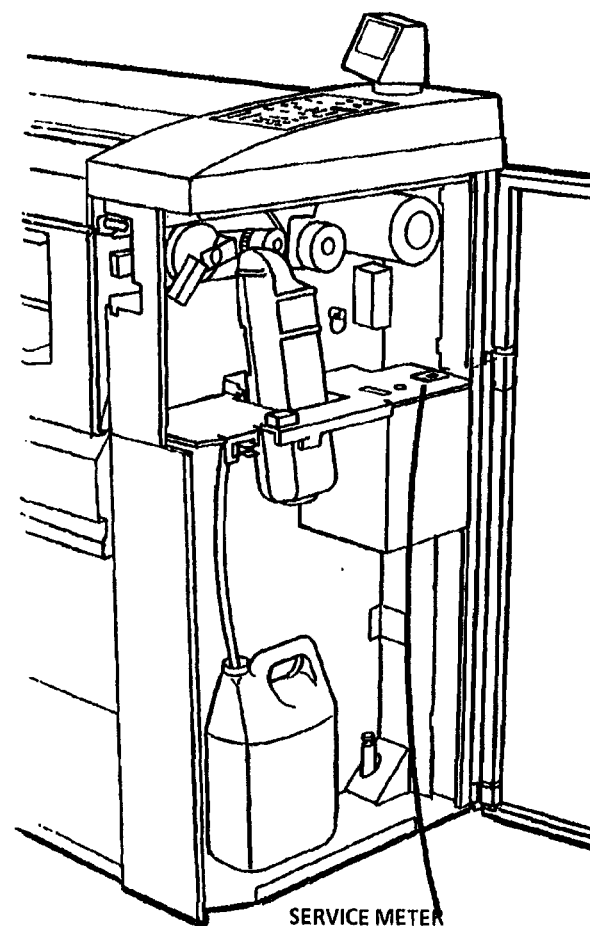
Figure 26. Record the Copy Count Readings

11. (Figure 26 and 27): Record the copy count meter readings.

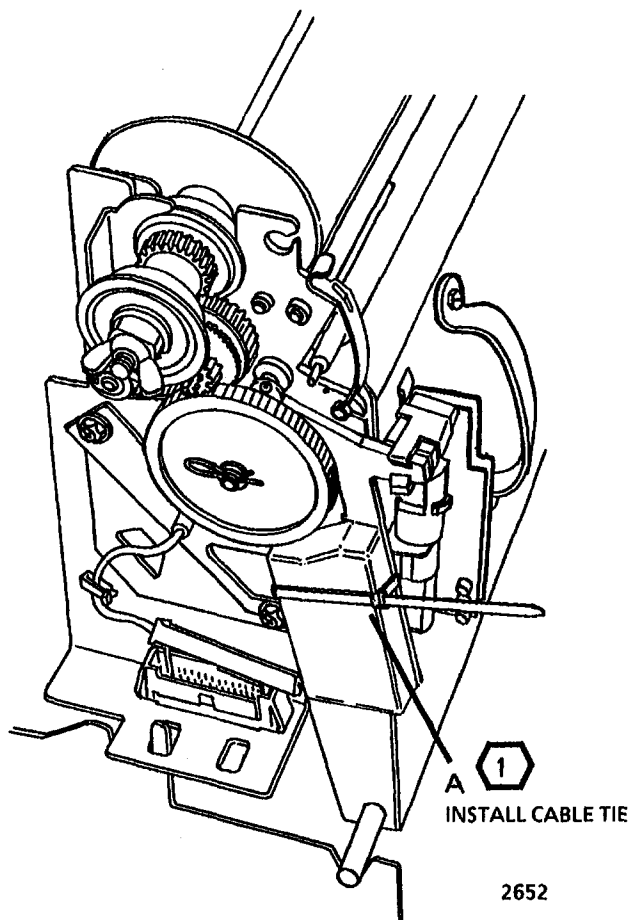
Figure 1. Installing the Cable Tie

1 *Step 4A: The Blade Weight will be secured using a second cable tie later in the procedure.*

5. Clean the entire cleaner blade area with a vacuum cleaner.
6. Clean the Cleaner Blade with film remover and put a light coating of zinc stearate on the Cleaner Blade.

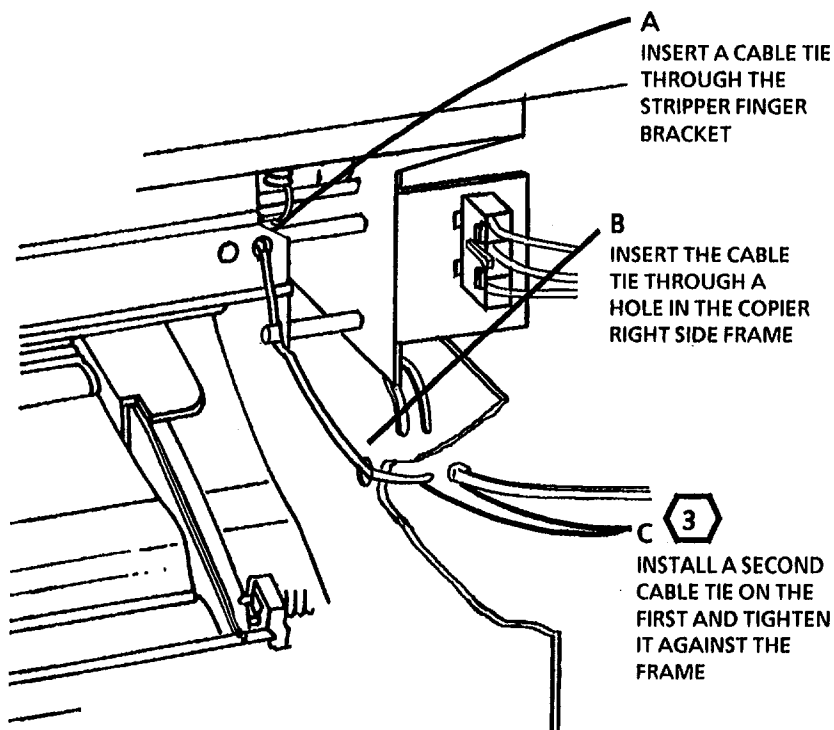
Figure 2. Securing the Stripper Finger Assembly

8. (Figures 2): Secure the Stripper Finger Assembly.

- 3 STEP 8 C: Slide the cable tie so that it is tight against the the frame of the copier to hold the stripper finger bracket from moving.

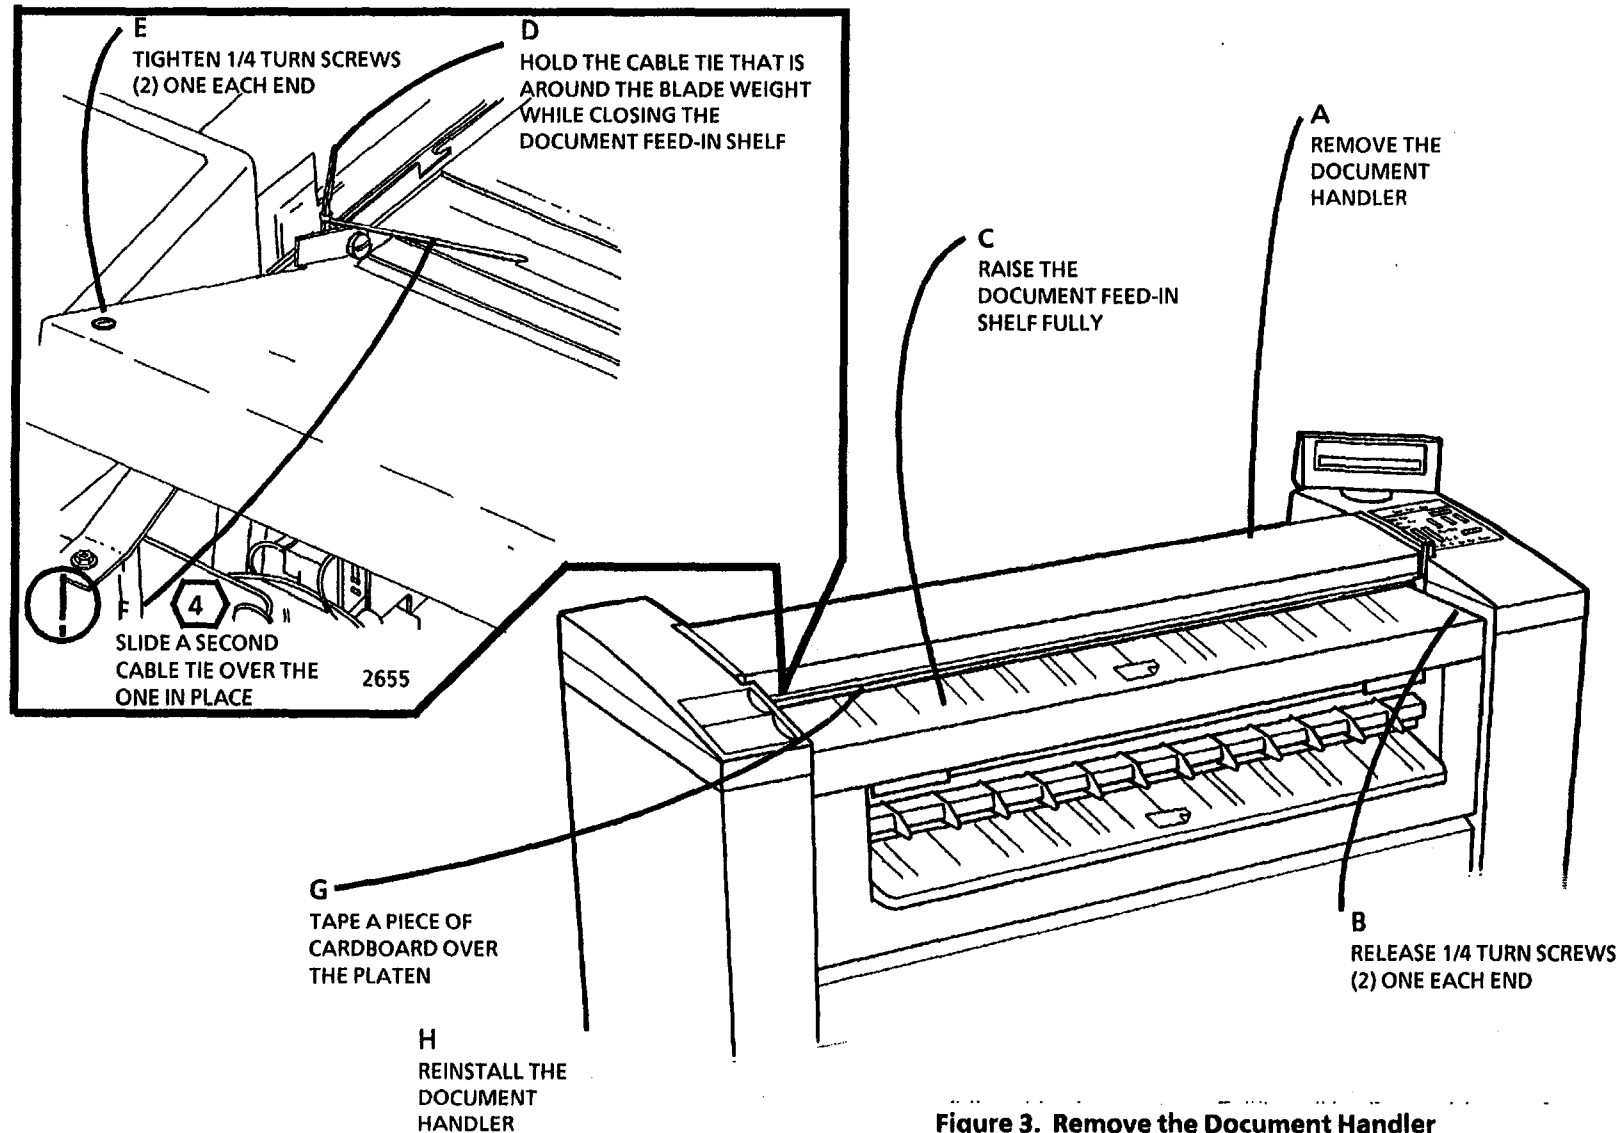
Figure 3. Remove the Document Handler

STEP 9C: Pull up on the cable tie that is around the blade weight while pushing down on the second cable tie. Push cable tie down until it is against the Document Feed-in Shelf.

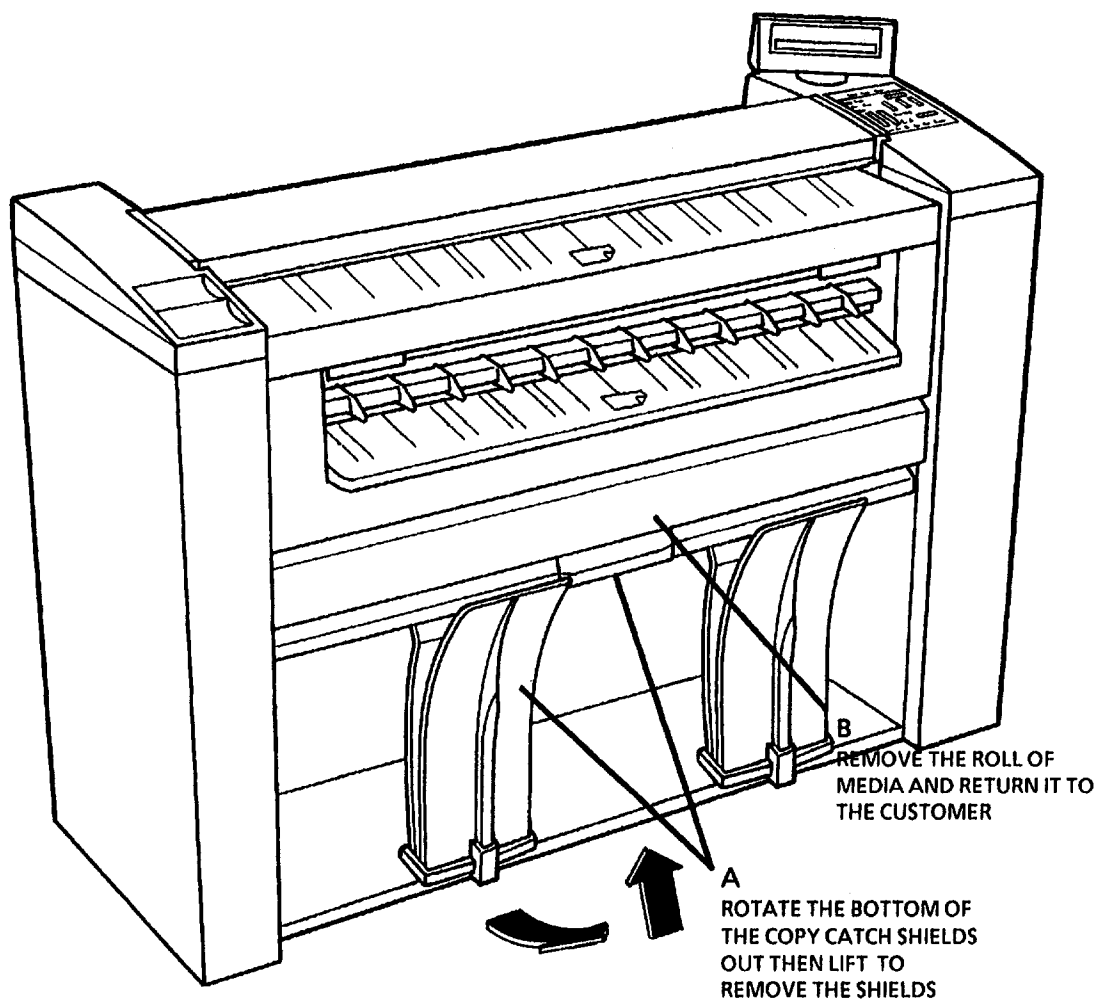
Figure 4. Remove the Copy Catch Shields

10. (Figure 4): Remove the Copy Catch Shields.

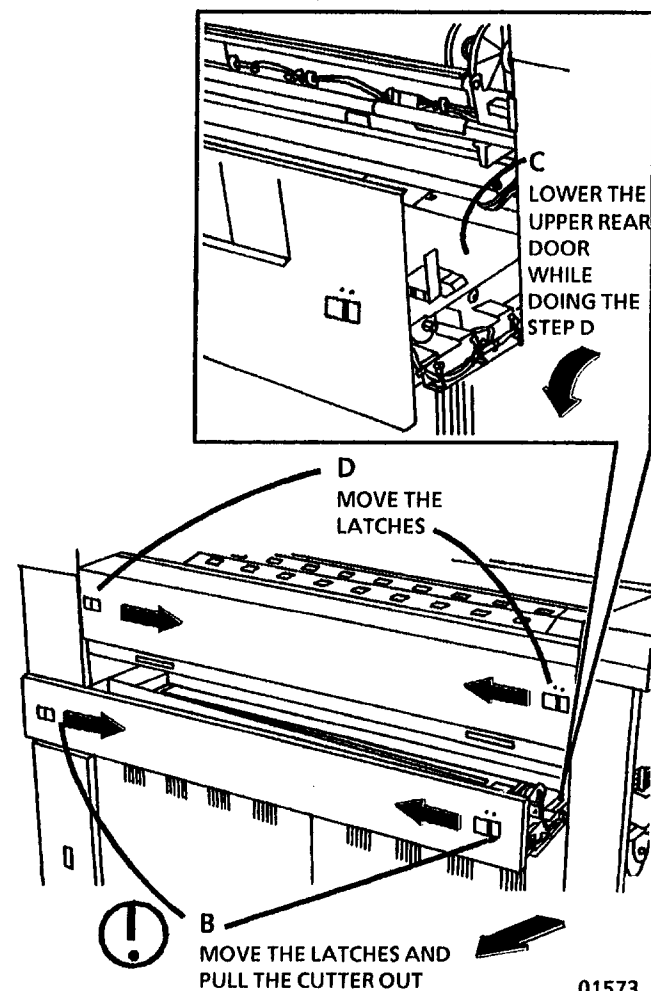
Figure 5. Prepare to remove the Developer Module
(Continued)

- ! STEP 11 A: To avoid damage to the hinges on the upper rear door, pull the cutter out to support the upper rear door.

11. (Figure 5): Prepare to remove the Developer Module.

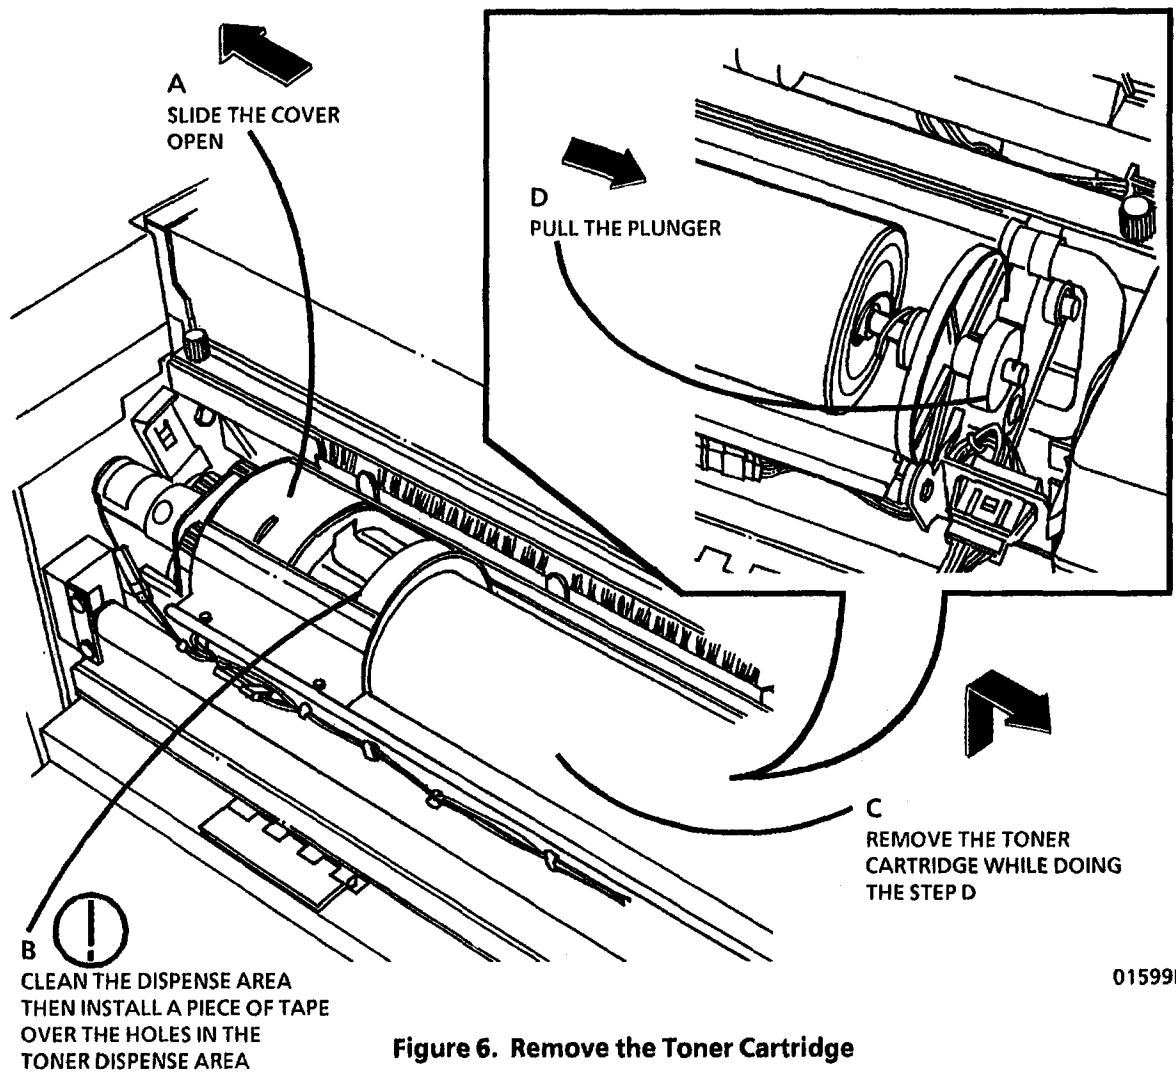
Figure 6. Remove the Toner Cartridge

STEP 12 B: Tape the toner cartridge dispense holes to prevent toner from spilling out when the toner cartridge is tipped up for removal.
