- **Call Flow Diagram** - This diagram outlines the major activities that are performed when a service call is made. The **Initial Actions** assist the Service Representative through the customer interface and help to identify the problem. The diagram also directs the Representative to verify, classify, repair the problem and perform the correct Maintenance Procedure.

2. Status Indicator Repair Analysis Procedures

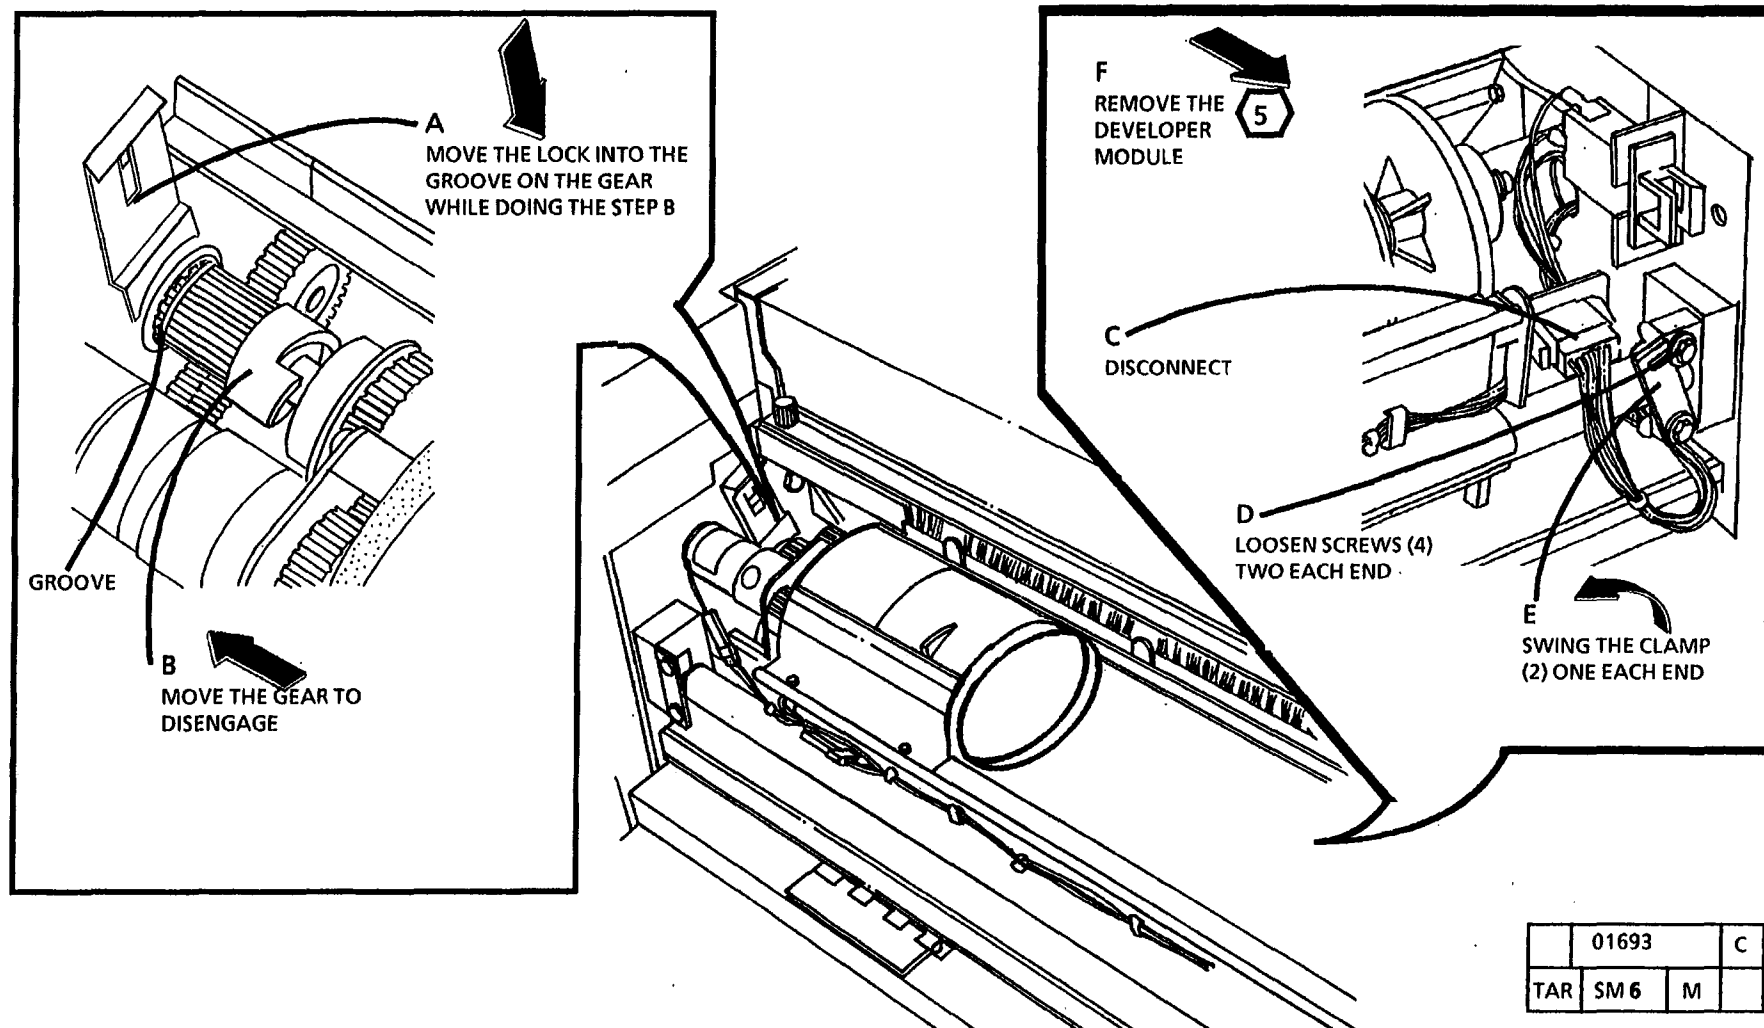
Figure 7. Remove the Developer Module

5 STEP 13F: Before removing the developer module, ensure that there is a clean area to place the module.

13. (Figure 7): Remove the Developer Module.

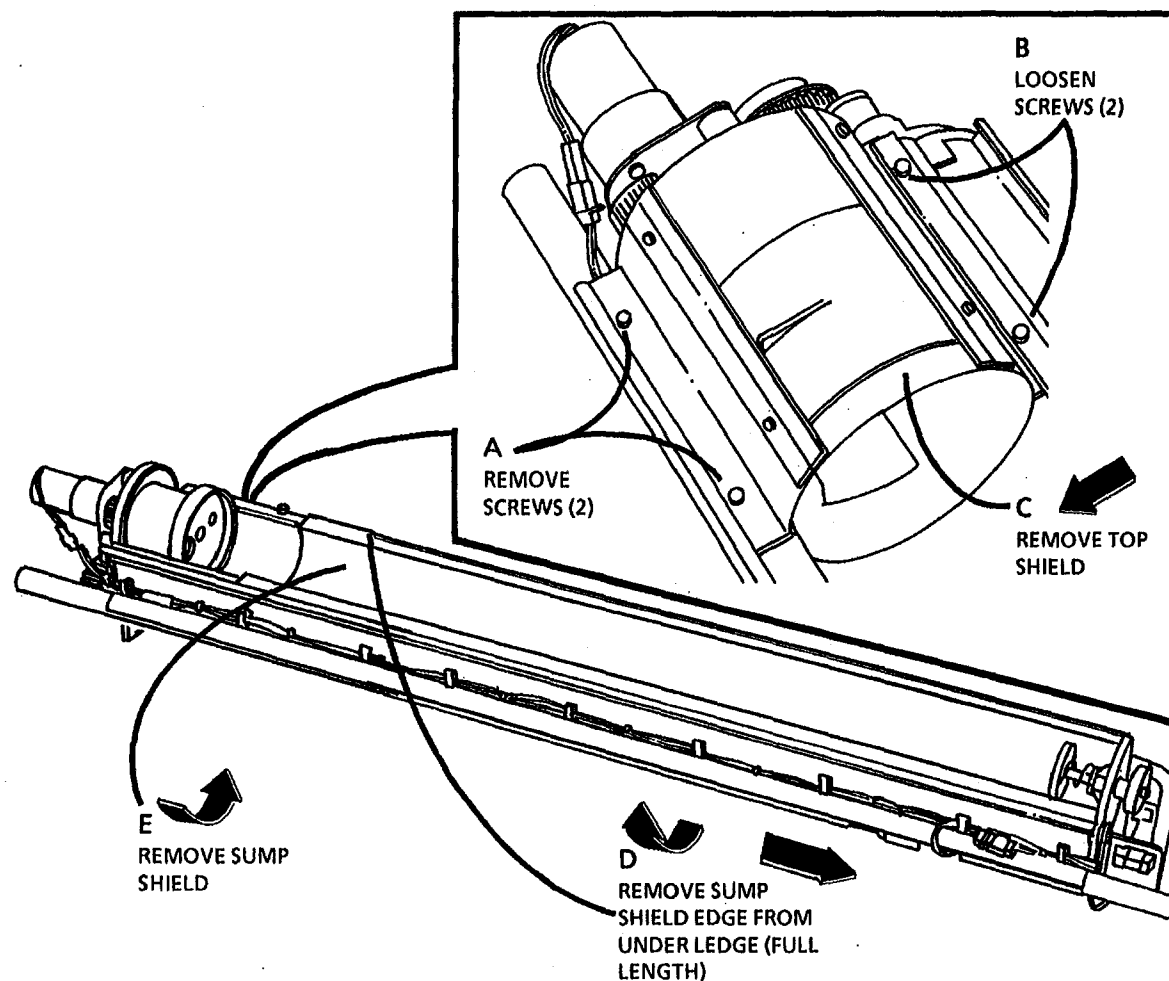
Figure 8. Removing the Sump Shield

14. (Figure 8): Remove the Sump Shield.

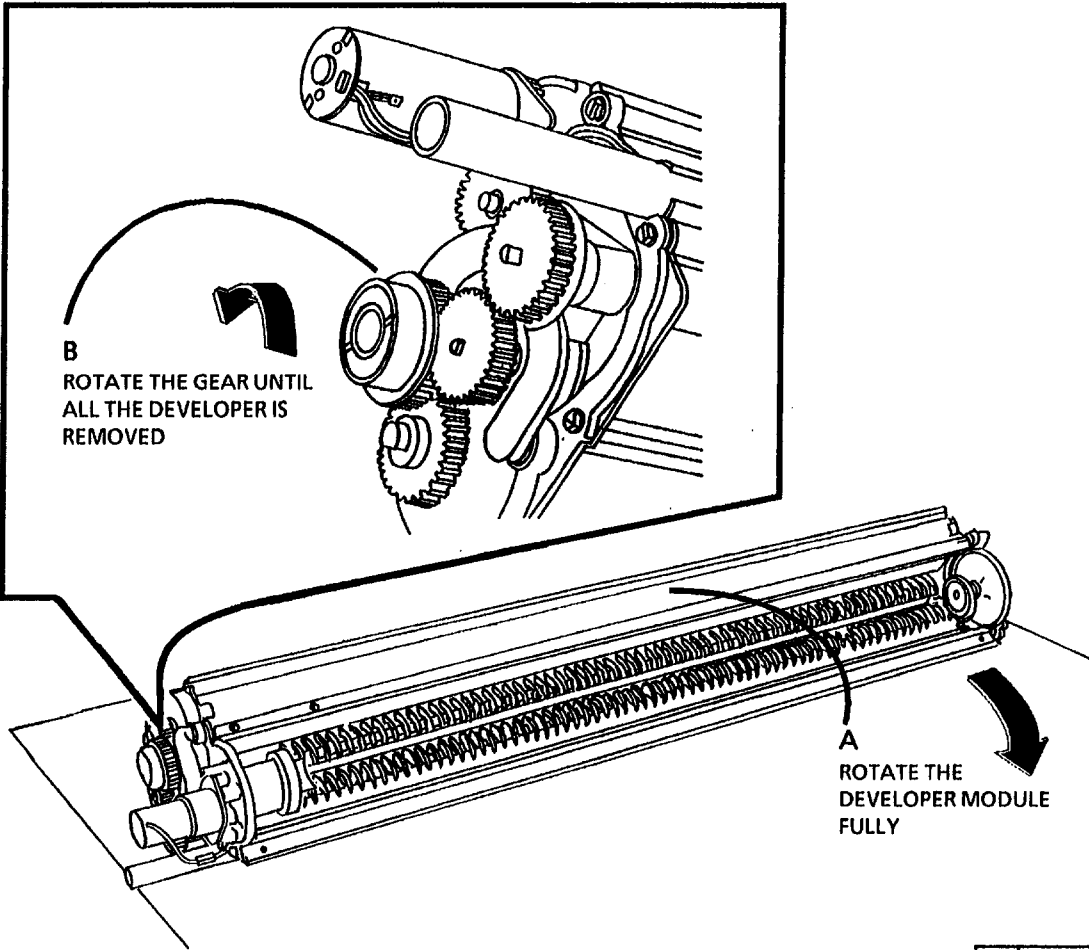
Figure 11. Dump the Developer Material

15. (Figure 9): Dump the Developer Material.

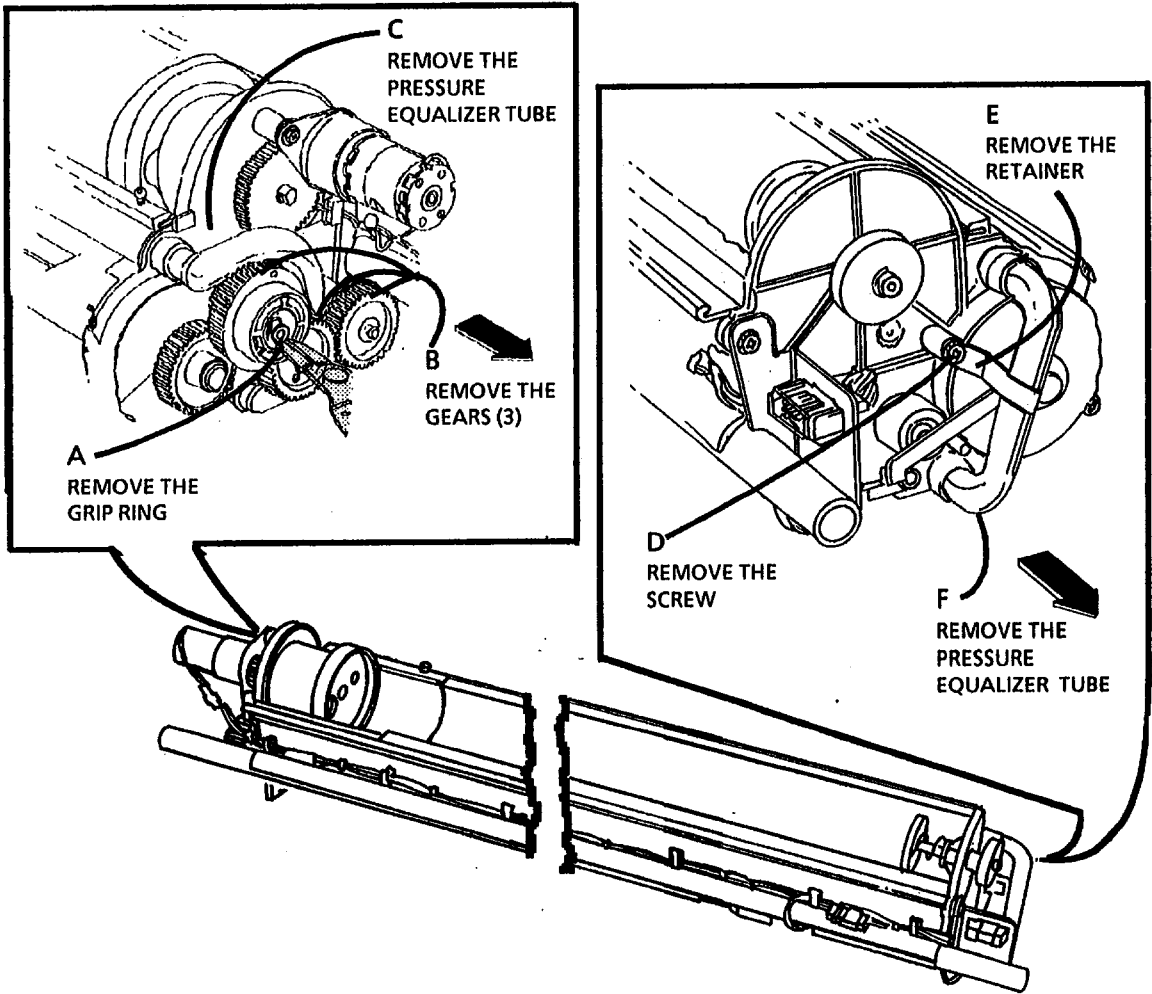
Figure 10. Remove the Pressure Equalizer Tubes

16. (Figure 10): Remove the Pressure Equalizer Tubes.

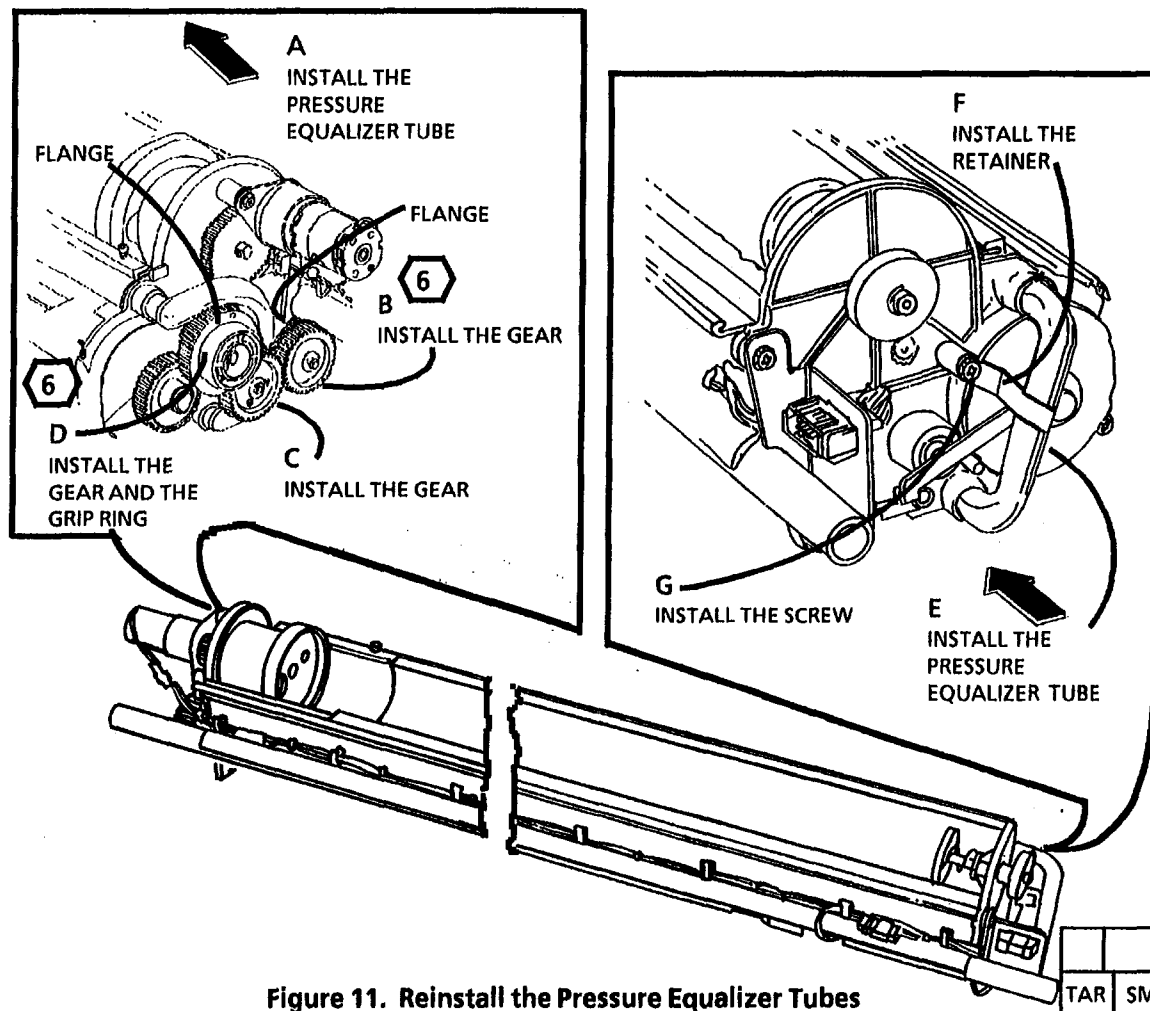
Figure 11. Reinstall the Pressure Equalizer Tubes

STEP 18 B and D: The gears must be reinstalled with the flanges as shown to ensure that all the gears are secured.

18. (Figure 11): Reinstall the Pressure Equalizer Tubes.

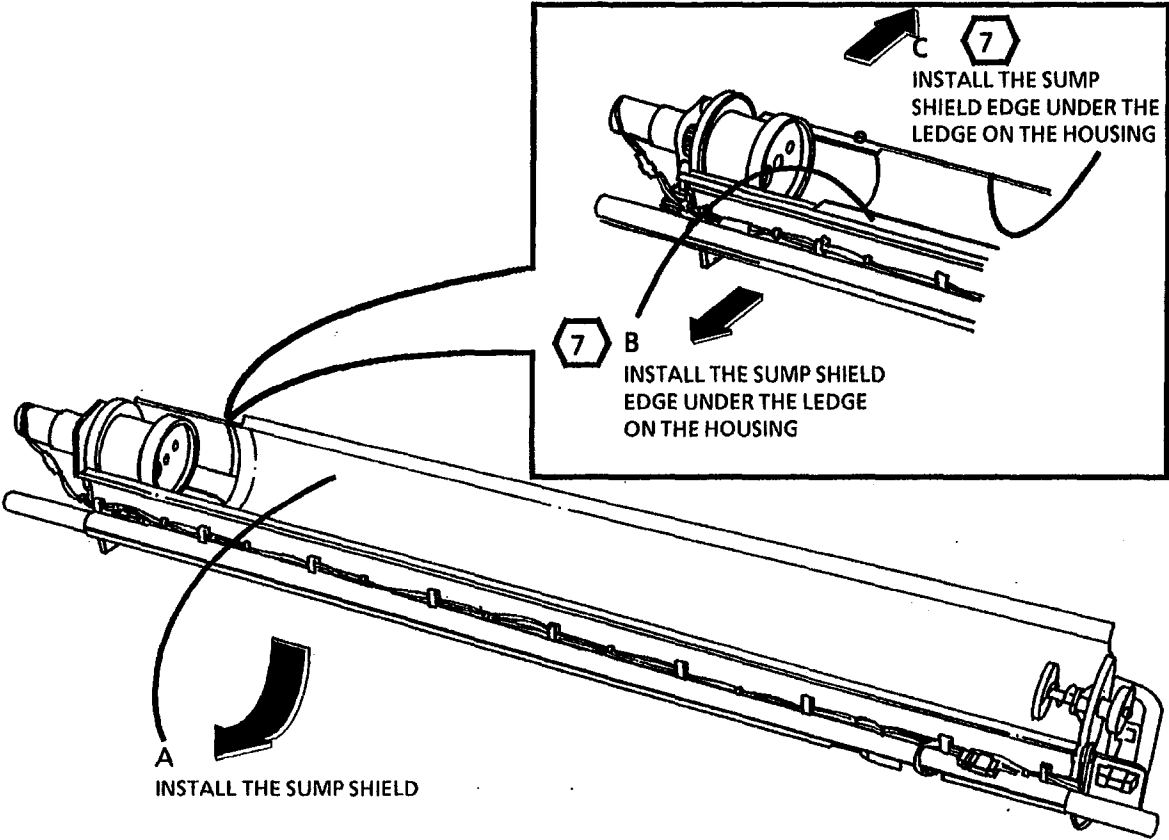
Figure 12. Reinstalling the Sump Shield

19. (Figure 12): Reinstall the Sump Shield.

7 STEP 19 B and C: Ensure that the full length of the edge of the shield is under the edge of the housing.

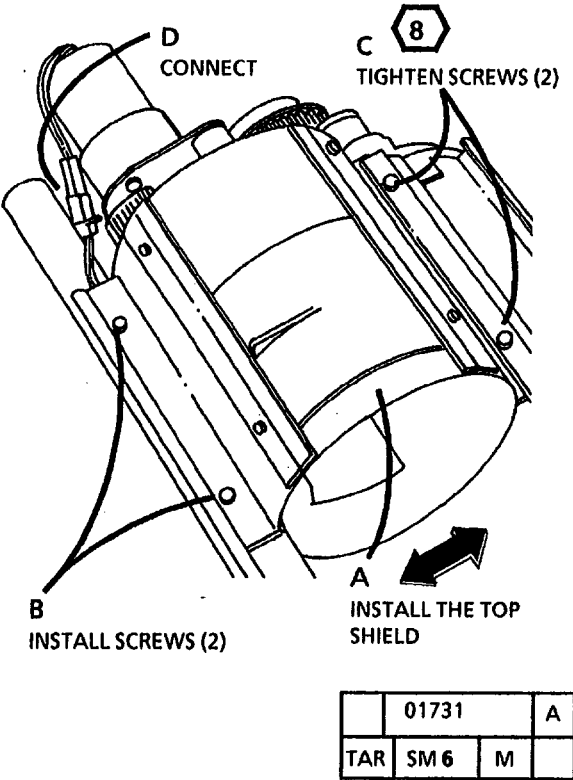
Figure 13. Reinstalling the Top Shield

8 STEP 20 C: Do not overtighten the screws.

20. (Figure 13): Reinstall the Top Shield.

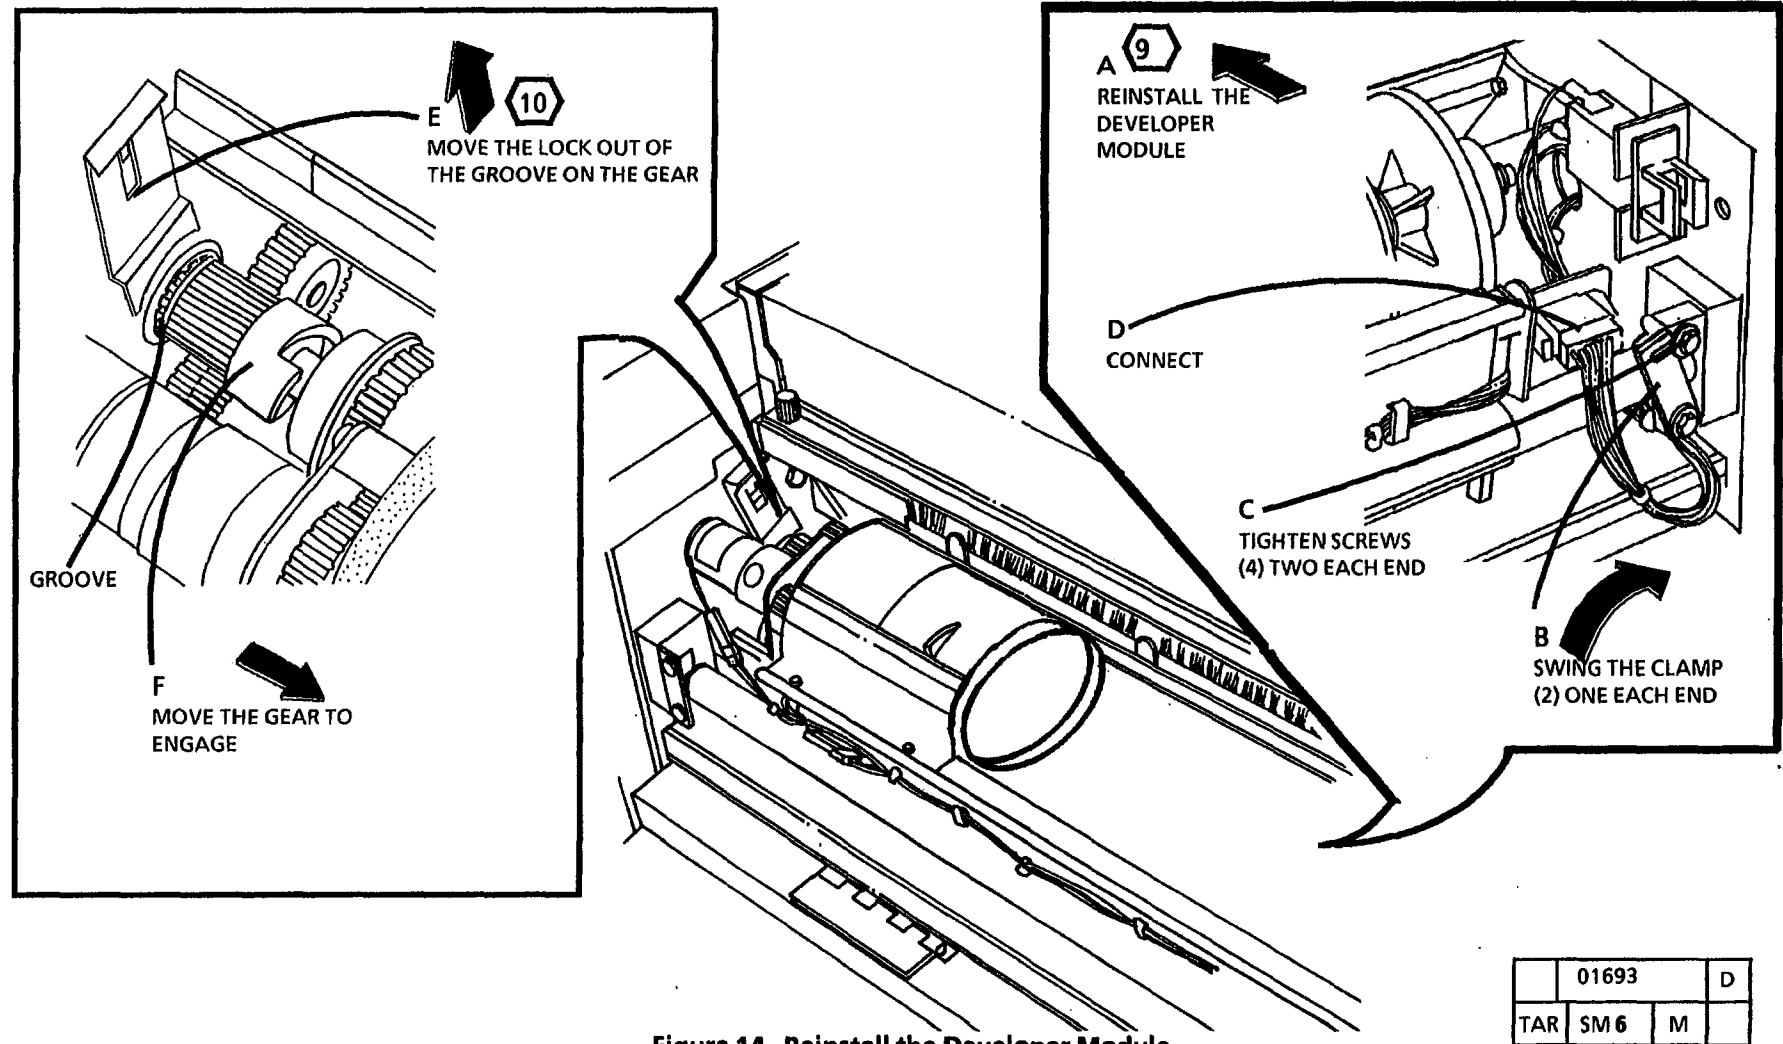
Figure 14. Reinstall the Developer Module

21. (Figure 14): Reinstall the Developer Module.
